## VEGETATION MANAGEMENT ASSESSMENT

**ASSESSMENT NO.: J14535A**

**Report Conducted on 29 August 2017**

**Property Address:** Go Print, 371 Vulture Street, Woolloongabba

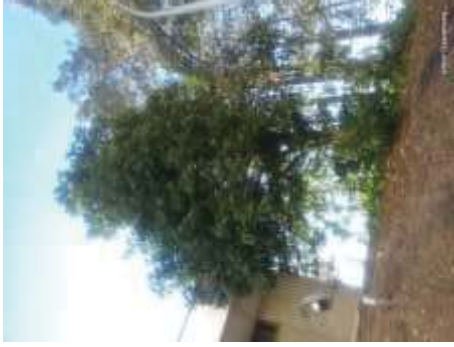
Photo 24: T054

- a) The location of these two specimens will not be compatible with proposed demolition works. Associated understorey shall require removal for access to the wall of the structure. Erection of scaffolding may be required to facilitate initial works.

- b) Remove trees, cut as low as possible and apply chemicals to prevent regrowth. Removal to be undertaken by an appropriately qualified AQF level 3 arborist and supervised by the project arborist.

- d) We have noted the presence of a potential stick bird's nest. Curlews frequent the area beneath the crowns of these specimens. A fauna spotter catcher shall be appointed and pre and post clearing reports undertaken.

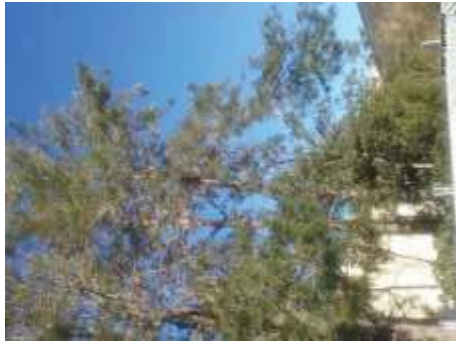
Photo 26: T056

T056	<i>Grevillea robusta</i>	Silky Oak	51.1	6.13	17.70	8	No	Good	Fair	Semi-Mature	Crown has a bias to the South with limited lateral growth to the North.
T057	<i>Grevillea robusta</i>	Silky Oak	46.2	5.54	17.00	9	No	Good	Fair	Semi-Mature	Crown has a bias to the South. Raised roots present.
T058	<i>Grevillea robusta</i>	Silky Oak	56.3	6.76	15.10	8	No	Fair	Fair	Semi-Mature	Crown has a bias to the North.

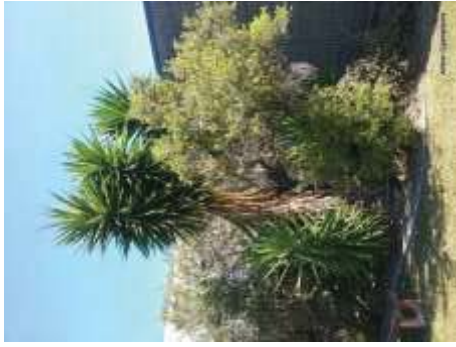
Photo 29: T059

Tree ID	Scientific Name	Common Name	DBH (cm)	TPZ (m)	Height (m)	Canopy Spread (m)	BCC SLT	Health	Form	Age	Comments
T059	<i>Yucca sp.</i>	Yucca	17.5	3.05	4.60	4	No	Good	Fair	Semi-Mature	Twin-stem structure.
T060											*** INTENTIONALLY BLANK – TREE NUMBER NOT USED ***
T061											*** INTENTIONALLY BLANK – TREE NUMBER NOT USED ***
T062											*** INTENTIONALLY BLANK – TREE NUMBER NOT USED ***
T063											*** INTENTIONALLY BLANK – TREE NUMBER NOT USED ***
T064	<i>Casuarina glauca</i>	Swamp She Oak	16.9	2.68	11.20	4	No	Good	Poor	Semi-Mature	Multi-stem with a weak union at the base.
T065	<i>Casuarina glauca</i>	Swamp She Oak	17.9	2.15	10.20	4	No	Good	Fair	Semi-Mature	Structure typical of the species.
T066	<i>Casuarina glauca</i>	Swamp She Oak	20.0	2.40	11.40	4	No	Good	Fair	Semi-Mature	Structure typical of the species.
T067	<i>Casuarina glauca</i>	Swamp She Oak	15.9	2.00	10.30	4	No	Good	Fair	Semi-Mature	Structure typical of the species.

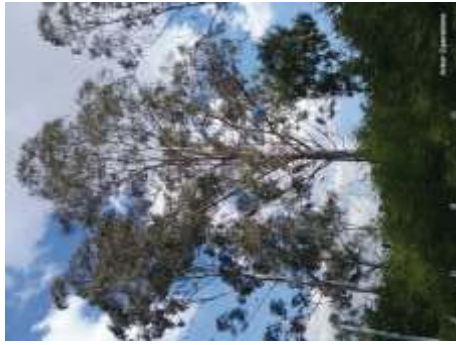
Photo 46: T109

T109	<i>Eucalyptus tereticornis</i>	Forest Red Gum	58.3	7.00	22.50	11	No	Good	Good	Semi-Mature	Deadwood is present. Bauhinia understorey is present.
T110	<i>Corymbia tessellaris</i>	Moreton Bay ash	15.0	2.00	8.30	4	No	Good	Fair	Semi-Mature	Multi-stem at 3m. Bauhinia understorey is present.
T111	<i>Corymbia tessellaris</i>	Moreton Bay ash	15.3	2.00	5.20	4	No	Good	Good	Semi-Mature	Bauhinia understorey is present.
T112	<i>Eucalyptus tereticornis</i>	Forest Red Gum	43.0	5.16	20.10	9	No	Good	Fair to good	Semi-Mature	Deadwood is present. Tip die-back is present. Bauhinia understorey is present.
T113	<i>Corymbia tessellaris</i>	Moreton Bay ash	21.3	2.56	9.60	4	No	Good	Good	Semi-Mature	Deadwood is present. Bauhinia understorey is present.
T114	<i>Eucalyptus tereticornis</i>	Forest Red Gum	48.7	5.84	19.90	12	No	Good	Good	Semi-Mature	Major deadwood is present. 1x stick nest is present. Bauhinia understorey is present.
