## **VEGETATION MANAGEMENT ASSESSMENT**

**ASSESSMENT NO.: J14535B**

**Report Conducted on 29 August 2017**

**Property Address:** South Brisbane Dental Clinic, Cnr Main &  
Stanley Streets, Woolloongabba

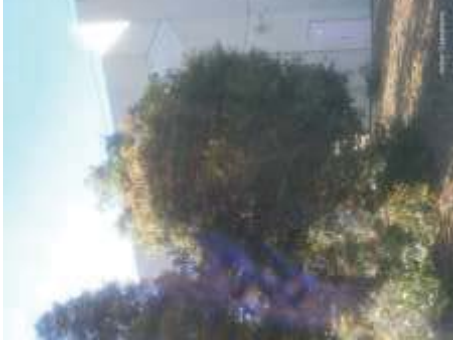
Photo 1: T119

Tree ID	Scientific Name	Common Name	DBH (cm)	TPZ (m)	Height (m)	Canopy Spread (m)	BCC SLT	Health	Form	Age	Comments
T119	<i>Syzygium smithii</i>	Lilly Pilly	15.7	3.11	4.20	3	No	Good	Fair to good	Semi-Mature	Multi-stem. Good crown density. Curlews frequent the area beneath the crown.
T120	<i>Syzygium smithii</i>	Lilly Pilly	19.6	2.35	3.50	3	No	Good	Fair to good	Semi-Mature	Good crown density. Curlews frequent the area beneath the crown.
T121	<i>Syzygium smithii</i>	Lilly Pilly	17.2	2.06	3.80	3	No	Good	Fair	Semi-Mature	Good crown density. Curlews frequent the area beneath the crown.
T122	<i>Auranticarpa rhombifolia</i>	Holly Wood	25.8	3.10	9.80	8	No	Good	Fair to good	Semi-Mature	Crown has a bias to the South East. Good crown density. Tree is impacting on the wall of the structure.
T123	<i>Tipuana tipu</i>	Tipuana	16.9	3.27	6.20	7	No	Good	Fair to poor	Semi mature	Crown has a bias to the South West with a tight fork union at the base. Tree is seeding.

### **1) T119-T121**

- a) Establish TPZ around the edge of the kerb to the south. Ensure trees are not impacted by traffic movements associated with demolition works.
- b) We have noted the potential presence of Curlews which frequent the area beneath the crown. A fauna spotter/catcher shall be appointed and pre and post clearing reports undertaken.
- c) Incorporation of these specimens into future design may limit optimal use of the site. However should retention be preferred, any works which fall within the TPZ shall be supervised by the project arborist.

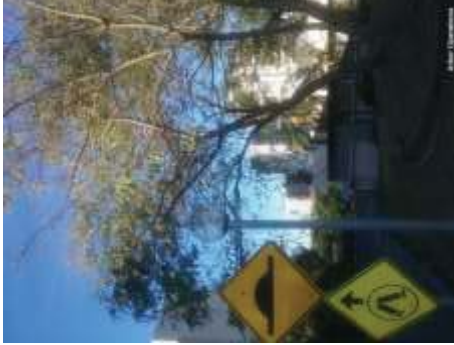
Photo 6: T124

T124	<i>Tipuana tipu</i>	Tipuana	26.5	3.18	9.10	8	No	Good	fair	Semi mature	Crown has a bias to the North West. Tree is seeding.
T125	<i>Tipuana tipu</i>	Tipuana	63.8	7.66	15.20	13	No	Good	fair	Semi Mature	Good crown balance. Tree is seeding.
T126	<i>Tipuana tipu</i>	Tipuana	50.4	6.05	12.20	15	No	Good	fair	Semi Mature	Crown has a bias to South and overhangs the roadway. Tree is seeding.
T127	<i>Tipuana tipu</i>	Tipuana	45.0	5.40	9.10	13	No	Good	fair	Semi Mature	Tree is seeding. Environmental Weed Species.
T128	<i>Syagrus romanzoffiana</i>	Cocos Palm	22.1	2.65	6.60	4	No	Good	Fair	Semi-Mature	Environmental Weed Species.
T129	<i>Syagrus romanzoffiana</i>	Cocos Palm	25.0	3.00	10.80	5	No	Good	Fair	Semi Mature	Environmental Weed Species. Tree is seeding.
T130	<i>Jacaranda mimosifolia</i>	Jacaranda	34.9	4.19	8.80	10	No	Good	Good	Seeding	Tree is seeding.
T131	<i>Jacaranda mimosifolia</i>	Jacaranda	33.8	4.06	8.90	11	No	Good	Good	Seeding	Tree is seeding.

### **3) T123- T127**

- a) Establish TPZ around the edge of the kerb to ensure trees are not impacted by traffic movements associated with demolition works. The fence should also be established between the eastern side of the specimens location and connect to the roadways.
- b) Retention of the stand will allow for a green buffer whilst demolition works are being undertaken.
- c) These specimens are in fair to good health and can be included in any landscape concept plan. Consideration should be given to removing T123 due to its suppressed structure and inappropriate location.
- d) We note the crown of T127 overhangs the roadway to the south. It shall require canopy raising to ensure traffic movement does not damage the crown.

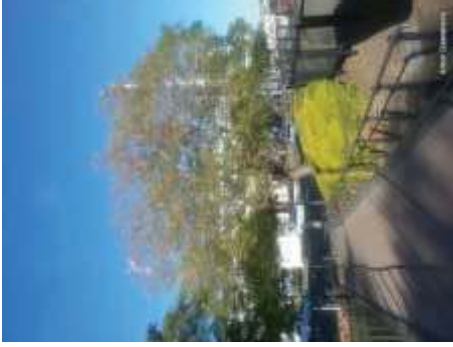
Photo 14: T132

T132	<i>Jacaranda mimosifolia</i>	Jacaranda	53.3	6.40	9.20	14	No	Good	Fair to good	Seeding	Tree is seeding.
T133	<i>Delonix regia</i>	Poinciana	43.7	7.73	8.30	13	No	Good	Good	Semi Mature	Multi-stem. Raised roots are present. Tree is seeding.
T134	<i>Delonix regia</i>	Poinciana	47.0	5.64	10.80	12	No	Fair	Poor	Semi Mature	This tree has been "topped" and possesses a bias to North. Tree is seeding.

**6) T132**

- a) This specimen is located on the South East corner of the precinct at the edge of the busway precinct.
- b) Establish a TPZ around the edge of the kerb to ensure trees are not impacted by construction related traffic movements associated with demolition works.
- c) Retention will allow for a green buffer whilst demolition works are being undertaken.
- d) This specimen is in fair to good health and can be included in any future landscape concept plan.

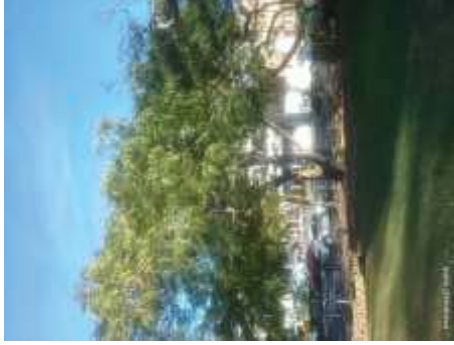
Photo 17: T135

Tree ID	Scientific Name	Common Name	DBH (cm)	TPZ (m)	Height (m)	Canopy Spread (m)	BCC SLT	Health	Form	Age	Comments
T135	<i>Delonix regia</i>	Poinciana	53.8	7.76	8.10	13	No	Good	Fair to poor	Semi mature	Raised roots are present. Major deadwood is present. Tree is seeding.
T136	<i>Delonix regia</i>	Poinciana	33.8	5.21	7.60	10	No	Good	Poor	Seeding	Multi-stem. Raised roots are present.
T137	<i>Delonix regia</i>	Poinciana	75.2	9.02	8.10	13	No	Fair to poor	Fair	Semi Mature	High level of Nectria is present. Sparse crown.
T138	<i>Jacaranda mimosifolia</i>	Jacaranda	35.5	4.26	7.80	10	No	Good	Fair to poor	Semi Mature	BCC street tree. Damaged lateral with epicormic growth to East.
T139	<i>Jacaranda mimosifolia</i>	Jacaranda	34.8	4.18	7.90	10	No	Good	Fair to poor	Semi Mature	BCC street tree with a suppressed bias to the East.
T140	<i>Delonix regia</i>	Poinciana	60.5	7.26	7.20	13	No	Good	Good	Semi Mature	Tree is seeding.

**7) T133-T137**

- a) Establish TPZ around the edge of the kerb to the east, south and north to ensure trees are not impacted by traffic movements associated with demolition works.

- d) Remove major deadwood over the BCC footpath to the west.
- e) Minor crown trimming may be required for construction related activity. Not more than 15-20% of vegetative matter to be removed in any one year. These works shall be performed by an appropriately qualified AQF level 3 arborist and authorised by the project arborist.
