Herston Quarter Heritage Precinct

Heritage Building
Dilapidation Report

Prepared for Australian Unity

24 May 2019

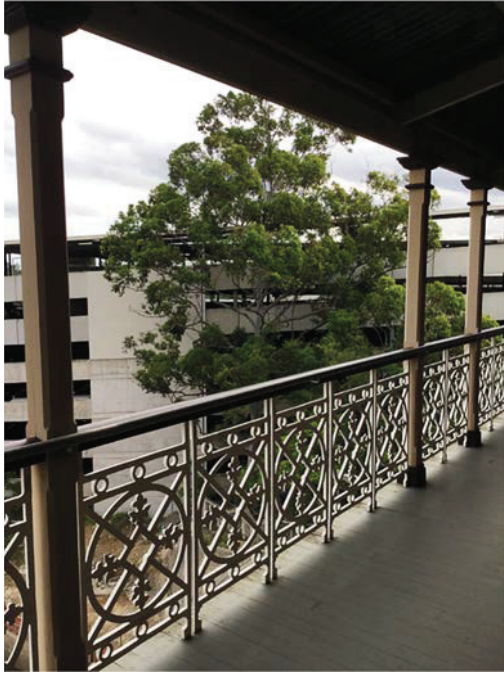
Photo 13

Comments: View of external balcony balustrade.
From location report: B3.L1.R12

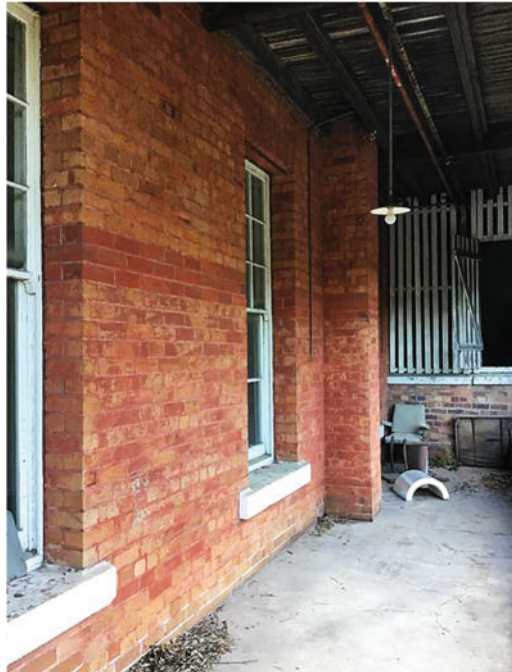
Photo 16

Comments: External view of brick façade. General wear of finishes.
From location report: B1.1896.B.B01

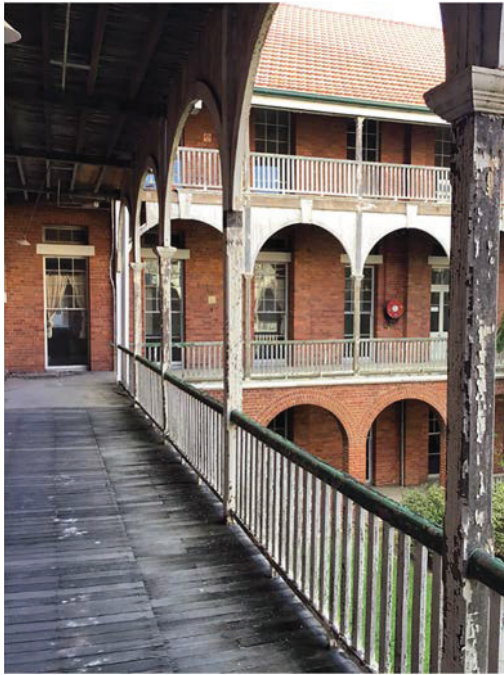
Photo 17

Comments: External view of timber balcony. General wear of timber surfaces and finishes.

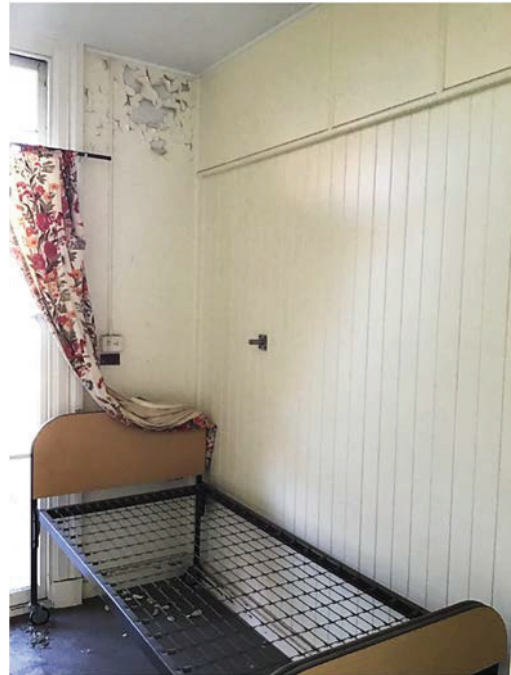
Photo 18

Comments: General view of wall partition. Wear of finishes.

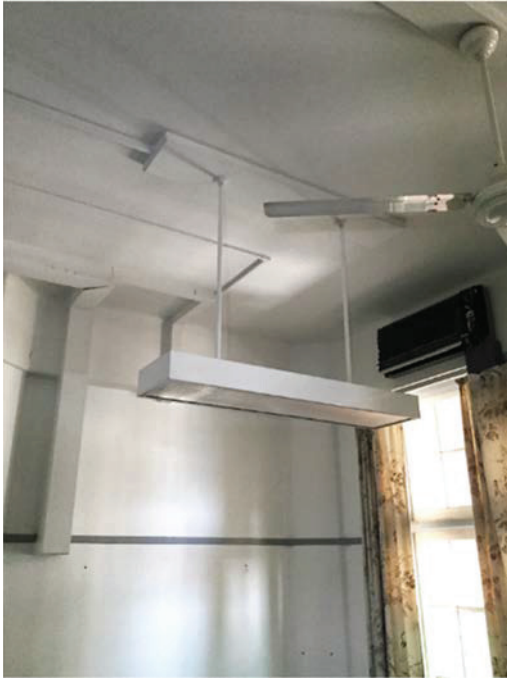
Photo 45

Comments: View of internal common room ceiling.
From location report: B1.NT.L2.R01

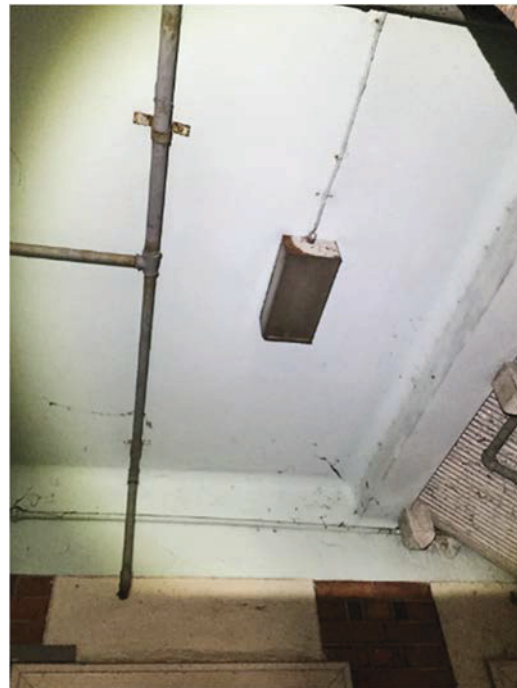
Photo 56

Comments: View of internal ceiling. Wear of ceiling services, corrosion.

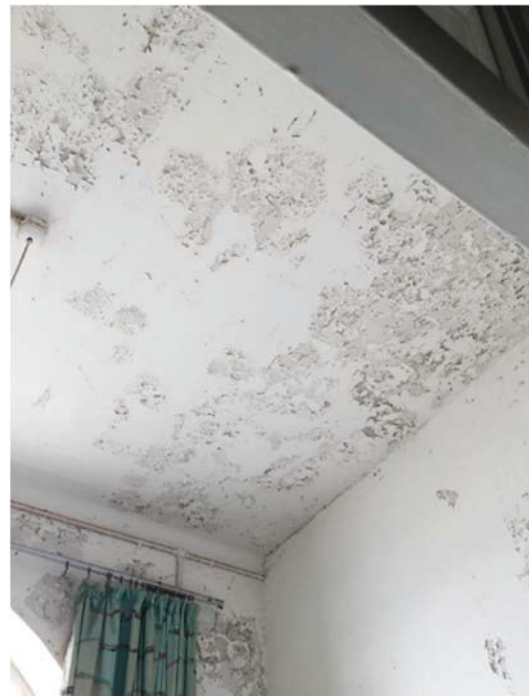
Photo 60

Comments: View of internal ceiling. Wear of finishes, peeling.

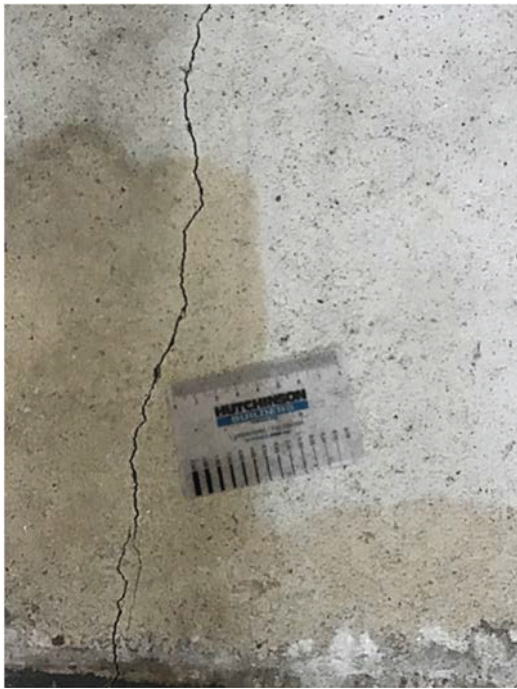
Photo 65

Comments: View of internal flooring. Concrete cracking.

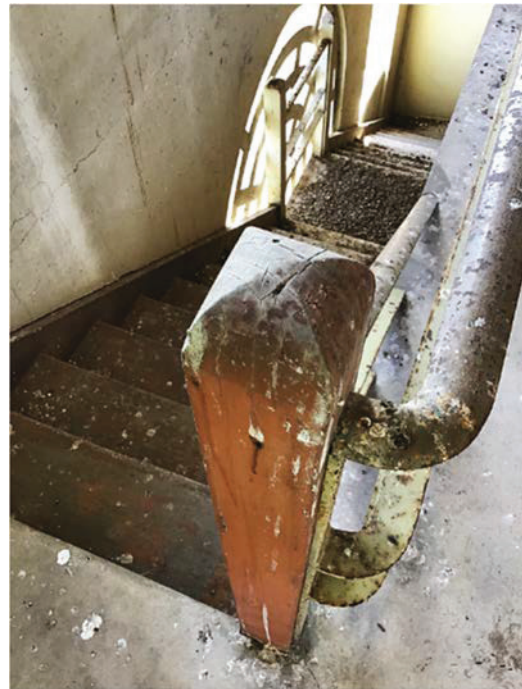
Photo 66

Comments: View of external balcony stairs. Cracking / wear of timber. Wear of finishes.

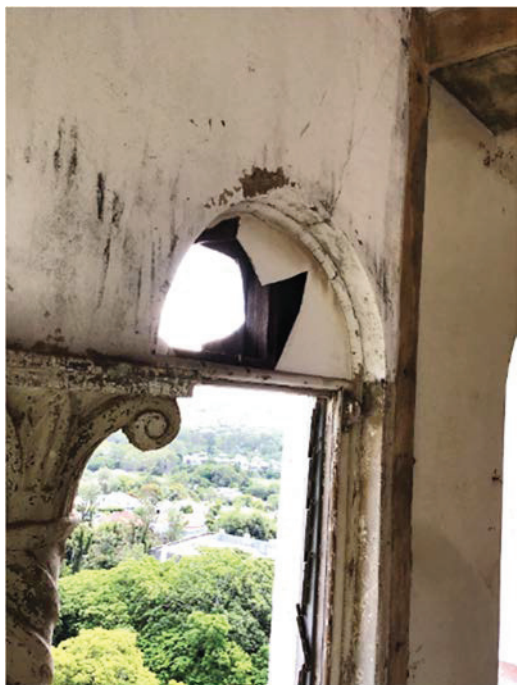
Photo 67

Comments: View of external façade. Damage to wall cladding.

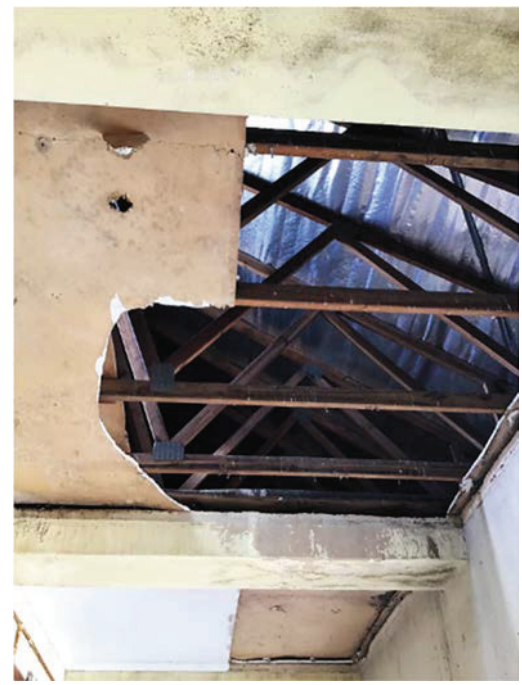
Photo 68

Comments: View of balcony ceiling. Damaged ceiling cladding, structure exposed to environment.

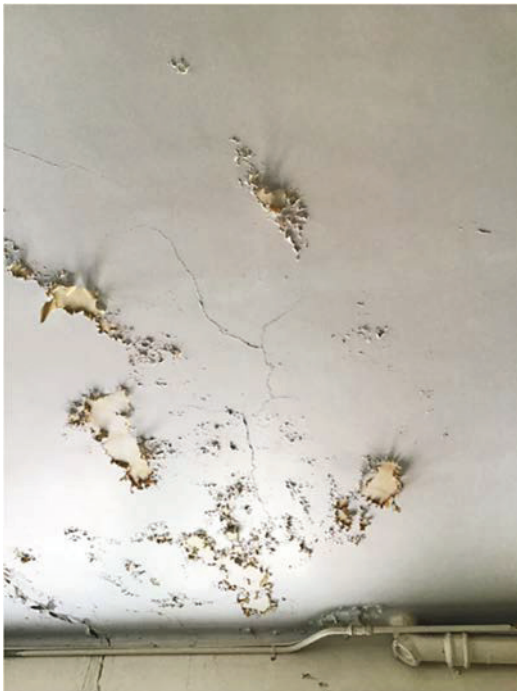
Photo 69

Comments: View of internal ceiling. Concrete cracking and wear of finishes, peeling.

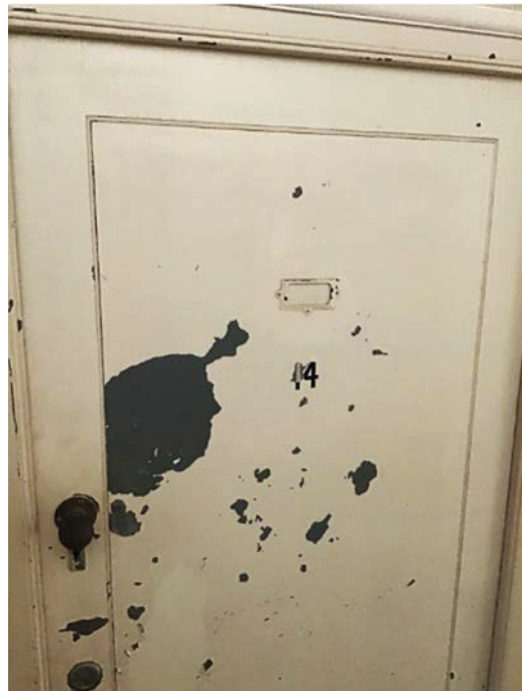
Photo 70

Comments: View of internal door. Damage to surface finish.

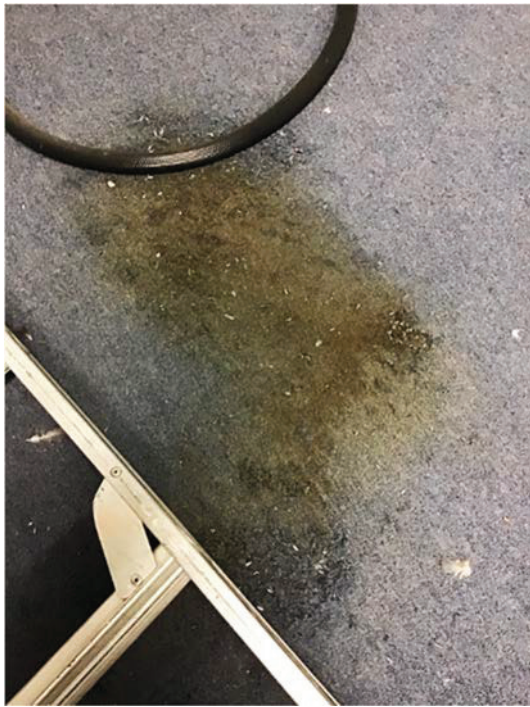
Photo 73

Comments: View of internal floor. Damage to finish, stained carpet.

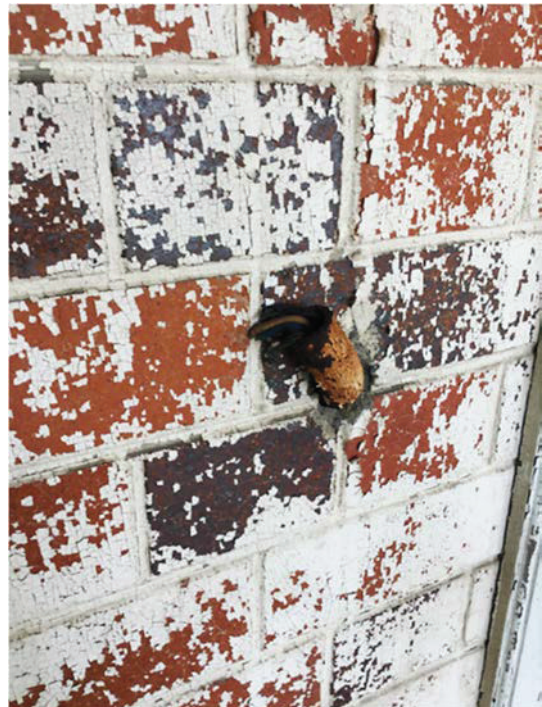
Photo 74

Comments: View of brick façade from outside. Damage to finishes, paint peeling. Exposed service.

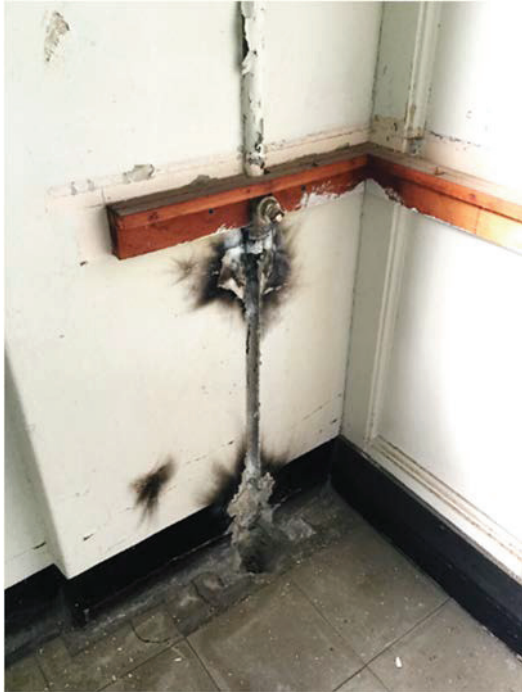
Photo 77

Comments: View of internal wall. Damage to service. Exposed floor penetration.

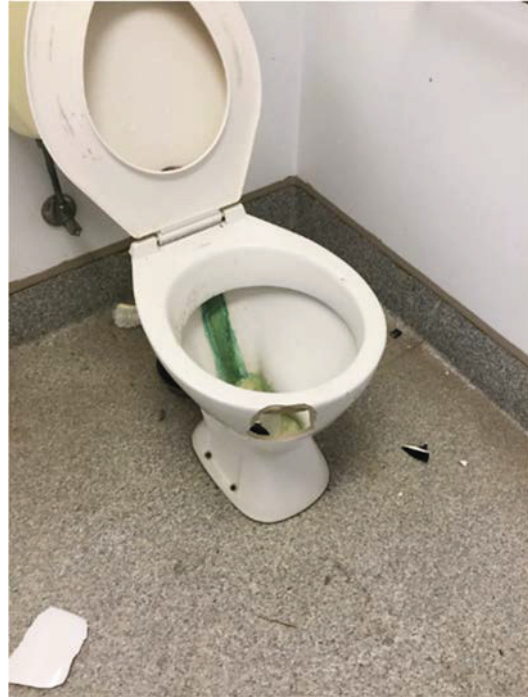
Photo 78

Comments: View of internal fixture. Damaged fixture.

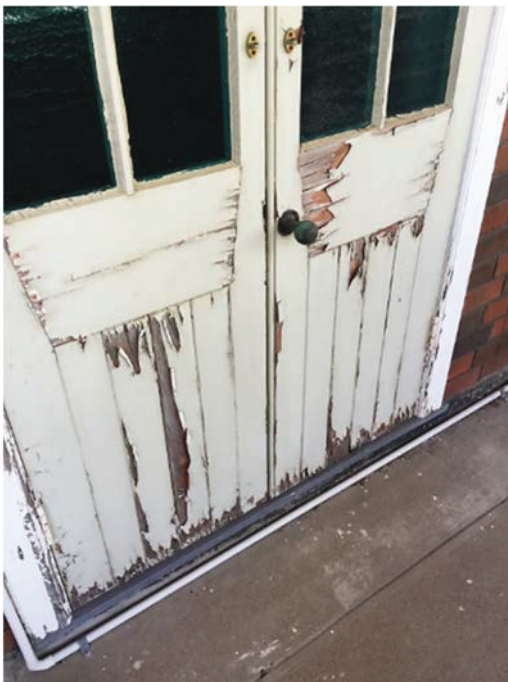
Photo 79

Comments: View of external timber door from outside. Wear of timber and finishes, paint peeling.

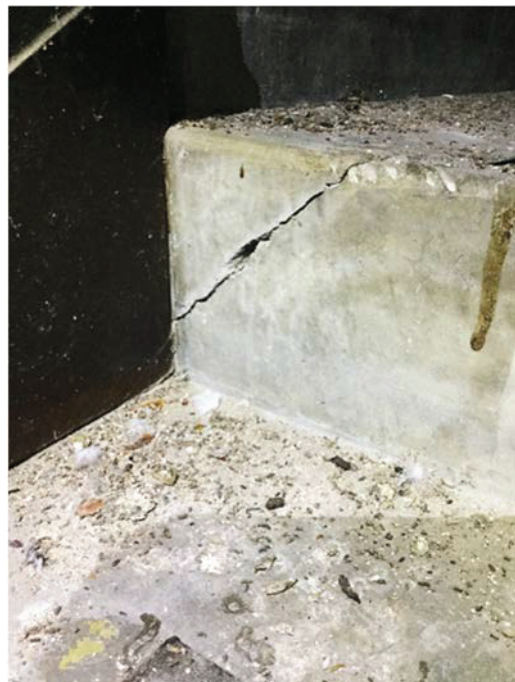
Photo 80

Comments: View of internal stairs. Concrete cracking, debris.

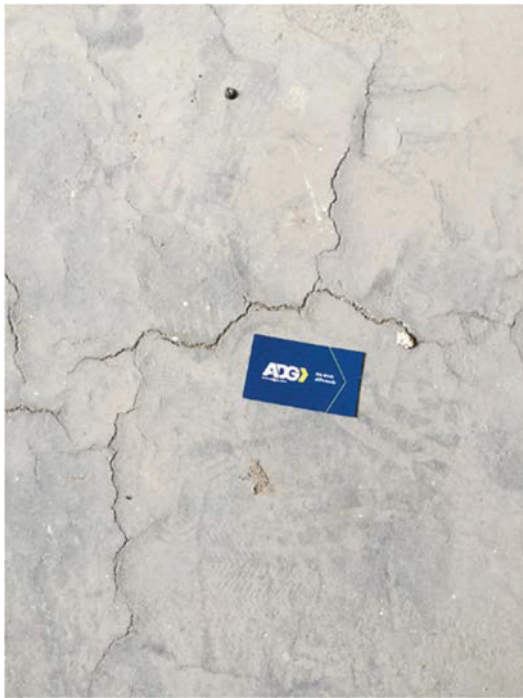
Photo 81

Comments: View of flooring. Cracking.
From location report: B1.NT.L1.B03

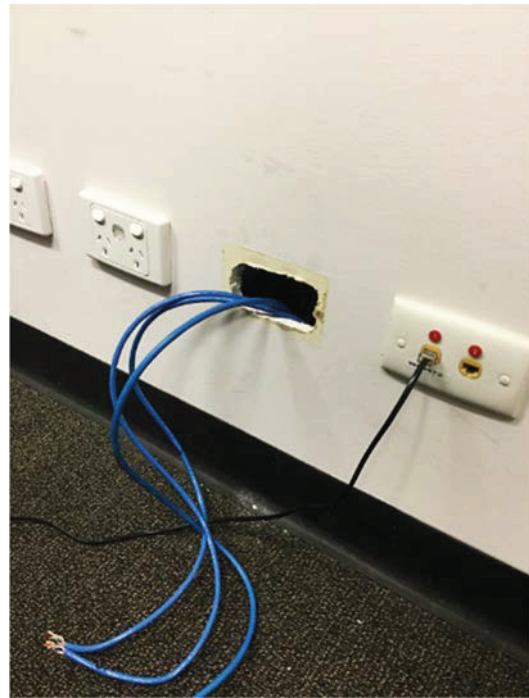
Photo 82

Comments: View of internal office space. Damaged fixture. Exposed wiring.
From location report: B1.NT.B.R10

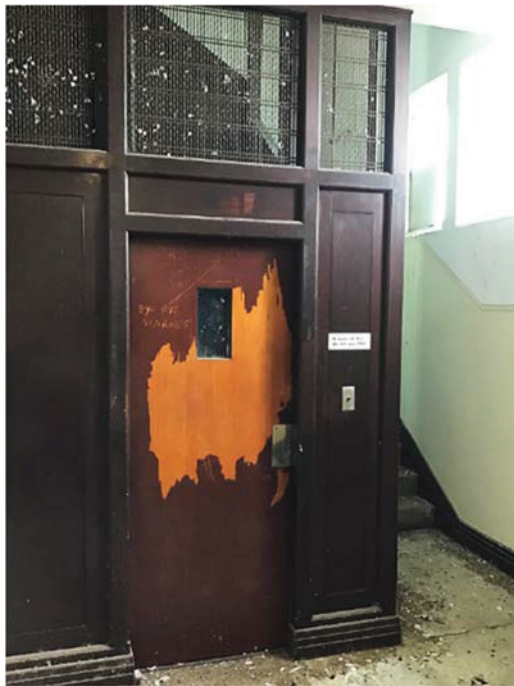
Photo 83

Comments: View of timber lift cladding. Damage to surface. Areas with scratch marks.
From location report: B1.ST.L4.L01

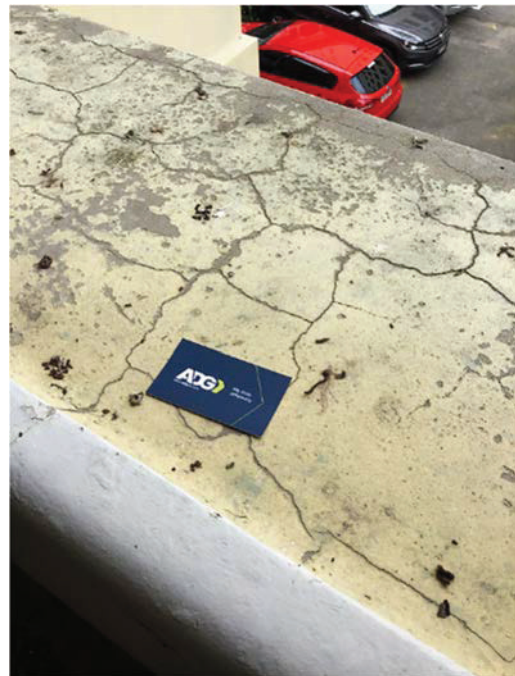
Photo 84

Comments: View of external balcony balustrade. Concrete cracking, damage to finishes, peeling.
From location report: B1.NT.L1.B02

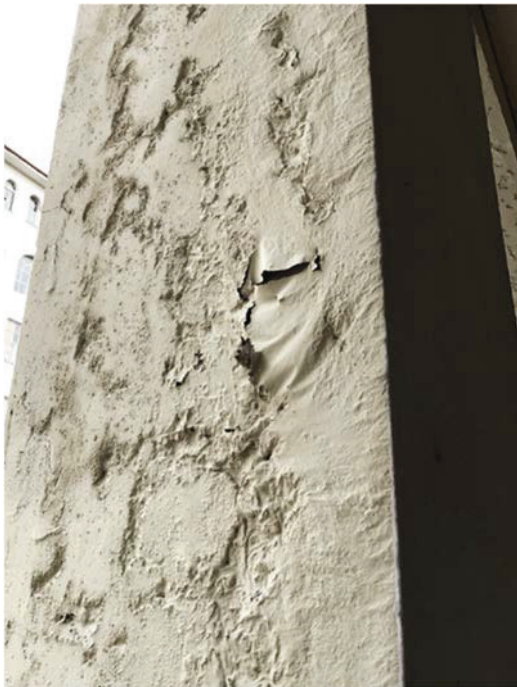
Photo 85

Comments: View of external balcony columns. Surface damage, peeling.

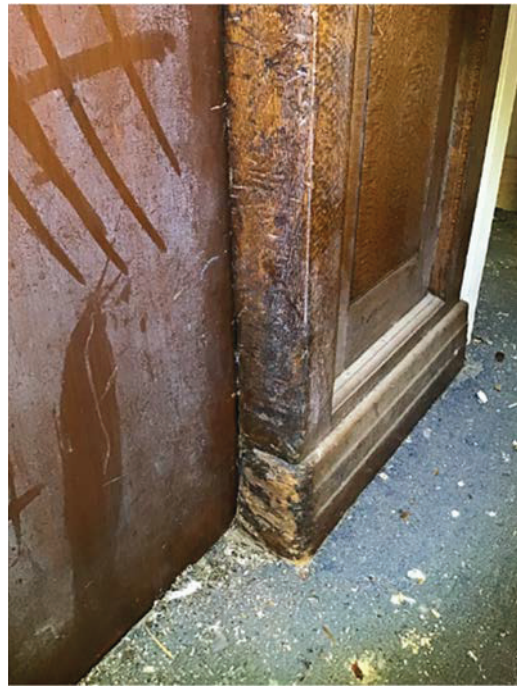
Photo 86

Comments: View of timber lift cladding. Damage to timber, scratch marks.

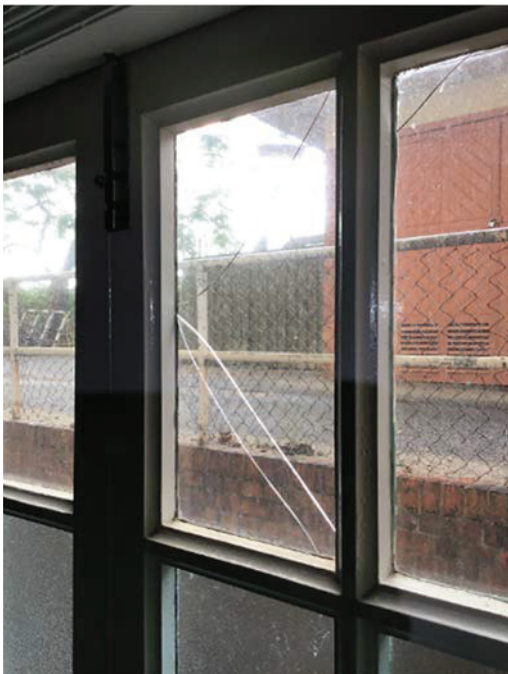
Photo 87

Comments: View of external glazing from inside. Damage to glazing, cracking.

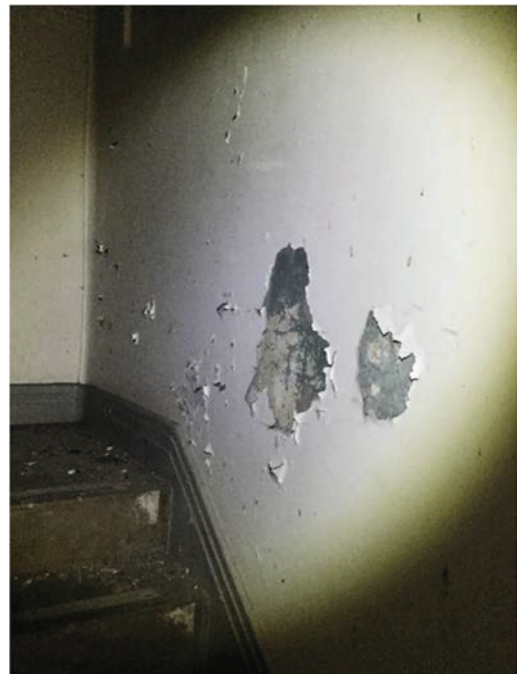
Photo 88

Comments: View of internal stair wall. Damage to finishes, peeling.

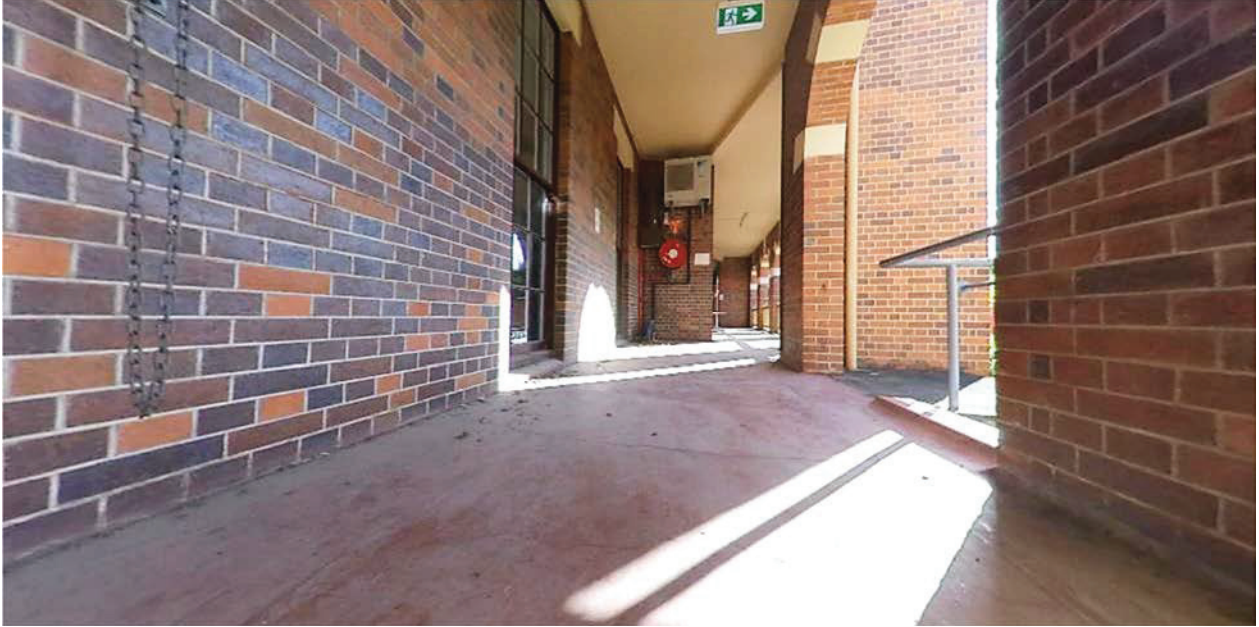
Photo 93

Comments: View of external ground floor balcony walls

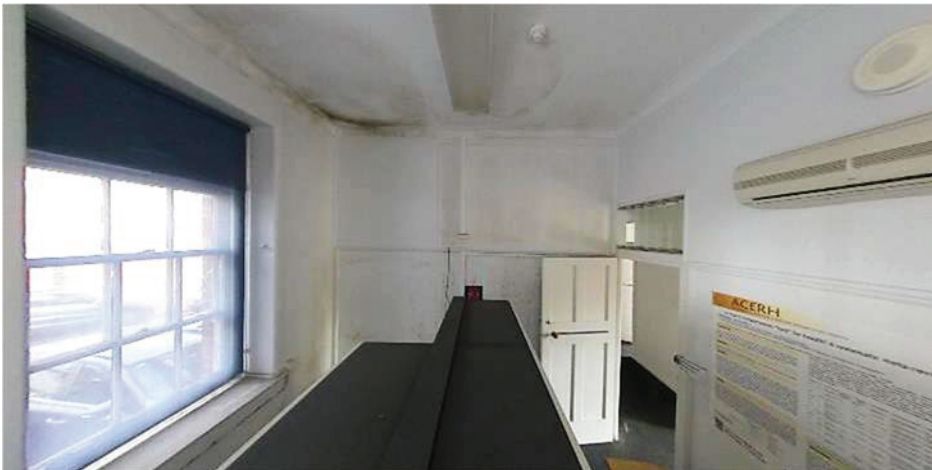
Photo 97

Comments: View of internal ground floor room. Visible surface staining, mould.
From location: B2.GF.R16

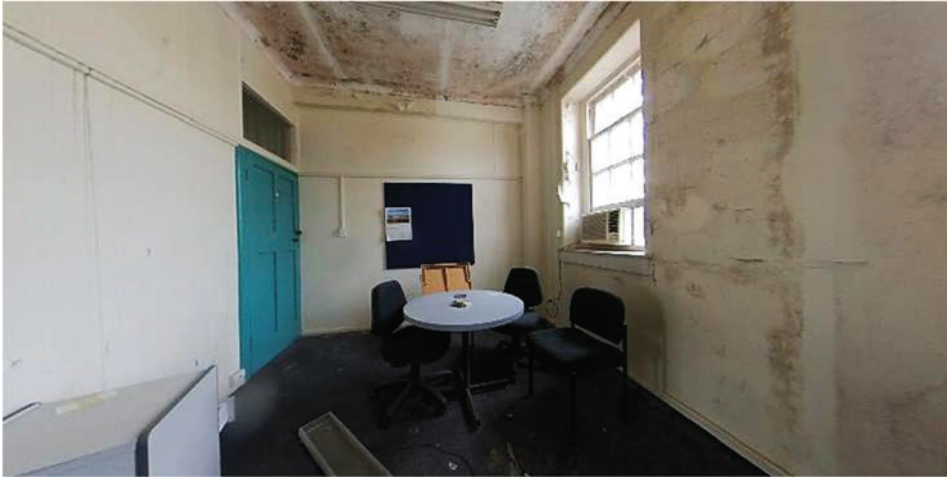
Photo 98

Comments: View of internal level 1 room. Visible surface staining, mould.
From location: B2.L1.R16

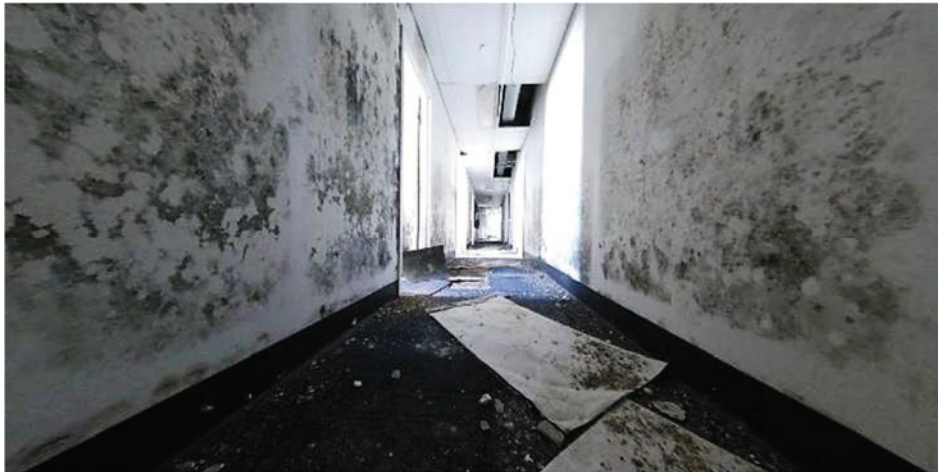
Photo 99

Comments: View of internal level 2 hallway. Significant visible surface staining, mould.
From location: B2.L2.H01.02

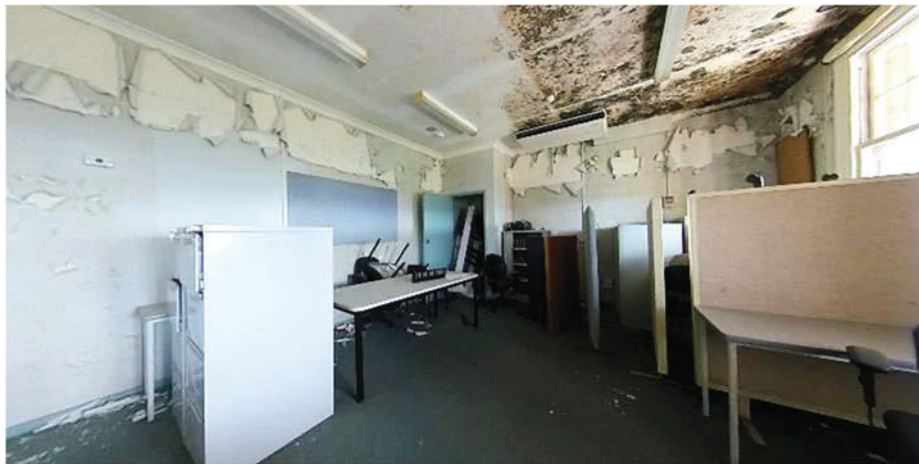
Photo 100

Comments: View of internal level 2 room. Significant surface staining, peeling, mould.
From location: B2.L2.R01

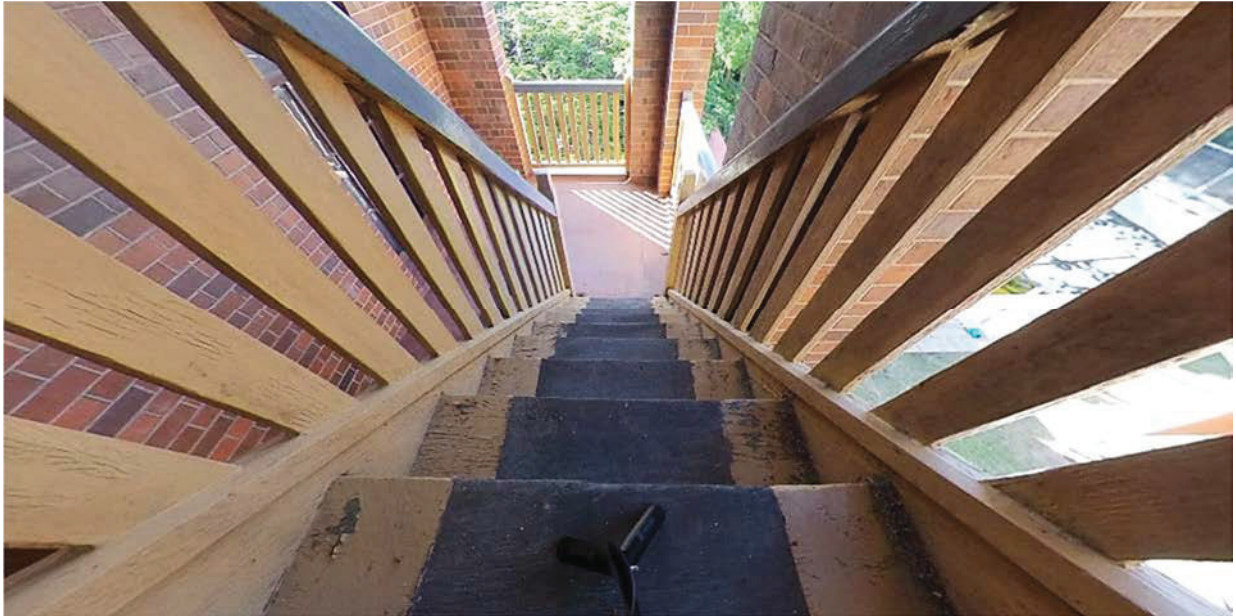
Photo 101

Comments: View of external level 2 stairs.

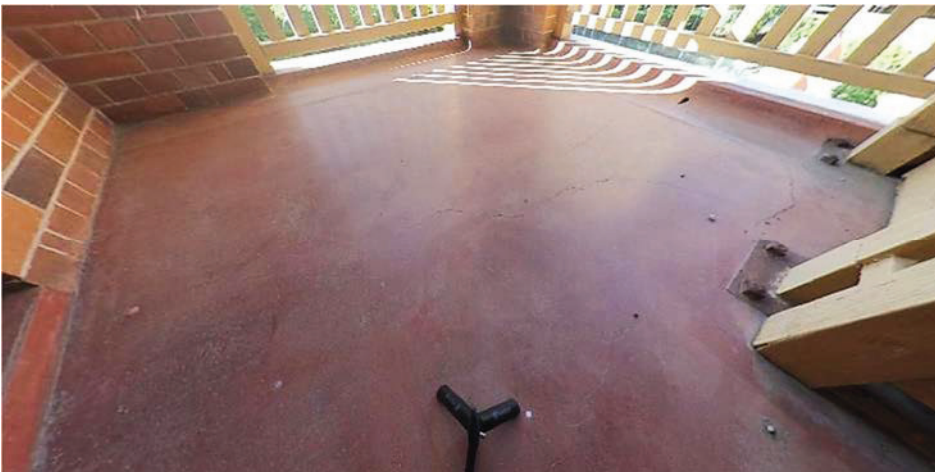
Photo 104

Comments: View of external level 1 balcony floor. Visible surface cracking.
From location: B2.L1.B01.01

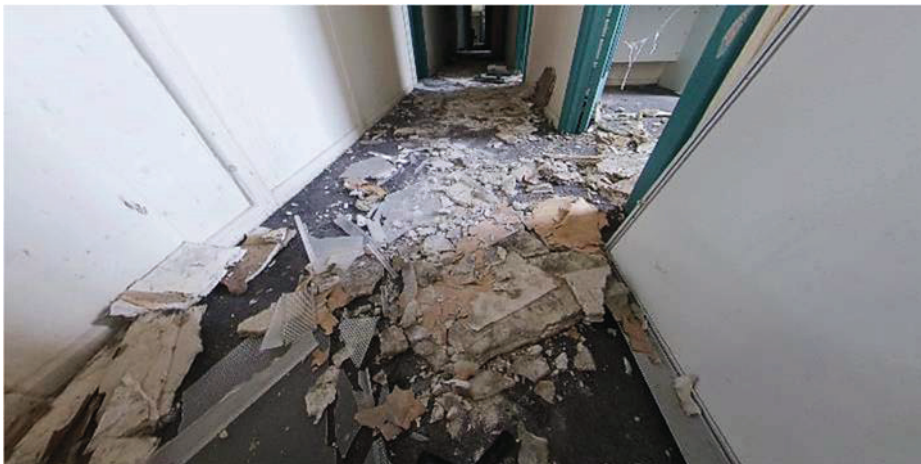
Photo 105

Comments: View of internal level 1 hallway. Collapsed ceiling on floor.
From location: B2.L1.H01.02

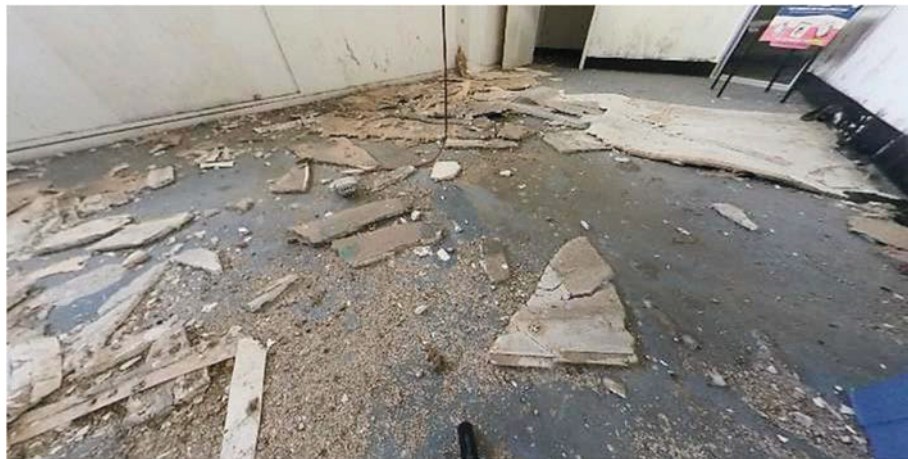
Photo 107

Comments: View of internal level 2 room flooring. Debris from collapsed ceiling over. Staining.
From location: B2.L2.R17

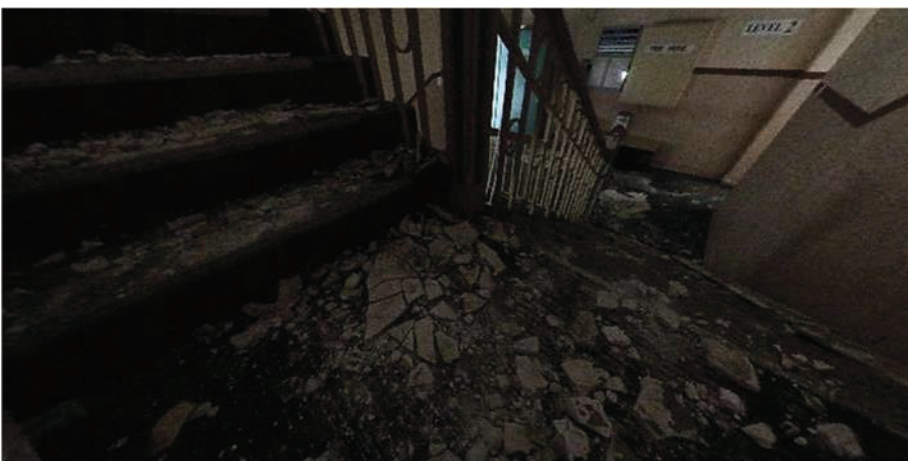
Photo 108

Comments: View of internal level 2 stair flooring. Debris from collapsed ceiling over.
From location: B2.L2.ST01.01

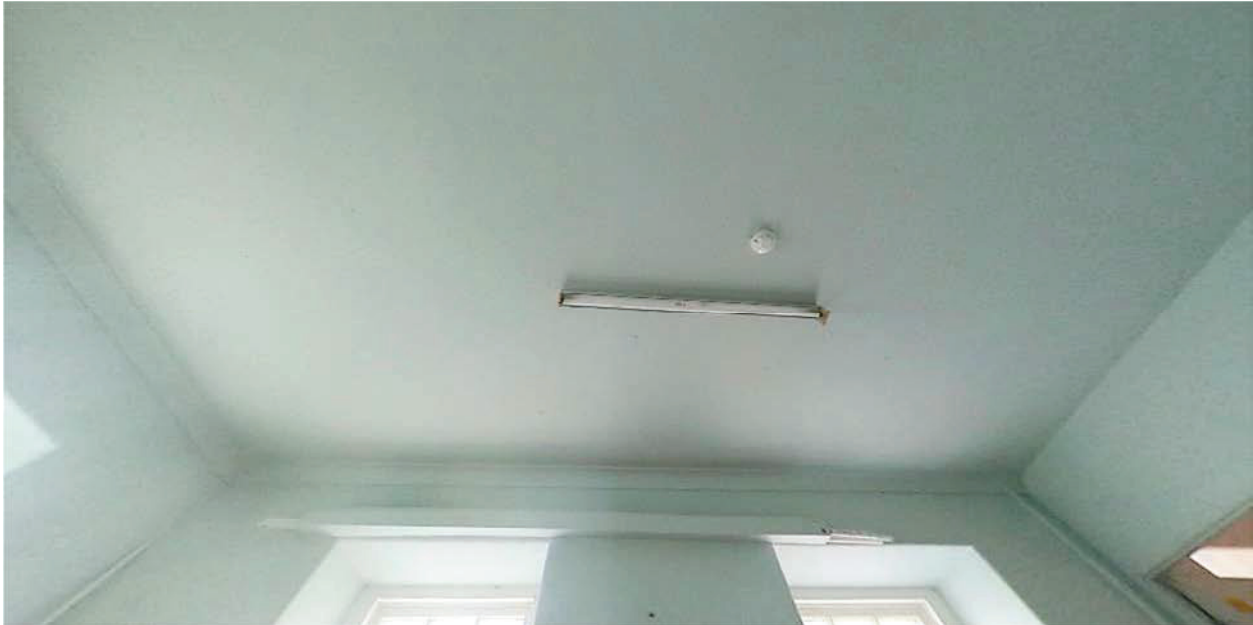
Photo 109

Comments: View of basement internal room ceiling.

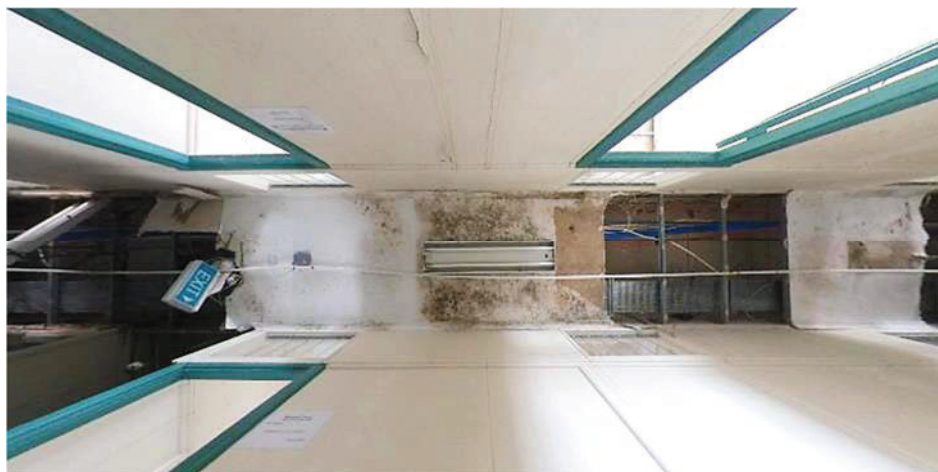
Photo 113

Comments: View of internal level 1 hallway ceiling. Partially collapsed suspended ceiling. Staining, mould.
From location: B2.L1.H01.02

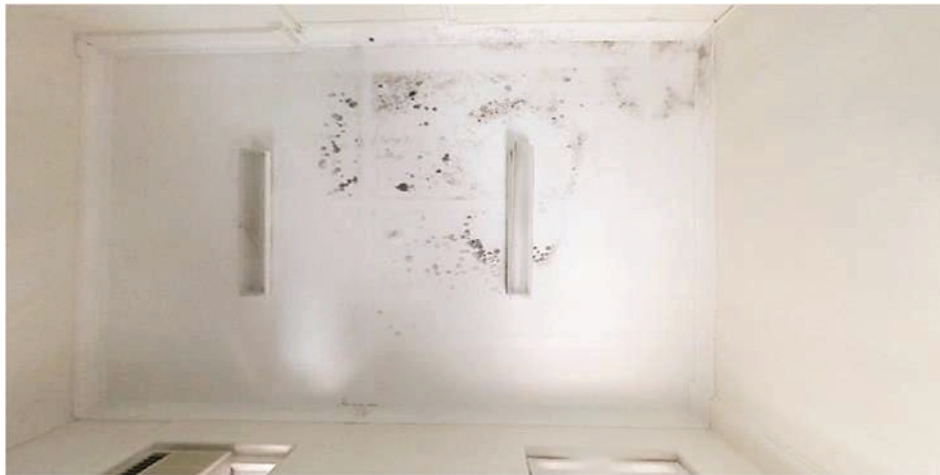
Photo 114

Comments: View of level 1 internal room ceiling. Surface staining, mould.

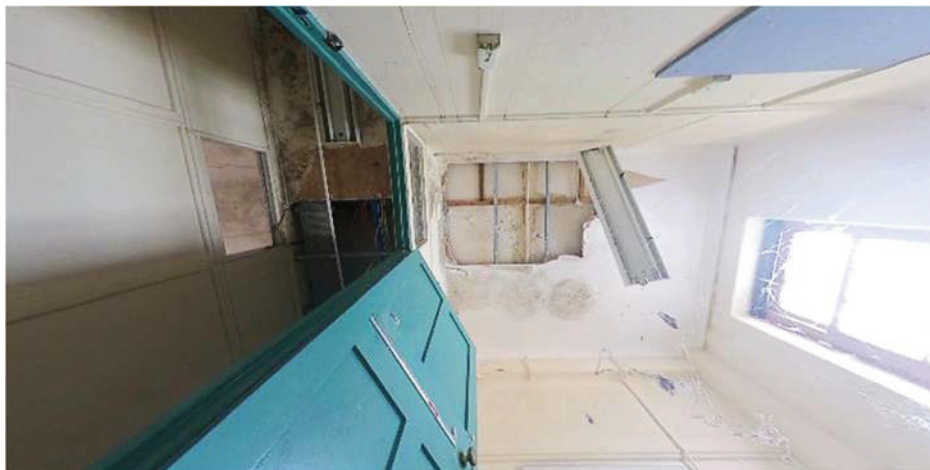
Photo 115

Comments: View of level 1 internal room ceiling. Partial collapse, staining, mould.

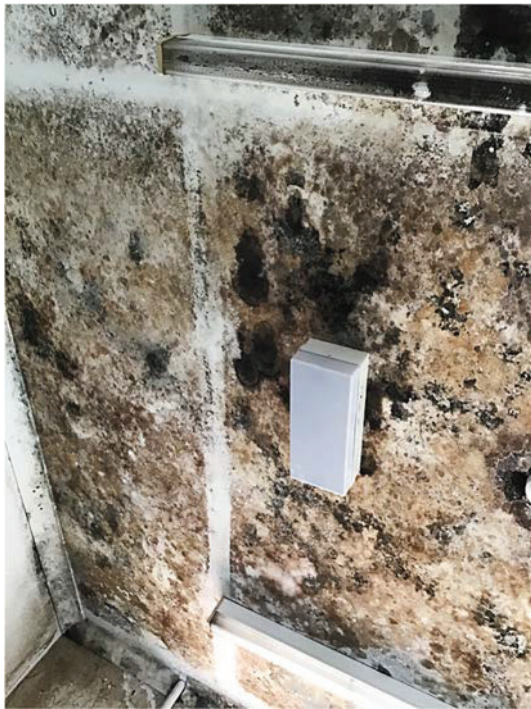
Photo 121

Comments: Significant surface damage, staining, mould.

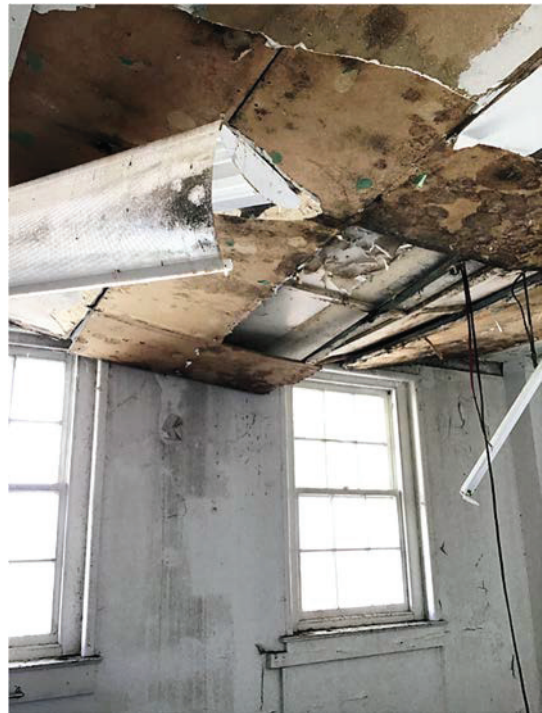
Photo 122

Comments: Major ceiling damage, unstable condition, staining, mould.

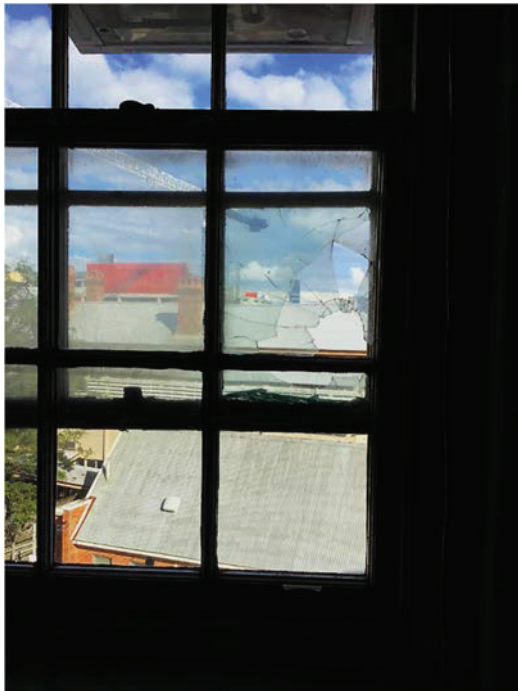
Photo 123

Comments: External glazing damage, broken glass.

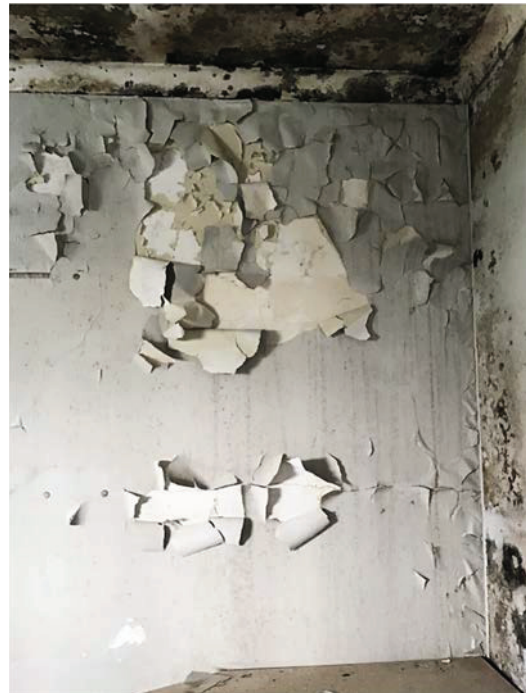
Photo 124

Comments: Extensive surface peeling, staining, mould damage.

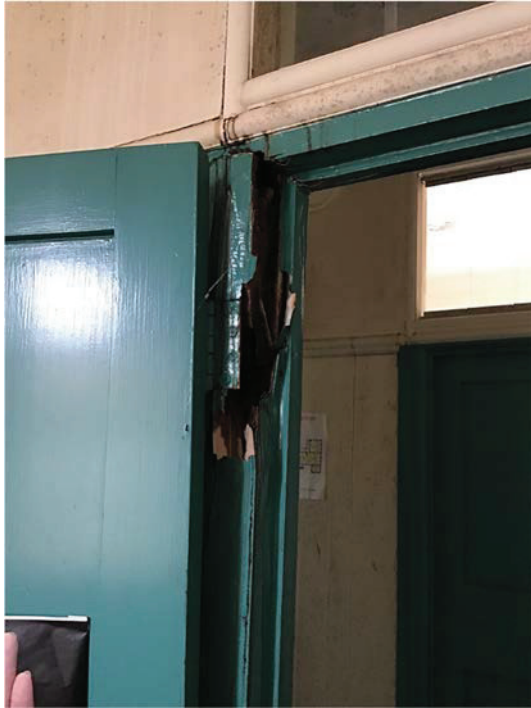
Photo 129

Comments: Damage to timber structure, rotting.
From location report: B2.L1.R17

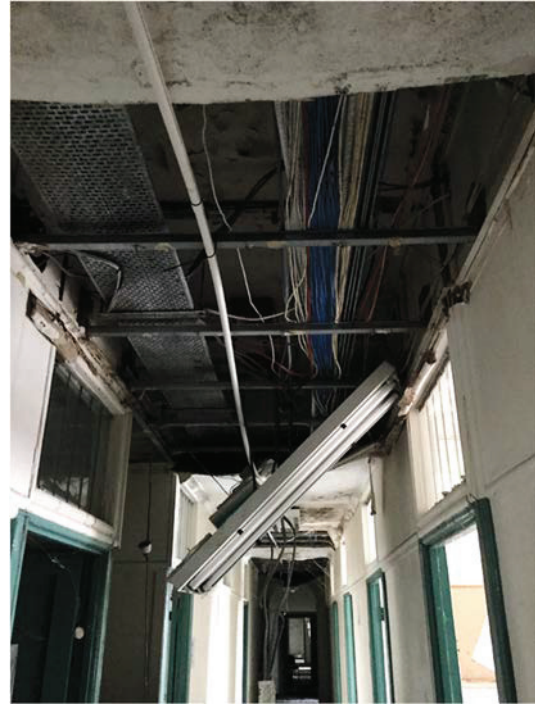
Photo 130

Comments: Damage to suspended ceiling and services.
From location report: B2.L1.H01

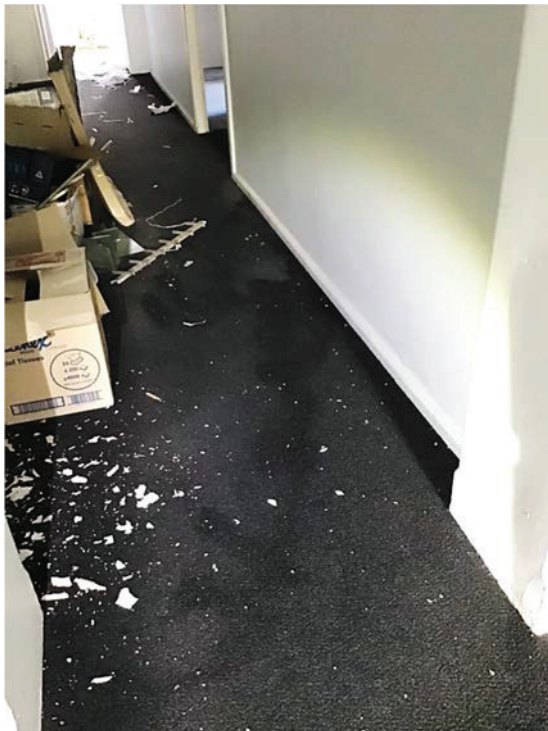
Photo 131

Comments: Damage to floor finishes.
From location report: B2.GF.H03

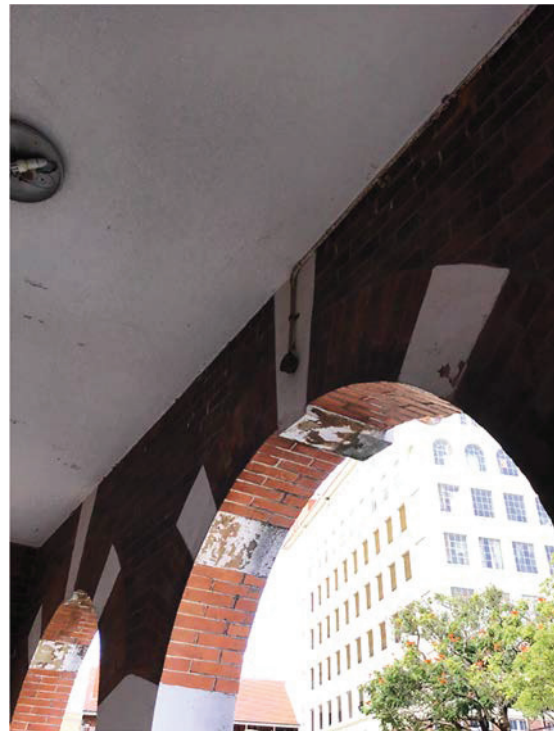
Photo 132

Comments: Surface finish damage to brickwork.
From location report: B2.GF.H02

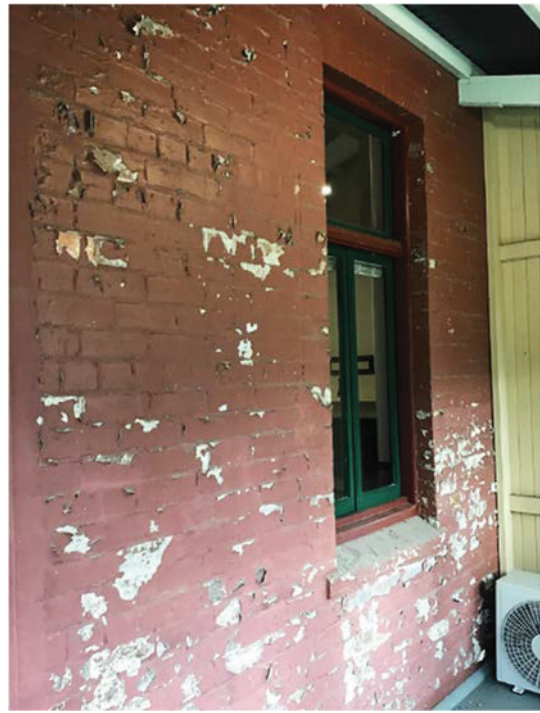
Photo 138

Comments: View of external brick façade. Wear to surface finishes, peeling.
From location report: B3.L1.R18

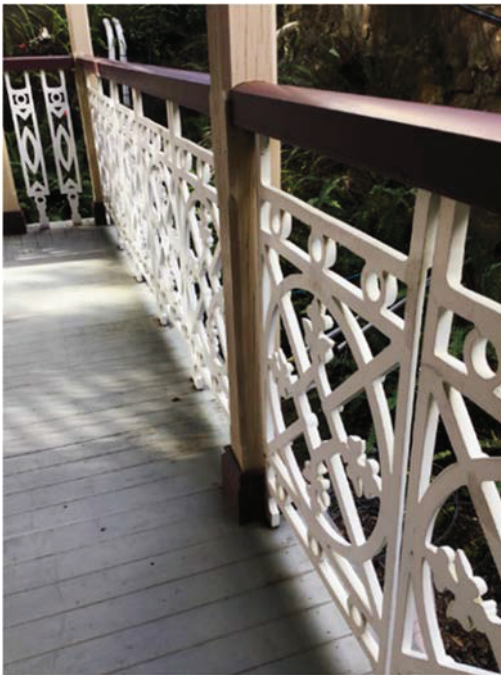
Photo 141

Comments: View of external balcony balustrade. Minor cracking of paint finish.

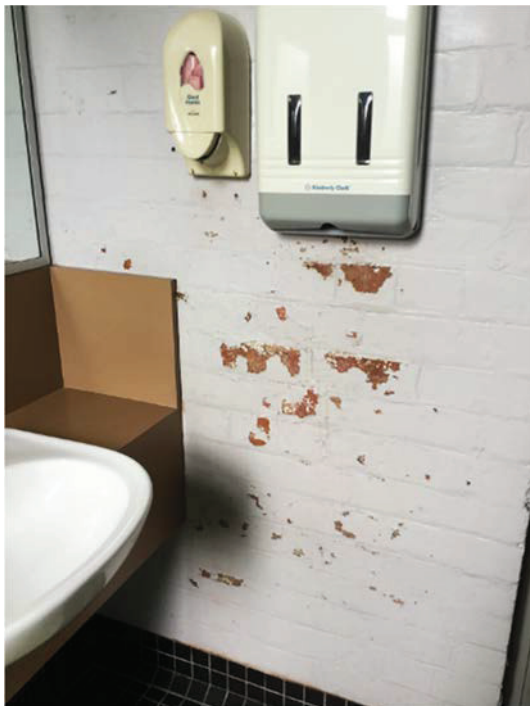
Photo 143

Comments: Internal view of brick wall. Surface wear of paint finish.

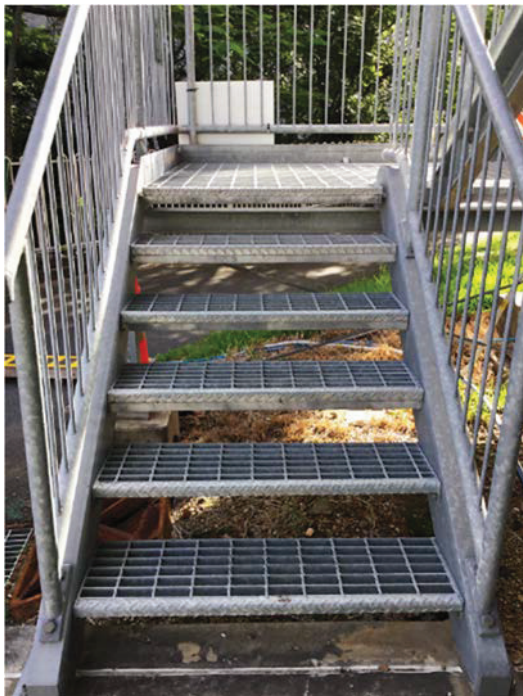
Photo 151

Comments: External steel stairs. Galvanised.
From location report: B3.GF.ST02

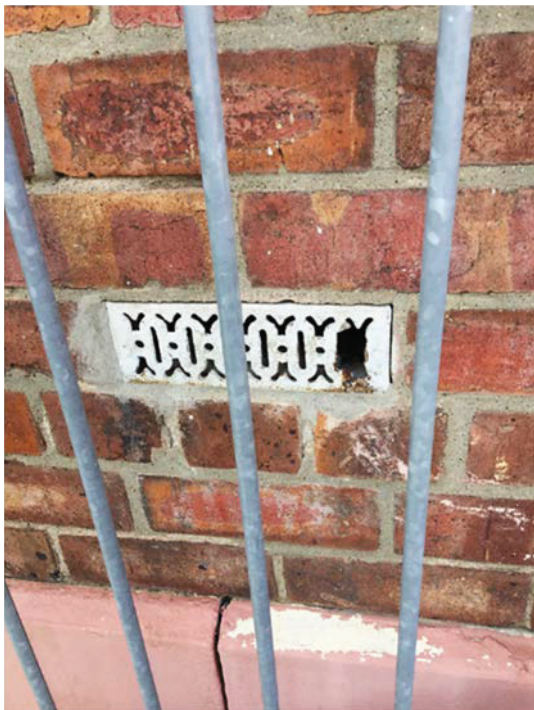
Photo 175

Comments: External wall air hole. Minor damage of fixture.
