Herston Quarter Heritage Precinct

Heritage Building
Dilapidation Report

Prepared for Australian Unity

24 May 2019

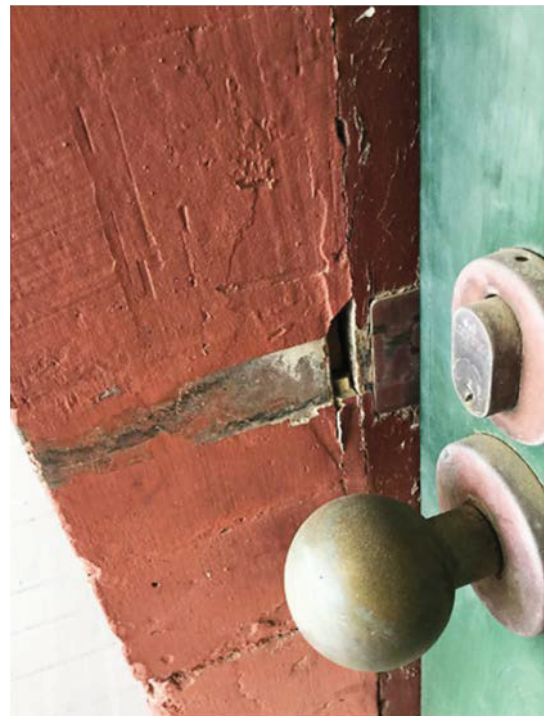
Photo 176

Comments: Damage of façade brickwork near door entry.

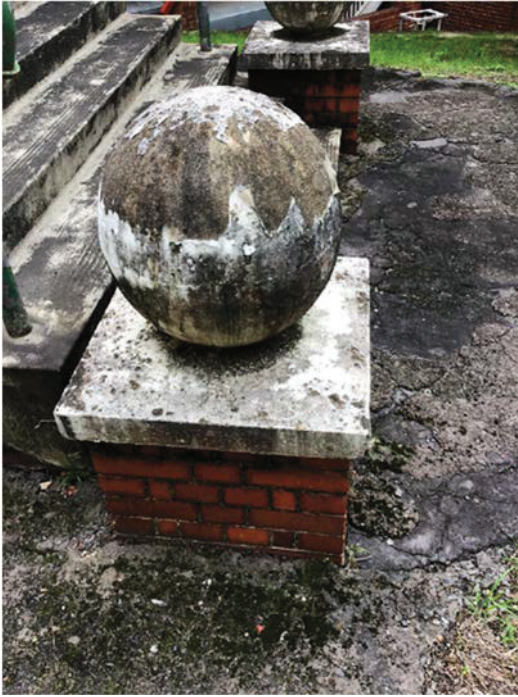
Photo 205

Comments: Surface damage, staining of stairs feature.

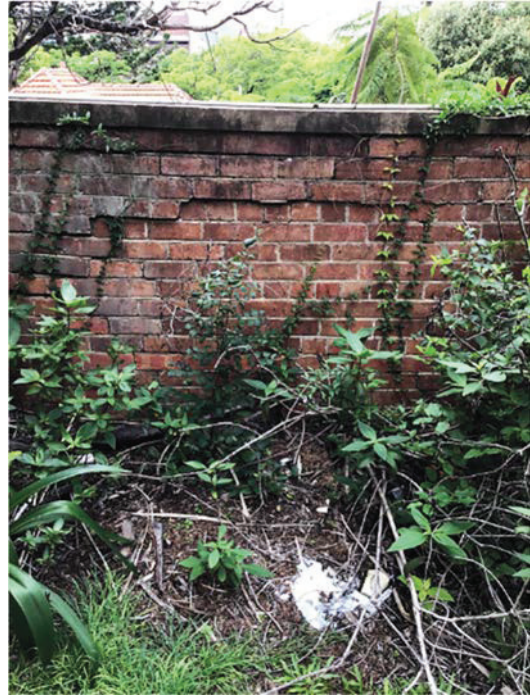
Photo 206

Comments: Damage to external brick wall.

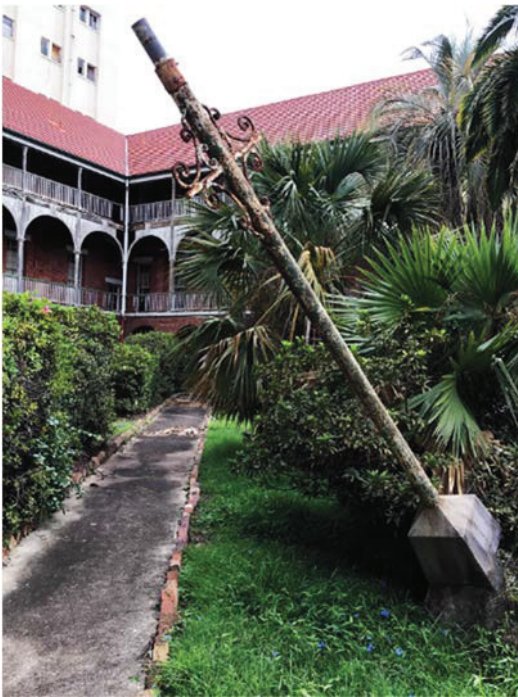
Photo 207

Comments: Damage to external pole feature.

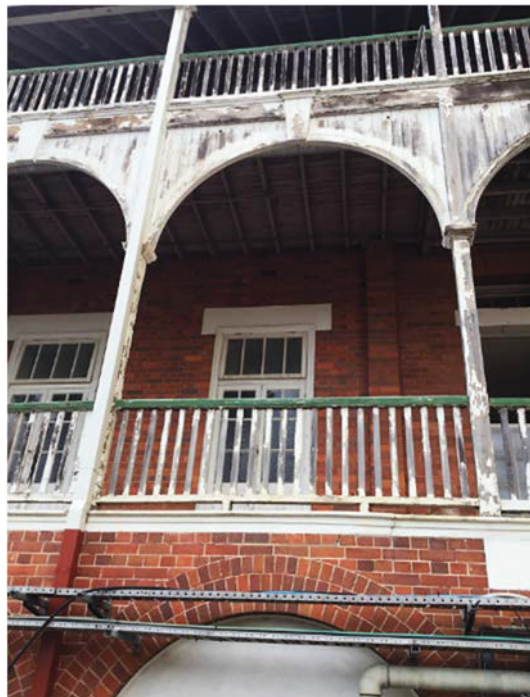
Photo 208

Comments: Damage to timber surface, paint.

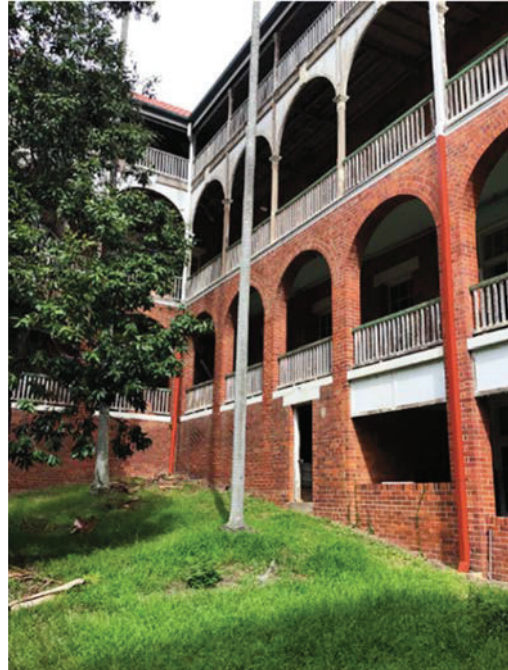
Photo 214

Comments: General view of Lady Lamington wing façade. Visible wear of finishes, timber.

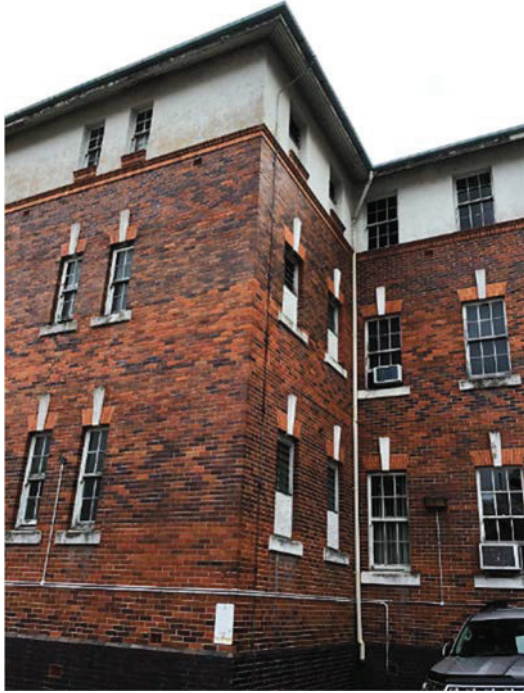
Photo 221

Comments: General view of Edith Cavell building façade. Some visible wear of surface finish.

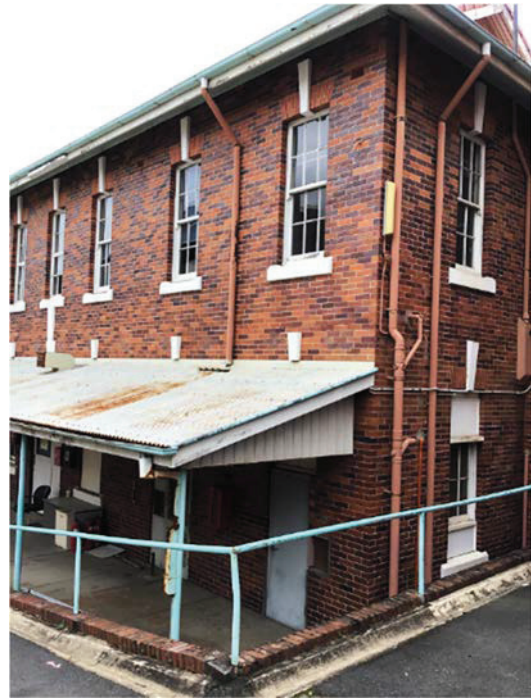
Photo 222

Comments: General view of Edith Cavell building façade. Rust to steel roof sheeting, drain pipe.
