## OAKS MEWS APARTMENTS BOWEN HILLS, QLD

### Stormwater Management Plan

**Oaks Mews Apartments**  
**141 Campbell Street**  
**Bowen Hills QLD 4006**

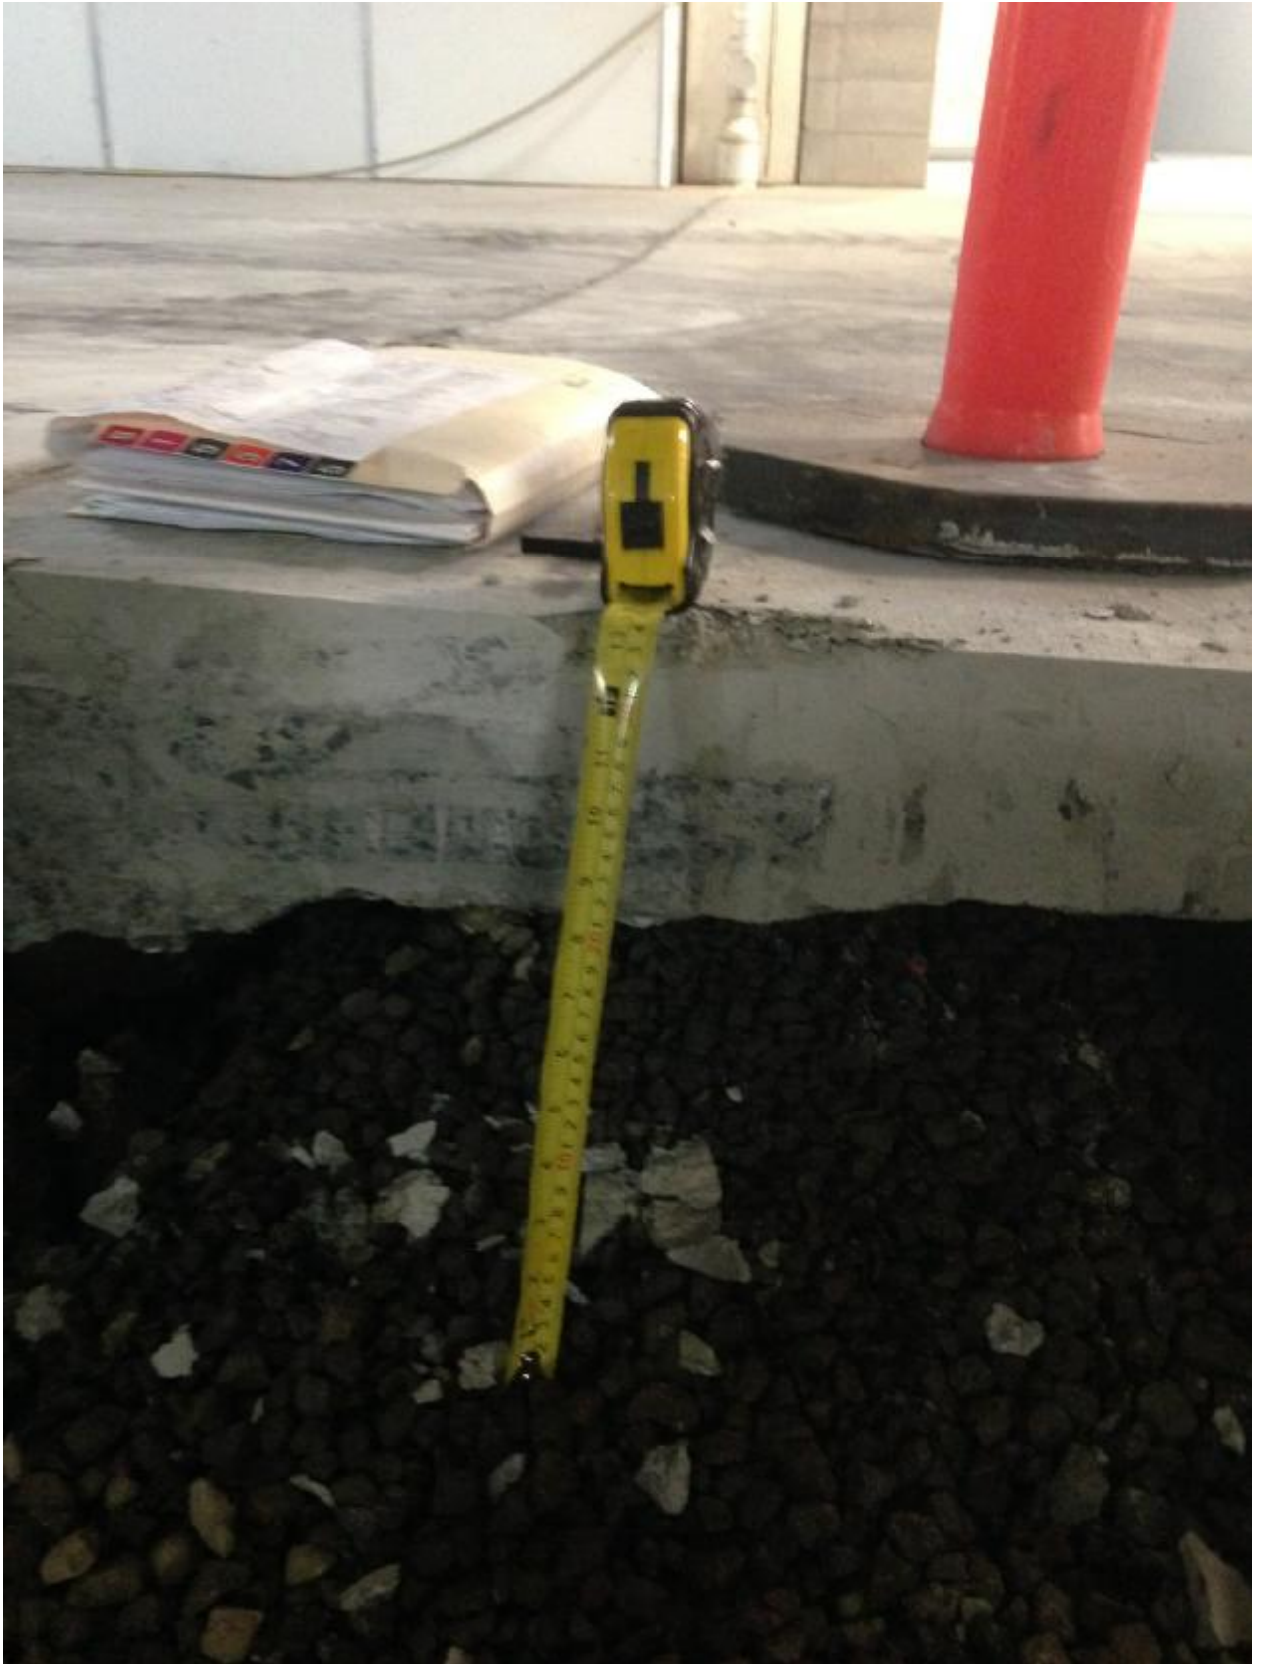
- There was a void under slab;
- Once the slab section was removed the surrounding slab areas dropped as the slab was 'caught up on the column'; and
- We noted that the slab thickness varied considerably and that the slab was cast on plastic on a gravel layer with a geofabric layer underneath – we did not observe any geofabric layer under the slab as nominated in the design.

Photo 1 – Void under slab

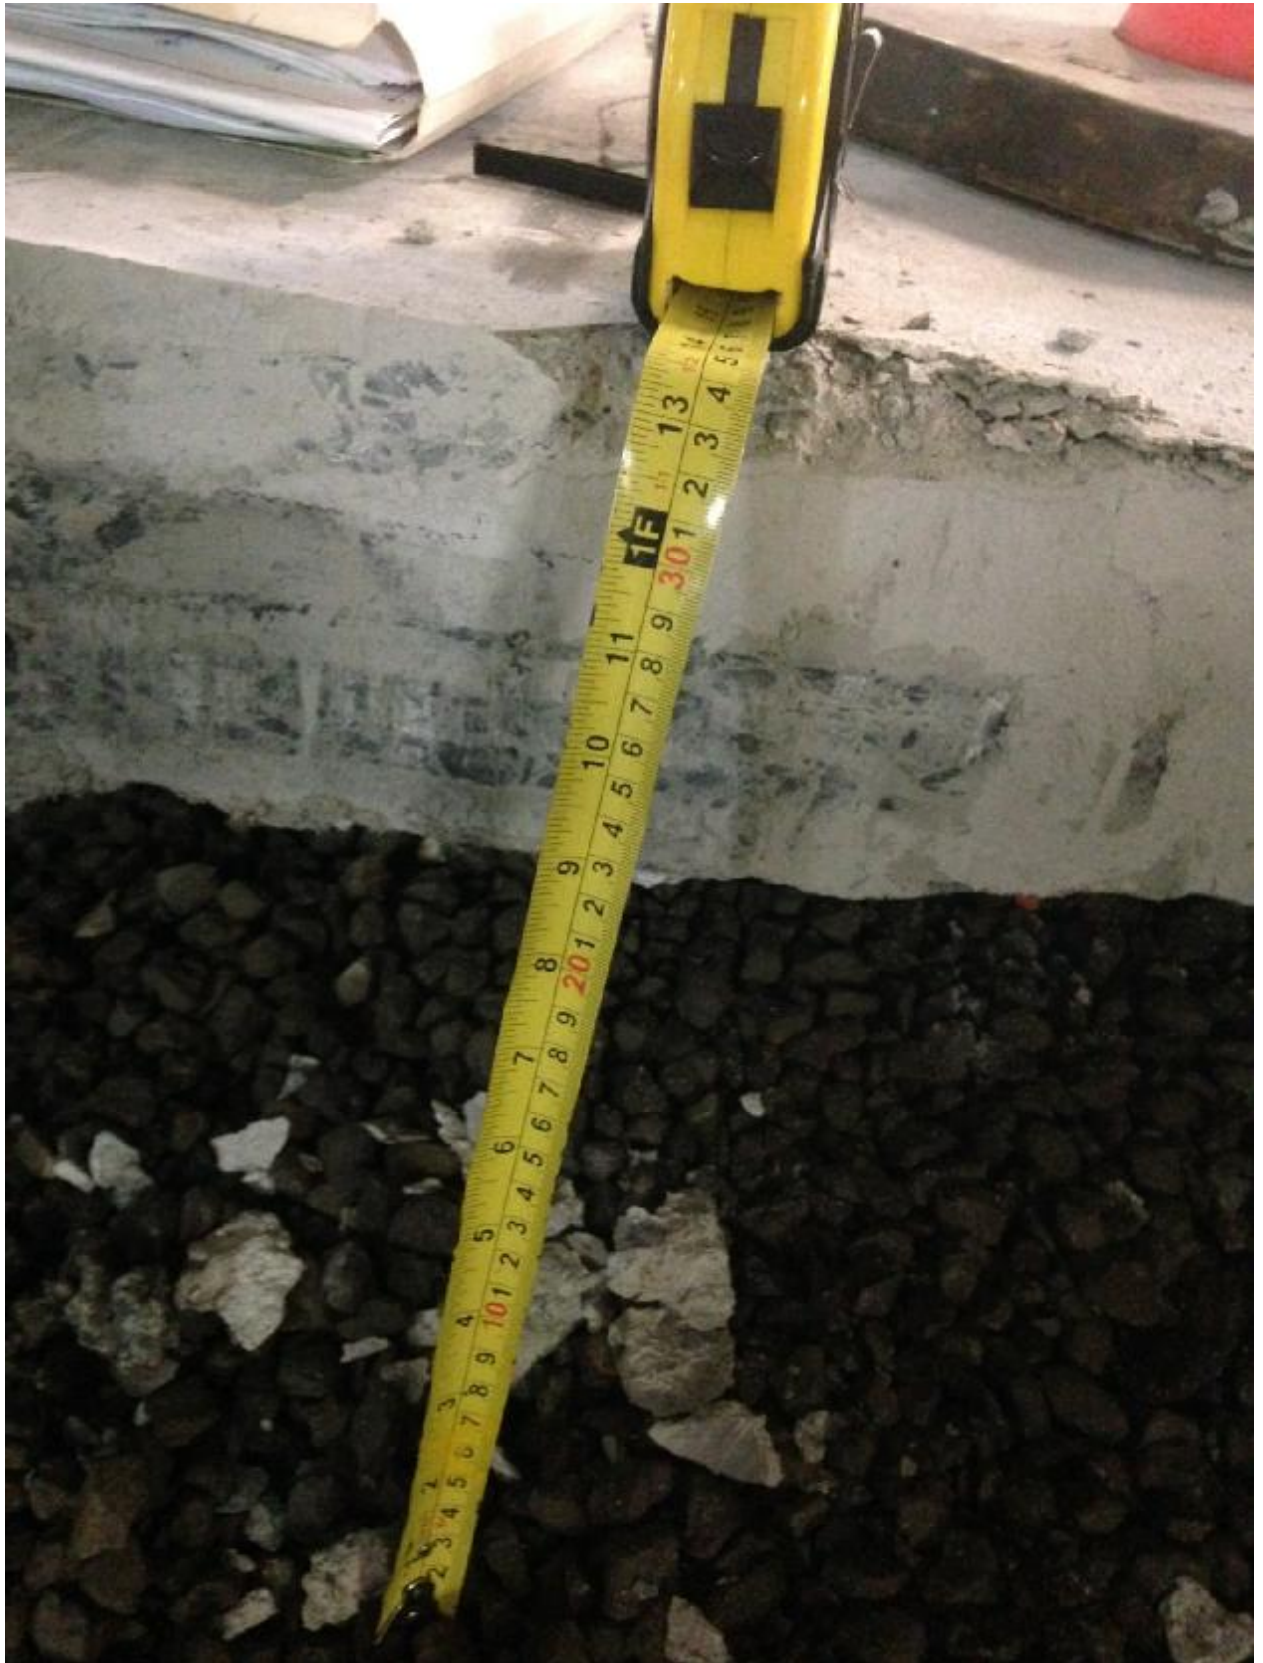
Photo 2 – Void under slab

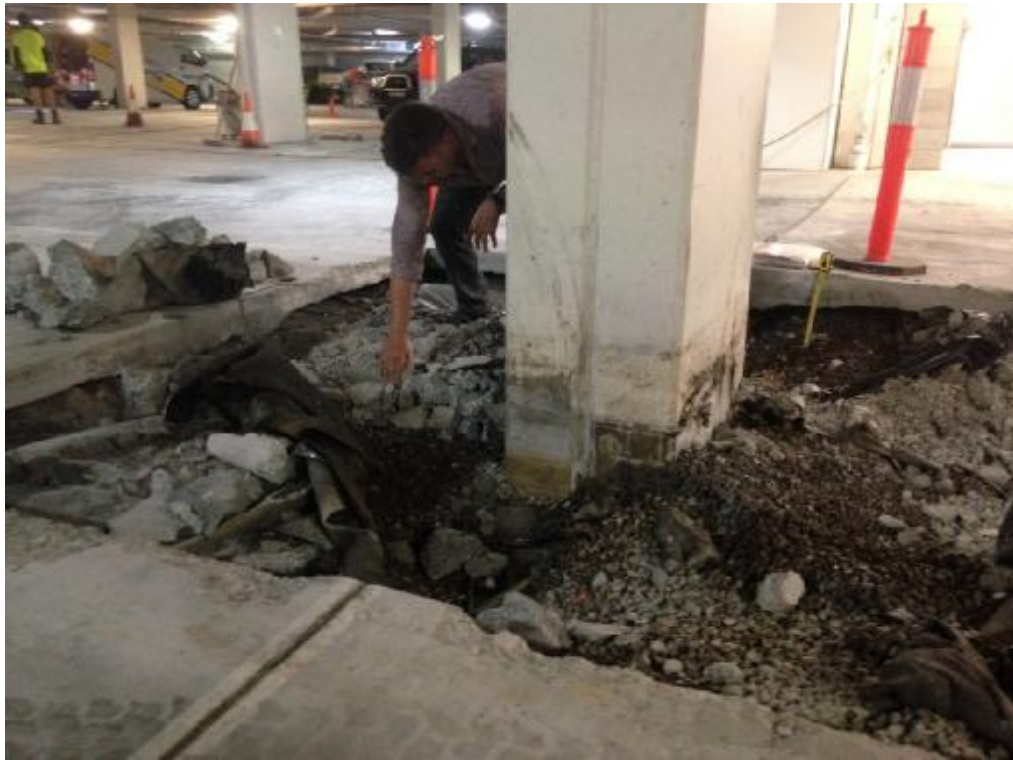
Photo 3 – General photo of excavation with void, drainage layer and geofabric visible

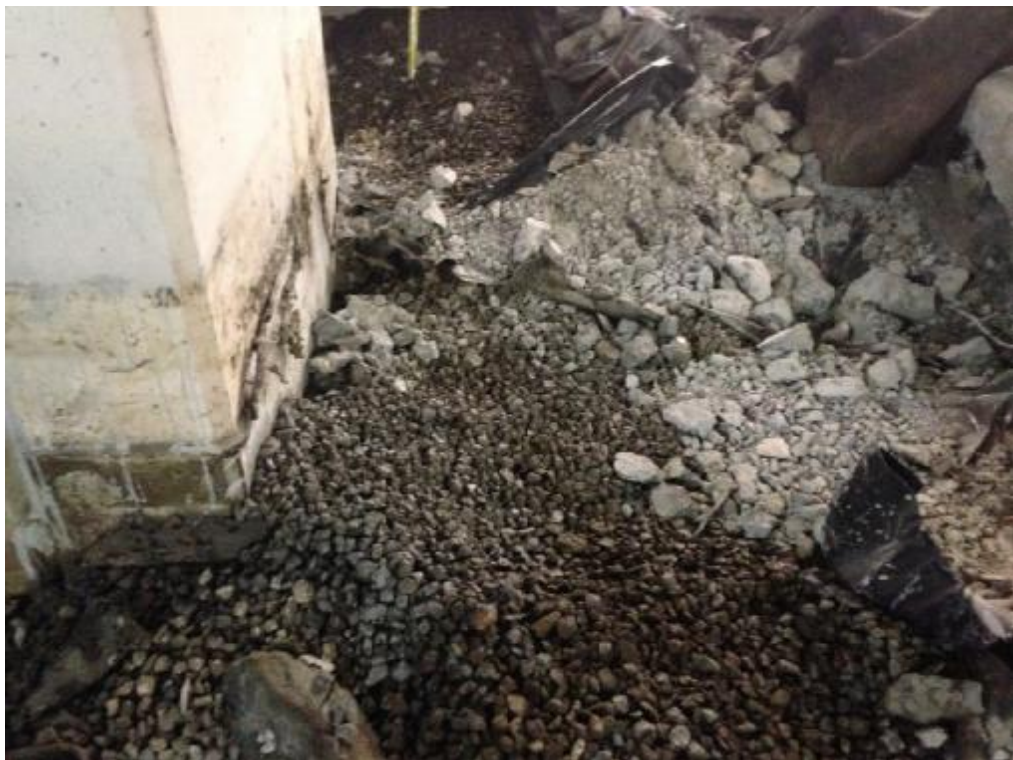
Photo 4 – Drainage Layer Material under slab

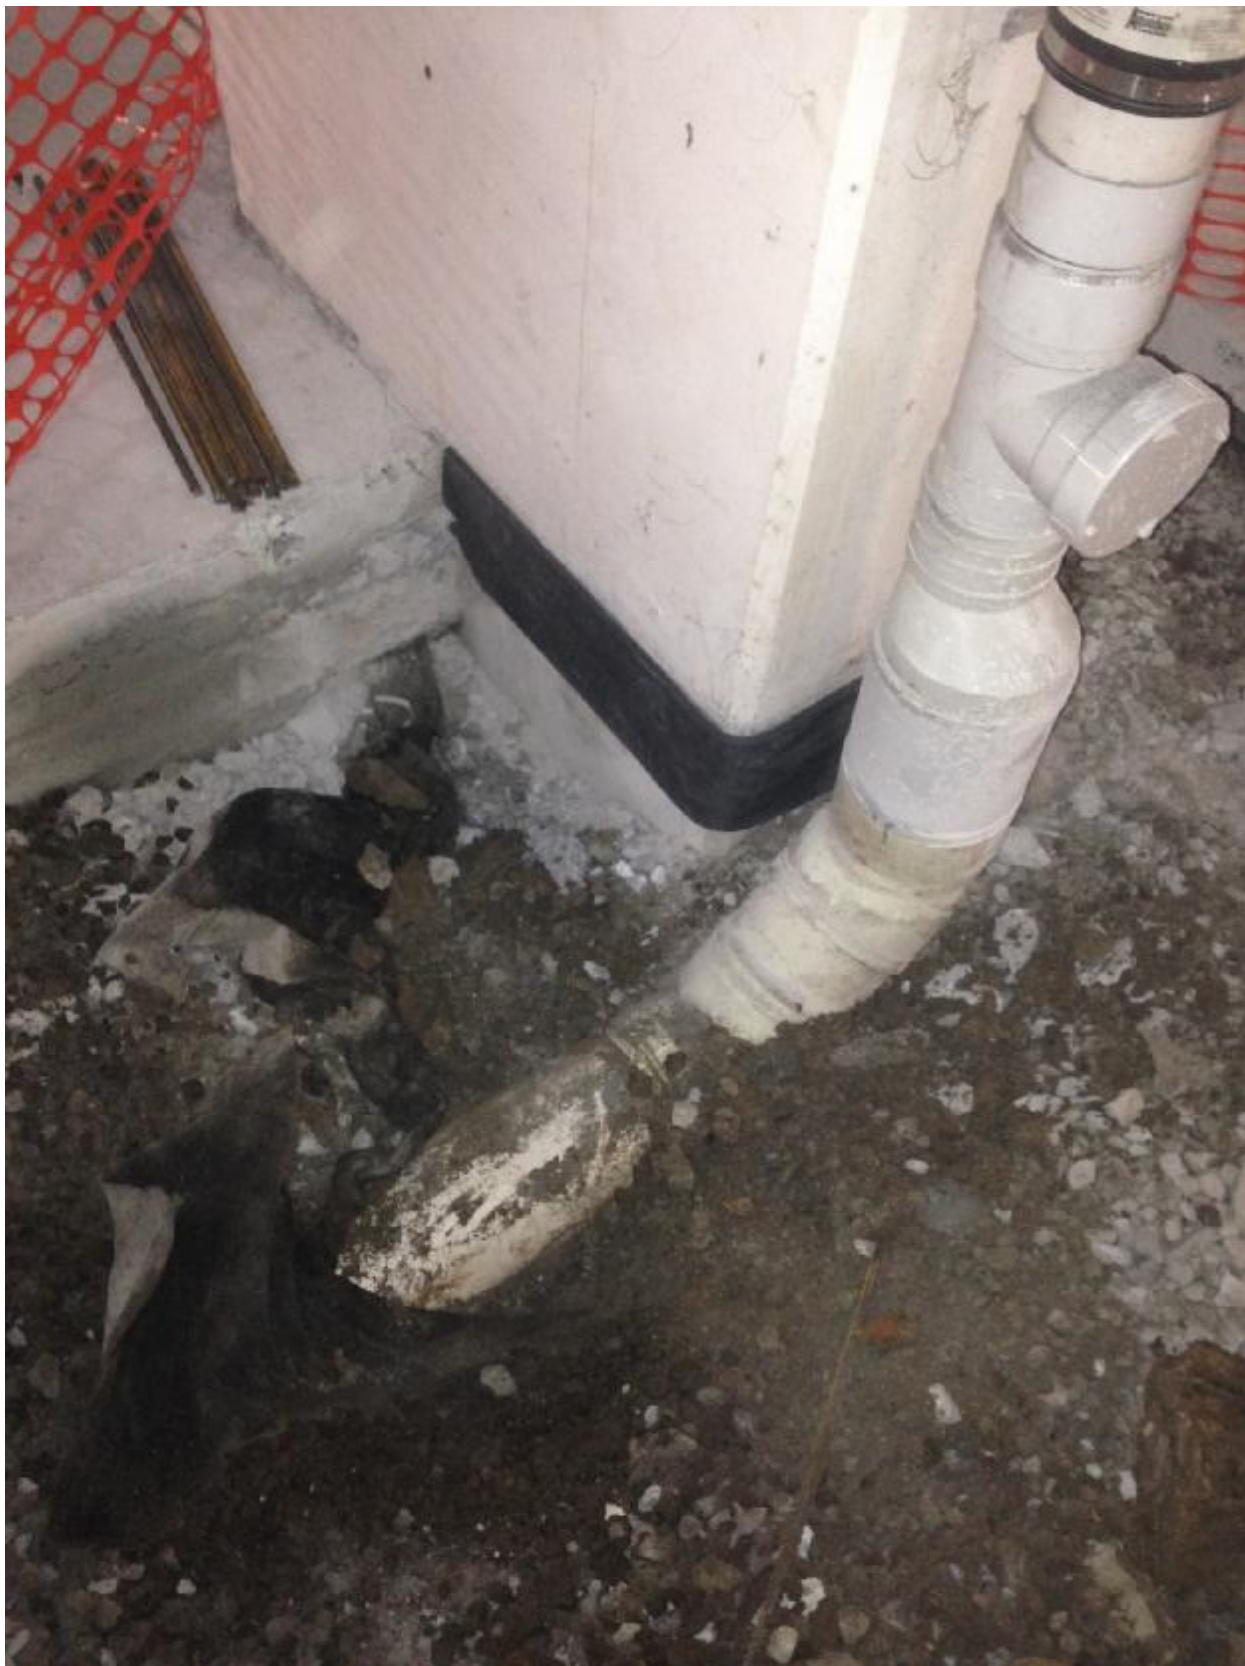
- There was a void under slab;
- The 150mm diameter sewer pipe at this location was not broken; and
- We noted that the slab was cast on plastic on a sandy gravel layer with a geofabric layer underneath – we did not observe any geofabric layer under the slab as nominated in the design and the gravel was contaminated.

Photo 5 - Existing sewer pipe not broken

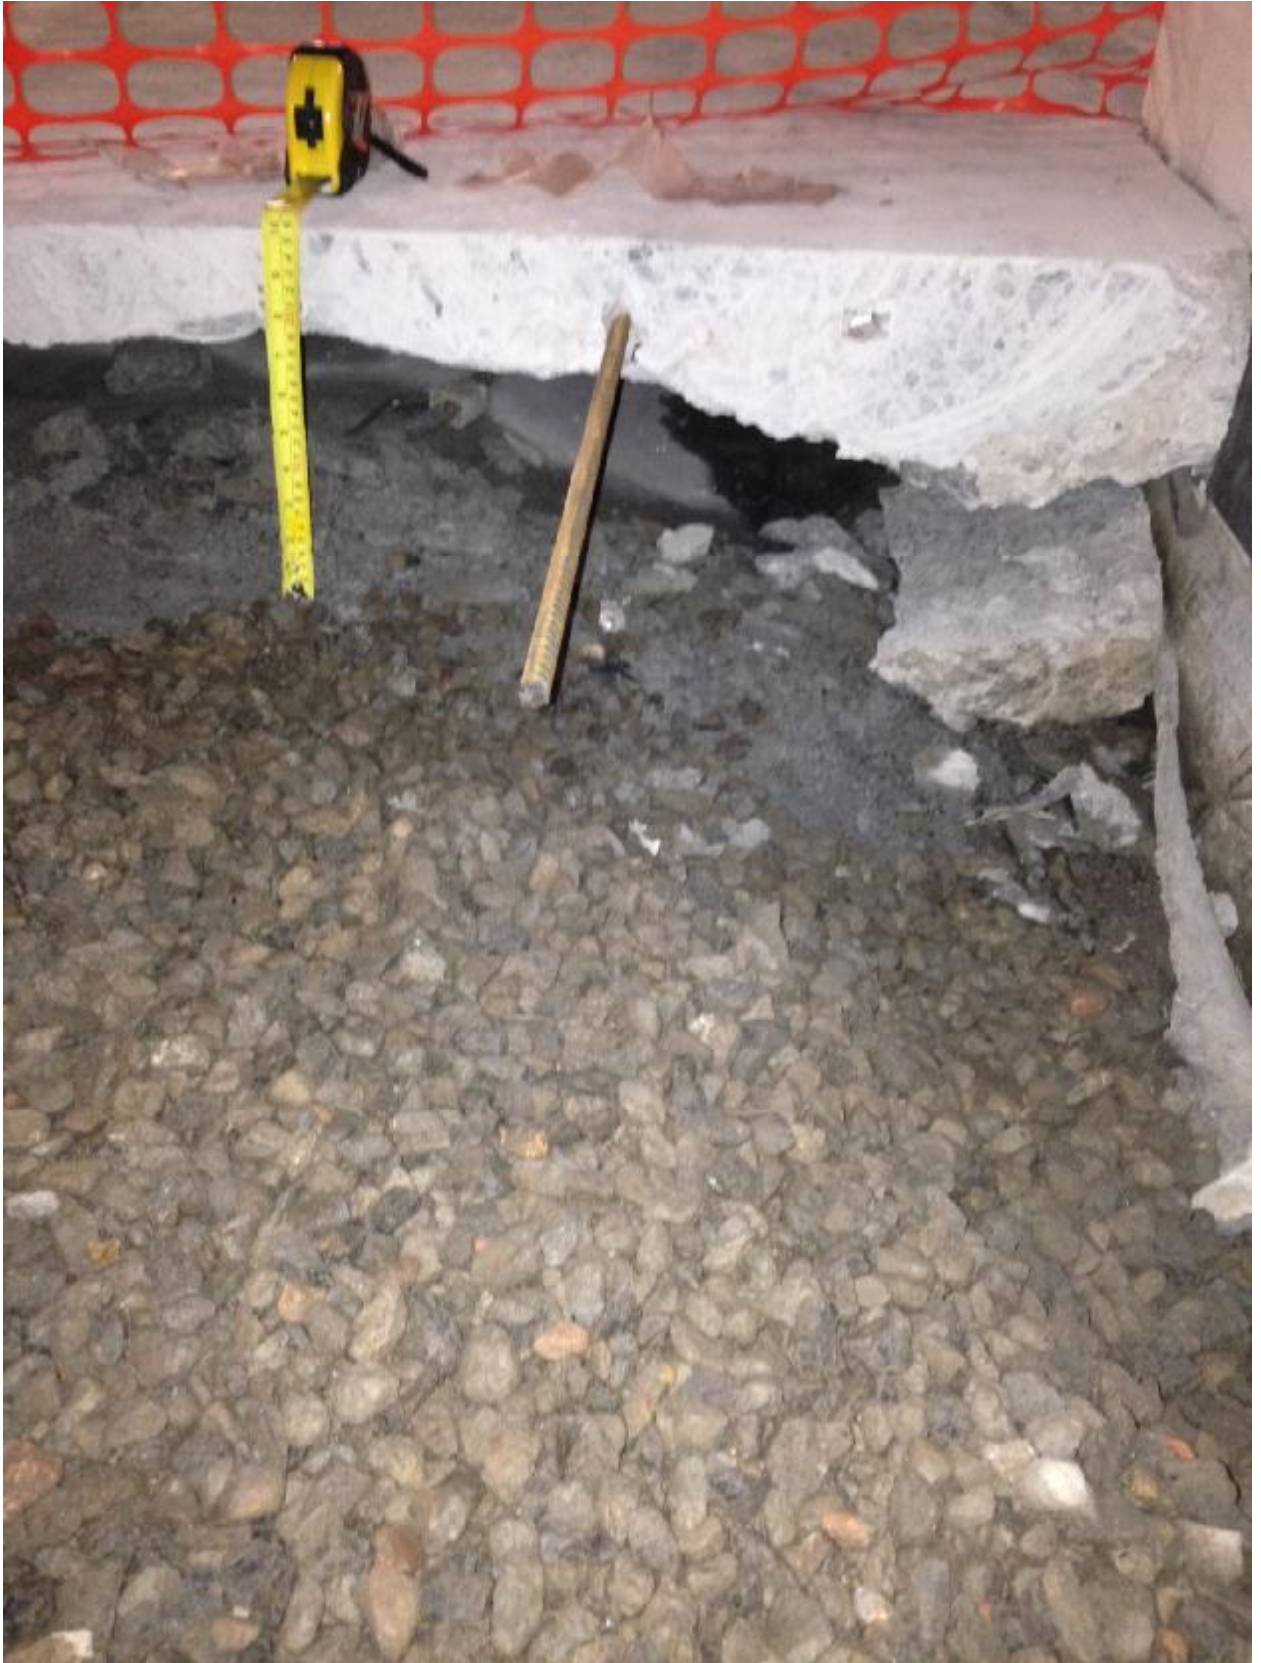
Photo 8 – Void under slab. Slab thickness only approximately 80mm thick

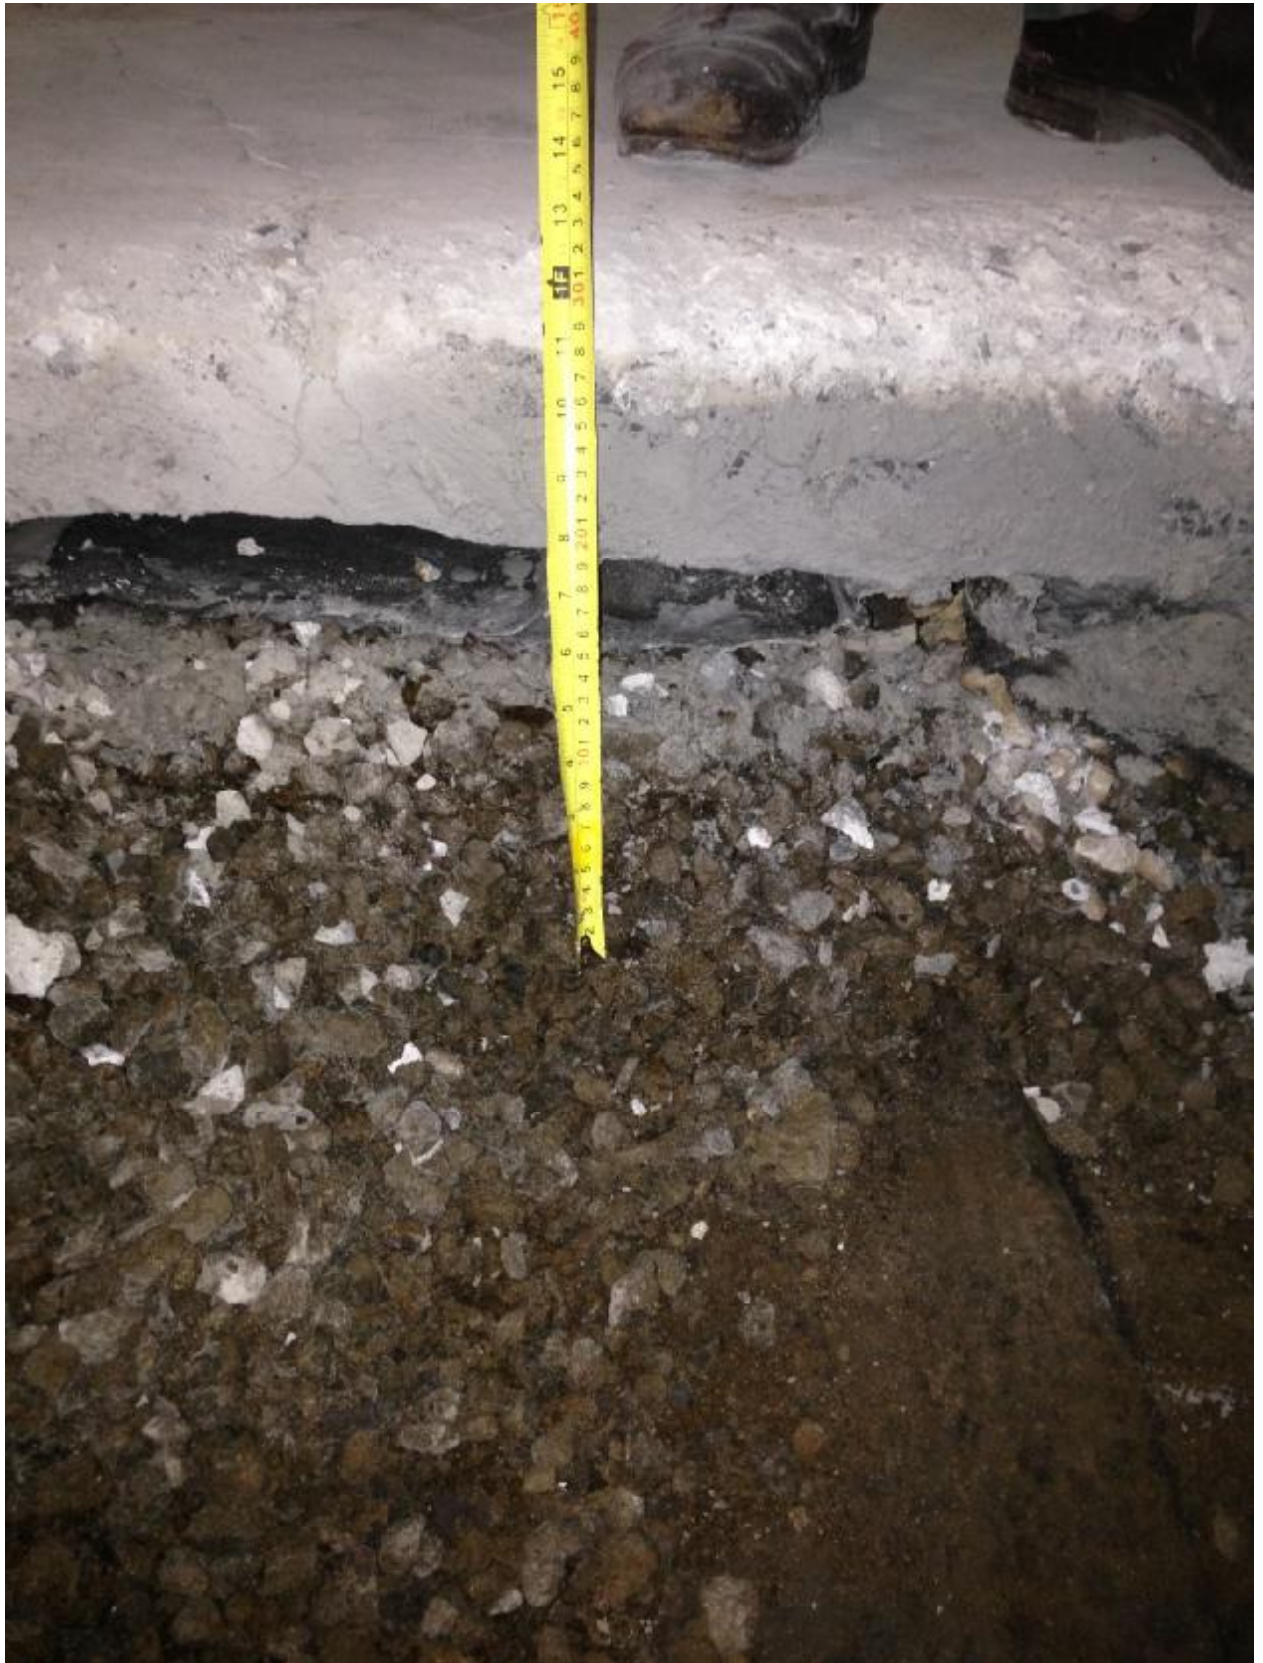
Photo 9 – Void under slab approximately 200mm deep

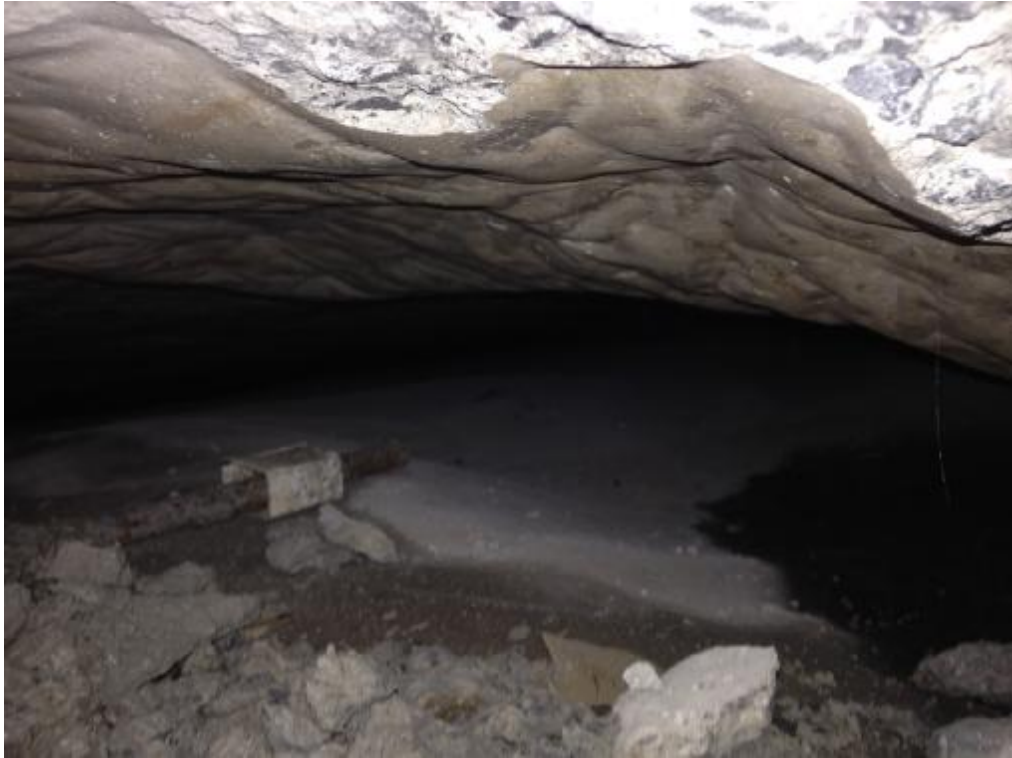
Photo 10 – Void under slab

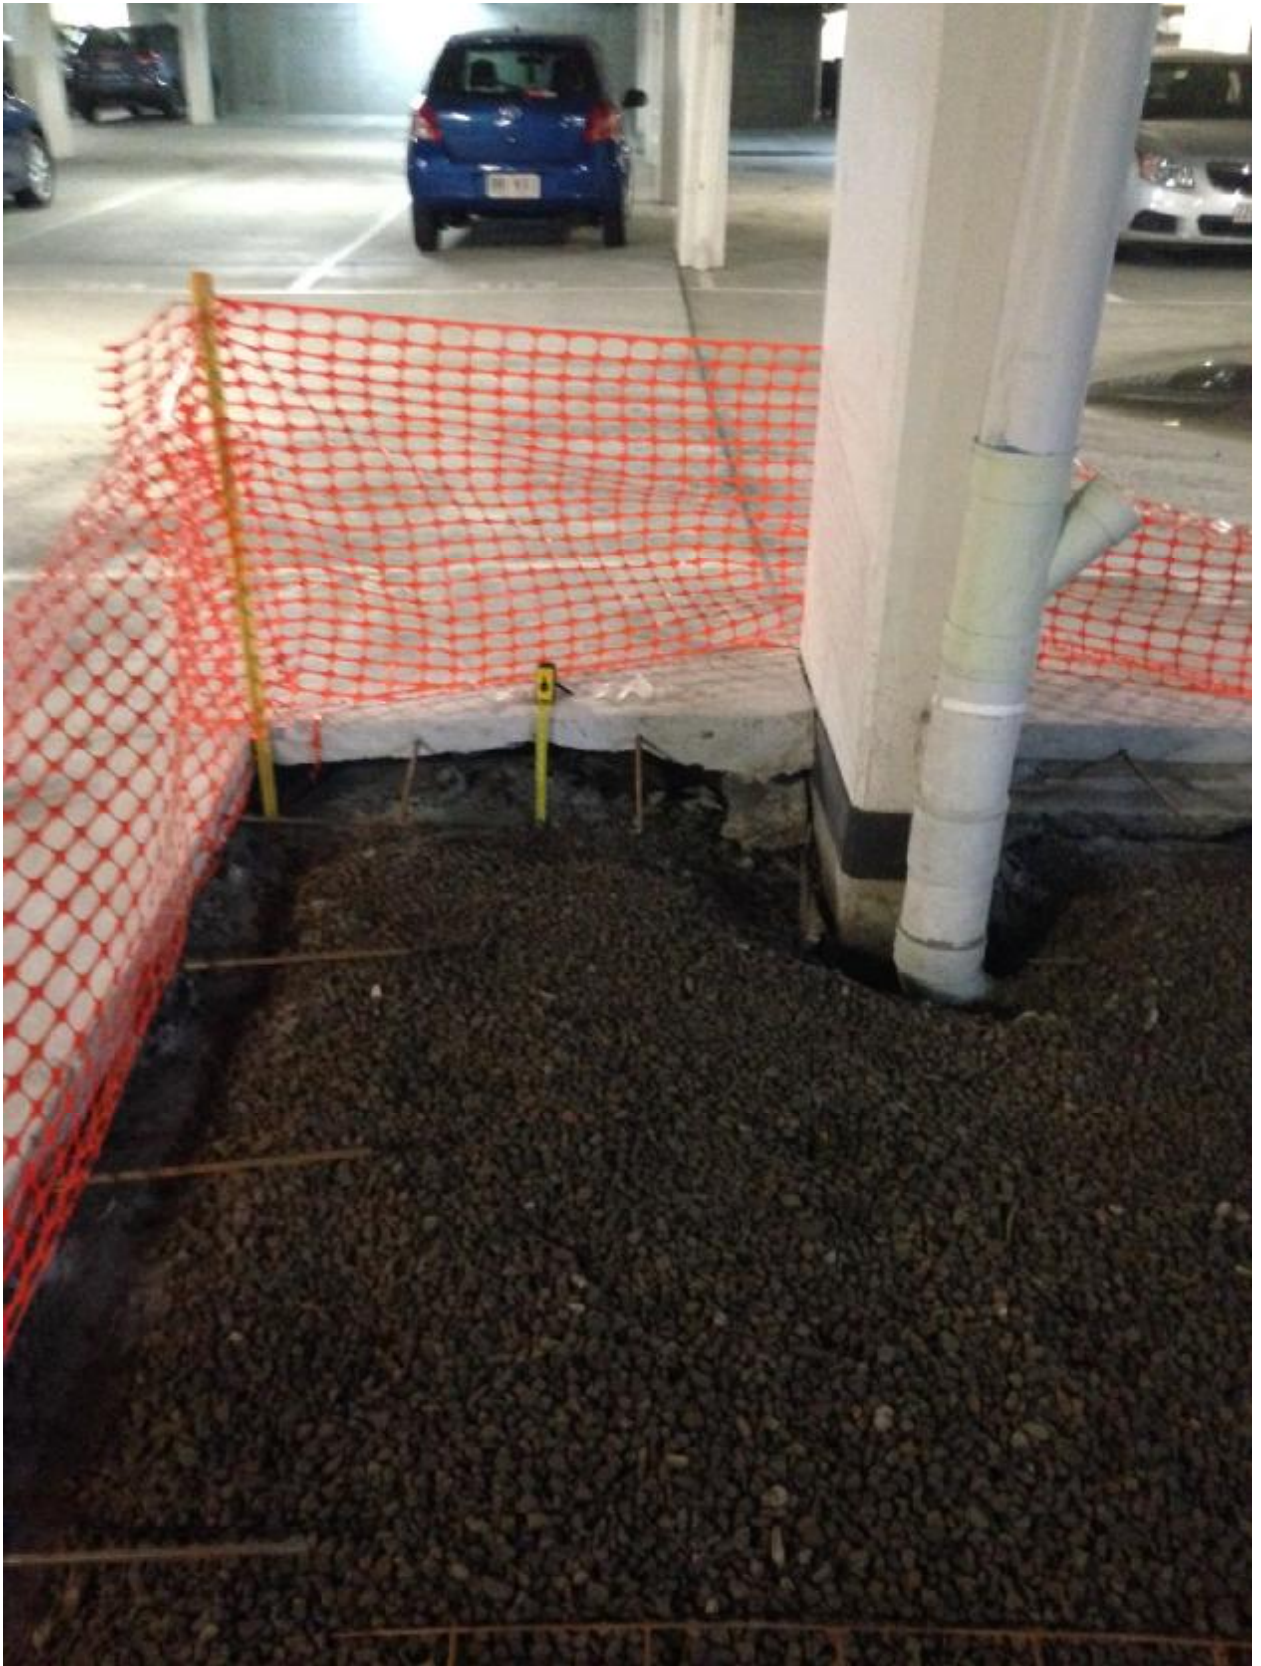
Photo 11 - Void under

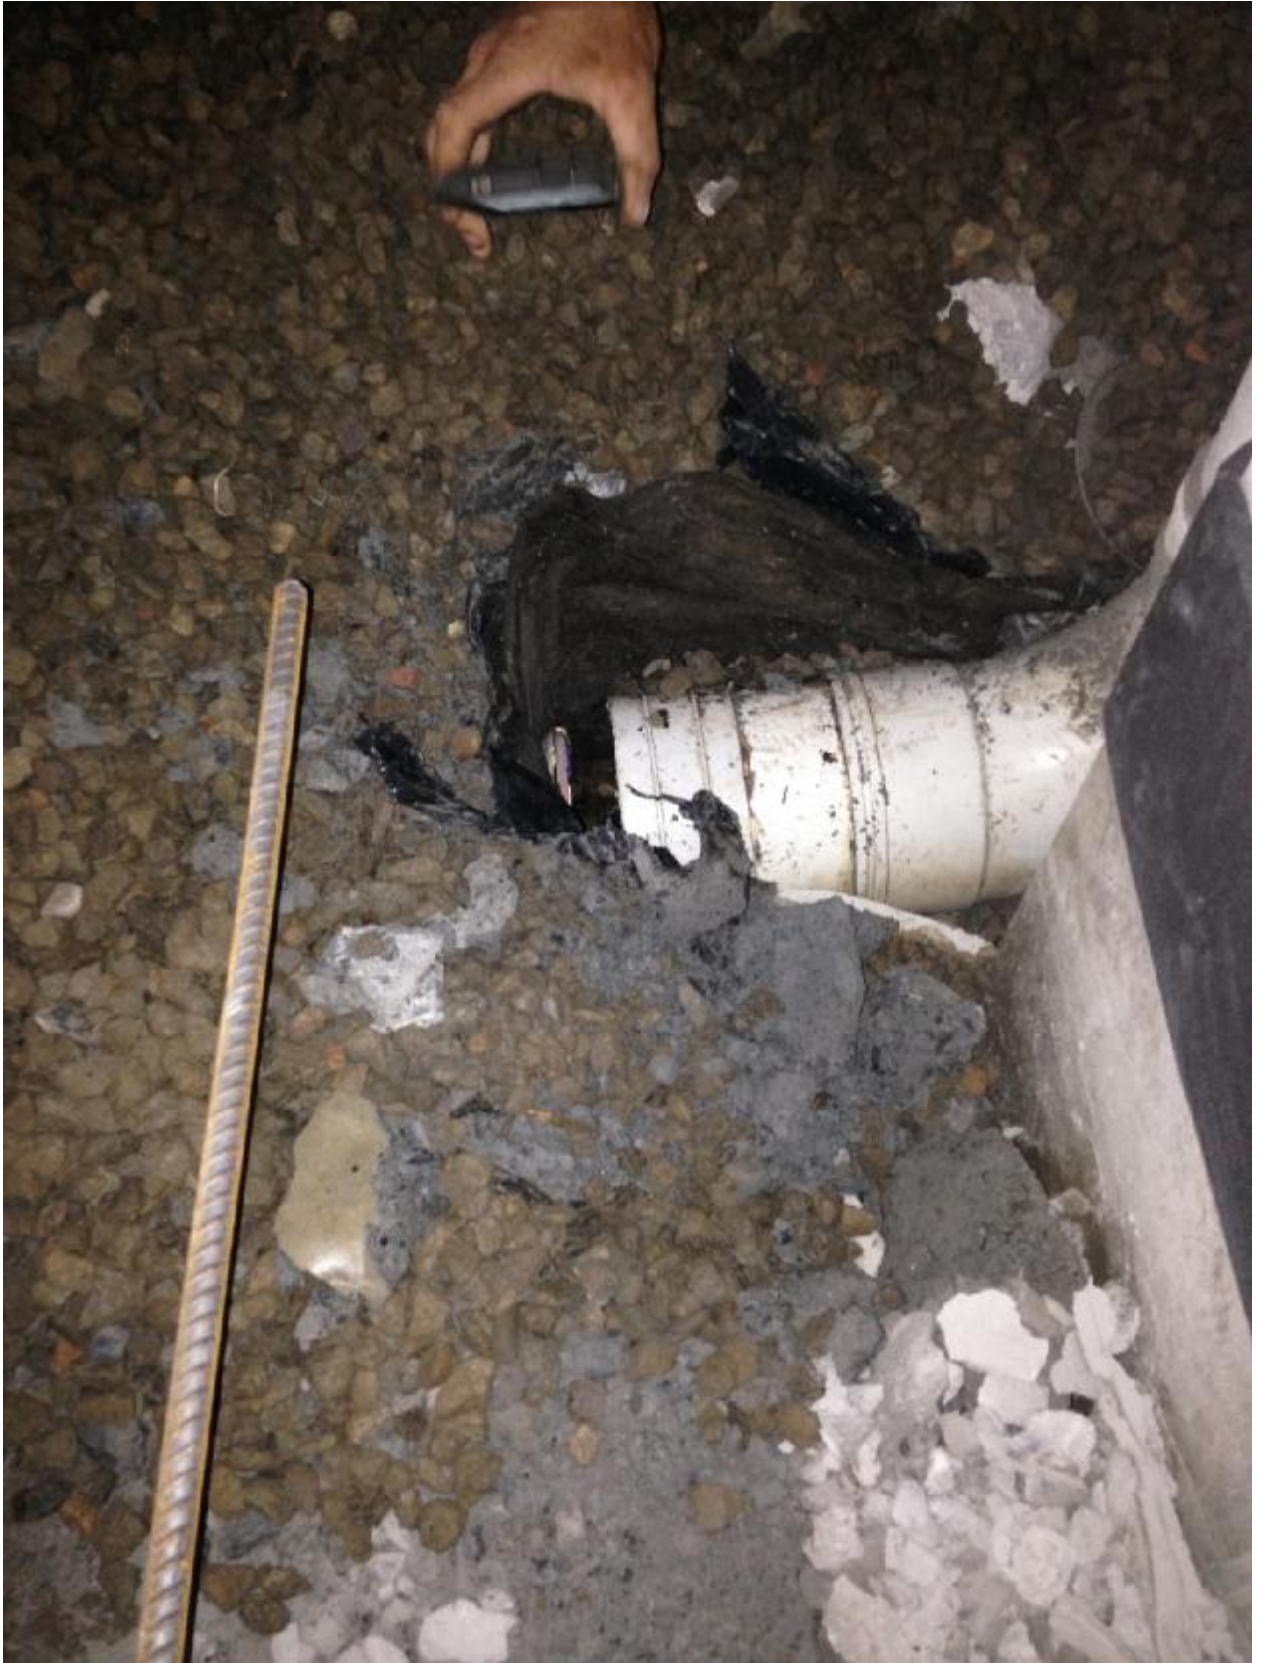
- There was a void under slab;
- The 150mm diameter roof-water pipe at this location was broken at a joint under the slab;
- We noted that the slab was cast on plastic on a sandy gravel layer with a geofabric layer underneath – we did not observe any geofabric layer under the slab as nominated in the design and the gravel was contaminated;
- The broken pipe was repaired prior to repouring the slab; and
- Once the slab was removed the surrounding slab dropped. Some further saw cutting and slab removal was required to allow the slab to drop around the column and minimise steps at existing slab joints.

Photo 12 - Broken roofwater pipe

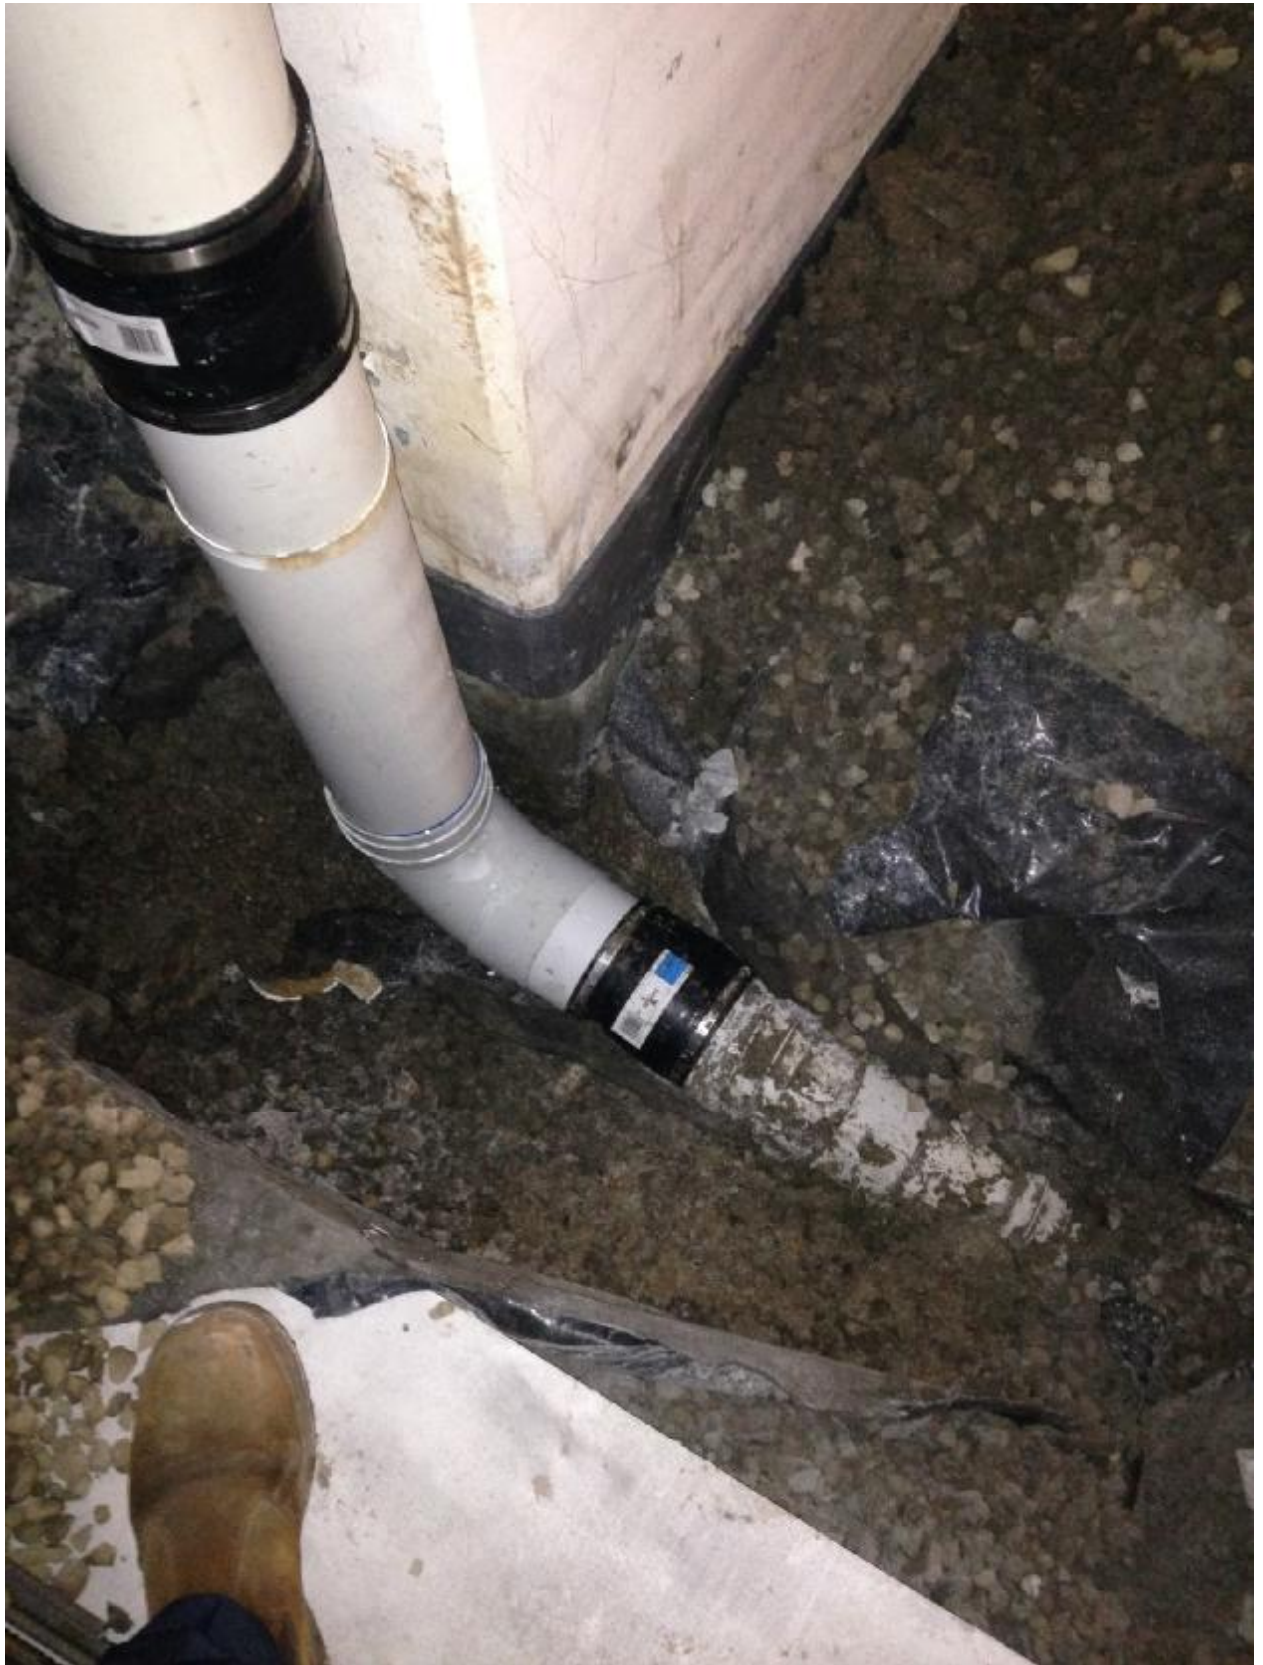
Photo 13 – Repair undertaken to broken roofwater pipe

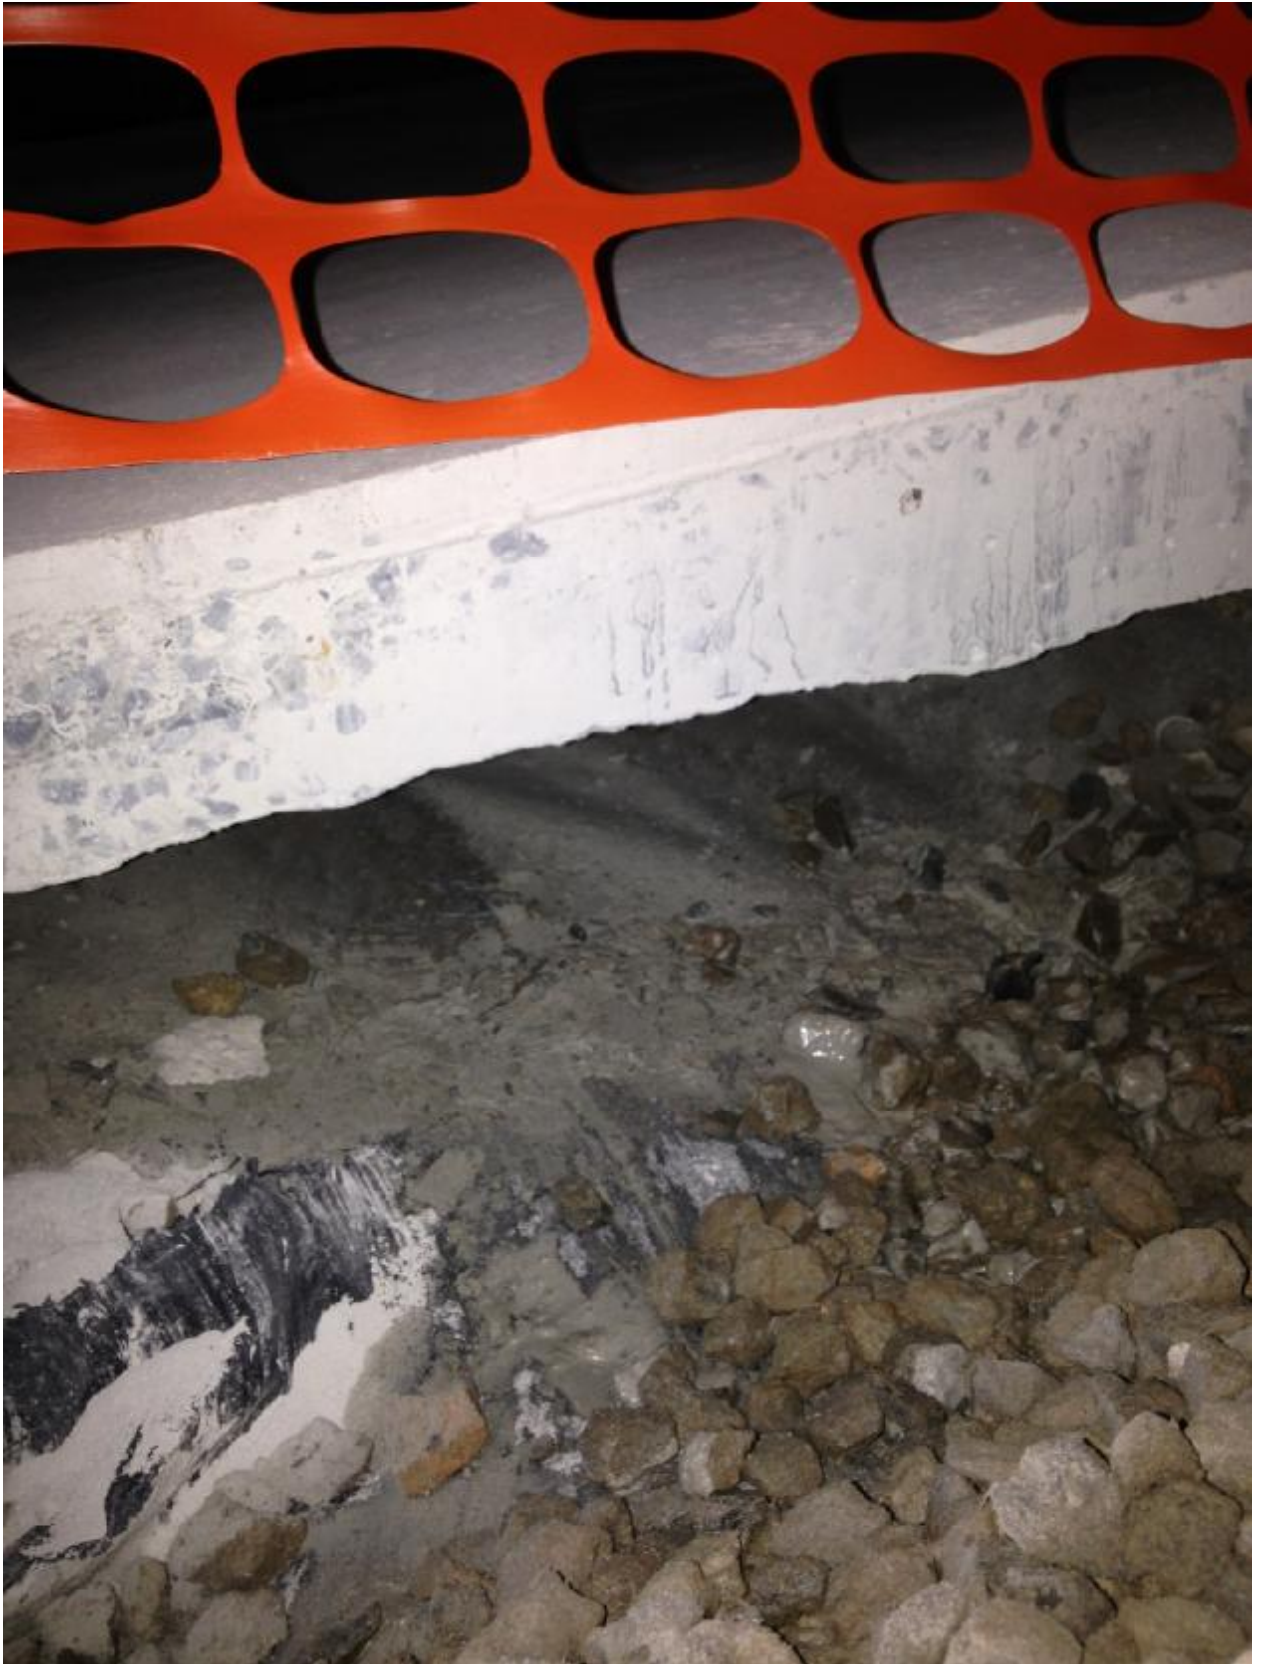
Photo 14 – Void under slab
