## OAKS MEWS APARTMENTS BOWEN HILLS, QLD

### Stormwater Management Plan

**Oaks Mews Apartments**  
**141 Campbell Street**  
**Bowen Hills QLD 4006**

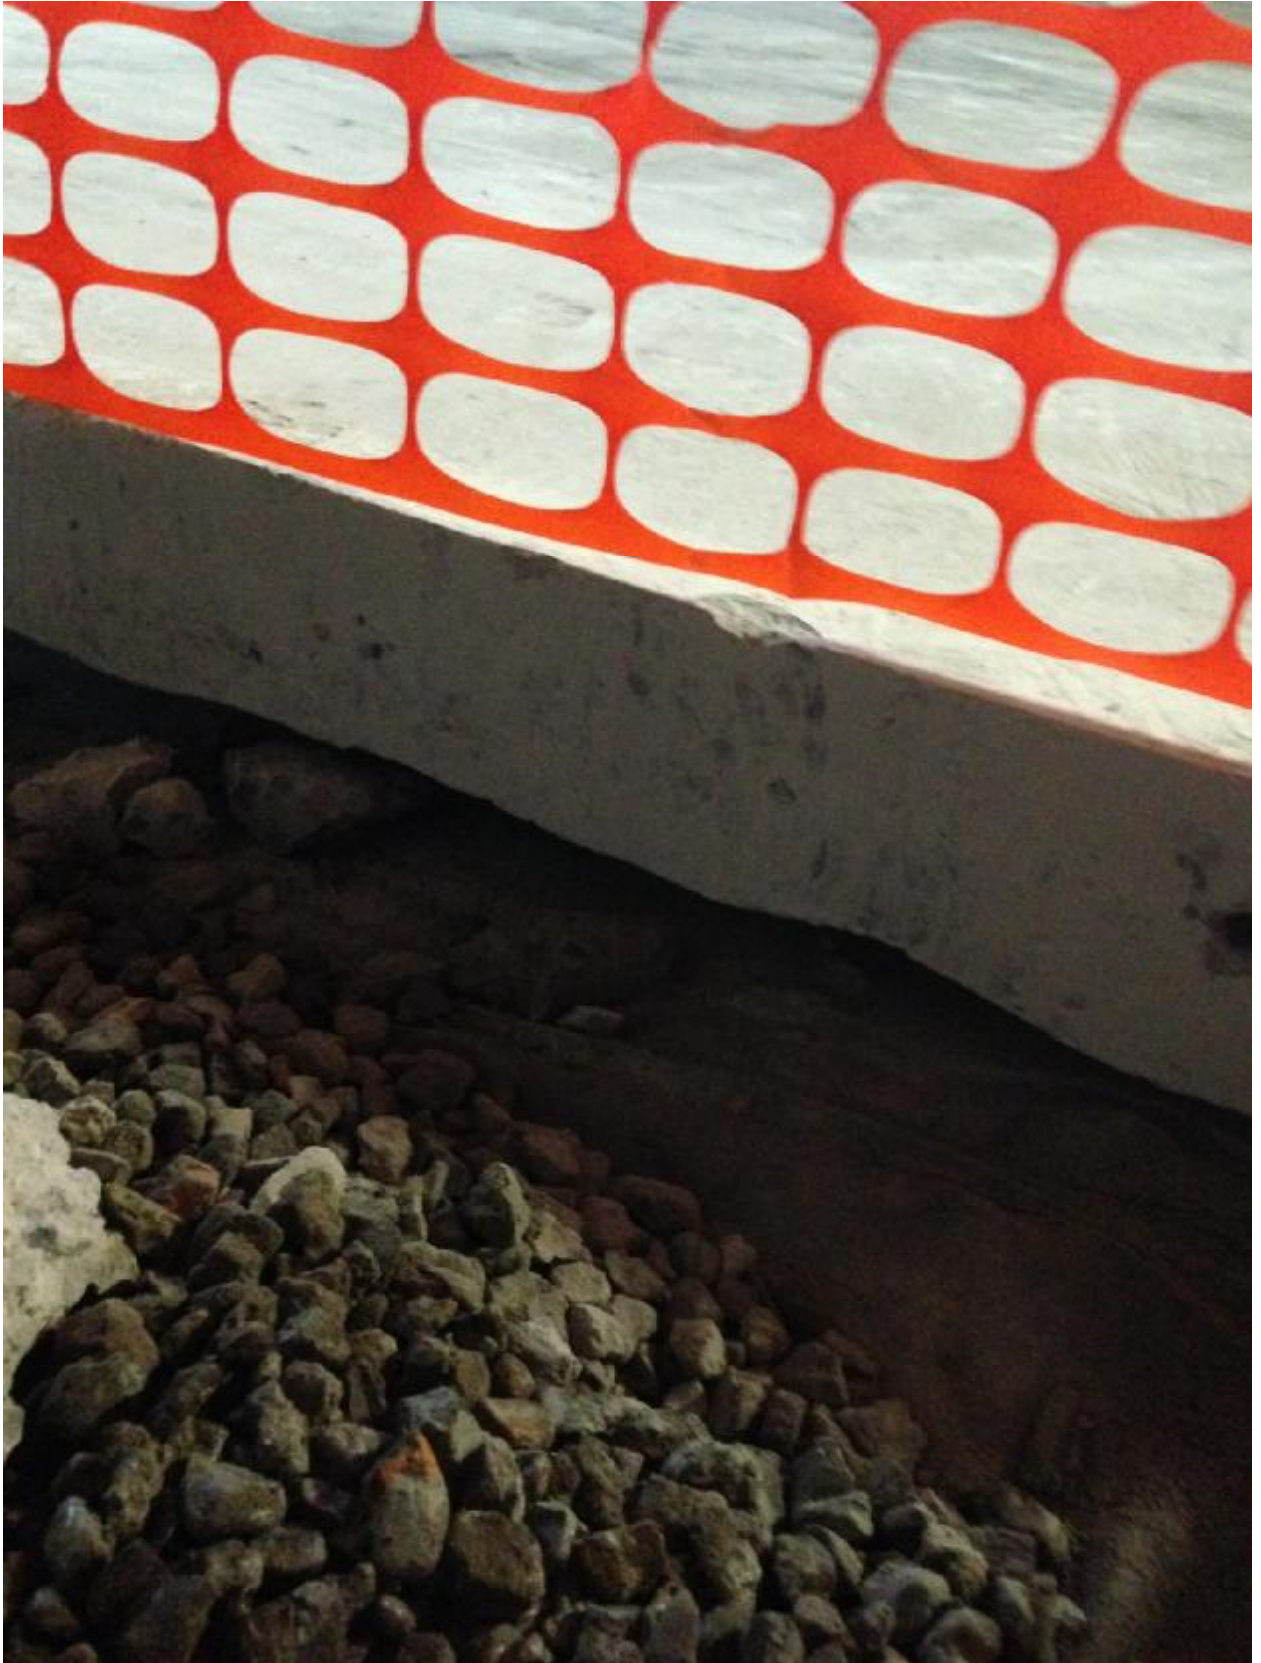
Photo 15 – Void under slab

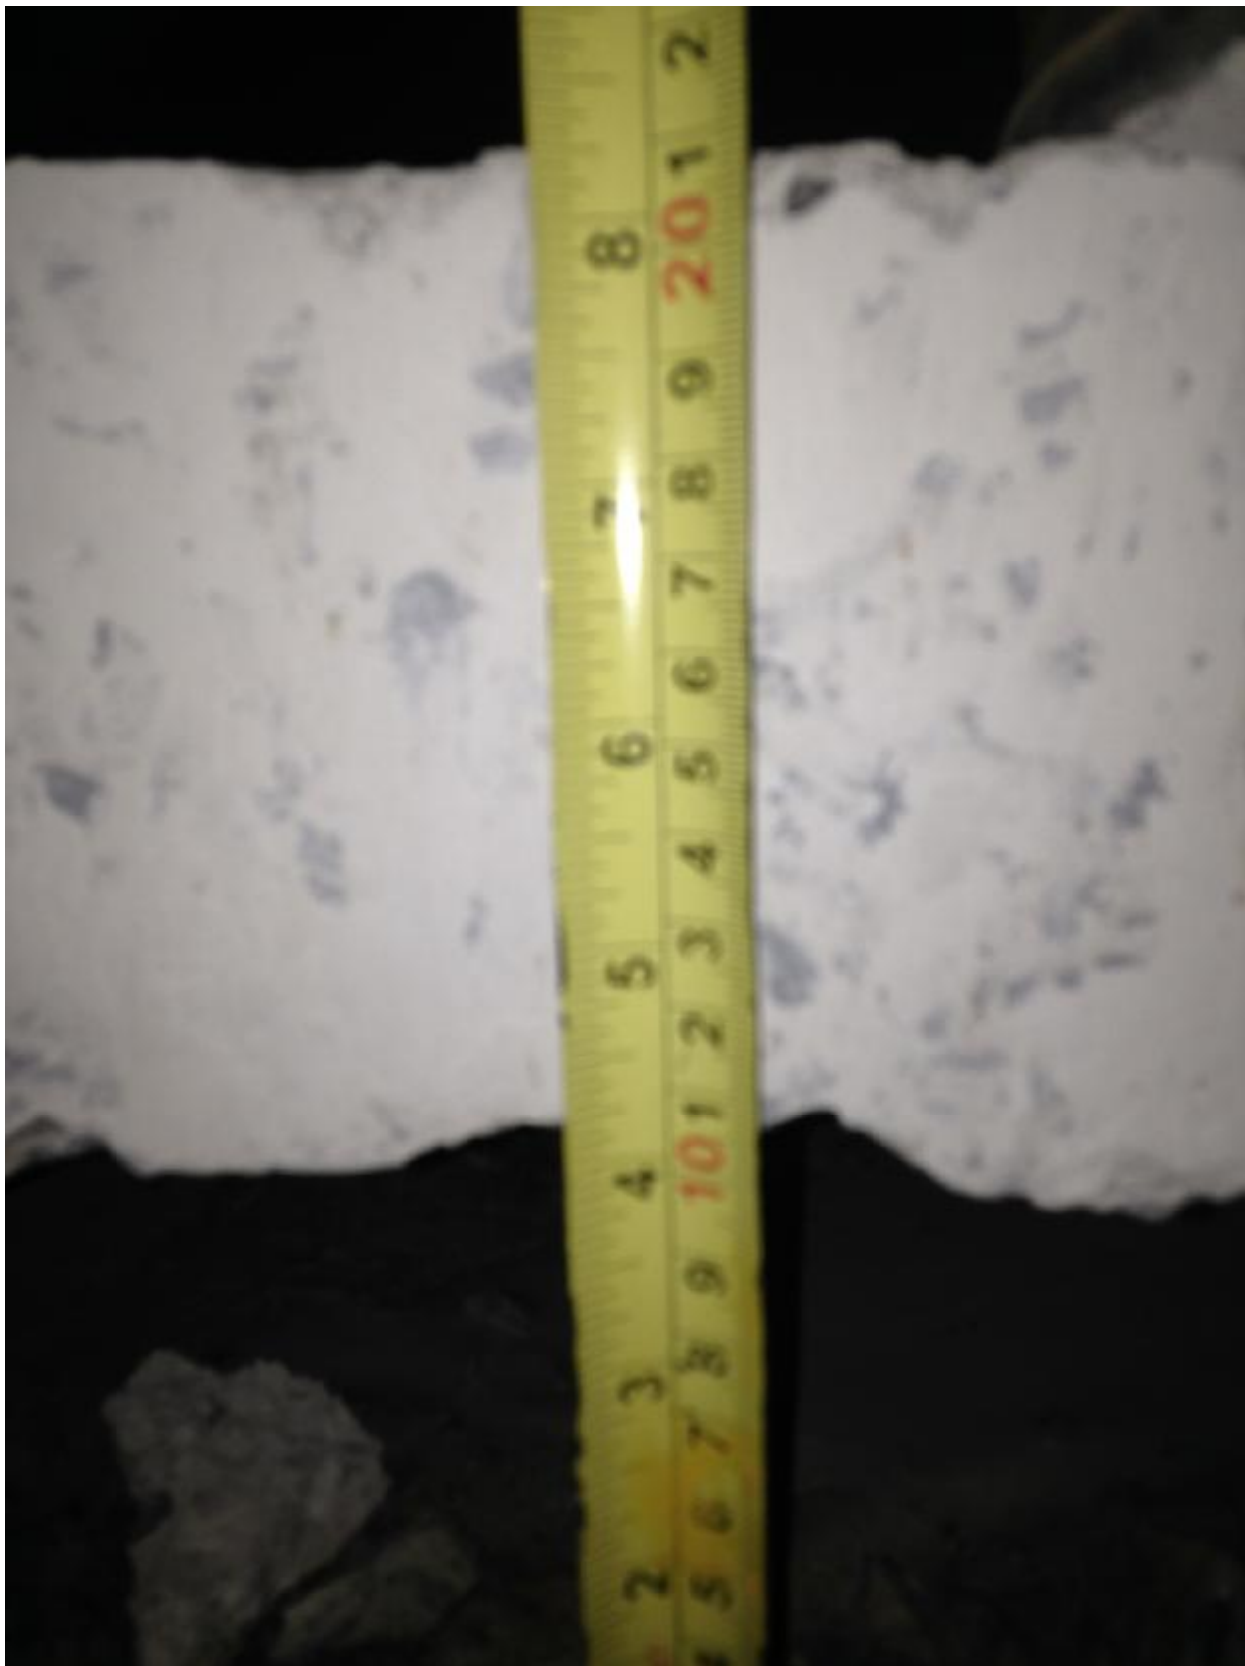
Photo 16 – Depth of void 100mm

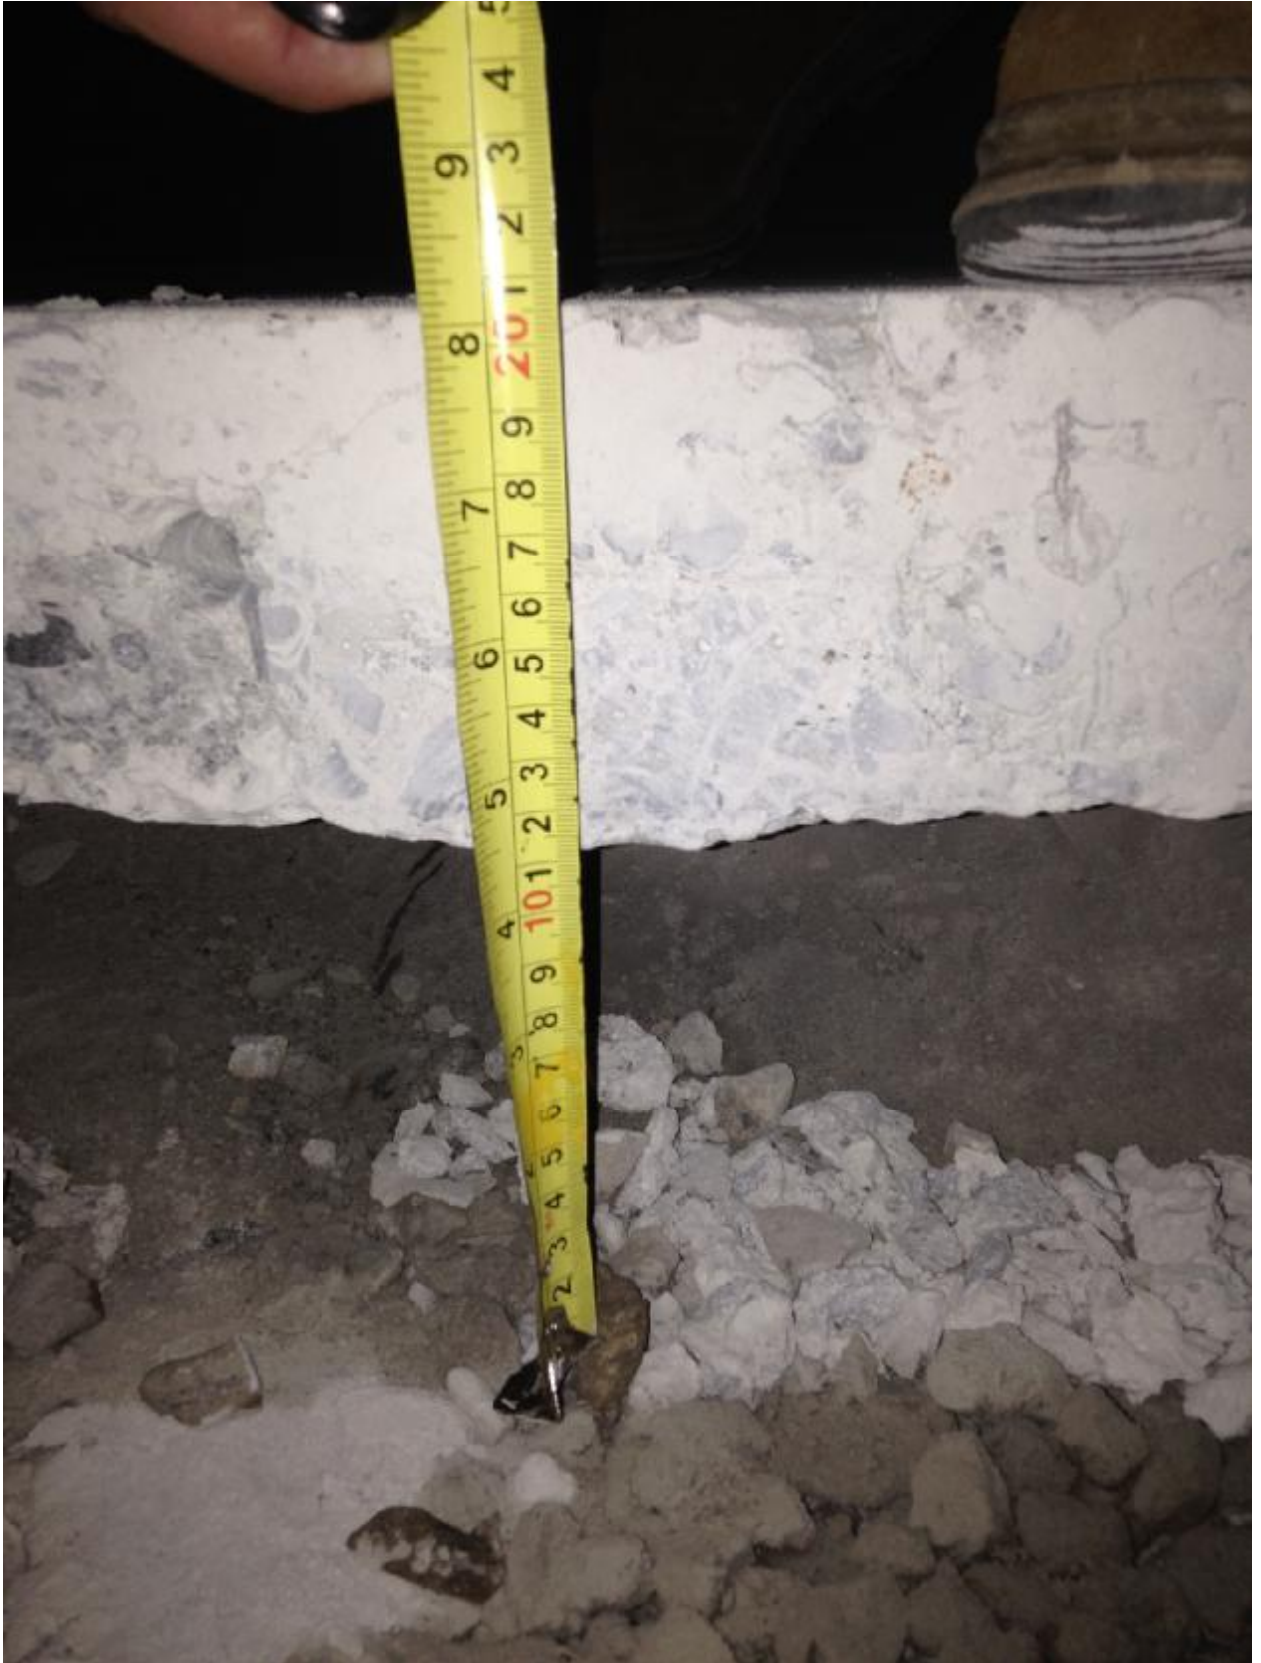
Photo 17 – Void under slab

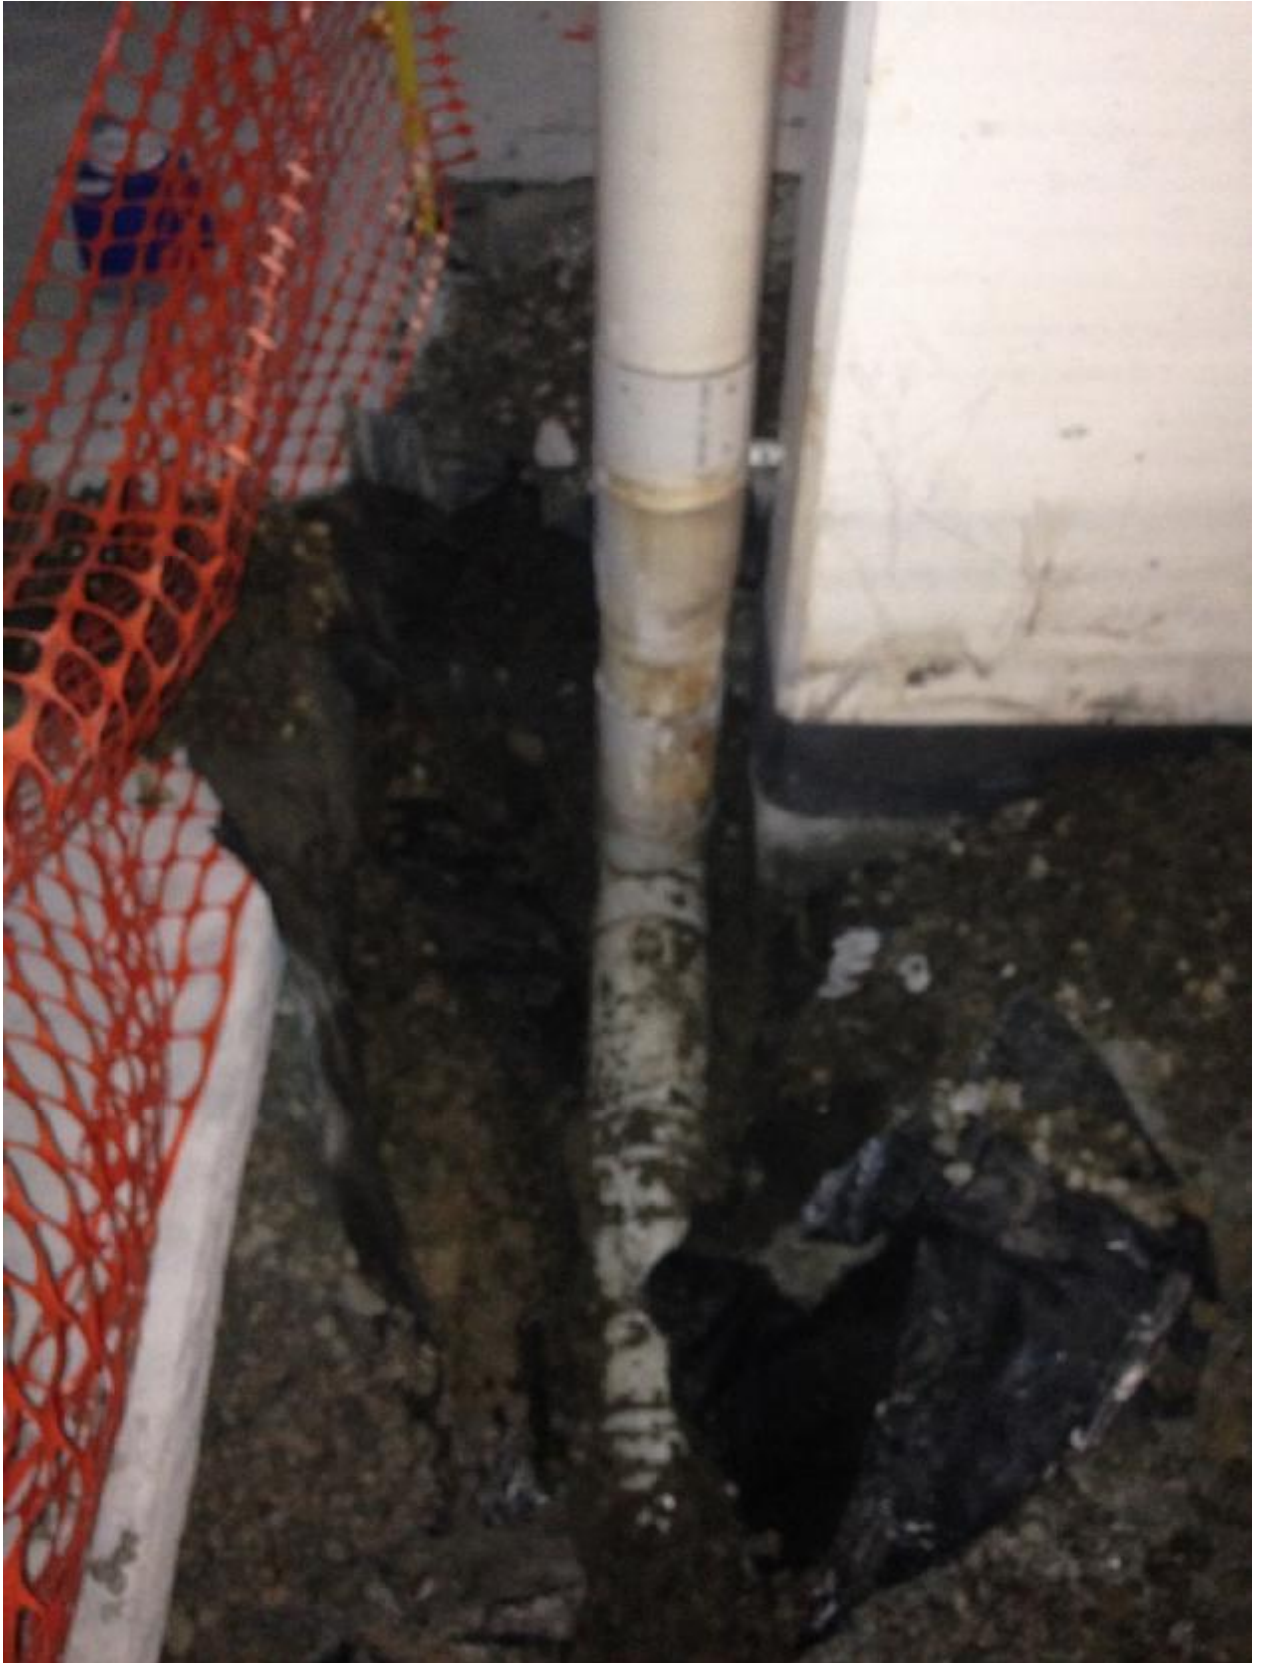
- There was a void under slab;
- The 150mm diameter roof-water pipe at this location was broken at a joint under the slab
- We noted that the slab was cast on plastic on a sandy gravel layer with a geofabric layer underneath – we did not observe any geofabric layer under the slab as nominated in the design and the gravel was contaminated; and
- The broken pipe was repaired prior to repouring the slab.

Photo 18 – Cracked roofwater pipe wide shot

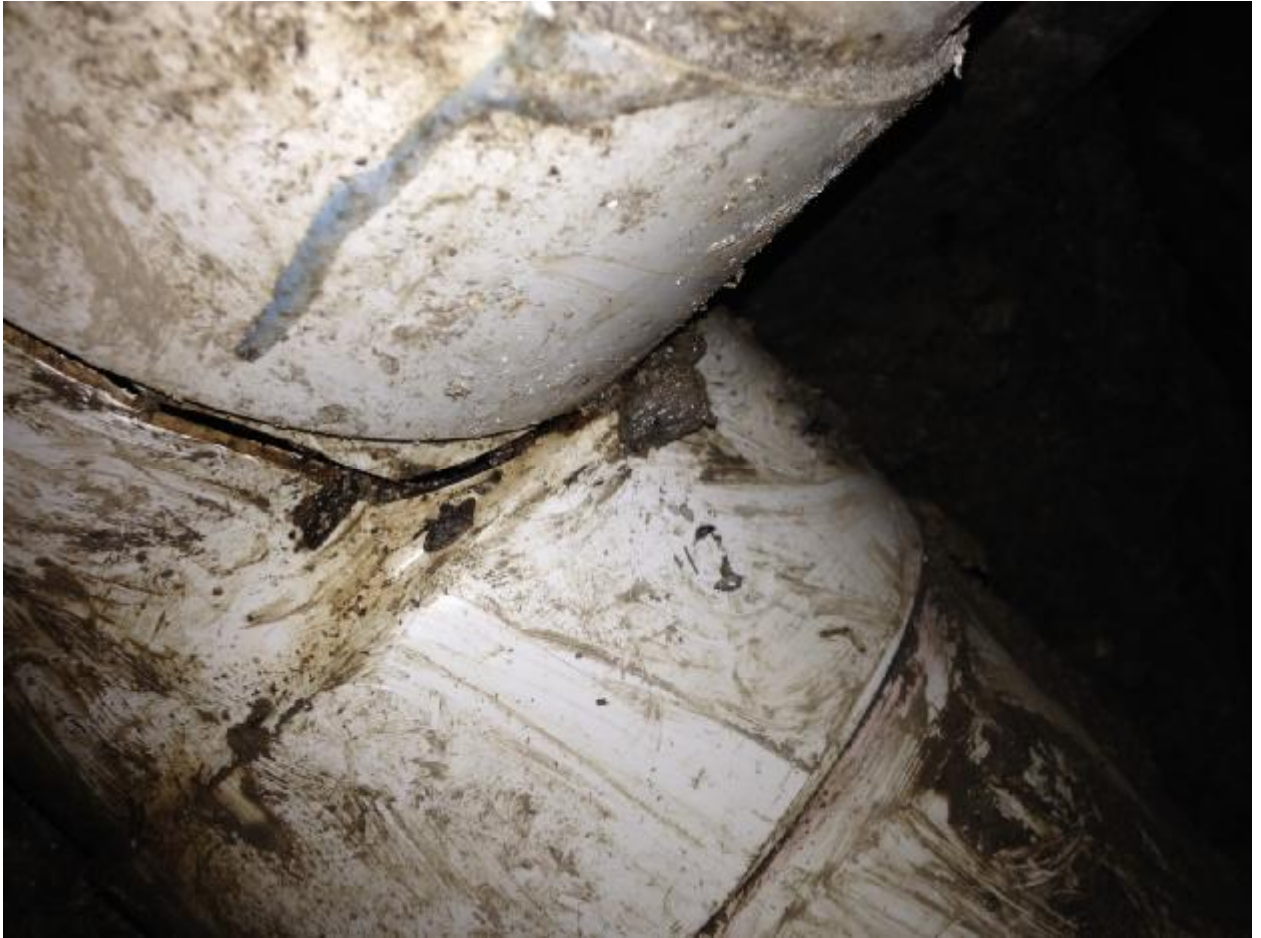
Photo 19 – Close up of broken roofwater pipe

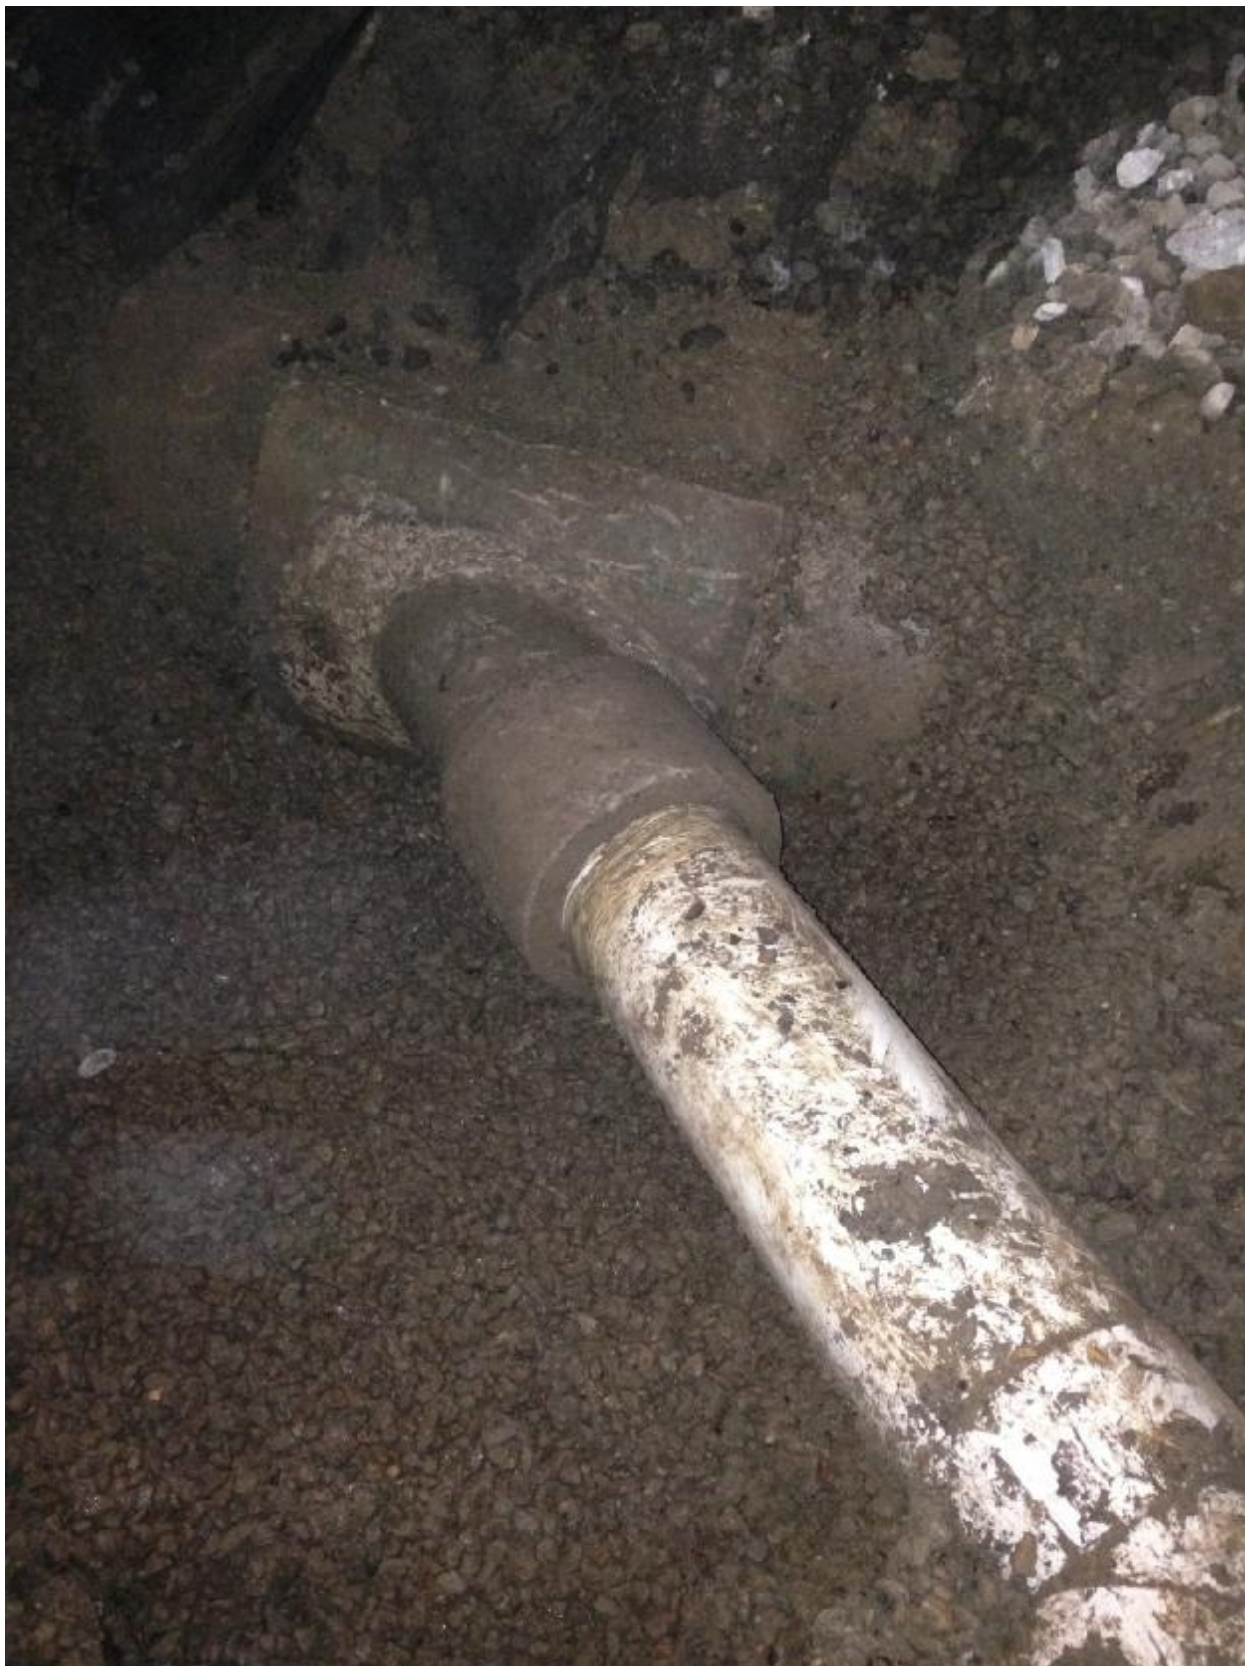
- There was a void under slab;
- The 150mm diameter roof-water pipe at this location was not broken.
- The saddle joint of the 150mm diameter roof-water pipe to the 525mm diameter pipe was secure;
- Once the slab was removed the surrounding slab dropped;
- We noted that the slab was cast on plastic on a sandy gravel layer with a geofabric layer underneath – we did not observe any geofabric layer under the slab as nominated in the design and the gravel was contaminated; and
- During the slab removal, the existing downpipe was damaged and needed to be repaired.

Photo 20 – 150mm roofwater saddle joint to 525mm diameter pipe

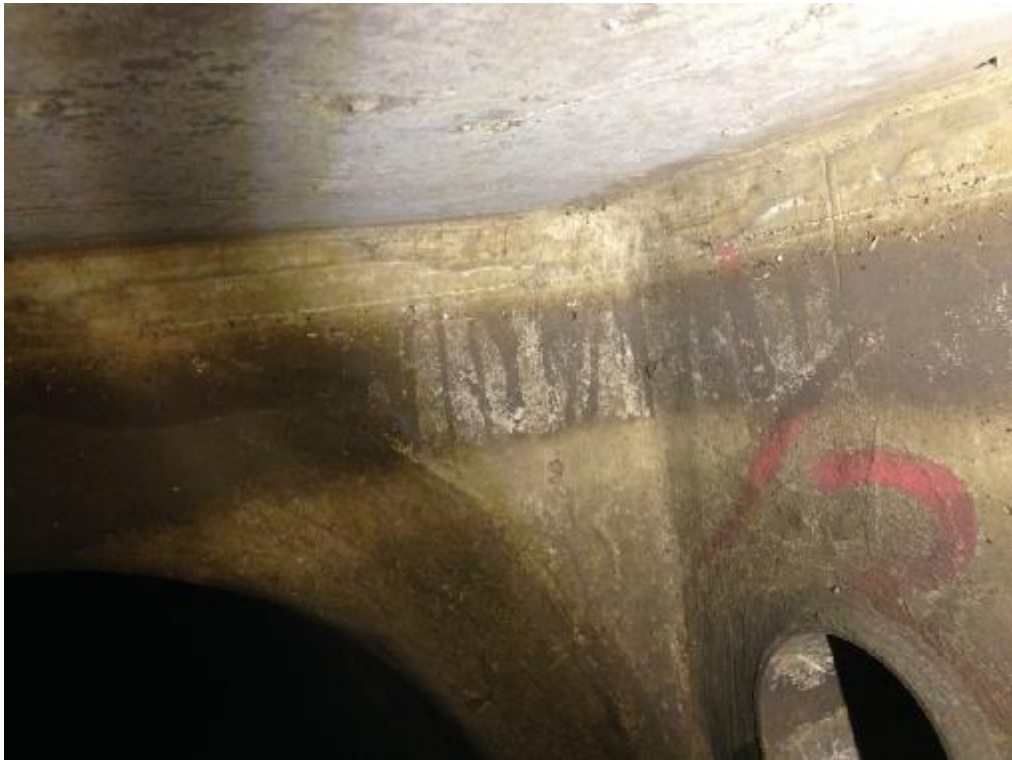
A visual inspection of the manholes located on the 'sealed' roof-water system indicated that the aspro slabs (top lid slab of a manhole) remained on top of and sealed to the top of the manhole chamber. No evidence of leakage from these chambers was present. The issue with these types of manholes is that they can tolerate no vertical movement of the lid as they are not structurally connected and would be susceptible to opening up if the basement slab was to lift. In the past these pits had clearly failed and they were repaired. It is our belief that these manhole chambers should have been constructed as cast-insitu pits with an insitu lid that is structurally connected – they are more robust and would not allow water to enter the subgrade when subjected to large flows and hydrostatic pressure. Refer to the photographs in Appendix C.

Photo 1 - Manhole on sealed roof water system. Aspro Slab still connected and sealed to main chamber

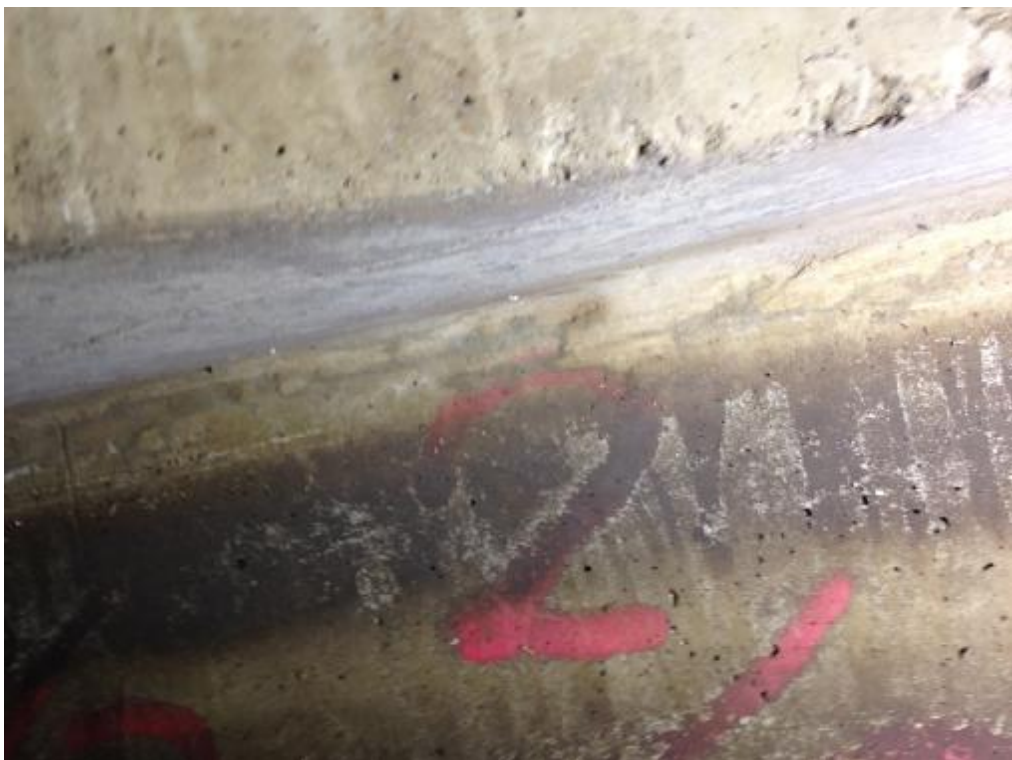
Photo 2 – Manhole on sealed roof water system. Aspro Slab still connected and sealed to main chamber

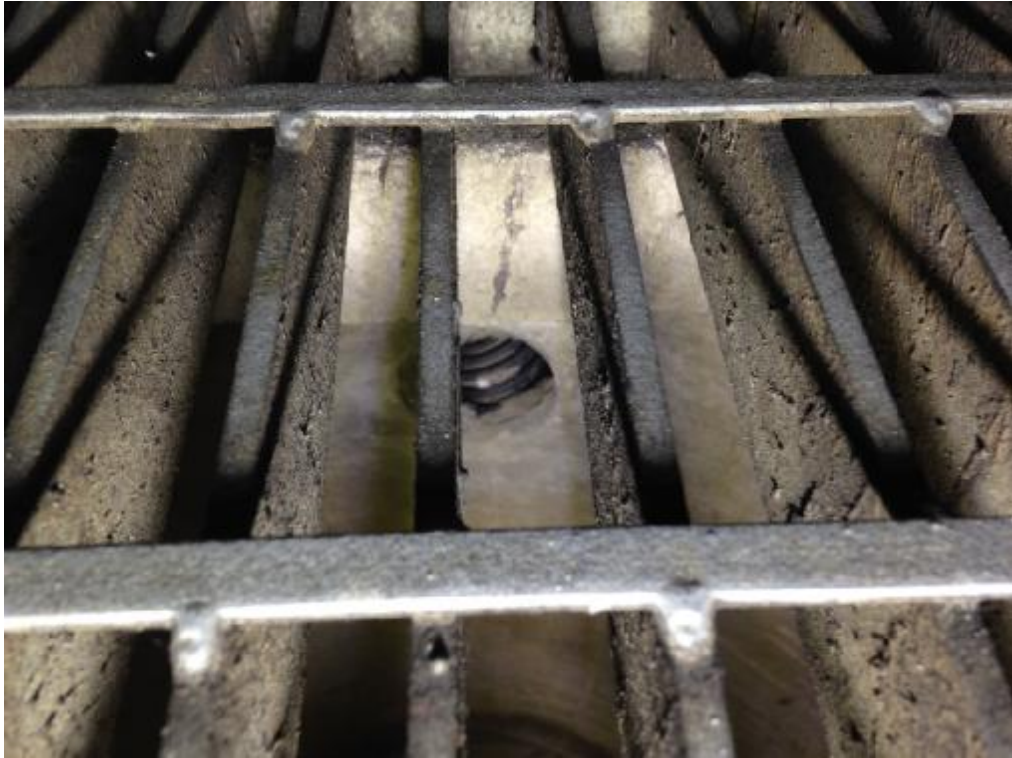
We also inspected the grated inlet pit structures on the basement drainage system and noted that multiple 75mm diameter agi drain outlets were provided at the top of these structures as per the note in the legend on the Basement Plan Hydraulic Services by Christopher Contracting. The size and spacing of these pipes is important to the success of a system sub-floor drainage system and requires detailed assessment of water inflows, soil permeability and drainage capacity.

Photo 3 – Grated Inlet Pit on basement drainage system – 50mm ag drain from under slab drainage layer can be seen

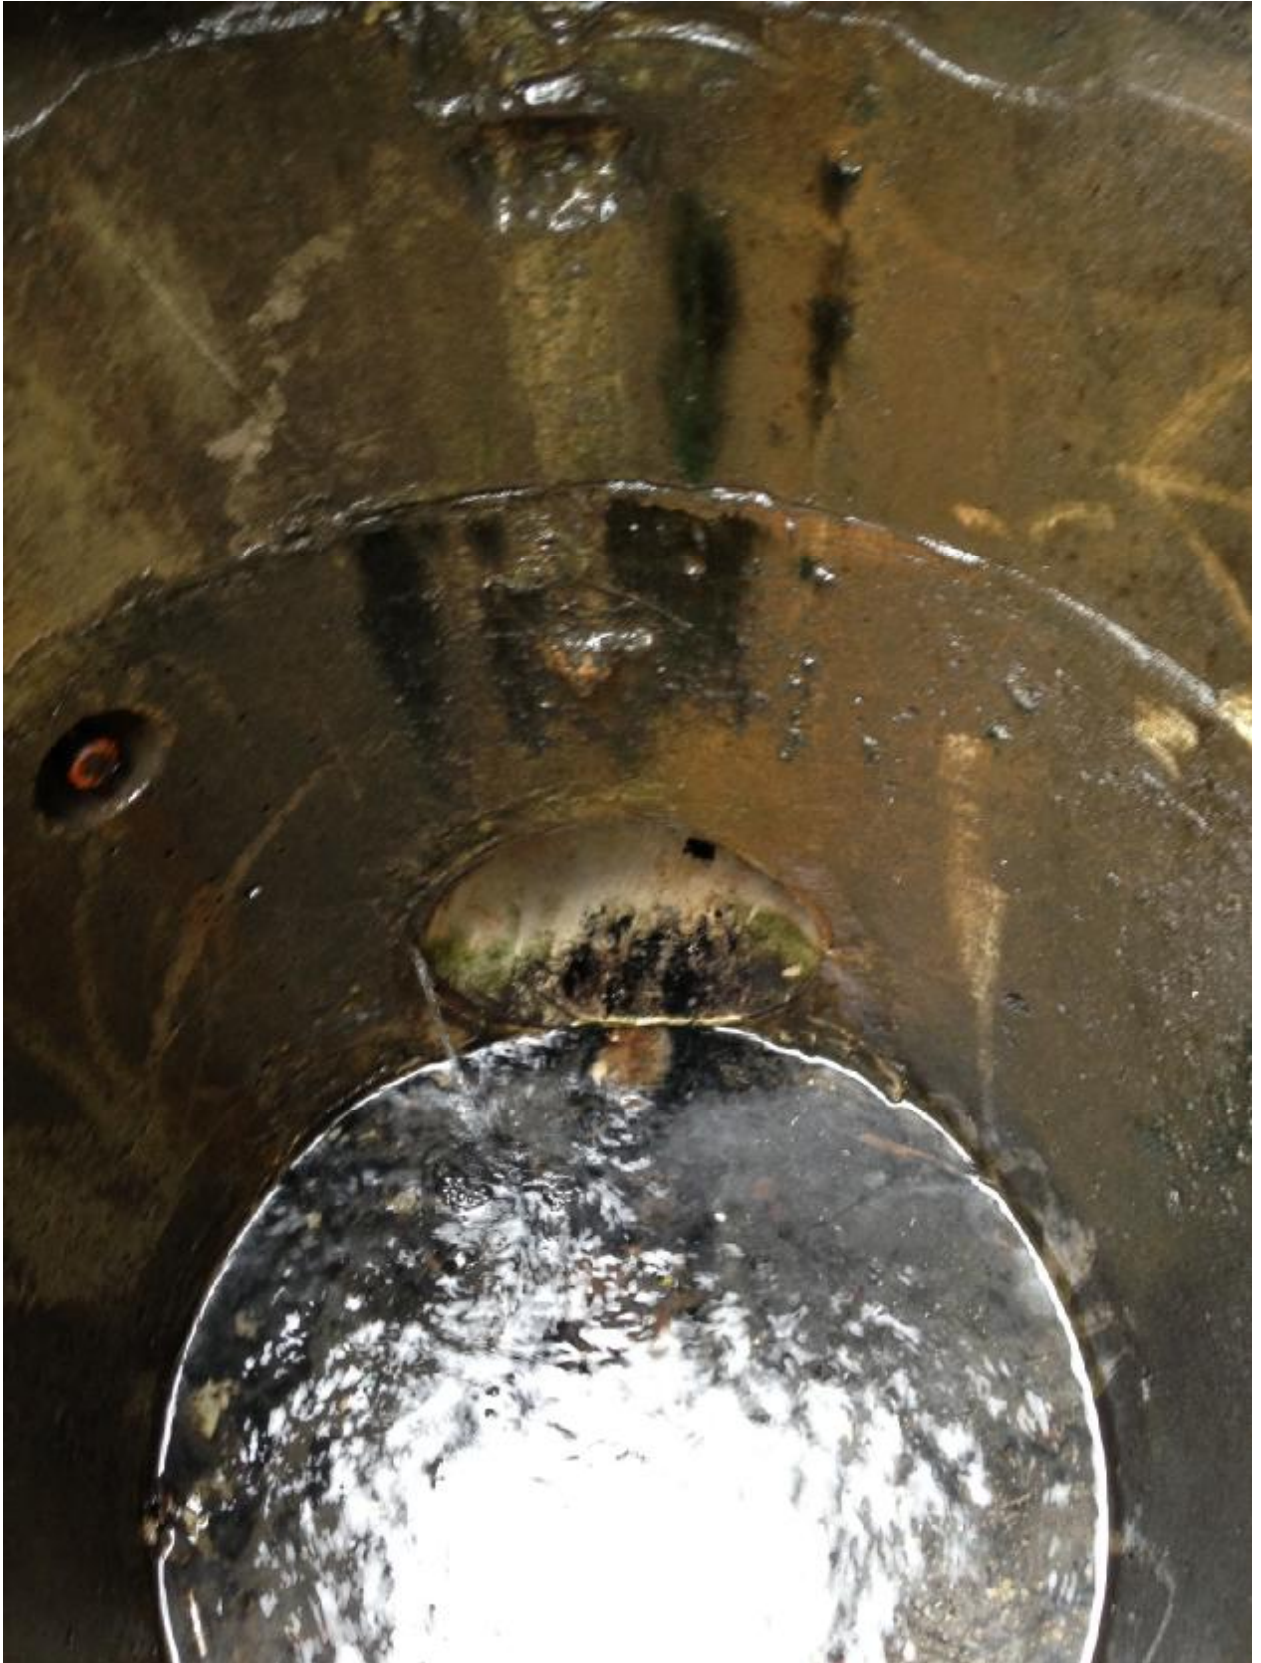
Photo 1 - Ground water entering around pipe penetration in basement drainage manhole located in loading dock

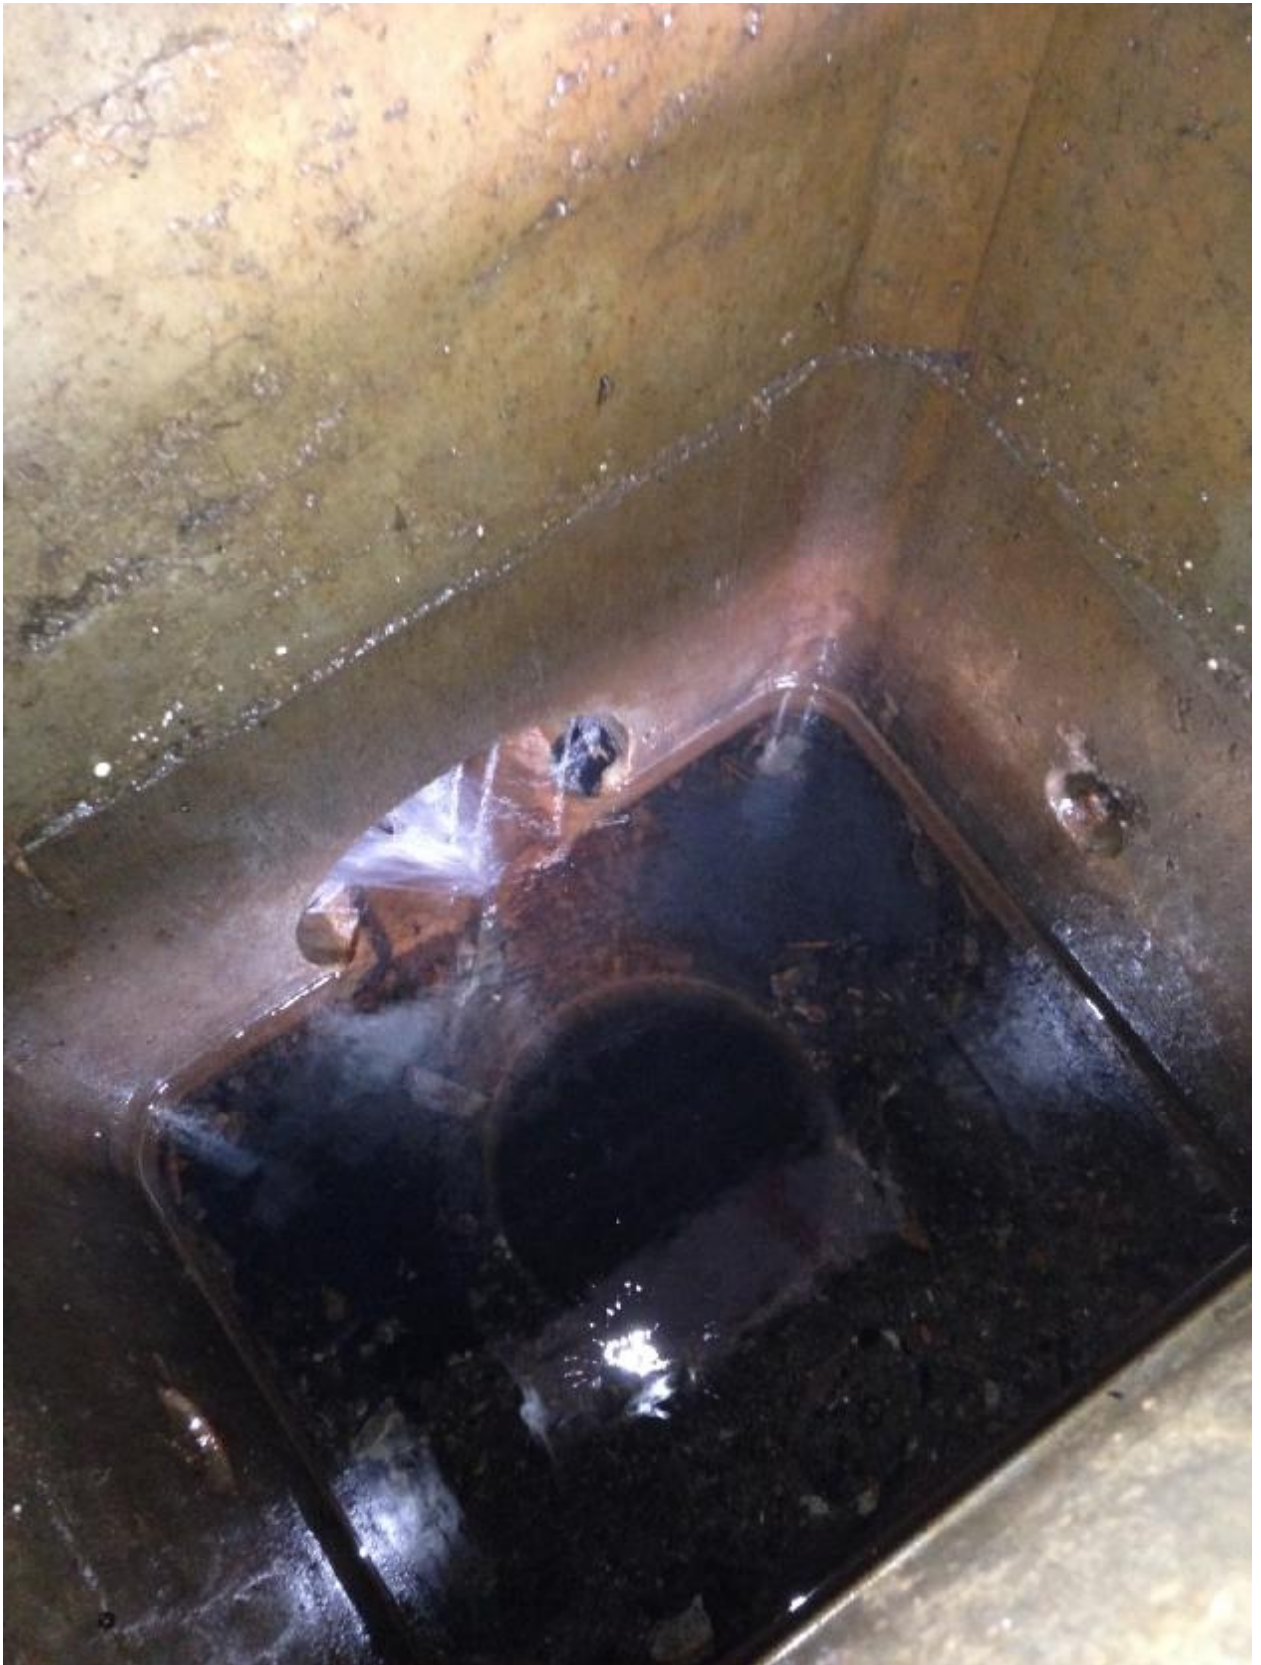
Photo 2 – Ground water entering around pipe penetration in the Ecosol Unit on basement drainage system located in loading dock

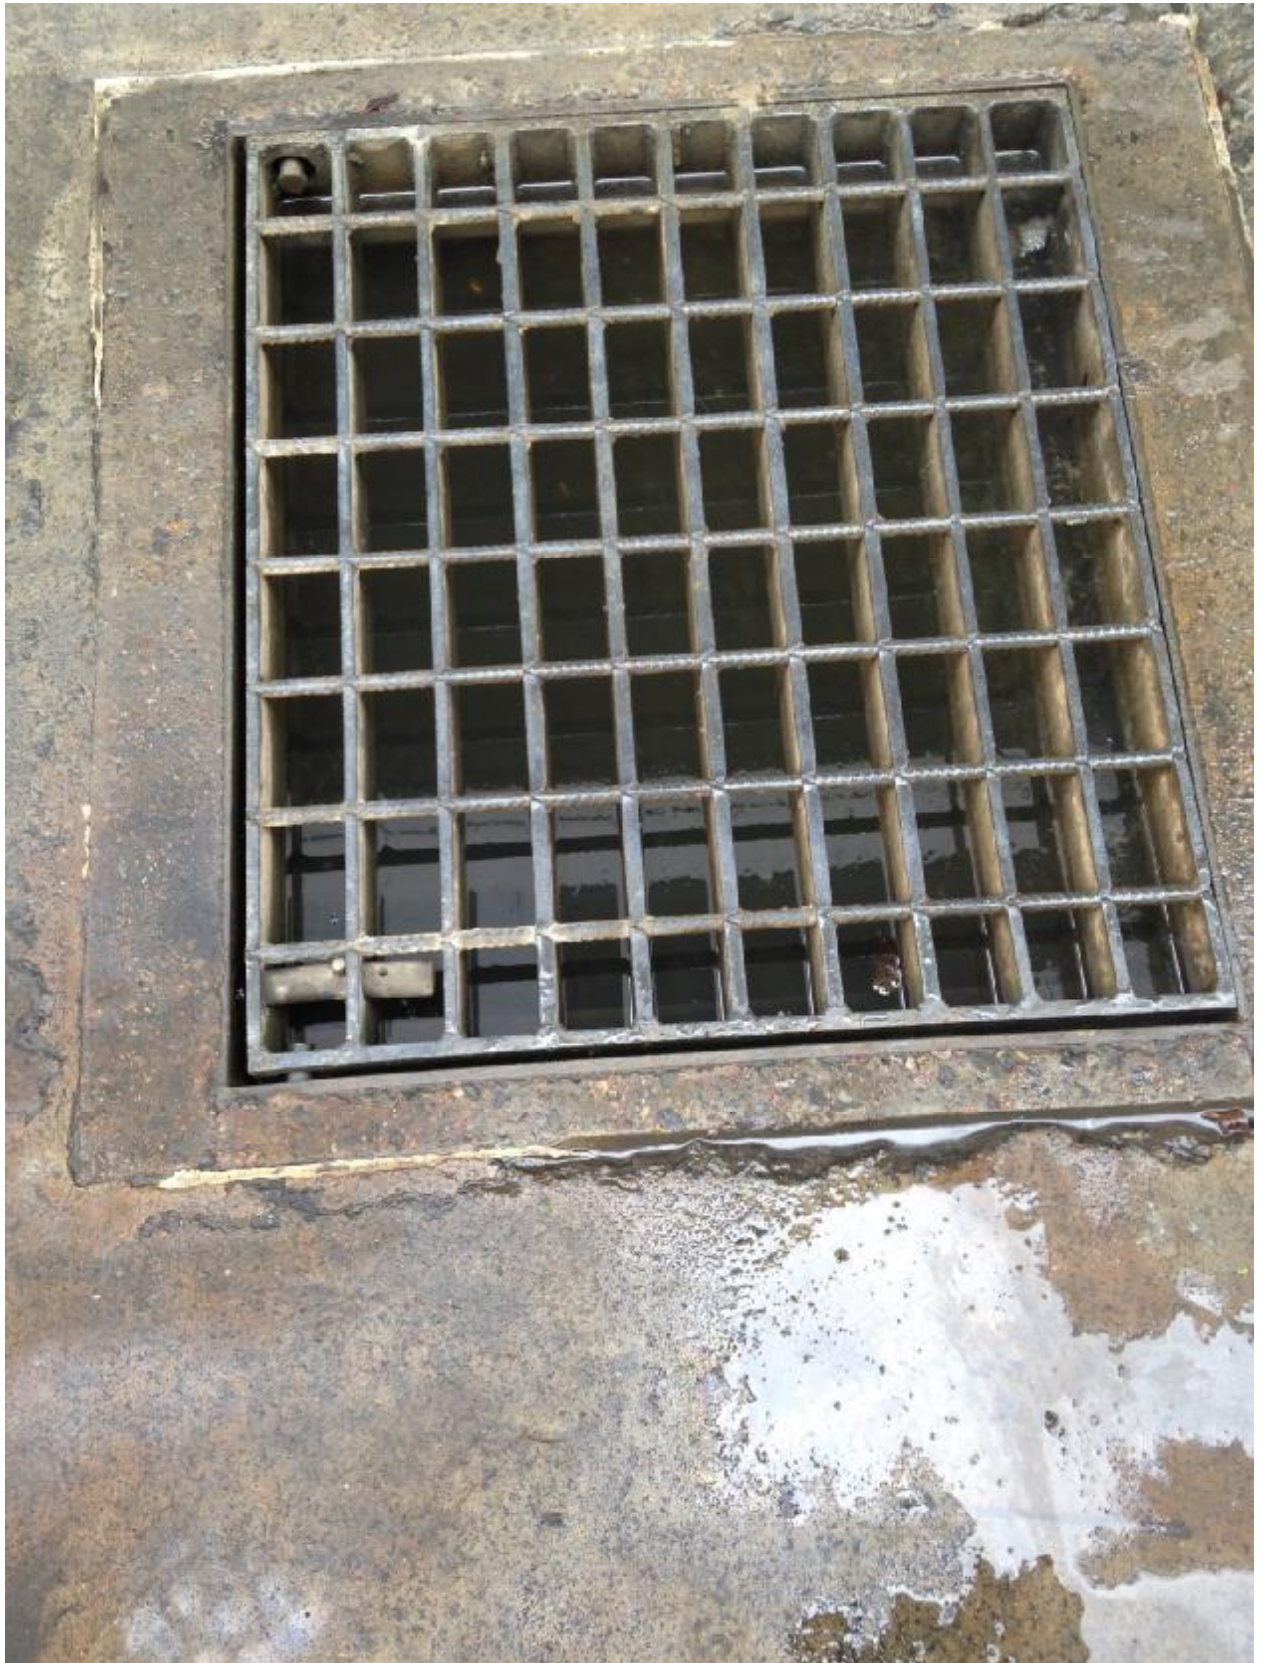
We observed that the pump system had failed and we understand that the system has not been operational in some rain events due to power failure. We also have determined that the tidal levels in the nearby creek prevent water within the under-slab drainage layer from draining away.

Photo 3 – Pit on basement drainage line located upstream of pumps in loading dock. Full of water due to non-operation of pumps

- Immediately repair and maintain the existing basement drainage pumps located in the loading dock so that the effects of rainfall events are reduced – it should be noted that large rainfall events will continue to result in basement flooding and slab heave;
