## OAKS MEWS APARTMENTS BOWEN HILLS, QLD

### Stormwater Management Plan

**Oaks Mews Apartments**  
**141 Campbell Street**  
**Bowen Hills QLD 4006**

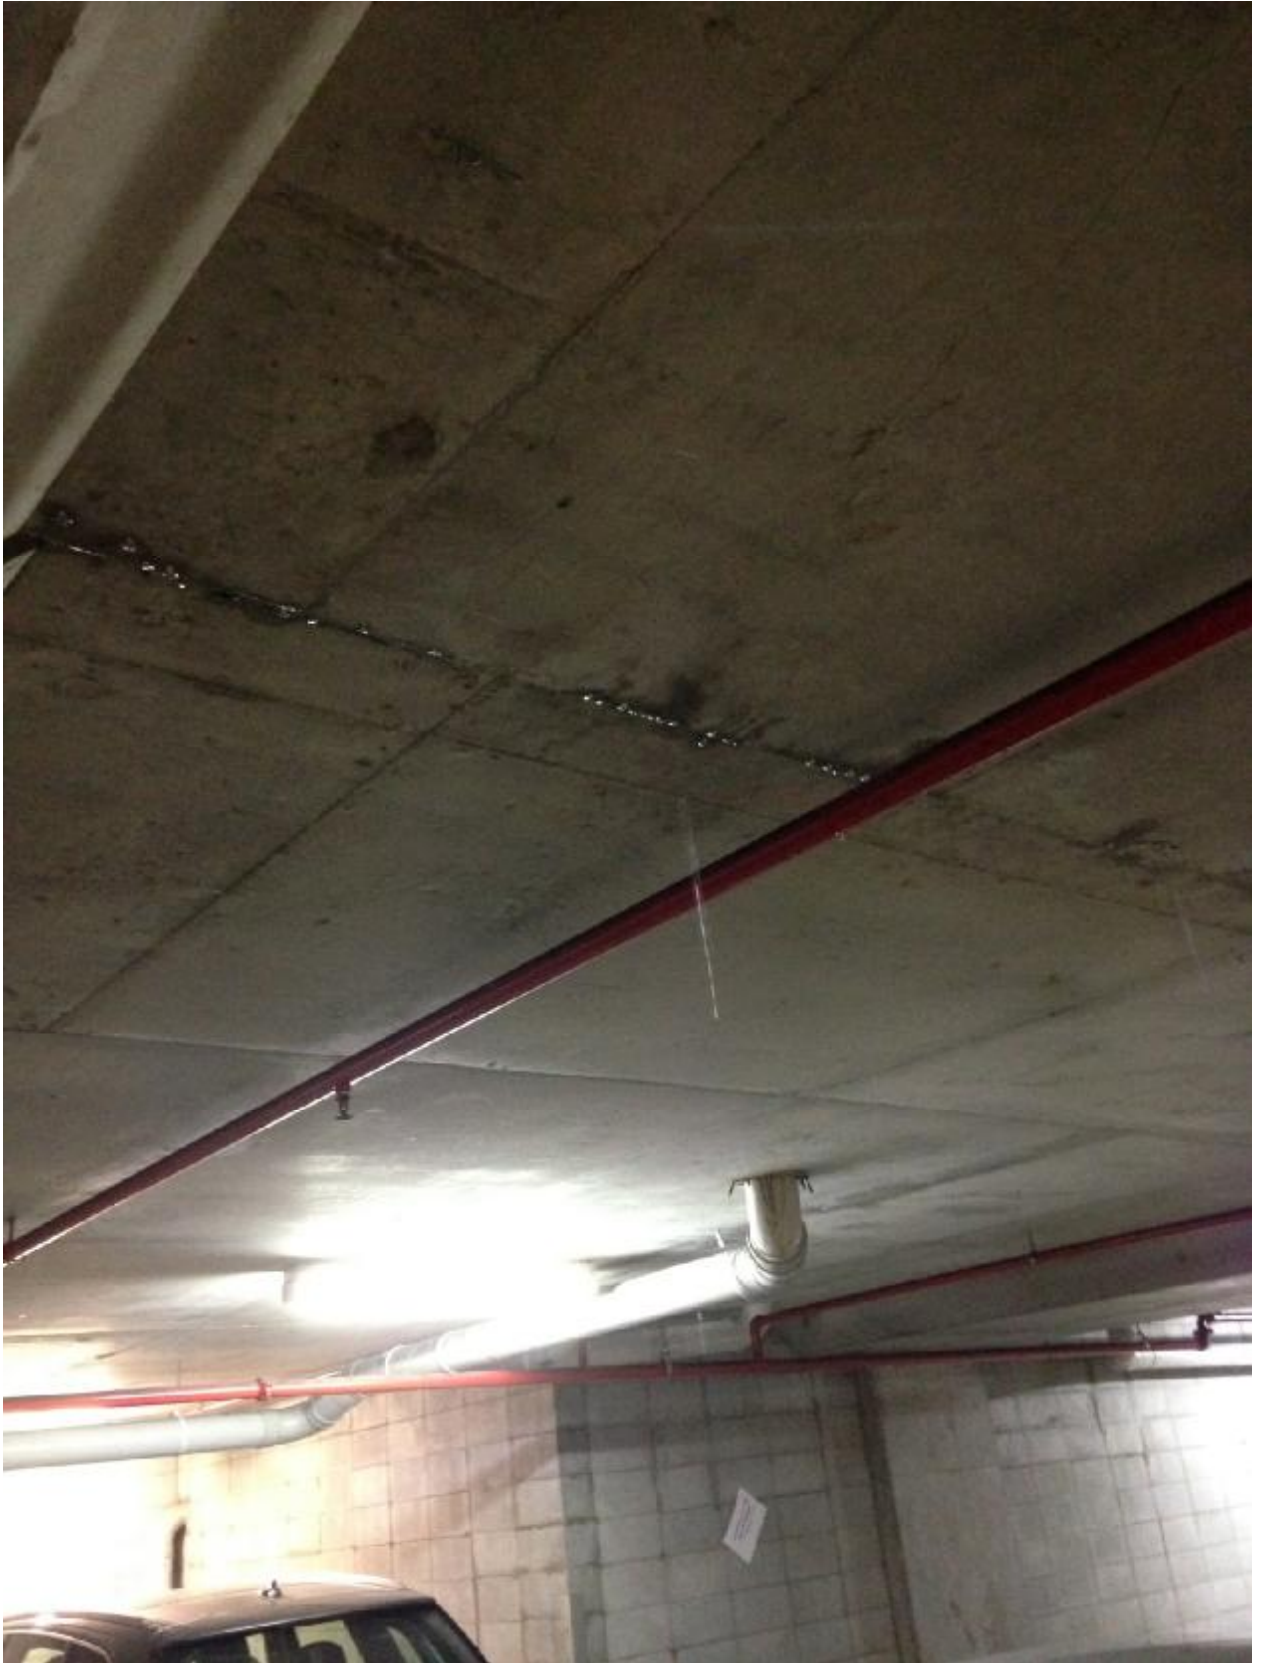
Photo 1 – Leakage through joints in podium slab into basement during rain event

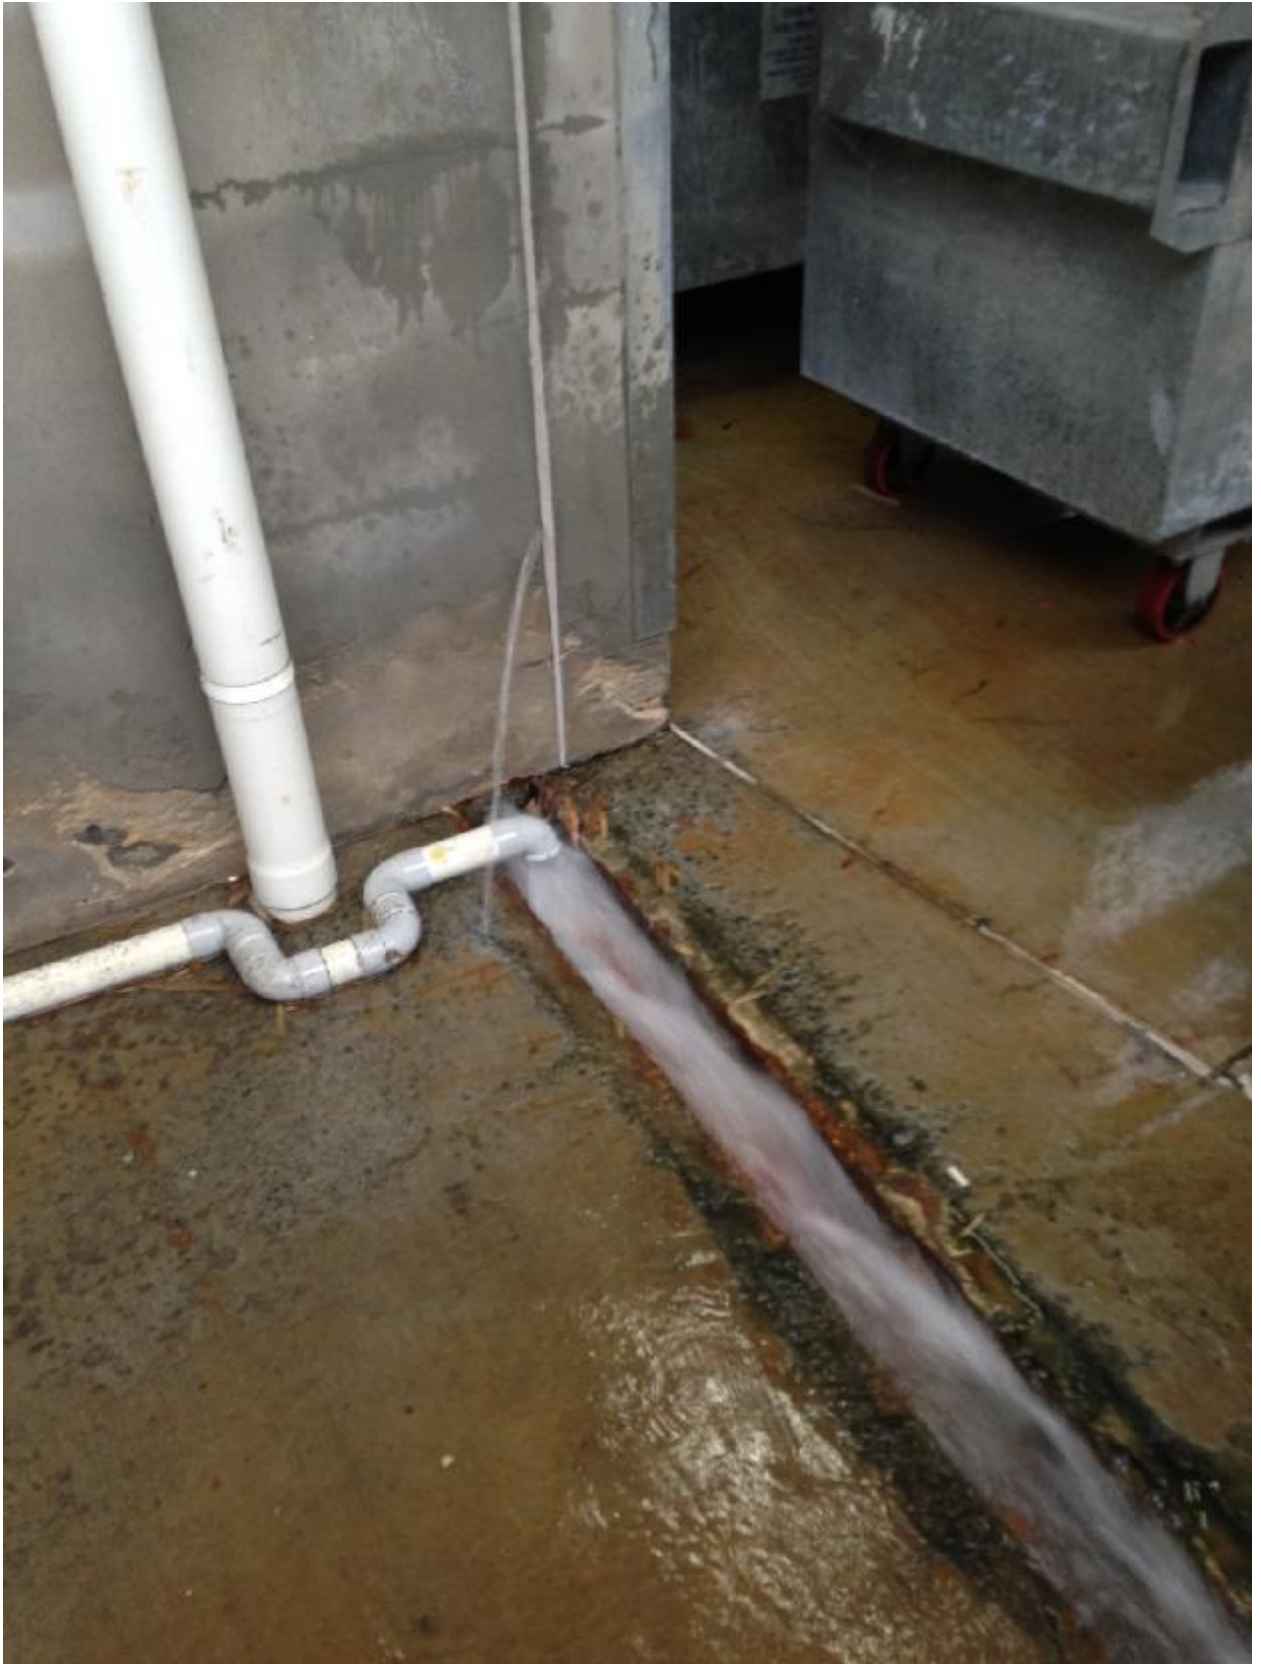
Photo 3 – Discharge to loading dock area from under basement slab

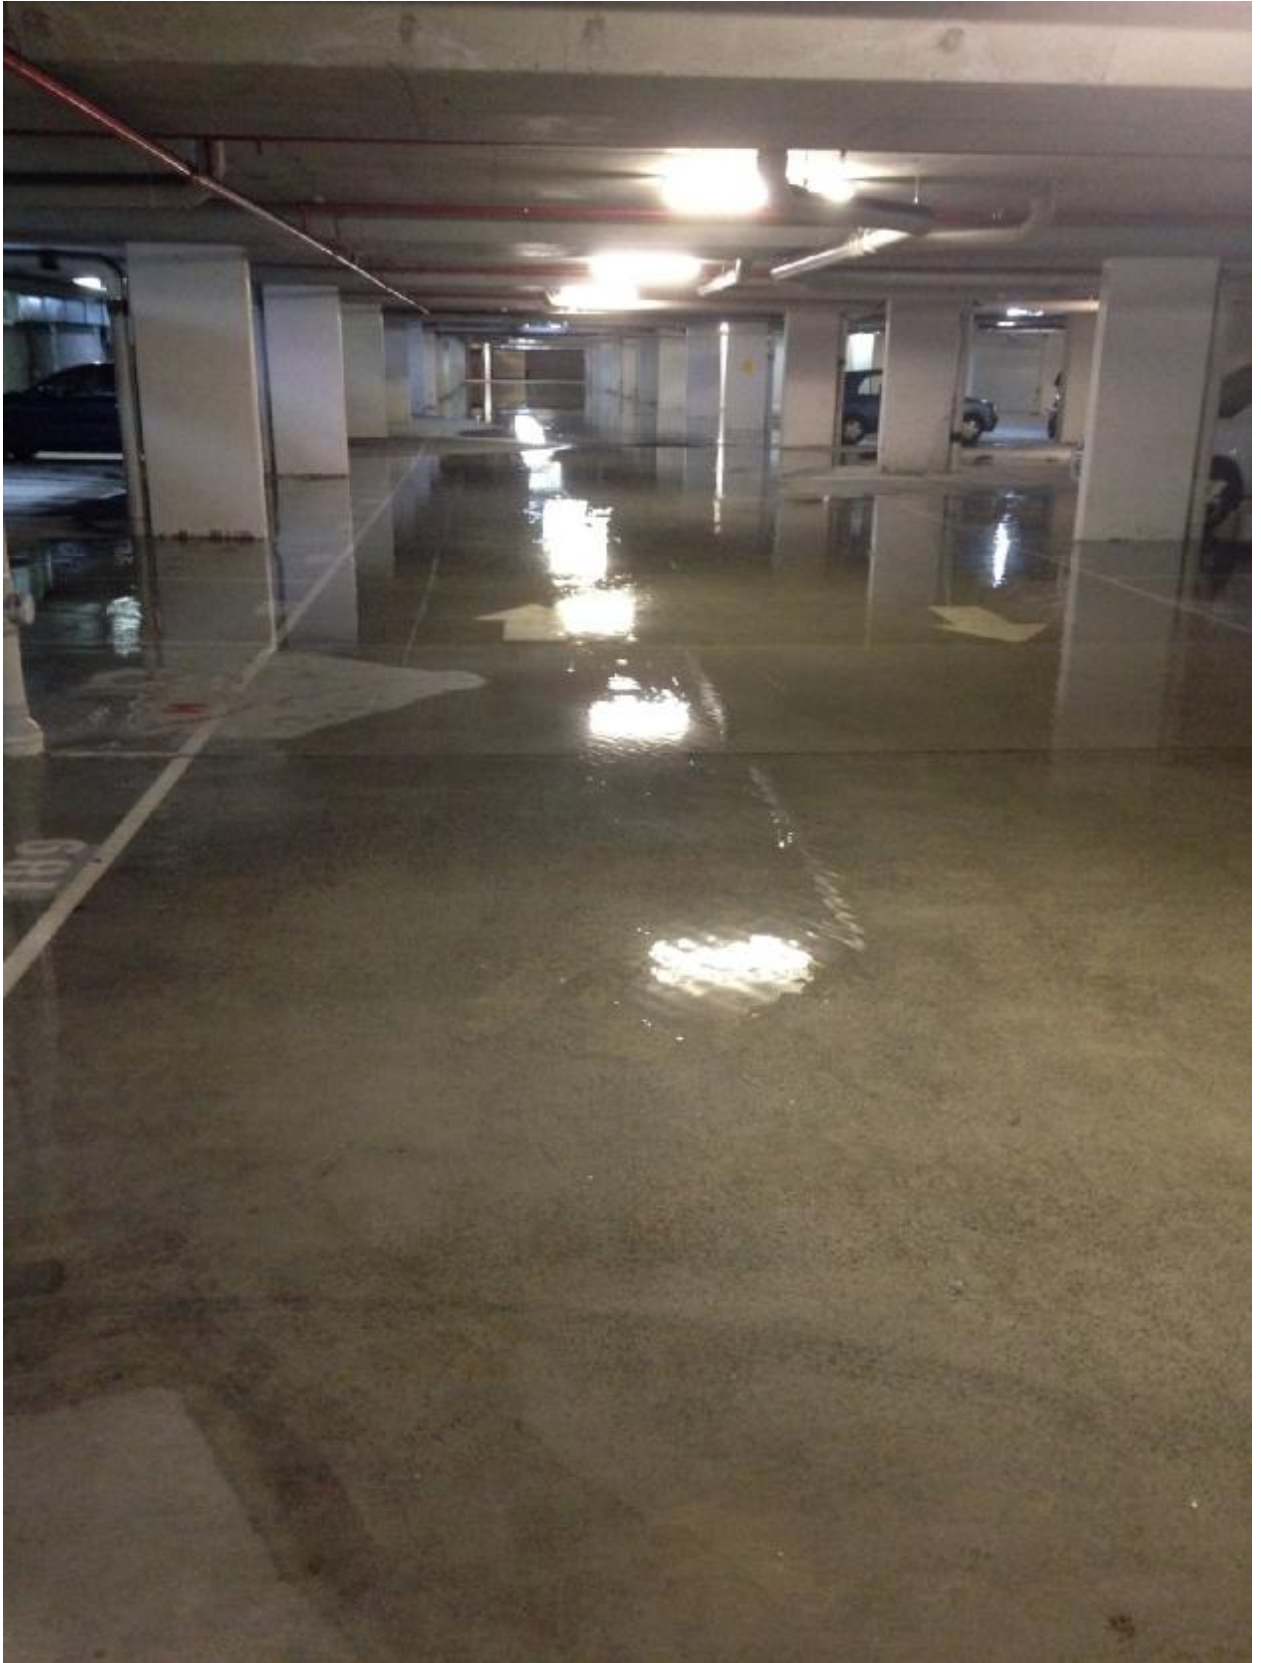
Photo 4 – Flooding of basement during rain event

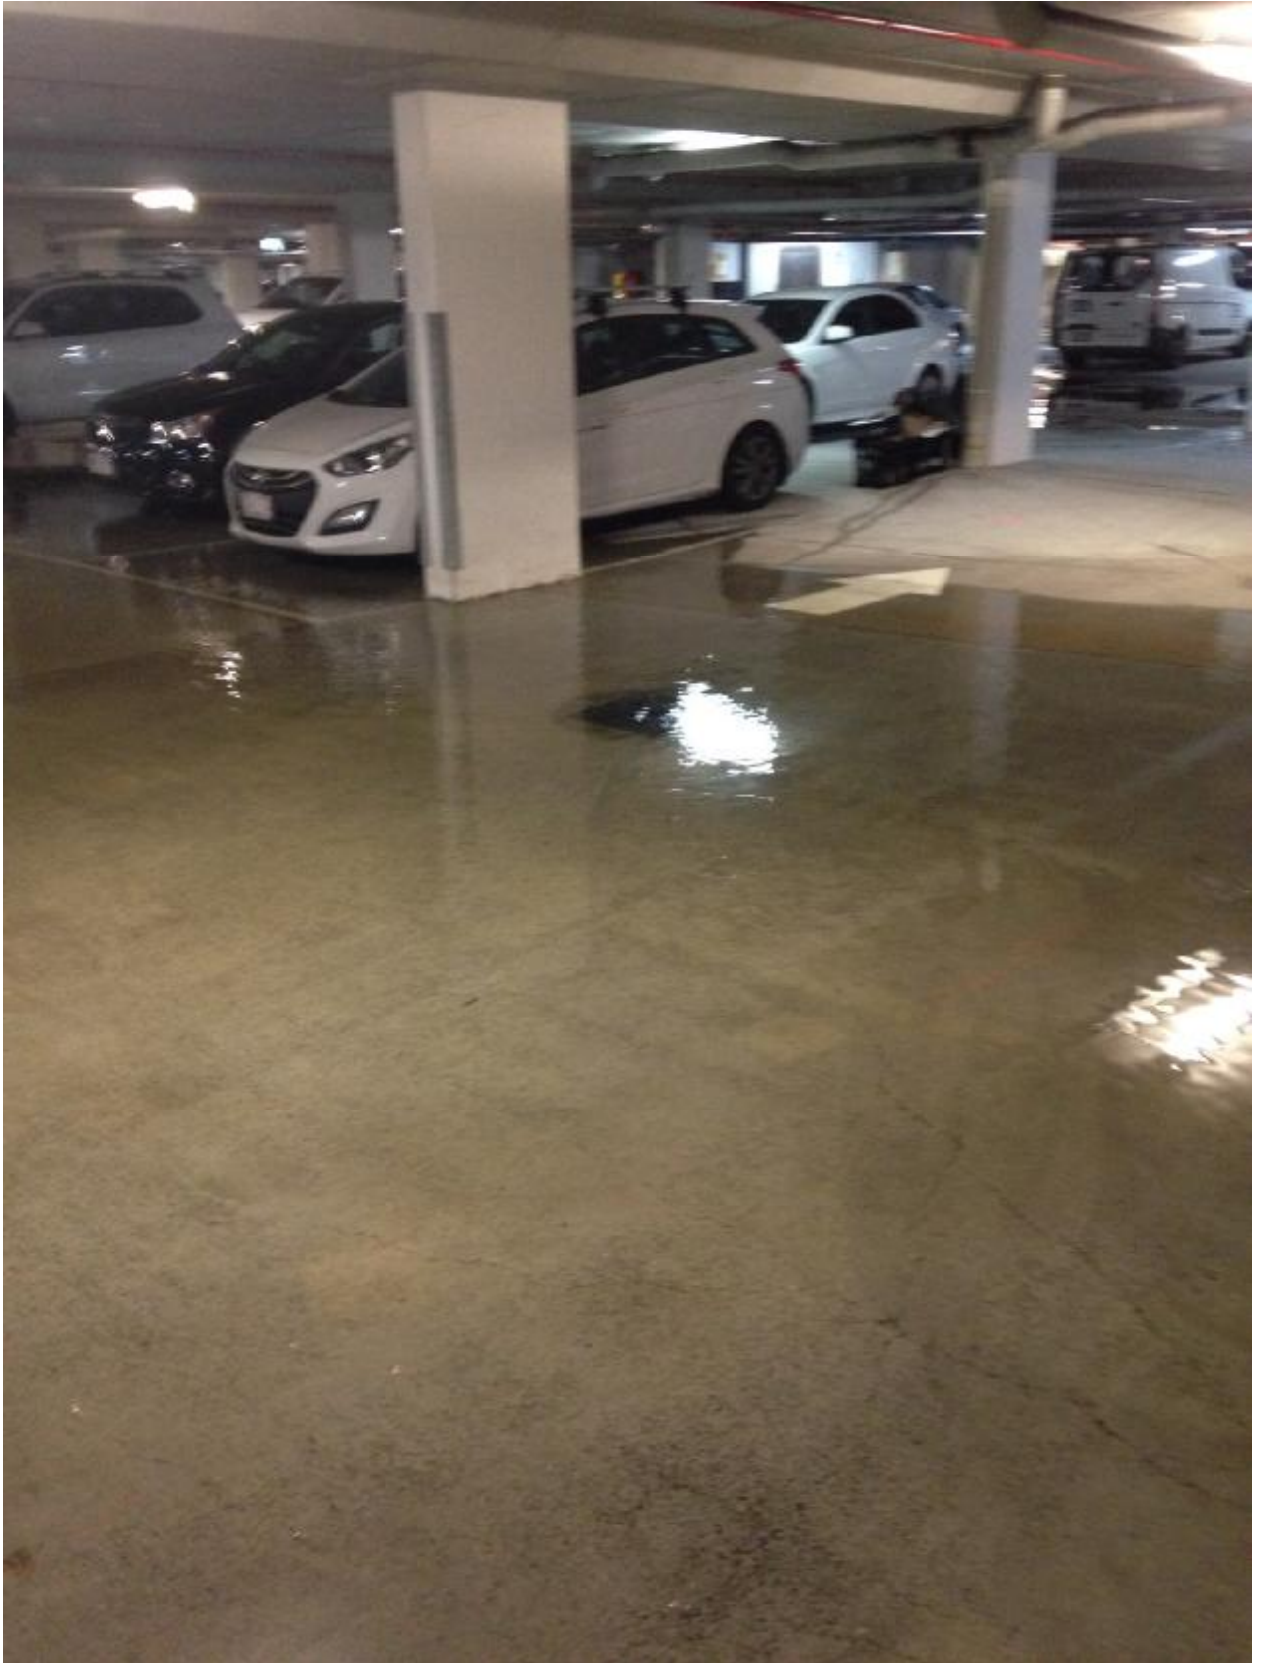
Photo 5 - Flooding of basement during rain event
