Project No. 019-113A

2 February 2021

**RE: TREE CLEARANCE AND WASTE REMOVAL METHODOLOGY- NORTHERN PORTION  
(REVISION THREE)  
FORMER YERONGA TAFE  
70 PARK ROAD, YERONGA**

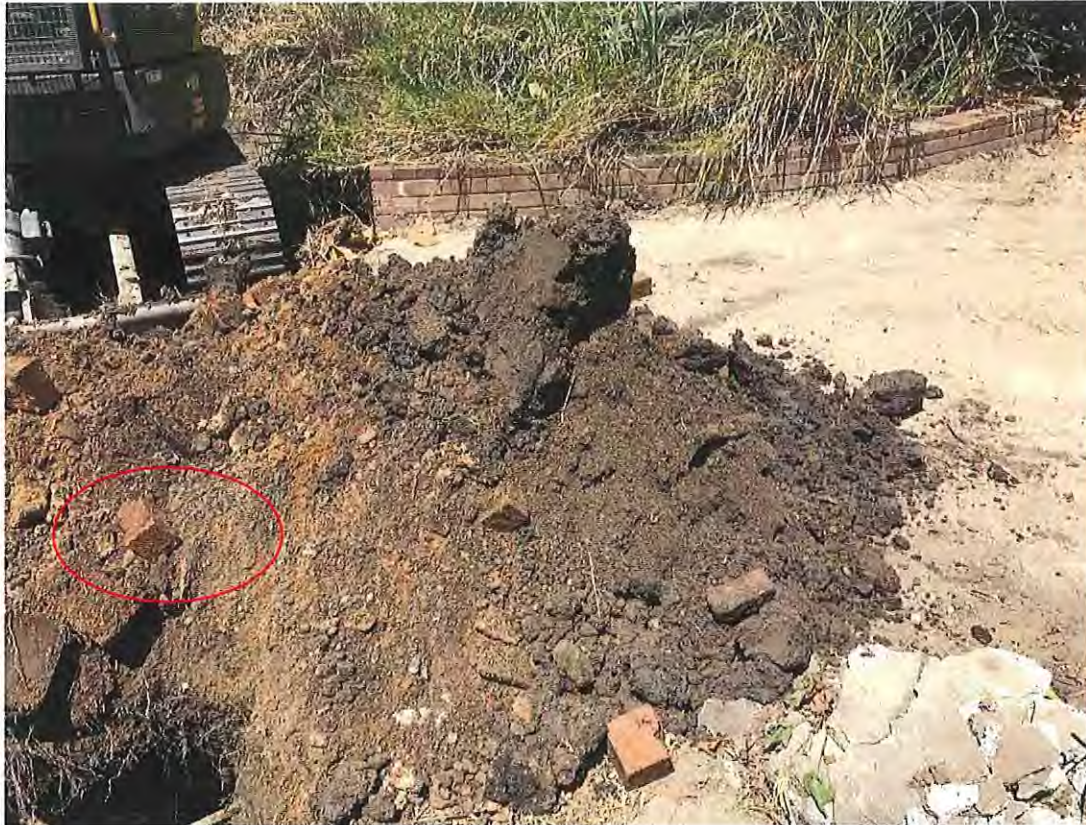
Although the fill identified in TP-N1, TP-N4, TP-N5, TP-N6 and TP-N9 were not observed to contain ACM, there was C&D waste such as glass, bricks and steel present, indicating the fill to be of the same origin and highly likely to contain ACM and also are considered to not comply with the 'Aesthetic Criteria' outlined in the National Environment Protection (Assessment of Site Contamination) Amendment Measure (NEPM), 2013. The test pit logs of the investigation locations specific to the northern portion of the site have been included.

*Photograph 1: An example of C&D Waste (circled in red) found in Test Pit (TP-N5) within the northern vegetated portion of the site. (Image Date: 3 December 2019)*

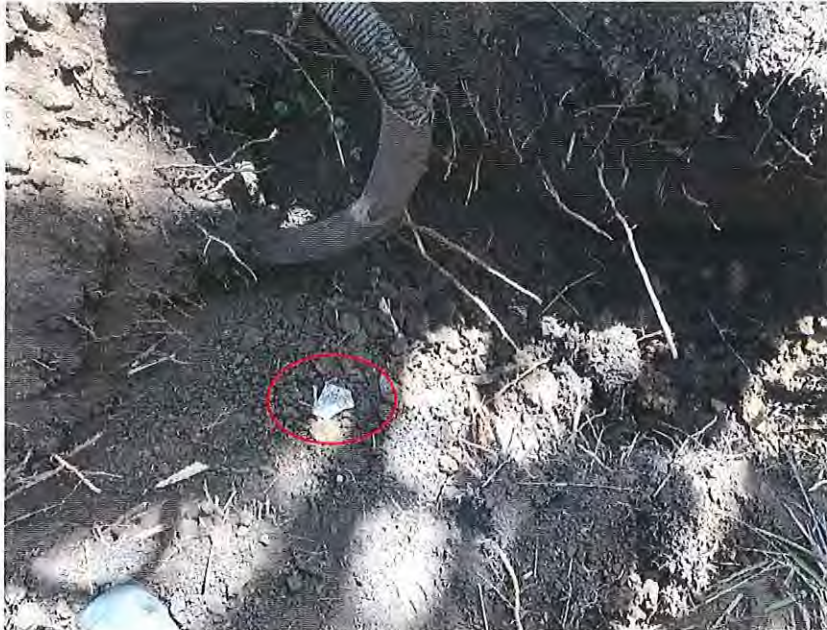
*Photograph 2: An example of ACM (circled in red) found in Test Pit (TP-N8) excavated in the northern vegetated portion of the site. (Image Date: 3 December 2019)*

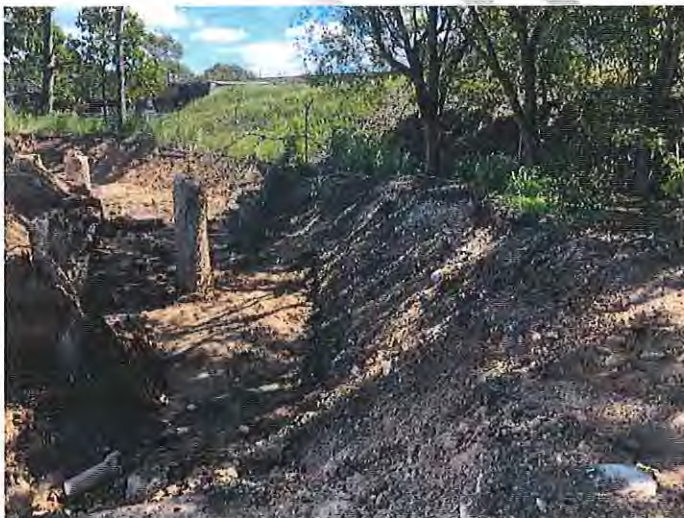
A bund currently exists in the north of the site, this bund currently contains trees/vegetation and divides the northern vegetated area and the rest of the site. This bund extends from the far western boundary to the eastern boundary shown in Photograph 3 and Photograph 4. A layer of geofabric can be seen in Photograph 5, this was placed across the bund to separate the C&D waste with ACM (contents of the bund) and the clean fill to the south of the bund at the conclusion of the waste removal works in December 2019.

Given the presence of C&D Waste and ACM that has been observed on the southern side of the bund, this material is required to be removed as part of the development of the site. The vegetation/trees that are growing within this bund require removal and the area is shown on the attached Drawing No. 8 Rev C.

*Photograph 3: A view of the northern vegetated portion of the site facing towards the west, with the bund material that contains C&D Waste and ACM pictured in the right of the photograph. (Image Date: 3 July 2019)*

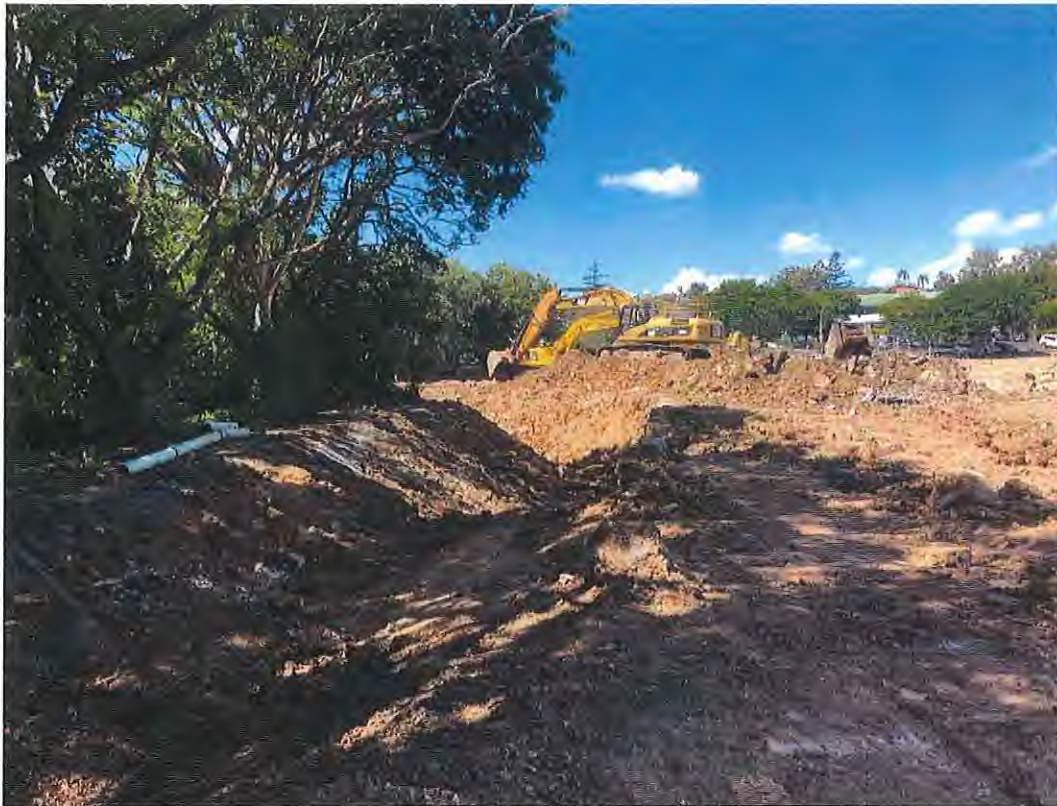
*Photograph 4: A view facing towards the east during waste removal works, with the bund and northern vegetated portion of the site visible in the left of the photograph. (Image Date: 4 April 2019)*

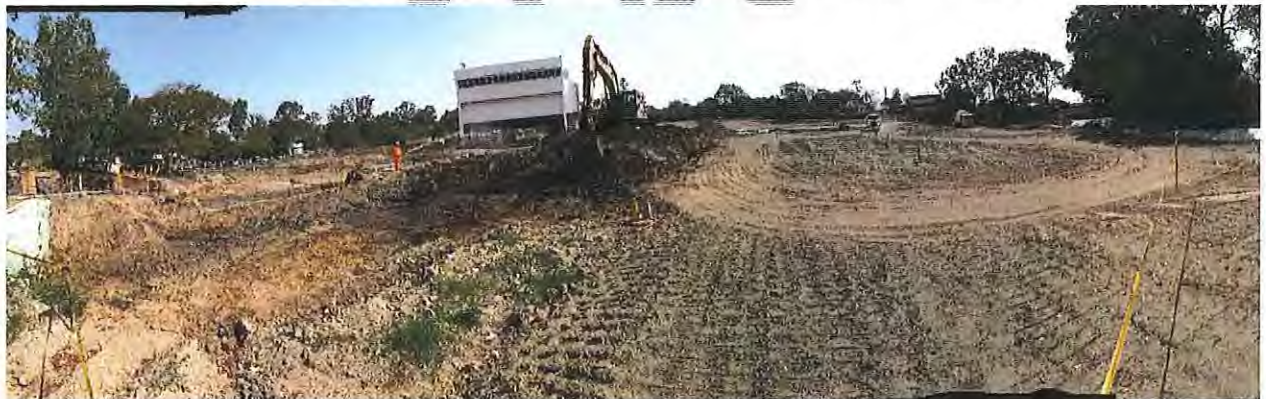
*Photograph 5: A panoramic view of the northern portion of the site after the conclusion of filling works, the northern vegetated portion of the site is visible with geofabric placed on the bund material pictured in the top right of the photograph. (Image Date: 9 October 2019)*

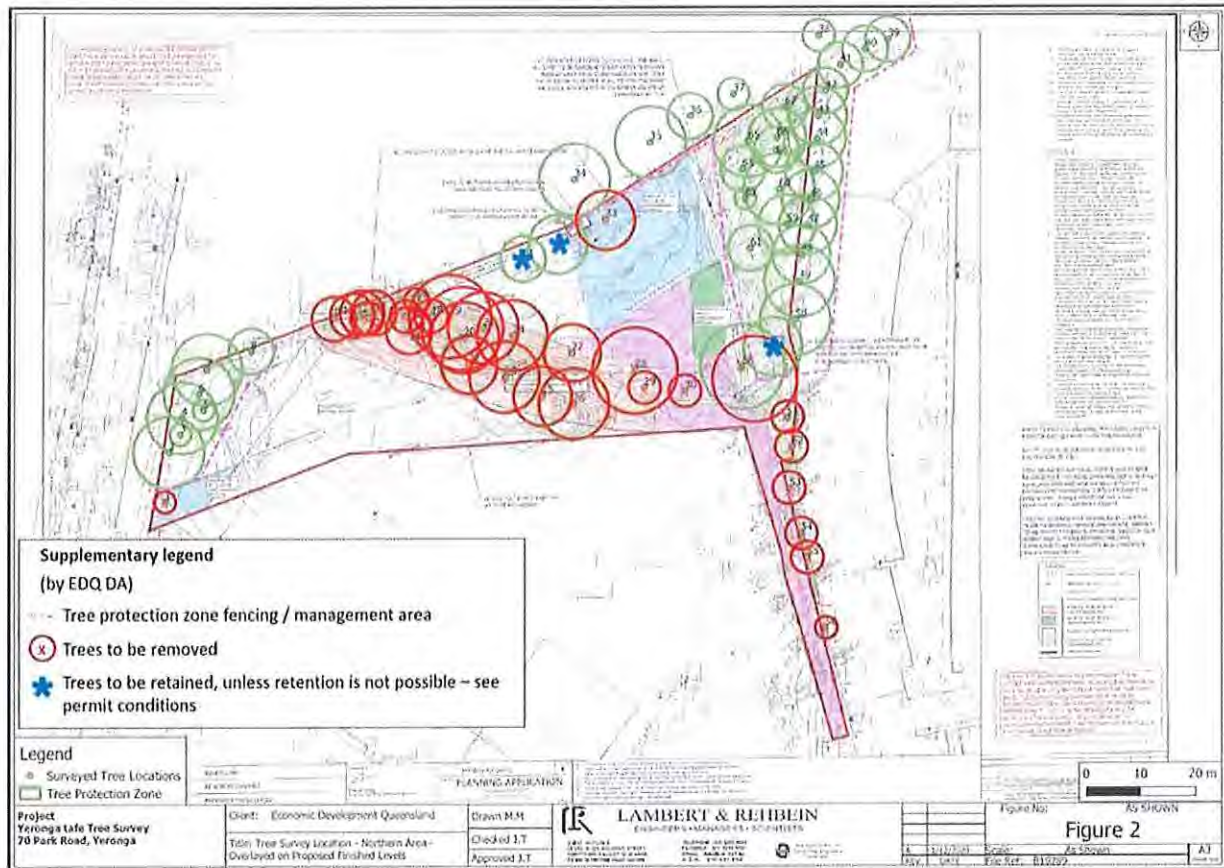
Figure 1: Lambert and Rehbeins Tree Survey Location- Northern Area- Overlayed on Proposed Finished Levels

Please be aware that the trees identified to be removed in Table 1 are based off Figure 1 (Lambert and Rehbeins Tree Survey Location Drawing, dated 1 December 2020) provided to Butler Partners by Rosenlund. If development is to extend outside of the areas shaded on Drawing No. 8 Rev C further tree removal may be necessary given the extent of the waste material through the northern portion of the site.

Prior to the required excavation of the ACM impacted C&D waste across the areas identified in Drawing No. 8 Rev C the trees should be safely cut back to approximate ground level. The resulting three branches and trunks may be reused by the way of mulching or other reuse. The tree root 'balls' and surrounding soils should be disposed of to landfill as they are within soils that have been identified to contain ACM.

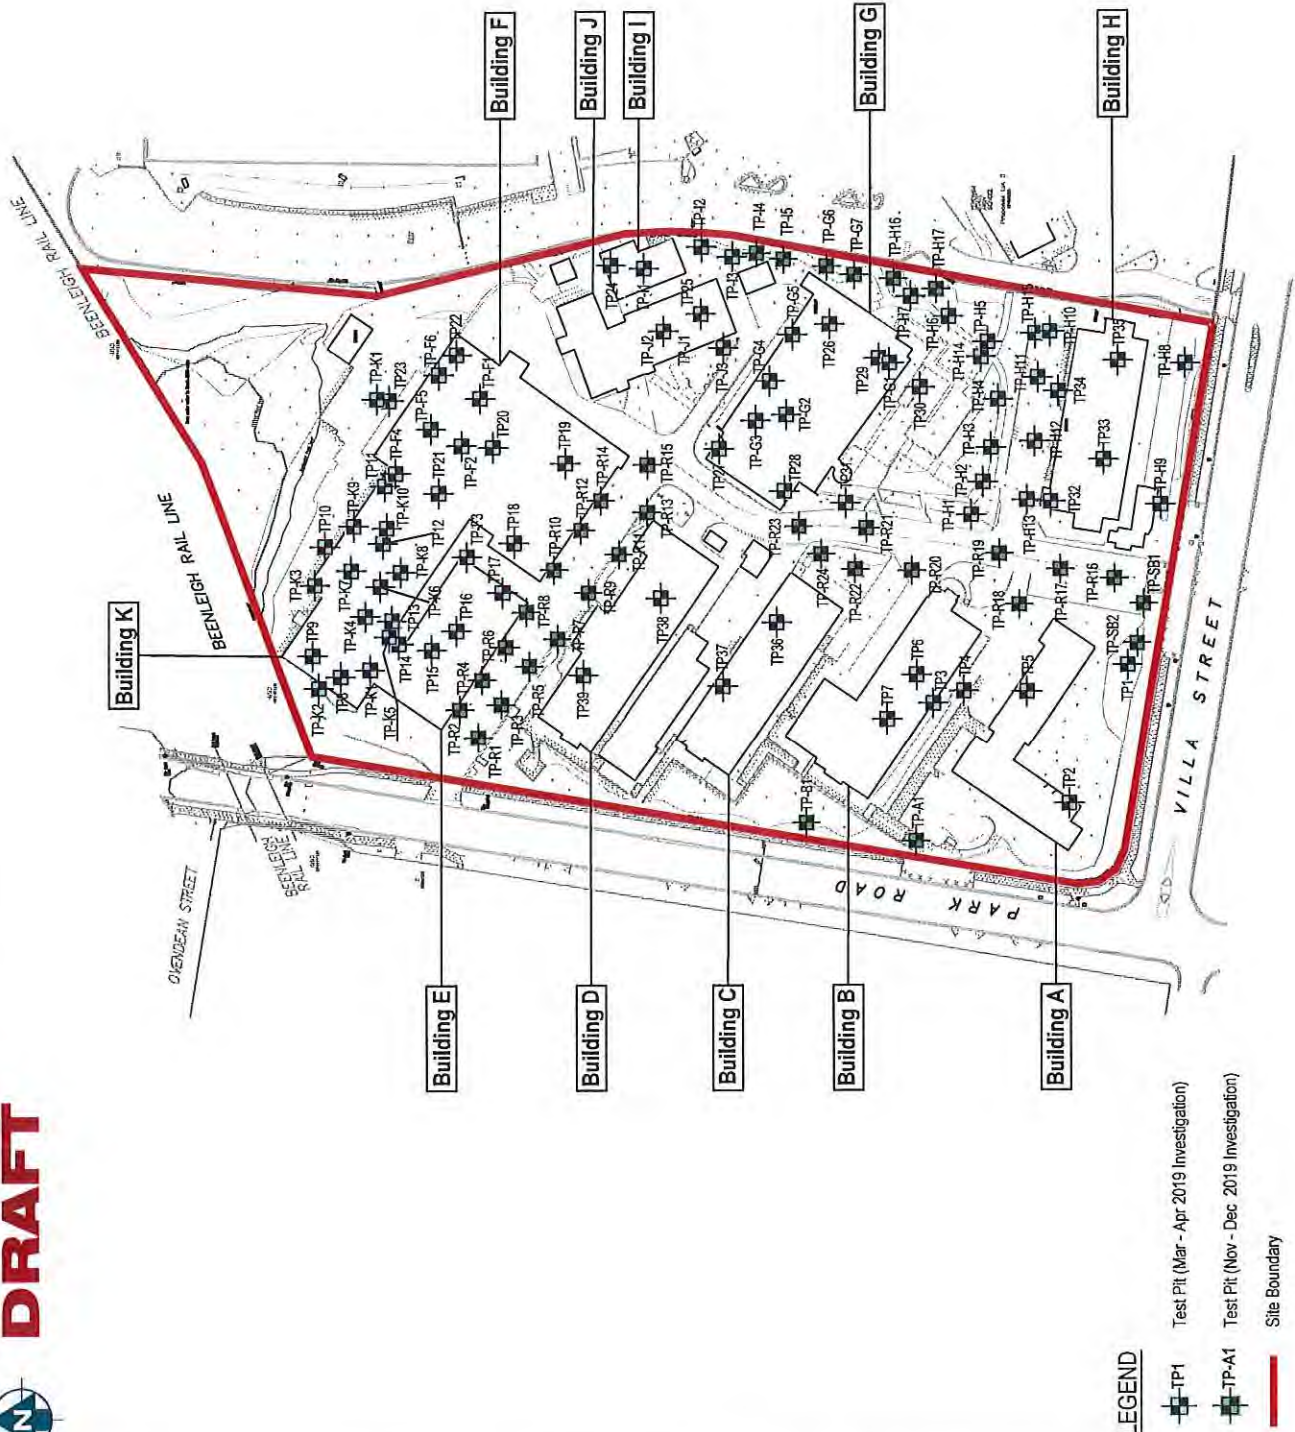
| DRAWING No: | 2 |

Butler Partners Pty Ltd (Butler Partners) initially undertook an investigation of the material beneath the slabs of the former buildings across the site in March 2019 by the excavation of thirty-nine test pits. The initial building slab investigation locations are presented in Drawing No. 2 Rev C. The investigation found that a number of the former building slab areas were underlain by construction and demolition (C&D) waste containing fibro fragments which laboratory analysis confirmed to be Asbestos Containing Materials (ACM). The locations where ACM fragments were initially identified within C&D waste are presented in Drawing No. 2 Rev C.

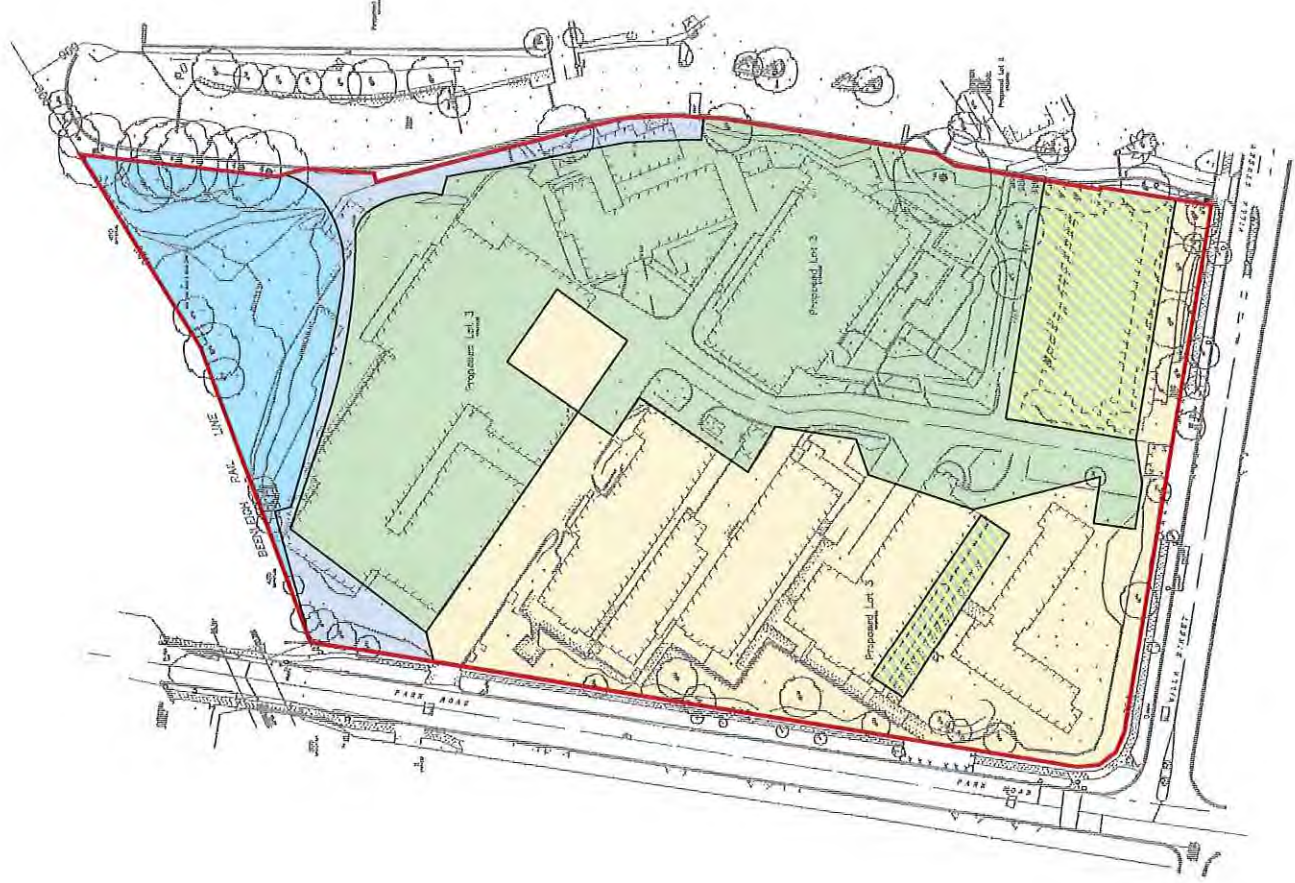
DATE: DECEMBER 2019  
DRAWN: LA  
APPROVED:  
PROJECT No: 019-113A  
DRAWING No: 7 REV: A

The majority of the C&D waste with ACM that was identified in previous investigations across the site has been removed, Drawing No. 7 Rev B shows where on the site C&D waste remains in-situ as of February 2021.
