Project No. 019-113A

17 February 2021

**RE: TREE CLEARANCE AND WASTE REMOVAL METHODOLOGY- NORTHERN PORTION  
FORMER YERONGA TAFE  
70 PARK ROAD, YERONGA**

**PLANS AND DOCUMENTS  
referred to in the PDA  
DEVELOPMENT APPROVAL**

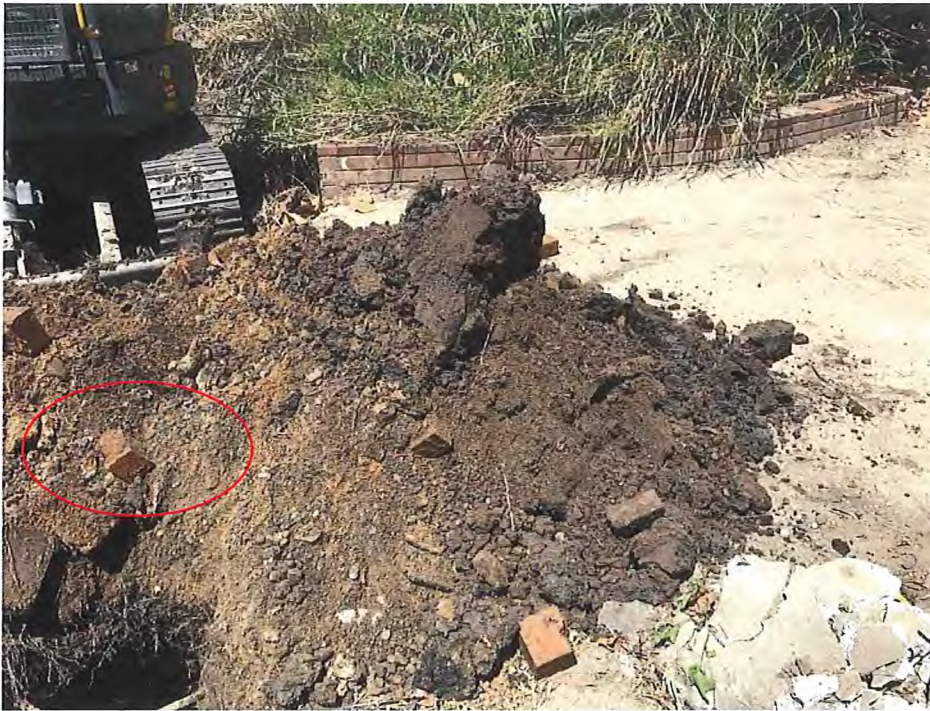
Although the fill identified in TP-N1, TP-N4, TP-N5, TP-N6 and TP-N9 were not observed to contain ACM, there was C&D waste such as glass, bricks and steel present, indicating the fill to be of the same origin and highly likely to contain ACM and also are considered to not comply with the 'Aesthetic Criteria' outlined in the National Environment Protection (Assessment of Site Contamination) Amendment Measure (NEPM), 2013. The test pit logs of the investigation locations specific to the northern portion of the site have been included.

*Photograph 1: An example of C&D Waste (circled in red) found in Test Pit (TP-N5) within the northern vegetated portion of the site. (Image Date: 3 December 2019)*

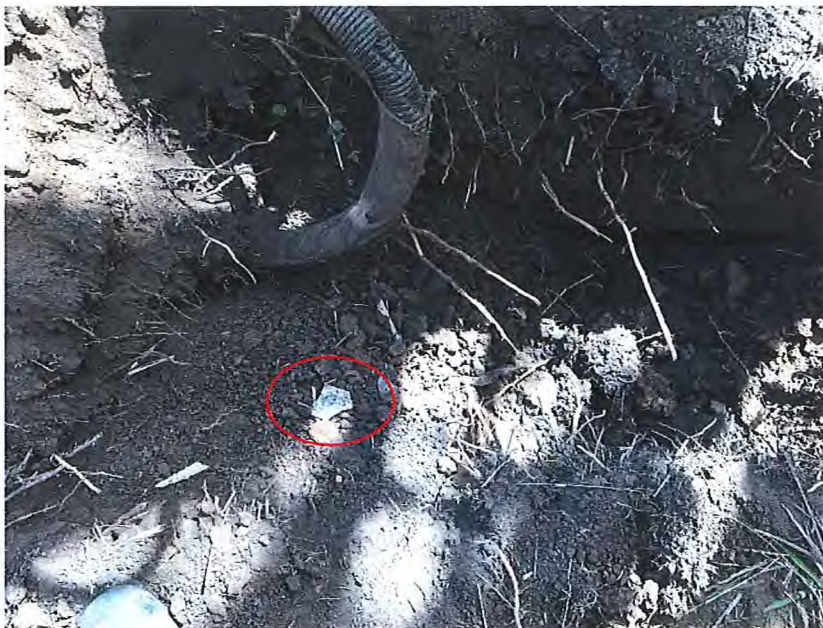
*Photograph 2: An example of ACM (circled in red) found in Test Pit (TP-N8) excavated in the northern vegetated portion of the site. (Image Date: 3 December 2019)*

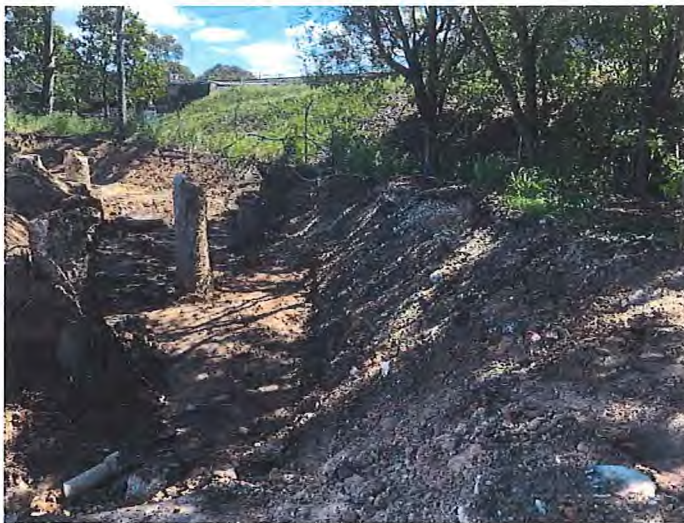
A bund currently exists in the north of the site, this bund currently contains trees/vegetation and divides the northern vegetated area and the rest of the site. This bund extends from the far western boundary to the eastern boundary shown in Photograph 3 and Photograph 4. A layer of geofabric can be seen in Photograph 5, this was placed across the bund to separate the C&D waste with ACM (contents of the bund) and the clean fill to the south of the bund at the conclusion of the waste removal works in December 2019.

*Photograph 3: A view of the northern vegetated portion of the site facing towards the west, with the bund material that contains C&D Waste and ACM pictured in the right of the photograph. (Image Date: 3 July 2019)*

Given the presence of C&D Waste and ACM that has been observed on the southern side of the bund, this material is required to be removed as part of the development of the site. The vegetation/trees that are growing within this bund require removal and the area is shown on the attached Drawing No. 8 Rev C.

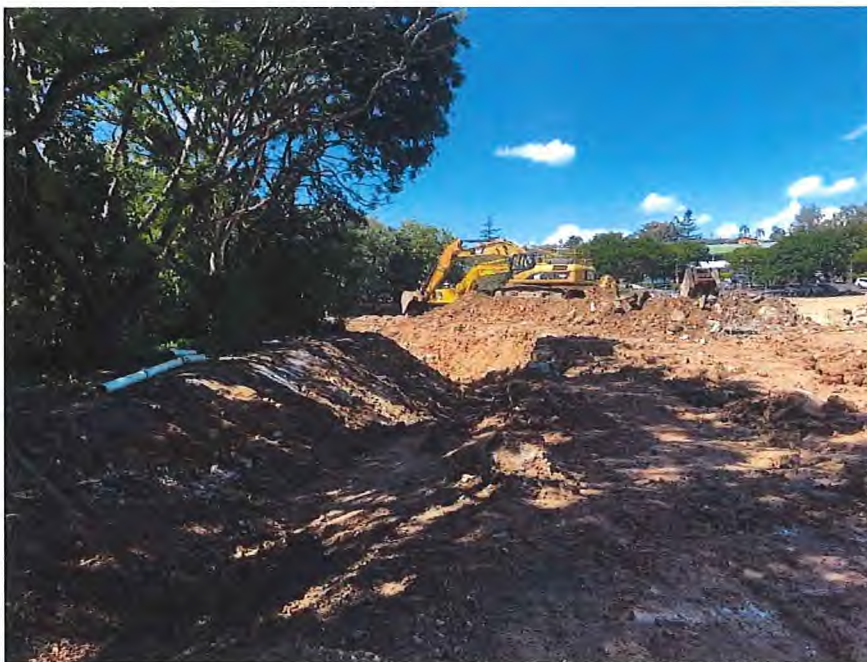
*Photograph 4: A view facing towards the east during waste removal works, with the bund and northern vegetated portion of the site visible in the left of the photograph. (Image Date: 4 April 2019)*

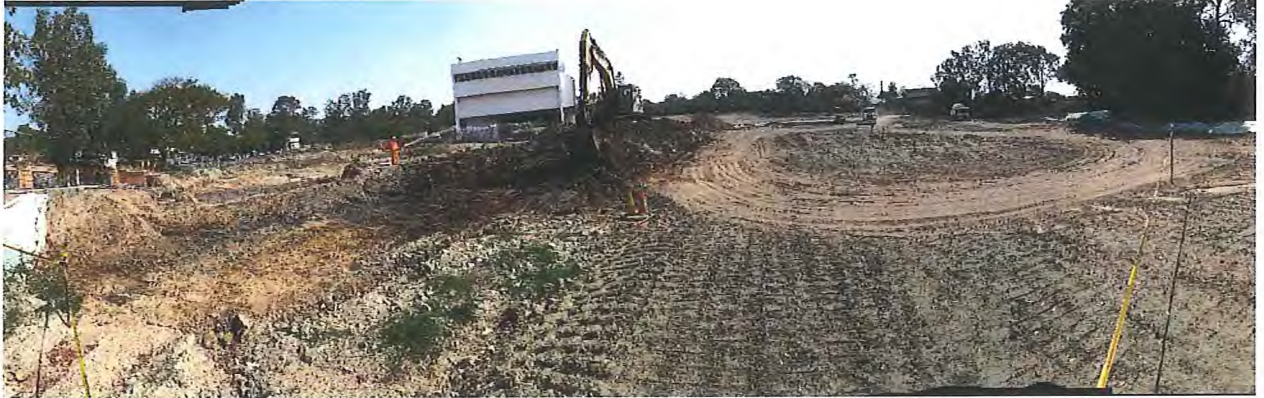
*Photograph 5: A panoramic view of the northern portion of the site after the conclusion of filling works, the northern vegetated portion of the site is visible with geofabric placed on the bund material pictured in the top right of the photograph. (Image Date: 9 October 2019)*

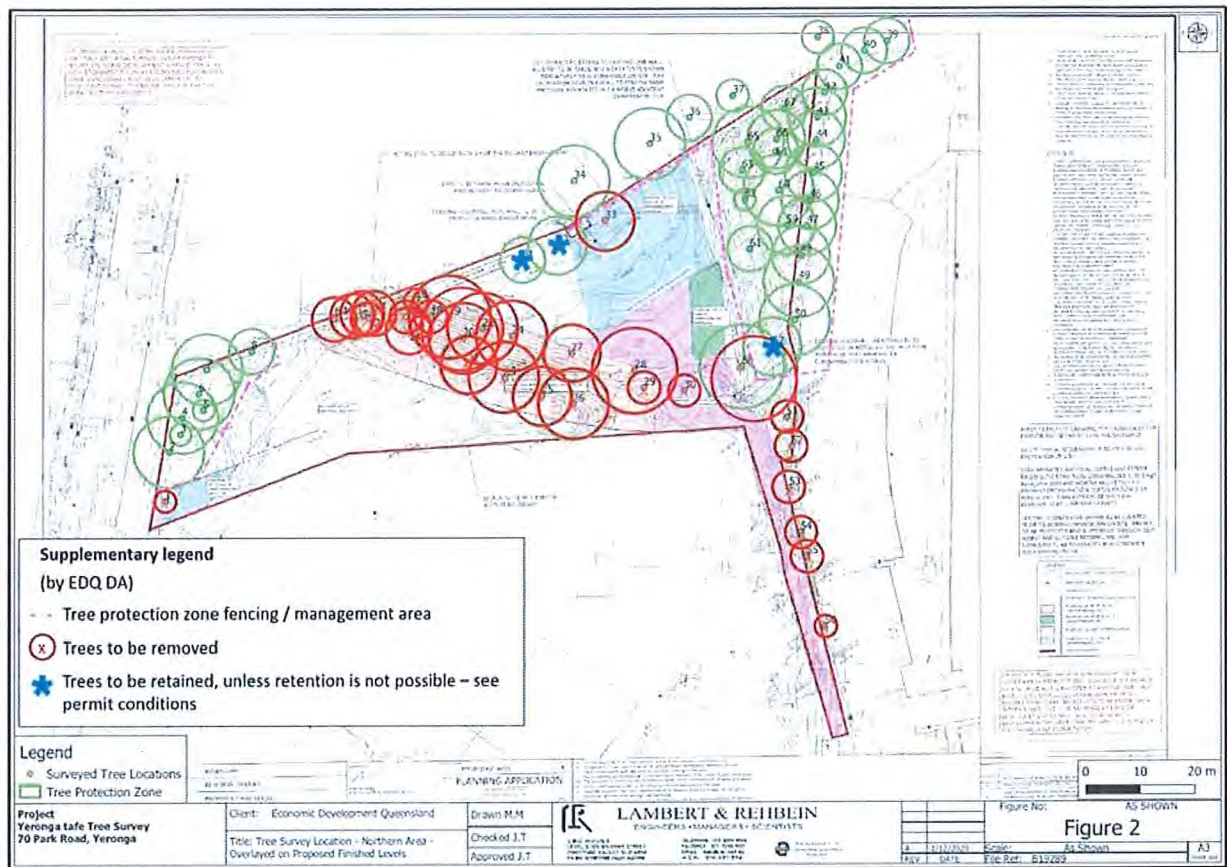
Figure 1: Lambert and Rehbein's Tree Survey Location- Northern Area- Overlayed on Proposed Finished Levels

Please be aware that the trees identified to be removed in Table 1 are based off Figure 1 (Lambert and Rehbein's Tree Survey Location Drawing, dated 1 December 2020) provided to Butler Partners by Rosenlund. If development is to extend outside of the areas shaded on Drawing No. 8 Rev C further tree removal may be necessary given the extent of the waste material through the northern portion of the site.

Prior to the required excavation of the ACM impacted C&D waste across the areas identified in Drawing No. 8 Rev C the trees should be safely cut back to approximate ground level. The resulting three branches and trunks may be reused by the way of mulching or other reuse. The tree root 'balls' and surrounding soils should be disposed of to landfill as they are within soils that have been identified to contain ACM.

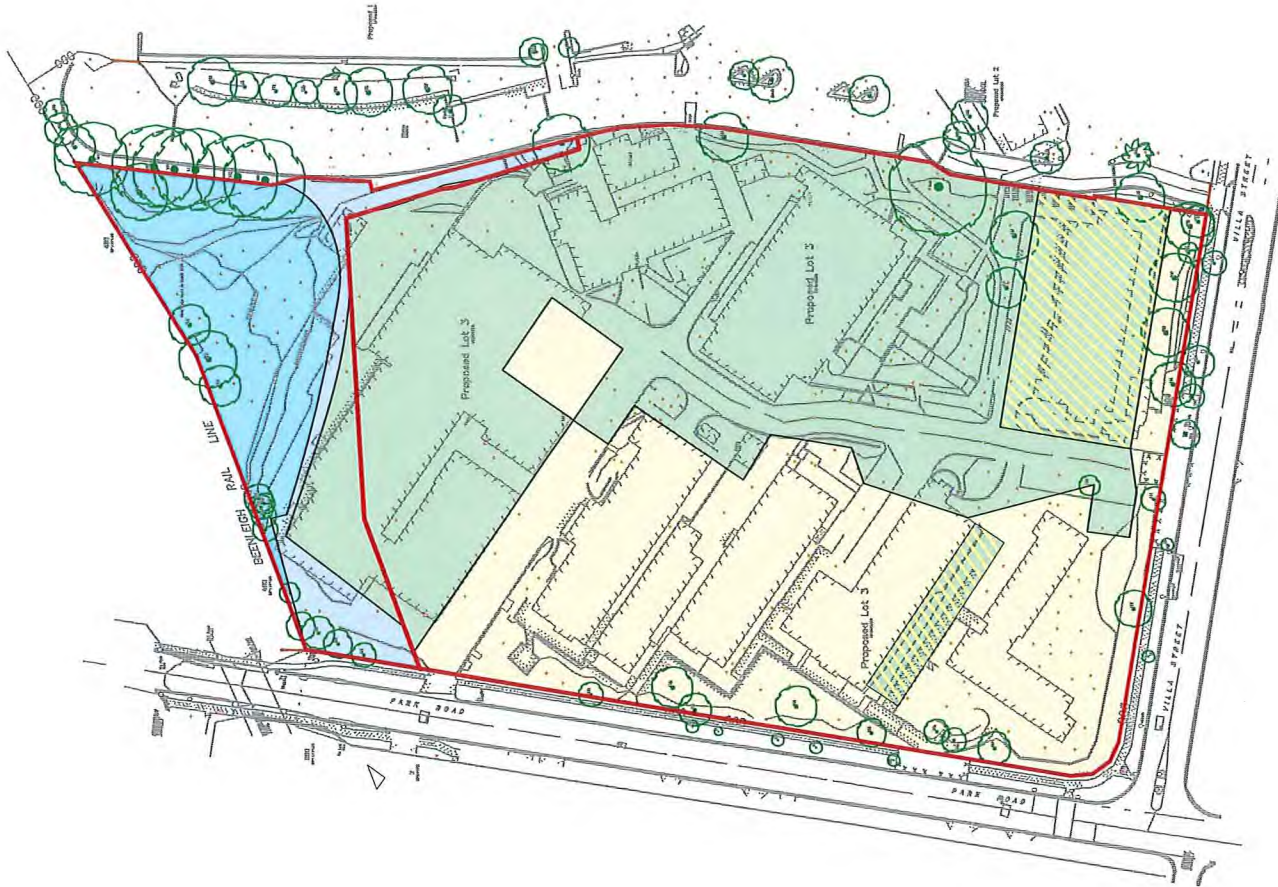
DATE: FEBRUARY 2019  
DRAWN: LA  
APPROVED:  
PROJECT No: 019-113A  
DRAWING No: 7 REV: B

The majority of the C&D waste with ACM that was identified in previous investigations across the site has been removed, Drawing No. 7 Rev B shows where on the site C&D waste remains in-situ as of February 2021.

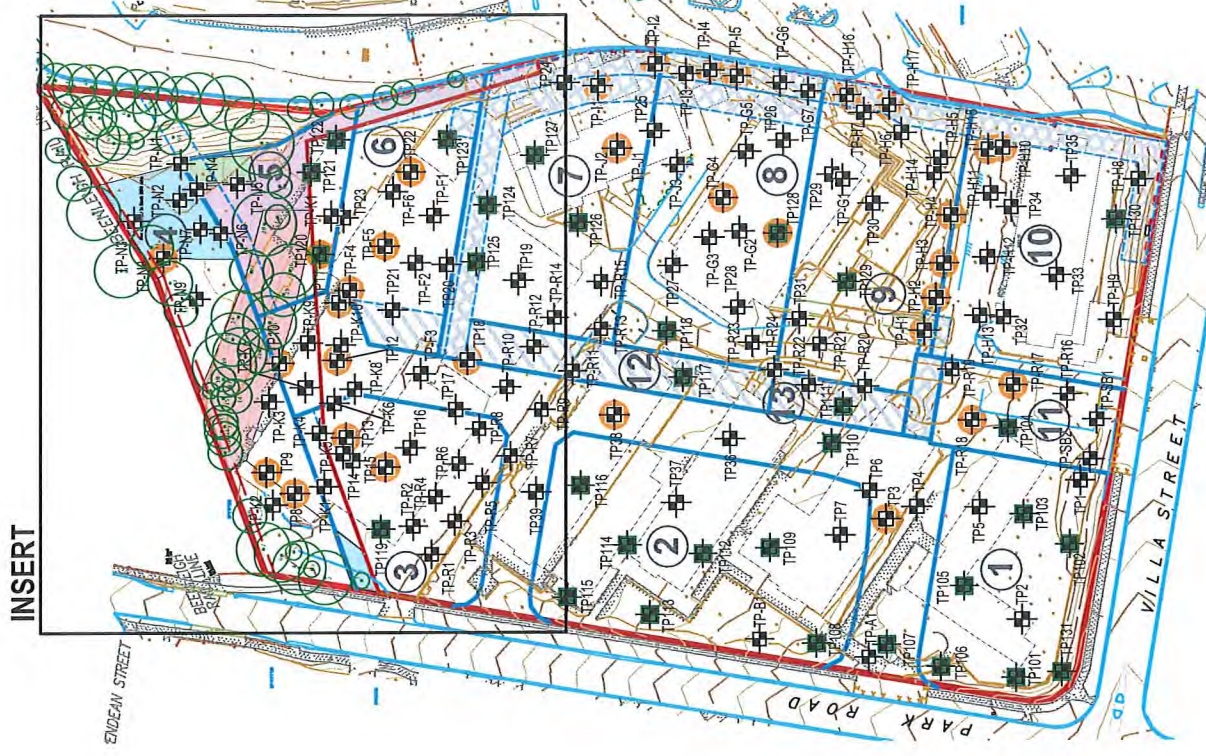
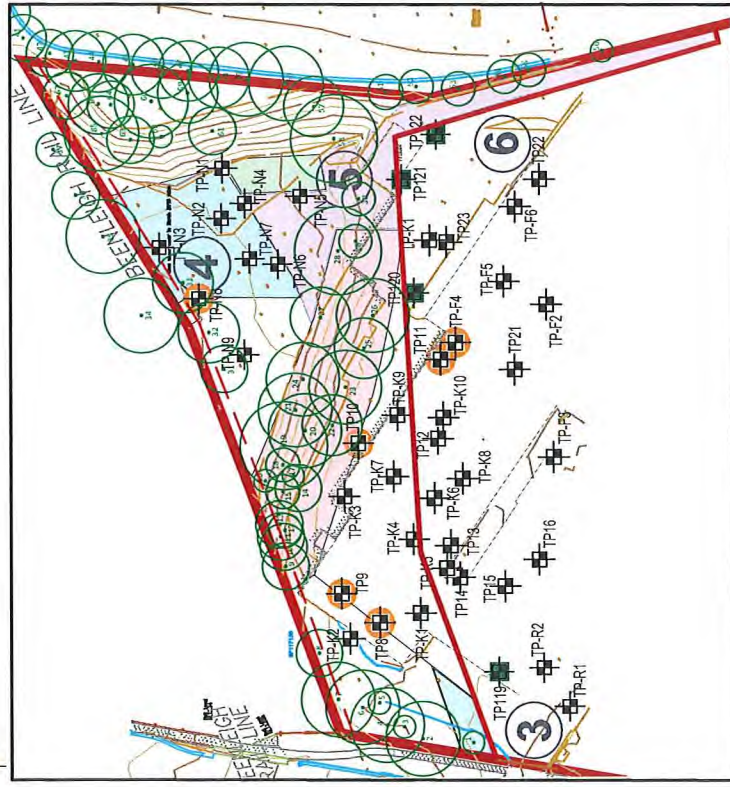
DRAWING No: 8 REV: C

During the removal of the C&D waste material across the site it became apparent that the ACM impacted waste extended beyond the footprints of the former buildings. In order to identify the extent of the ACM impacted C&D waste across the site, an additional investigation was undertaken in December 2019 by test pitting within the suspected areas in the northern vegetated portion of the site. The additional and previous investigation locations specific to this tree assessment are presented in the attached Drawing No. 8 Rev C.
