Geotechnical Report

Geotechnical Investigation ReportVehicle Ferry Terminal Weinam Street, Redland Bay

Report Number: J001183-001-R-Rev0

October 2020

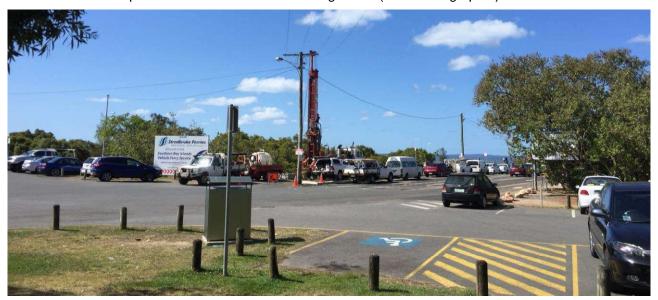
Photograph 1: Looking north-east toward borehole BH2, at the time of our investigation on 29 September 2020.

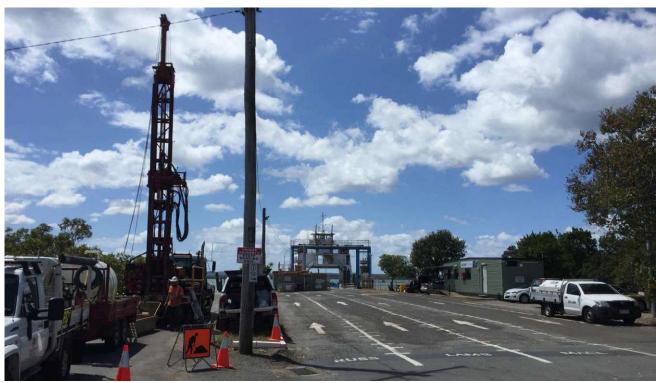
Photograph 2: Looking east towards borehole BH2, at the time of our investigation on 29 September 2020.

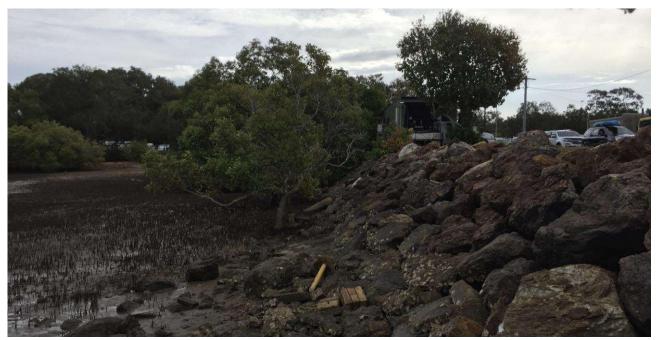
The southern side of the pier comprises a boulder fill batter, refer Photograph 3Photograph 1. The northern side of the pier is retained by a brick retaining wall at the western end (refer Photograph 4), while the eastern end comprises a soil/rock fill batter with vegetation (refer Photograph 5).

Photograph 3: Looking west along the southern side of the pier

The batters should comprise rock fill of sound igneous or metamorphic material that will not disintegrate in seawater or when exposed to weather. Rocks should be fresh or slightly weathered, and of very high strength (or stronger) as defined by AS 1726. The least dimension of the rock should not be less than half its greatest dimension.

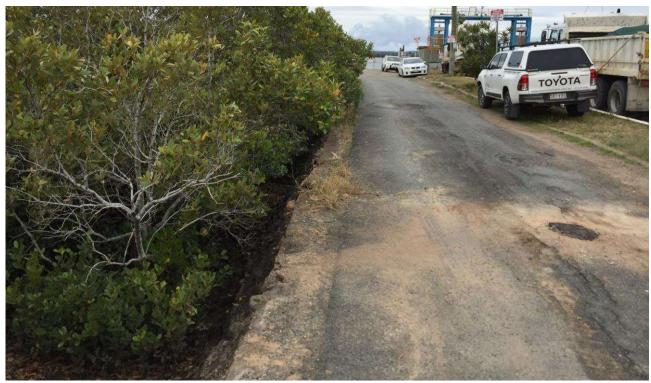
Photograph 4: Looking north east along the western end of the northern side of the pier

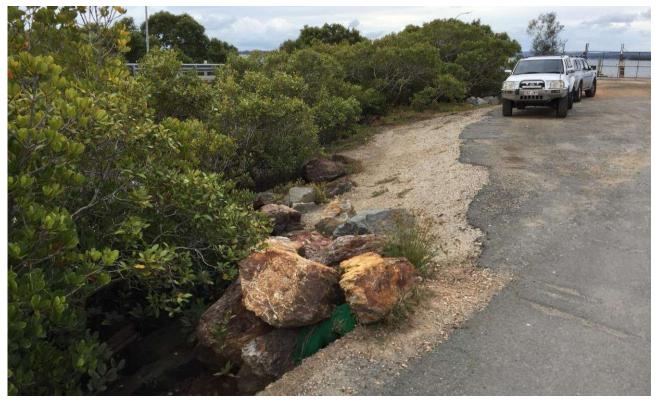
Photograph 5: Looking north east toward the eastern end of the northern side of the pier.

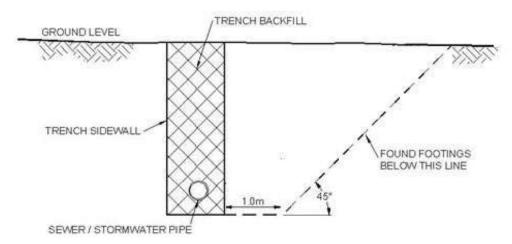
Diagram 1: Exclusion zone for base of footings.

Footing excavations must be inspected by a geotechnical engineer from Core prior to construction. All footings should found such that they are not adversely affected by any adjacent excavations batter slopes, trenches, or retaining walls that are not designed to support building loads. To minimise the potential for any adverse interaction effects, footings should found at least below a plane extending 1 m horizontally from the base of trenches/batter slopes/excavations/retaining walls, then rising up at 1V:1H. This requirement is illustrated in Diagram 1.

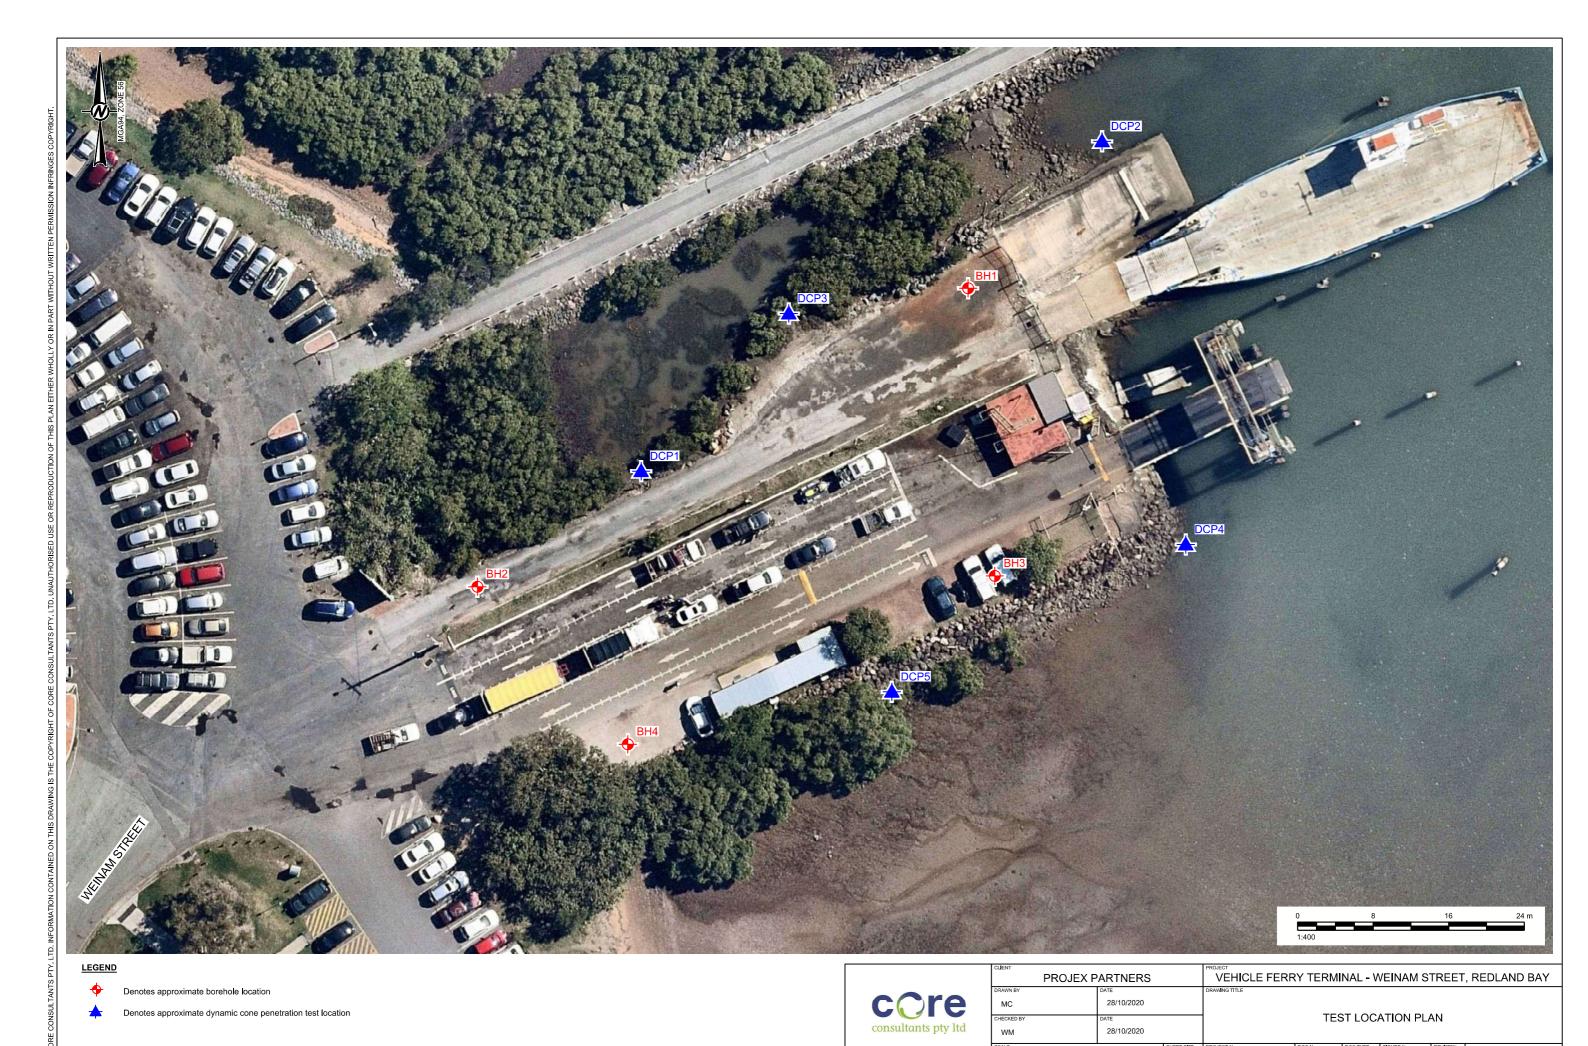
Figure 1: Test Location Plan

Test locations are shown on the attached Figure 1. Borehole and DCP reports are provided in Appendix A, along with Explanatory Notes. Subsurface conditions are discussed in Section 5.2.
