**Updated Report**  
**Additional Slope Stability Assessment**  
**Oxley PDA - Stage 2**  
Blackheath Road, Oxley

Prepared for  
**Economic Development Queensland**  
**Project No. 018-118B**

23 April 2021

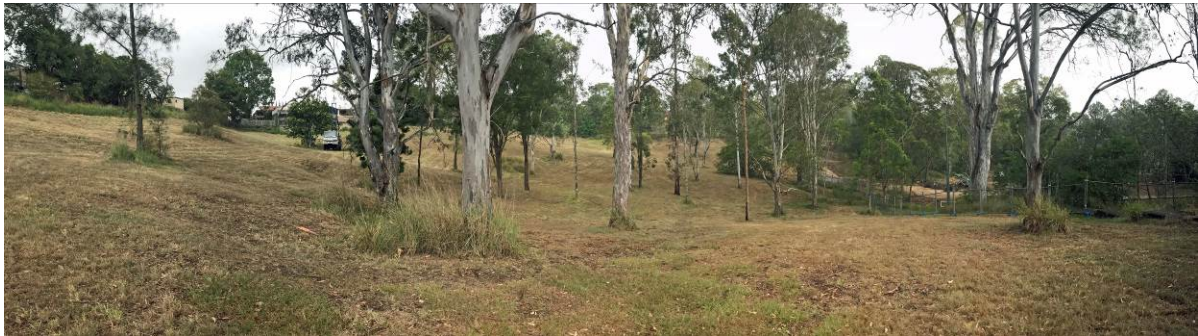
Several depressions (referred to as 'sink-holes' by others) were noted on the slopes, generally in the vicinity of old service lines etc.

*Photograph 2: Panoramic view of the site looking south-east to west from near Bore 20*

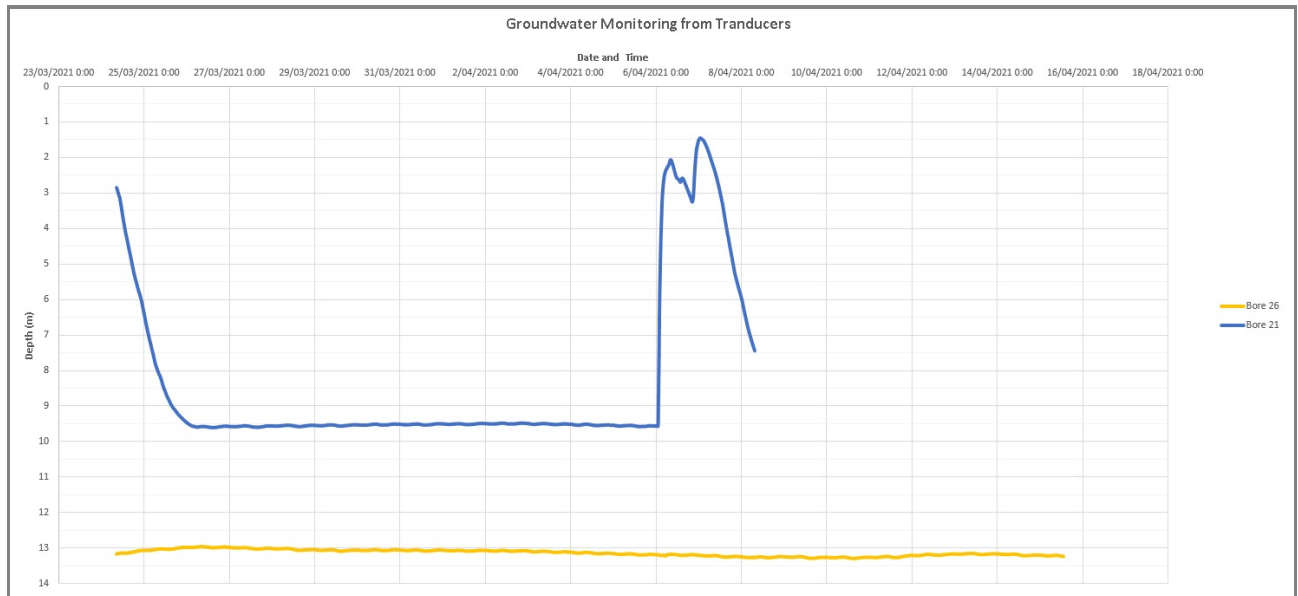
The long term monitoring of Wells 21 and 25 to 29 indicates two instances of measured 'shallow' groundwater depths in Well 21; 3.1m (on 7 February 2020) and 2.8m (on 24 March 2021). In order to confirm if the monitoring well was correctly recording groundwater depths, a pressure transducer was installed in Wells 21 and 26, just after a period of intense and heavy rainfall. The time-groundwater depth readings from the two monitoring wells are shown in Figure 4 and the results are considered to indicate that Well 21 is not providing reliable groundwater level information and 'shallow' depth readings should be ignored. It is considered likely that surface water seepage is somehow entering the well.

Figure 4: Continuous Groundwater Depth Monitoring in Wells 21 and 26

It is recommended that monitoring of groundwater levels should be continued after heavy rainfall events for as long as possible, prior to commencement of construction.

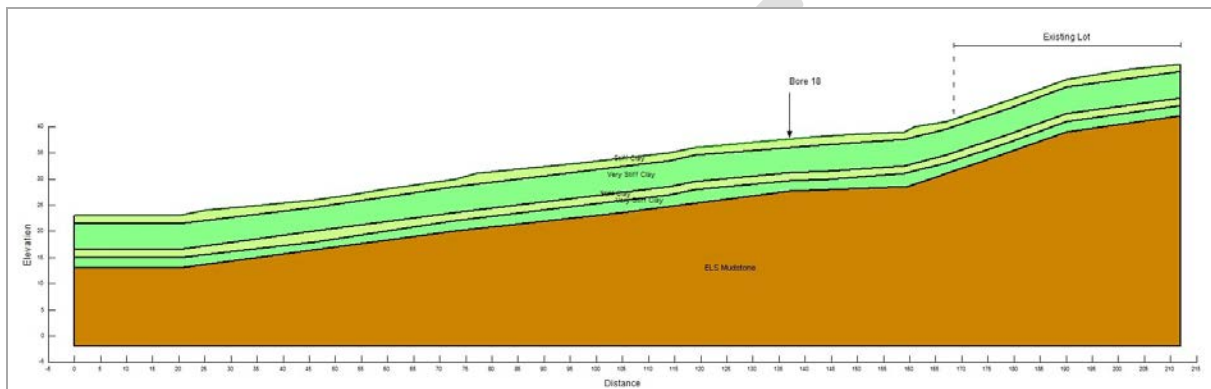
It should be carefully noted that at the location of Bore 18, the fill was assumed to be controlled for the purpose of the stability analysis; if the existing fill is uncontrolled, a lower FOS value would apply to this location.

Figure 6: Adopted slope profile and stratigraphy of section near Bore 18

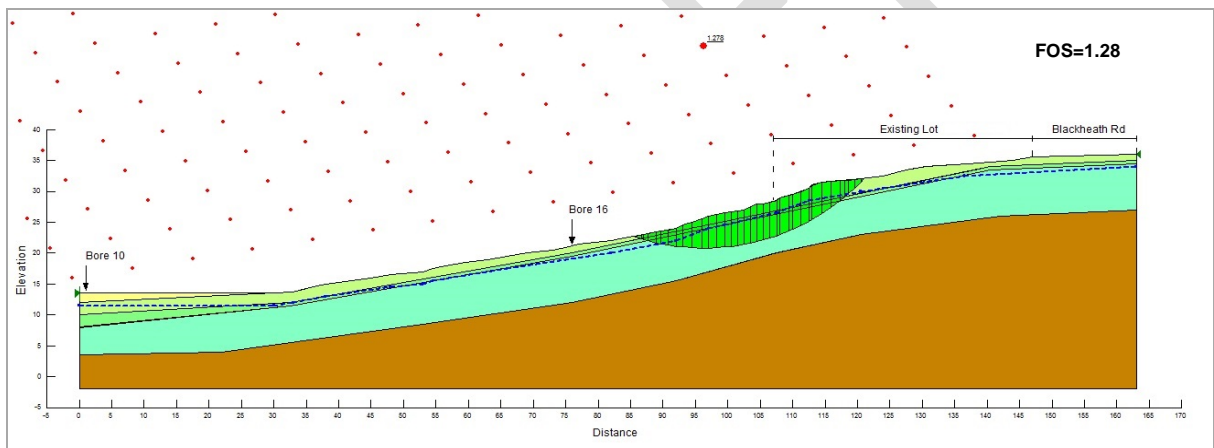
Figure 9: 'Long term' analysis of natural slope profile near Bore 16 (with 2m deep groundwater)

The calculated FOS value for a 2m deep groundwater level is considered to be acceptable for the Bore 19 slope and marginally acceptable (for a short term condition) for a water table depth of 2m for the slope at Bores 16 and 25. However at the time of writing, there has not been any indication of groundwater levels above approximately 9m depth, based on ongoing groundwater monitoring at the site; groundwater level monitoring should be continued for as long as possible.

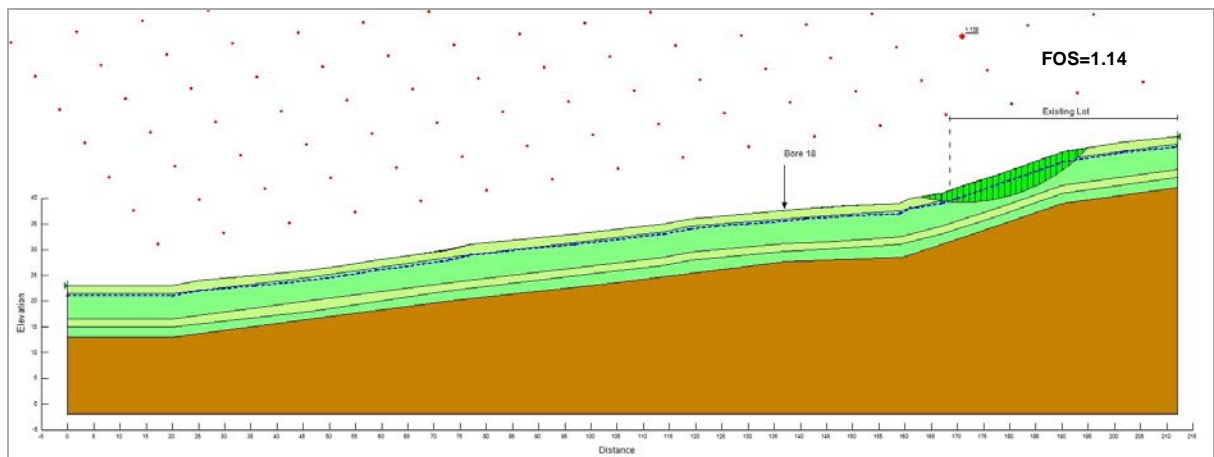
Figure 10: 'Long term' analysis of natural slope profile near Bore 18 (with 2m deep groundwater)

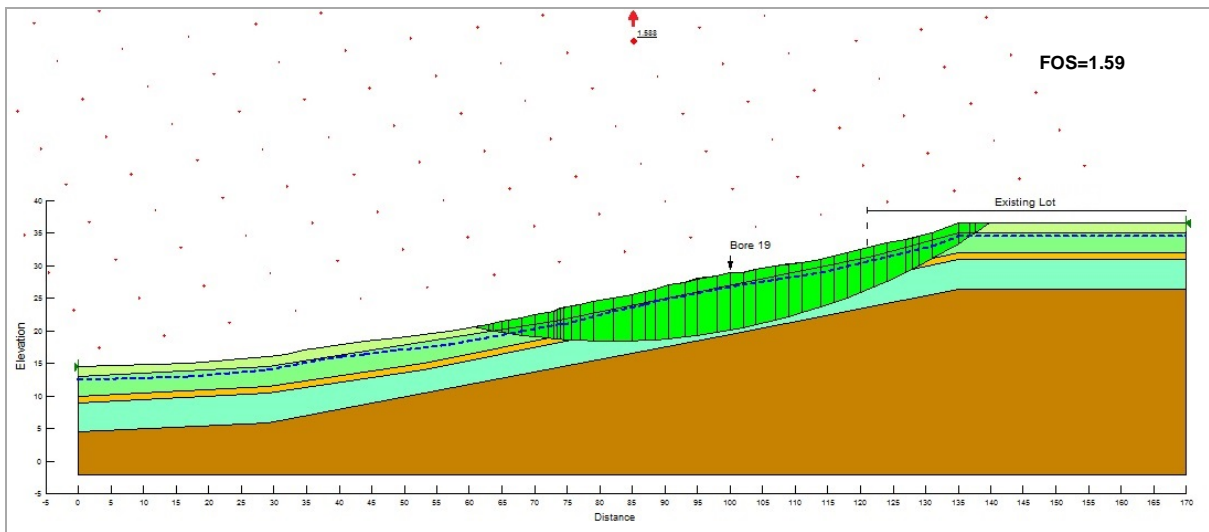
Figure 11: 'Long term' analysis of natural slope profile near Bore 19 (with 2m deep groundwater)

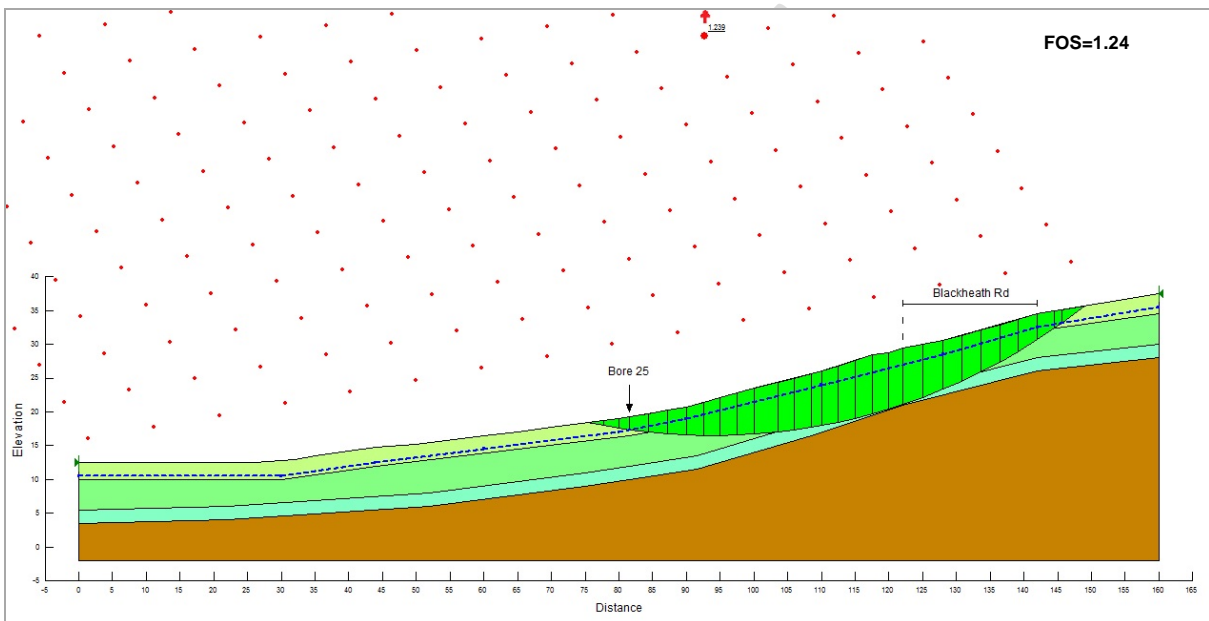
Figure 12: 'Long term' analysis of natural slope profile near Bore 25 (with 2m deep groundwater)

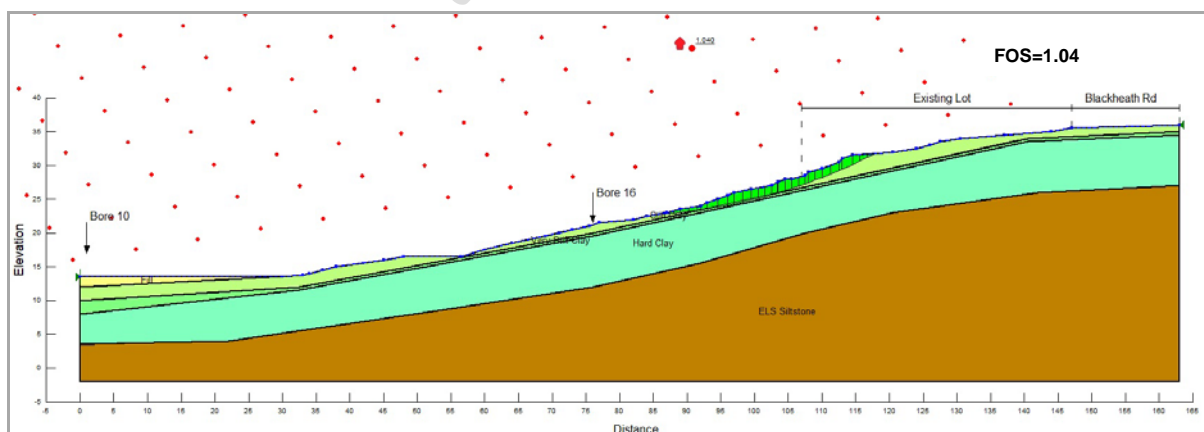
Figure 21: Analysis of near surface soils for the slope profile near Bore 16

The stability analysis results for near surface soils summarised Table 10 indicate that localized instability of these materials is likely to occur under saturated conditions. It is suggested that revegetation of the slopes would provide root support and help prevent surface erosion; installation of some shallow drainage and concrete lining of existing zones of concentrated surface water flow would assist in preventing near surface creep.

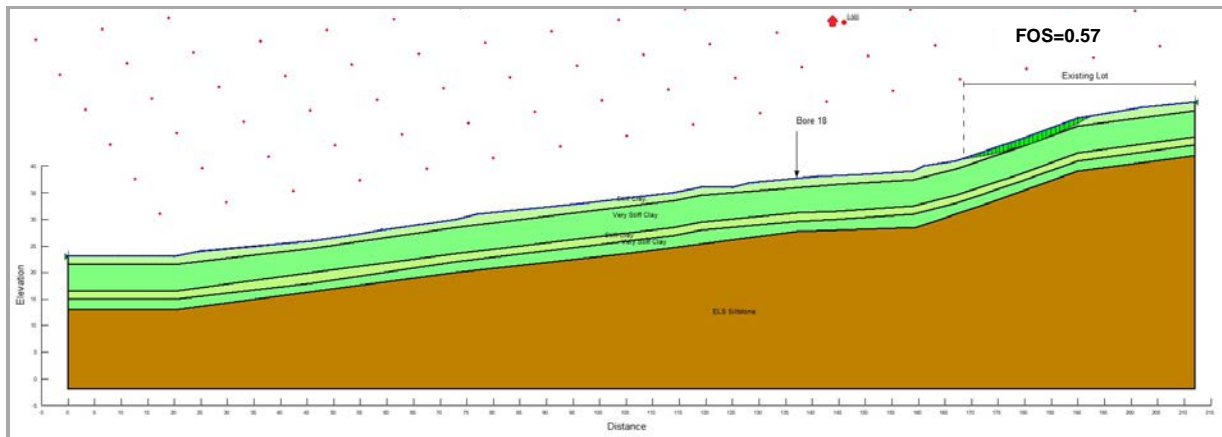
Figure 22: Analysis of near surface soils for the slope profile near Bore 18

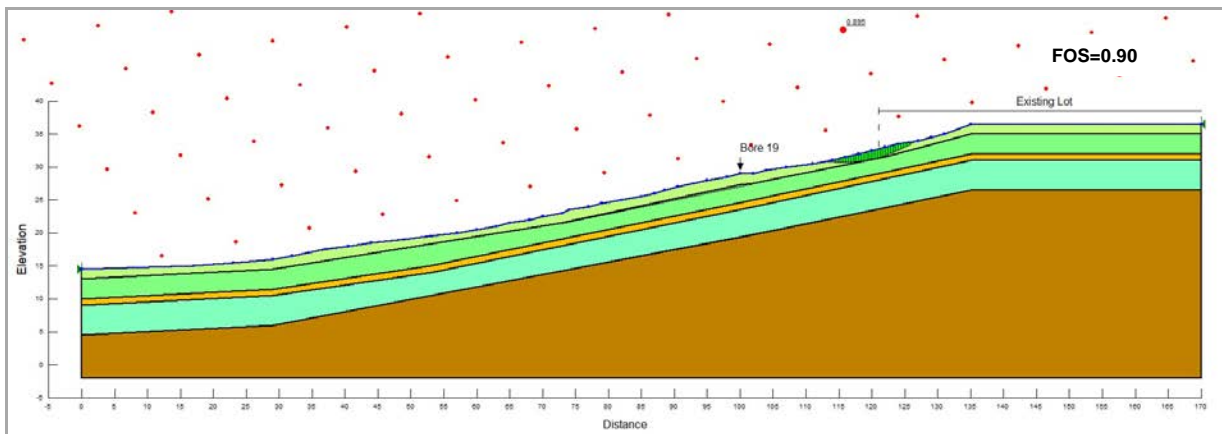
Figure 23: Analysis of near surface soils for the slope profile near Bore 19

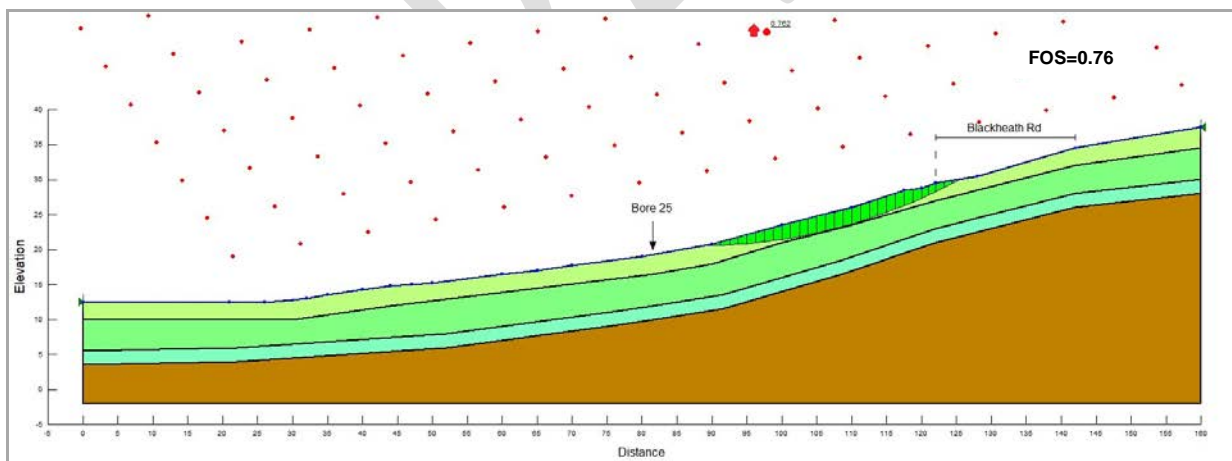
Figure 24: Analysis of near surface soils for the slope profile near Bore 25
