Butler Partners
geotechnical • geo-environmental • groundwater

**Slope Stability Assessment
Oxley PDA - Stage 1A**
Seventeen Mile Rocks Road, Oxley

Prepared for
**Economic Development Queensland
Project No. 018-118D**

29 September 2020

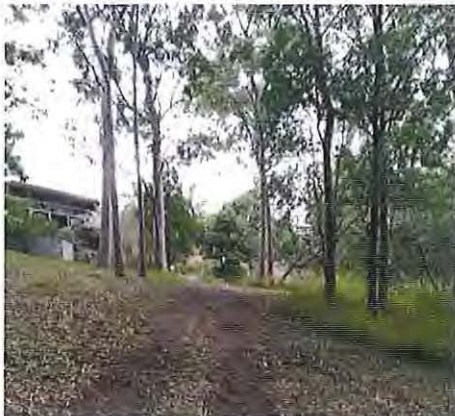
A walk over inspection of the sloping sections of the Stage 1A site did not reveal any indications of site slope creep (or any indications of general instability). No indication of slope creep could be observed in mature trees located on the sloping sections of the site; as indicate in selected Photograph 7 and Photograph 8, no indication of bent tree trunks (which is indicative of slope creep/failure), was observed.

Photograph 7: General view of mature trees

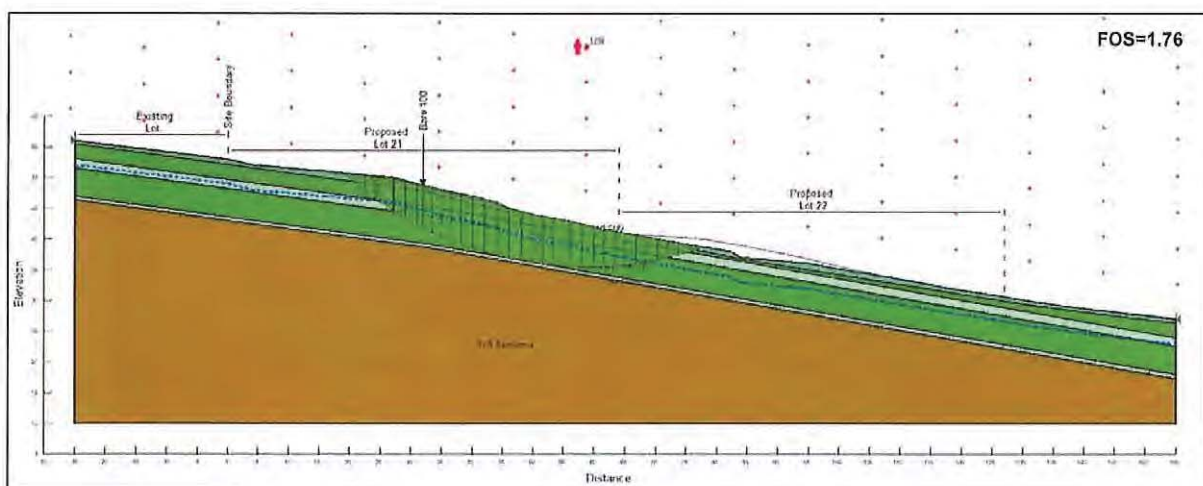
Figure 10: 'Long term' analysis of natural slope profile near Bore 100 (with 4m deep groundwater)

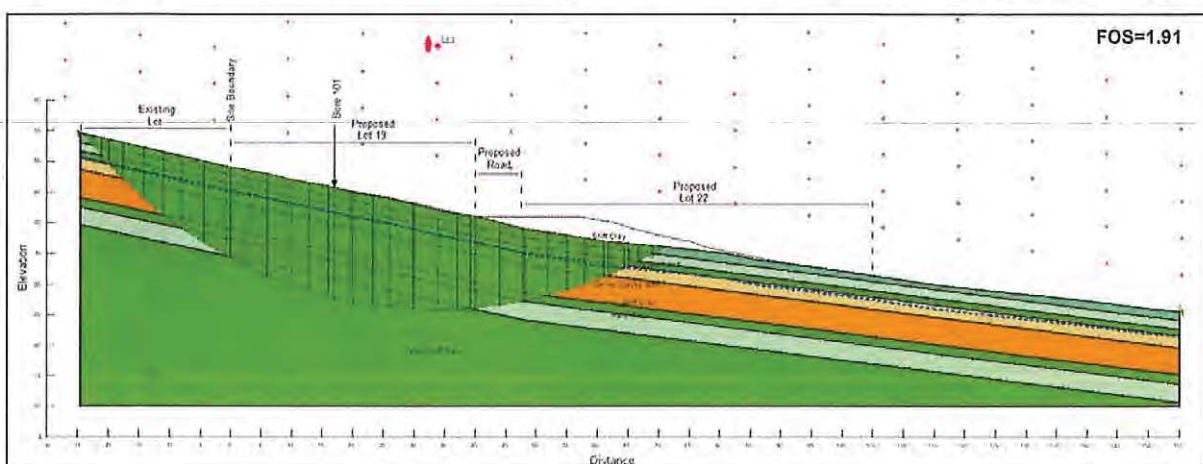
Figure 11: 'Long term' analysis of natural slope profile near Bore 101 (with 4m deep groundwater)

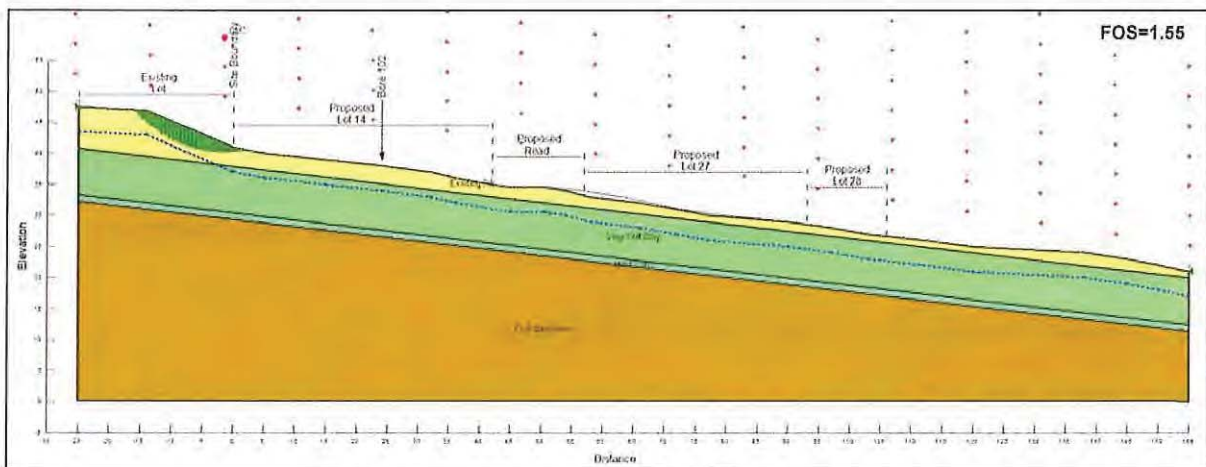
Figure 12: 'Long term' analysis of natural slope profile near Bore 102 (with 4m deep groundwater)

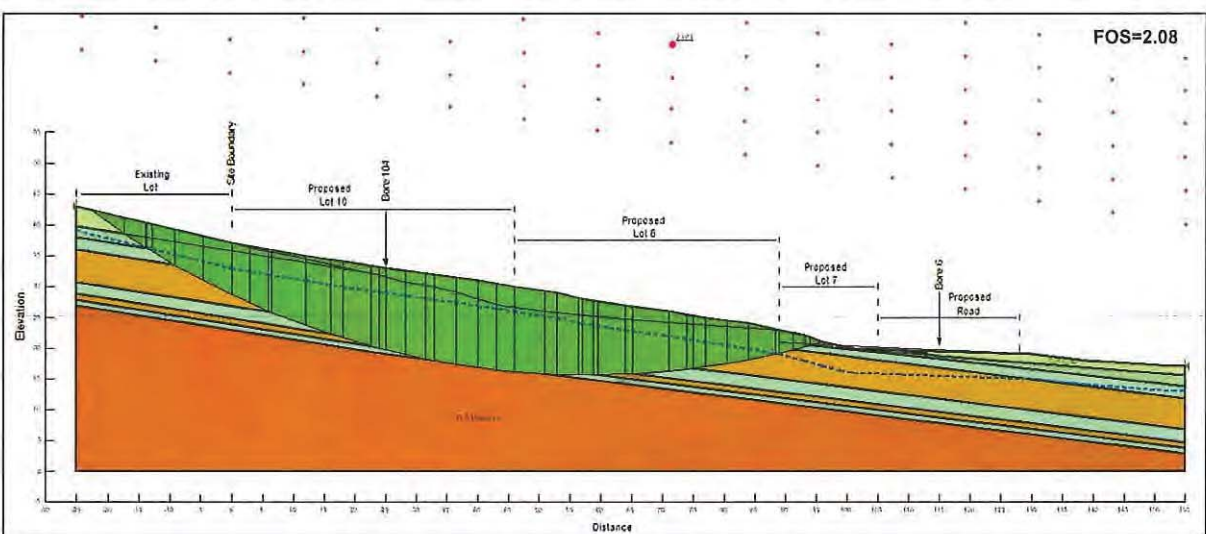
Figure 14: 'Long term' analysis of natural slope profile near Bore 104 (with 4m deep groundwater)

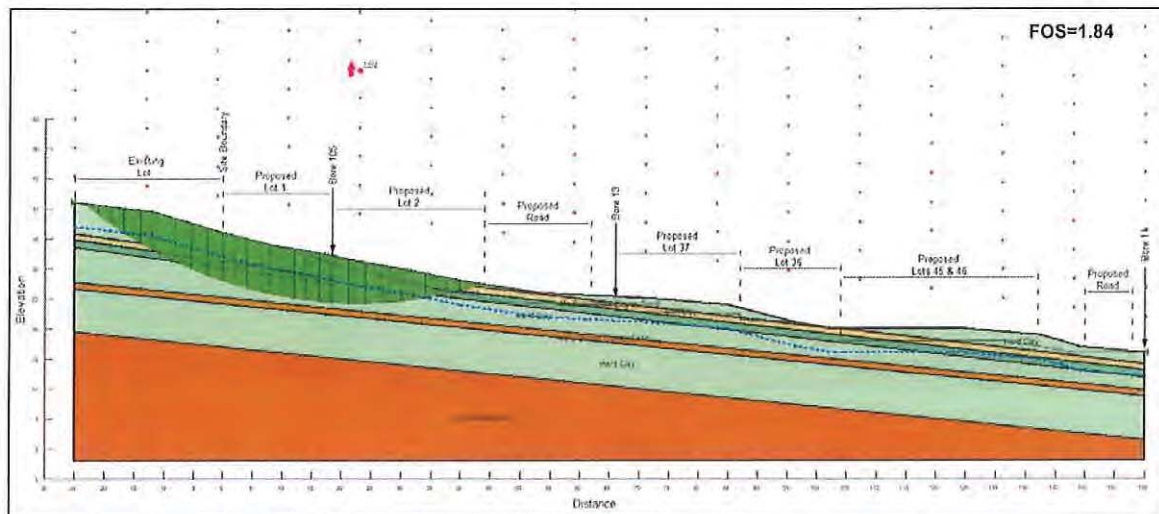
Figure 15: 'Long term' analysis of natural slope profile near Bore 105 (with 4m deep groundwater)

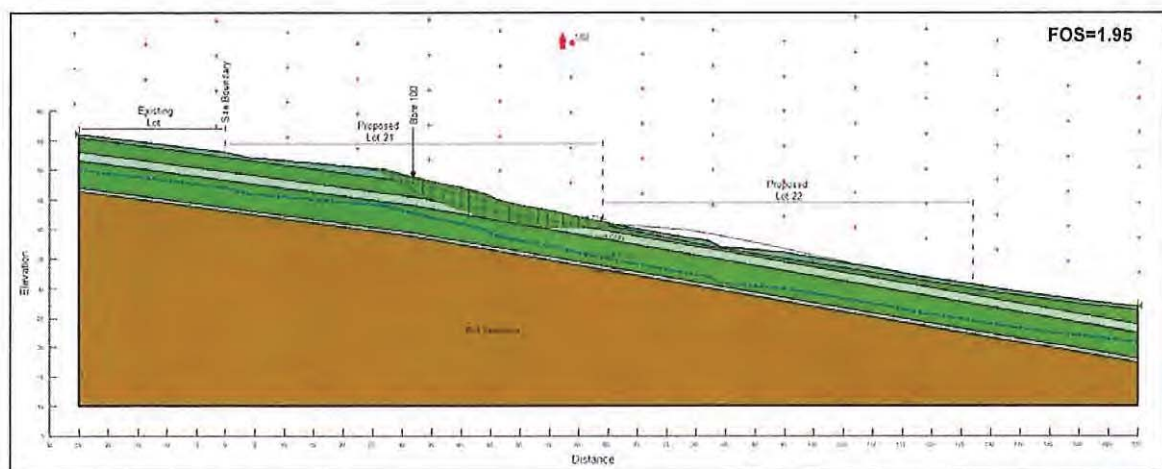
Figure 16: 'Long term' analysis of natural slope profile near Bore 100 (with 6m deep groundwater)

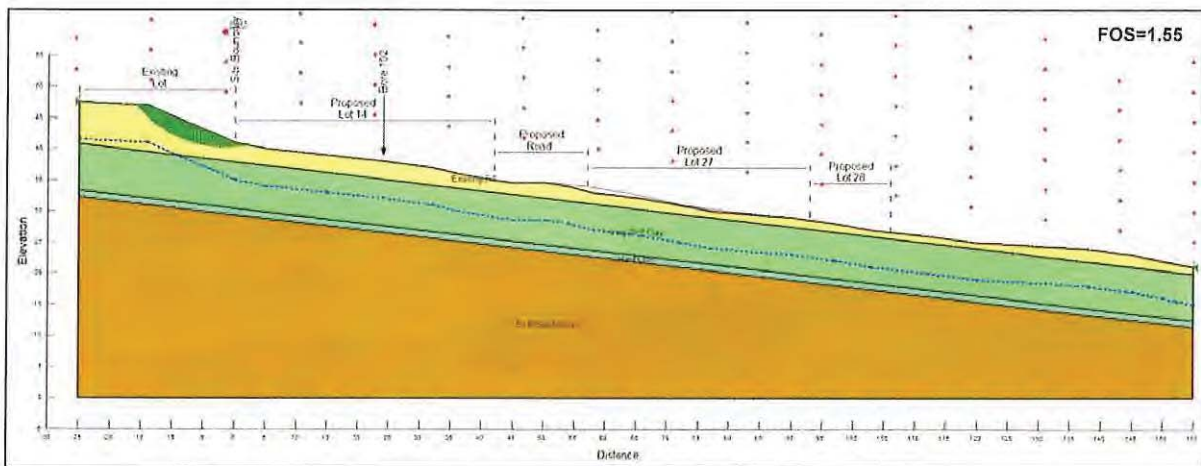
Figure 18: 'Long term' analysis of natural slope profile near Bore 102 (with 6m deep groundwater)

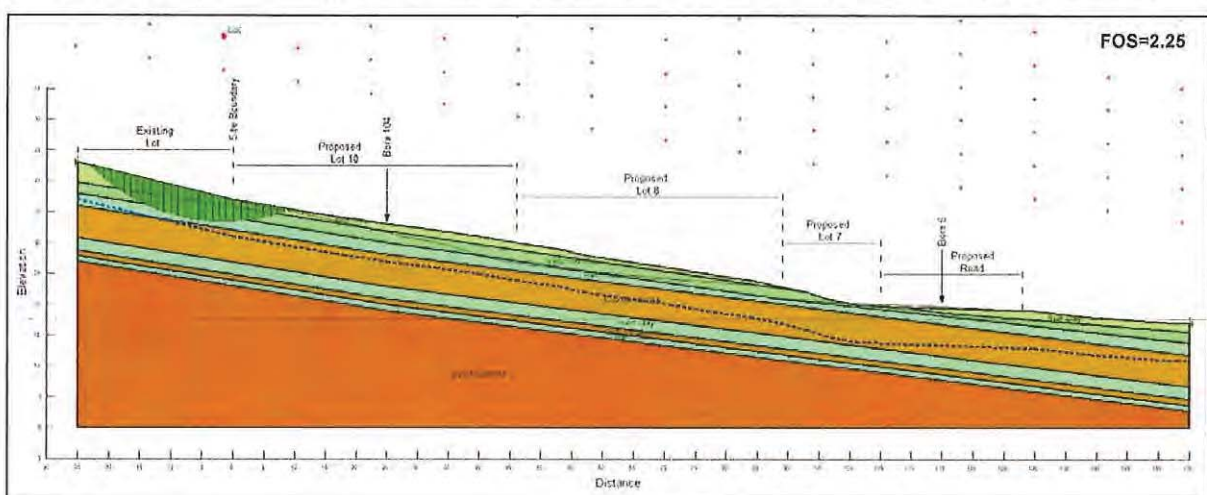
Figure 20: 'Long term' analysis of natural slope profile near Bore 104 (with 6m deep groundwater)

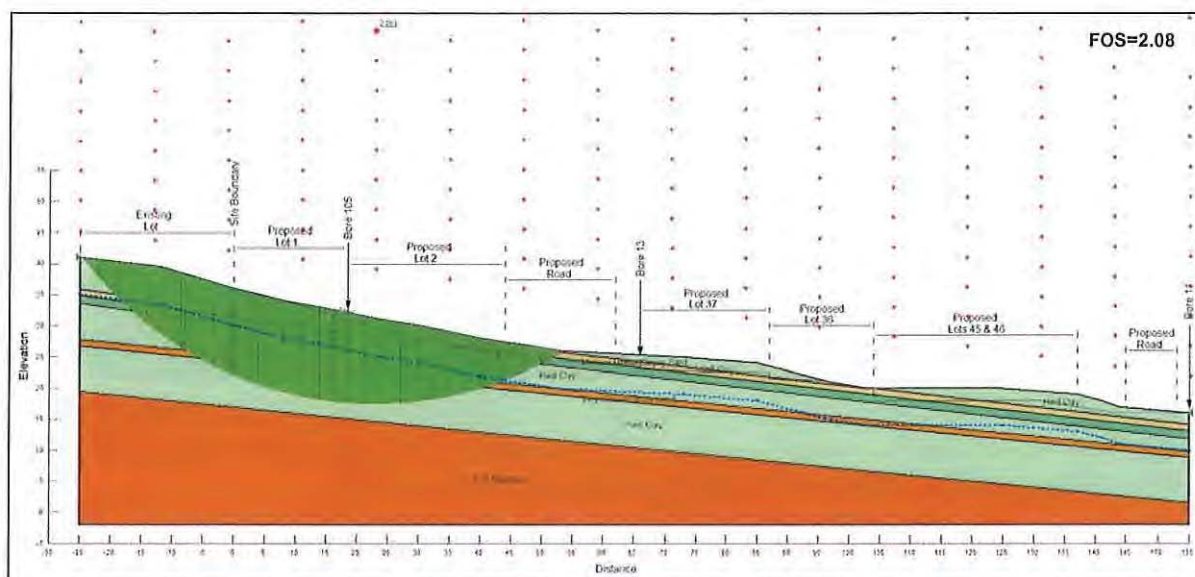
Figure 21: 'Long term' analysis of natural slope profile near Bore 105 (with 6m deep groundwater)

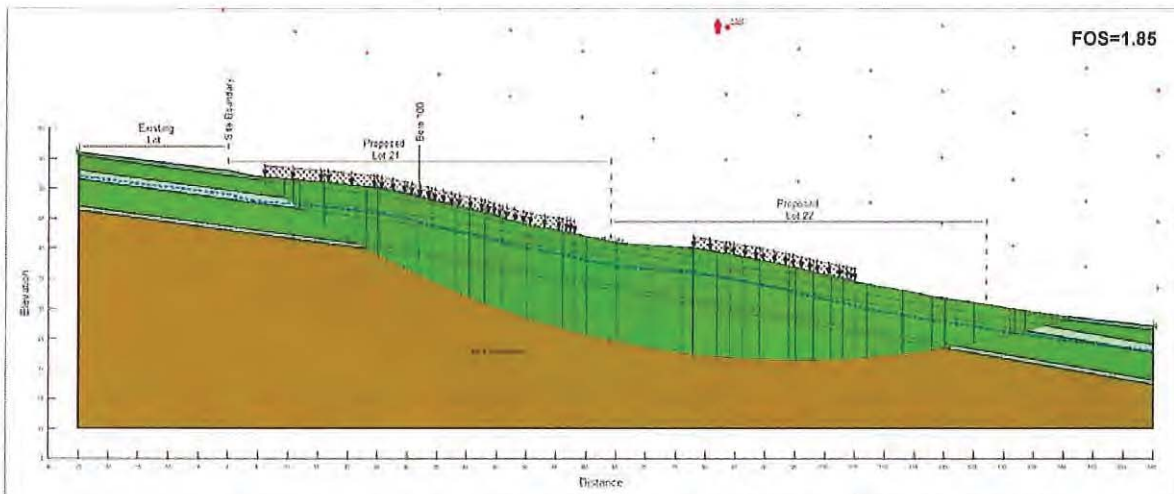
Figure 28: 'Long term' analysis of final design profile near Bore 100 (with 4m deep groundwater)

It should be noted that the stability analysis results summarised in Table 11 include a 5kPa surcharge allowance for future development load, together with the slope modification works nominated on KN's earthworks design drawings. It is recommended that (if possible), no development surcharge be added to slopes.

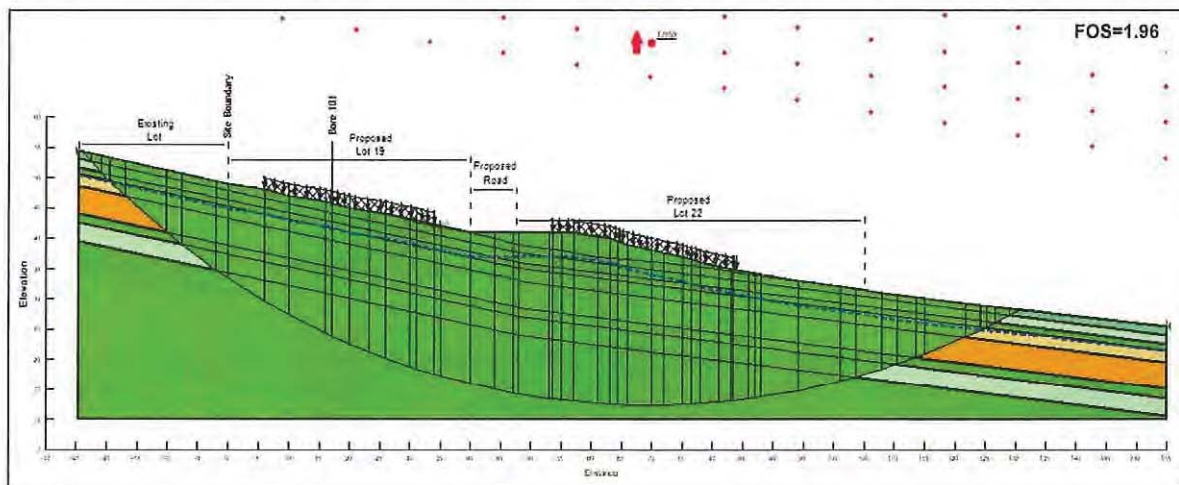
Figure 29: 'Long term' analysis of final design profile near Bore 101 (with 4m deep groundwater)

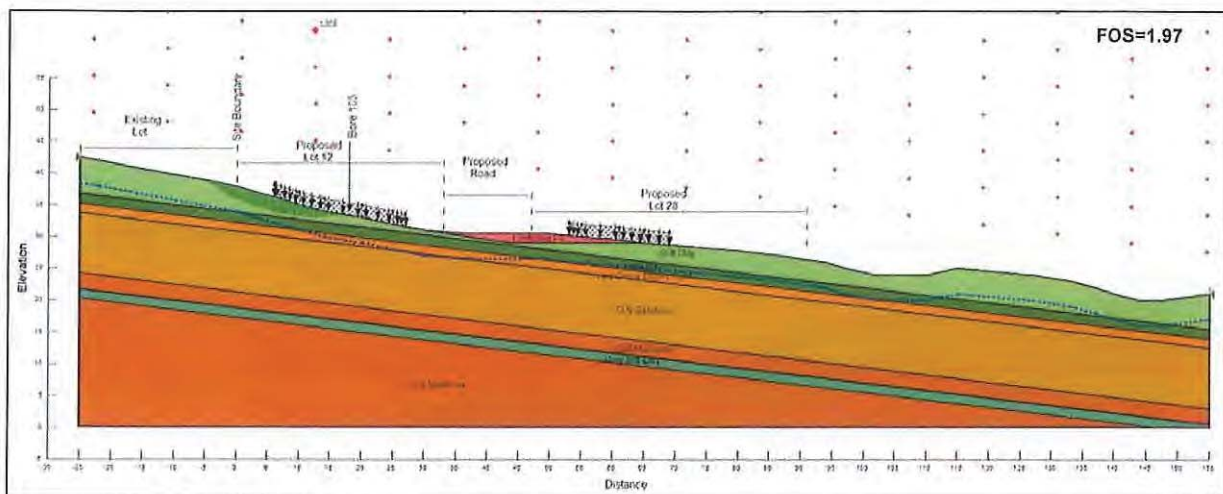
Figure 31: 'Long term' analysis of final design profile near Bore 103 (with 4m deep groundwater)

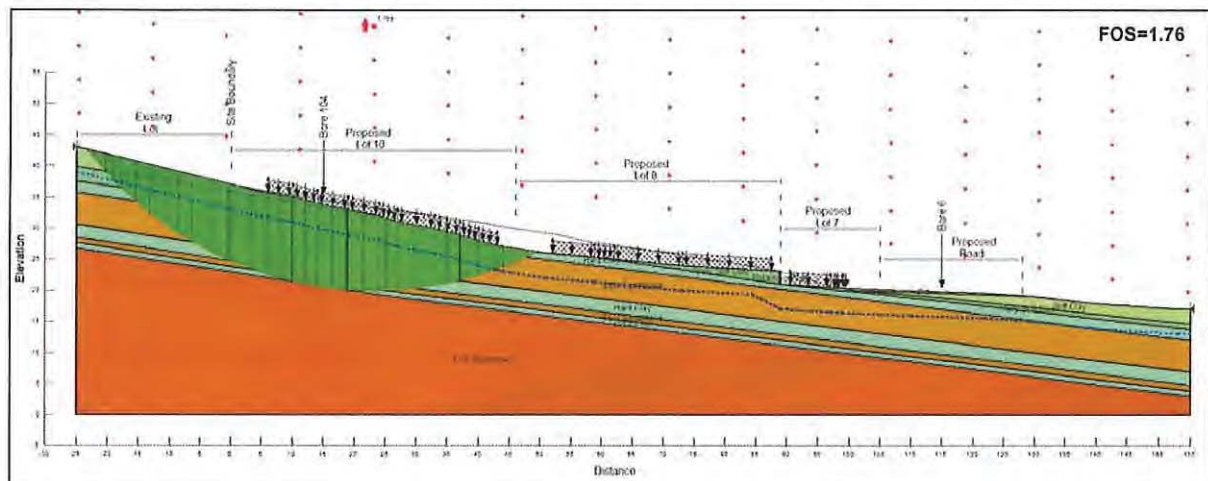
Figure 32: 'Long term' analysis of final design profile near Bore 104 (with 4m deep groundwater)

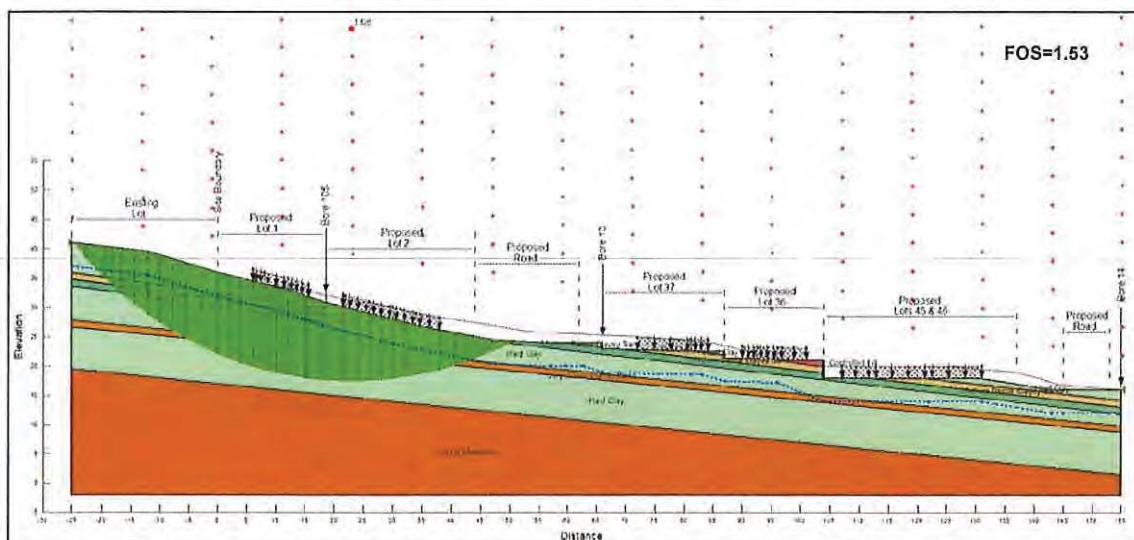
Figure 33: 'Long term' analysis of final design profile near Bore 105 (with 4m deep groundwater)

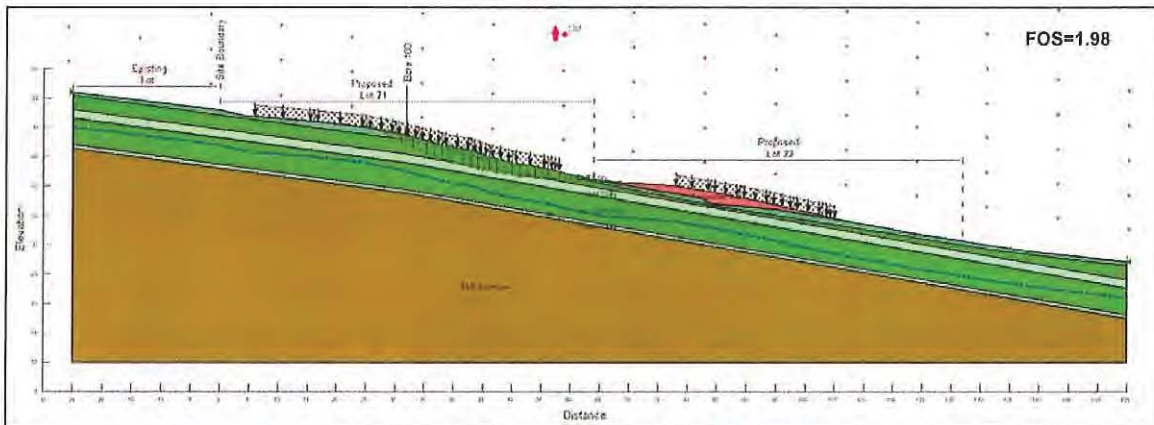
Figure 34: 'Long term' analysis of final design profile near Bore 100 (with 6m deep groundwater)

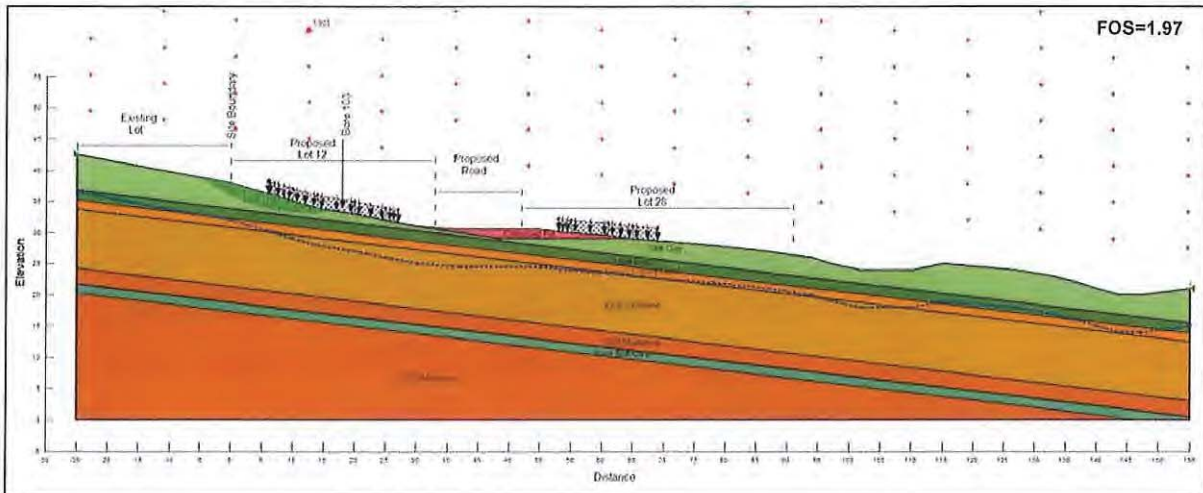
Figure 37: 'Long term' analysis of final design profile near Bore 103 (with 6m deep groundwater)

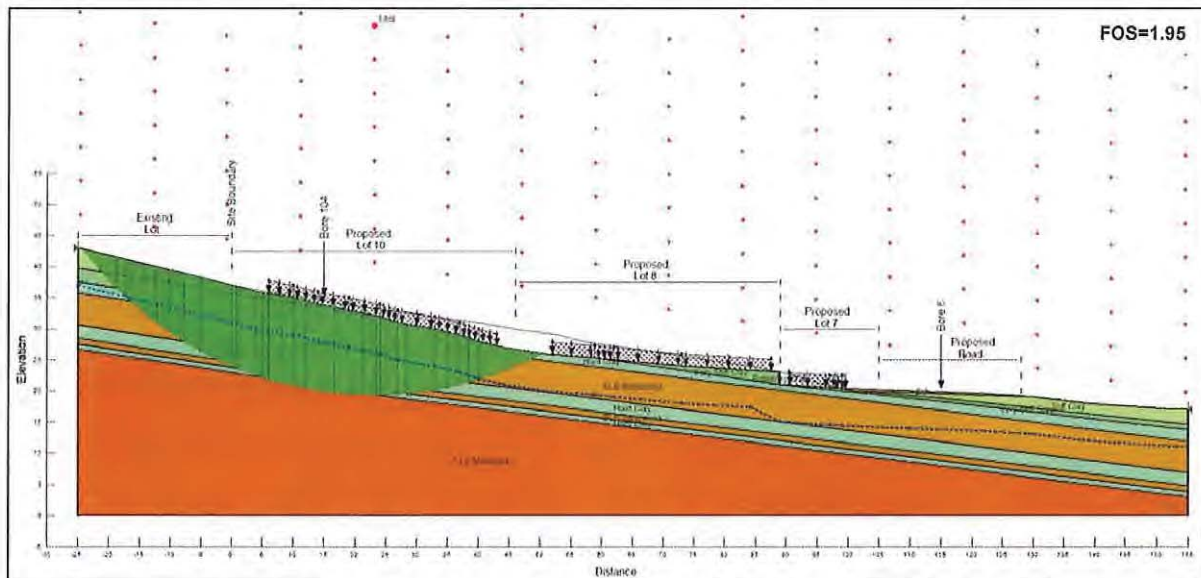
Figure 38: 'Long term' analysis of final design profile near Bore 104 (with 6m deep groundwater)

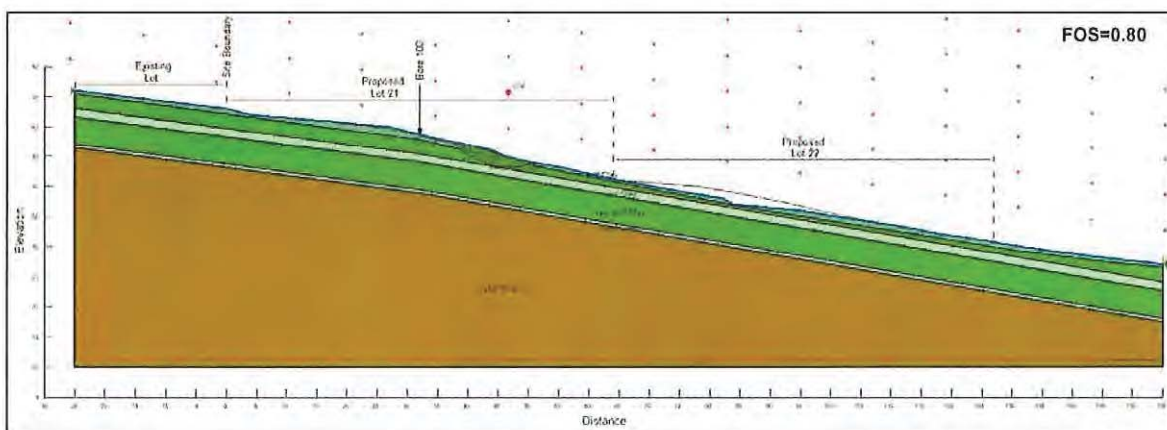
Figure 40: Analysis of near surface soils for the slope profile near Bore 100

The analysis results confirm that, in zones of saturated surface soils, zones of relatively shallow soil failure could be expected. However, visual observations over the sloping sections of Stage 1A, did not reveal any zones of shallow (or deep) failures, presumably because broad scale saturation of near surface soils does not readily occur at the site.

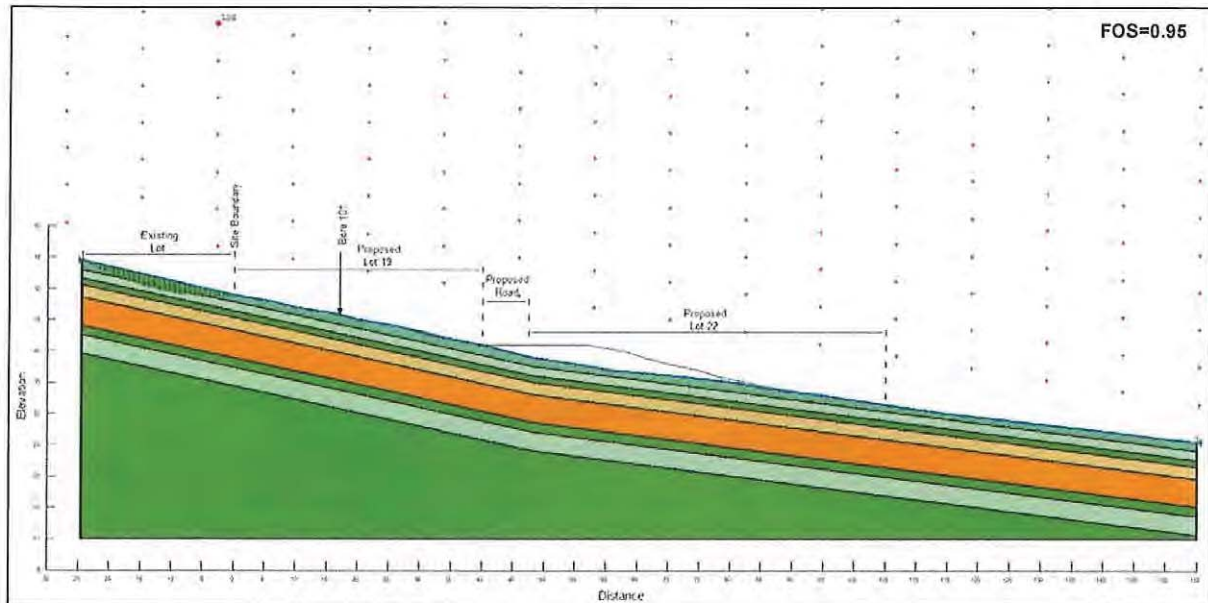
Figure 41: Analysis of near surface soils for the slope profile near Bore 101

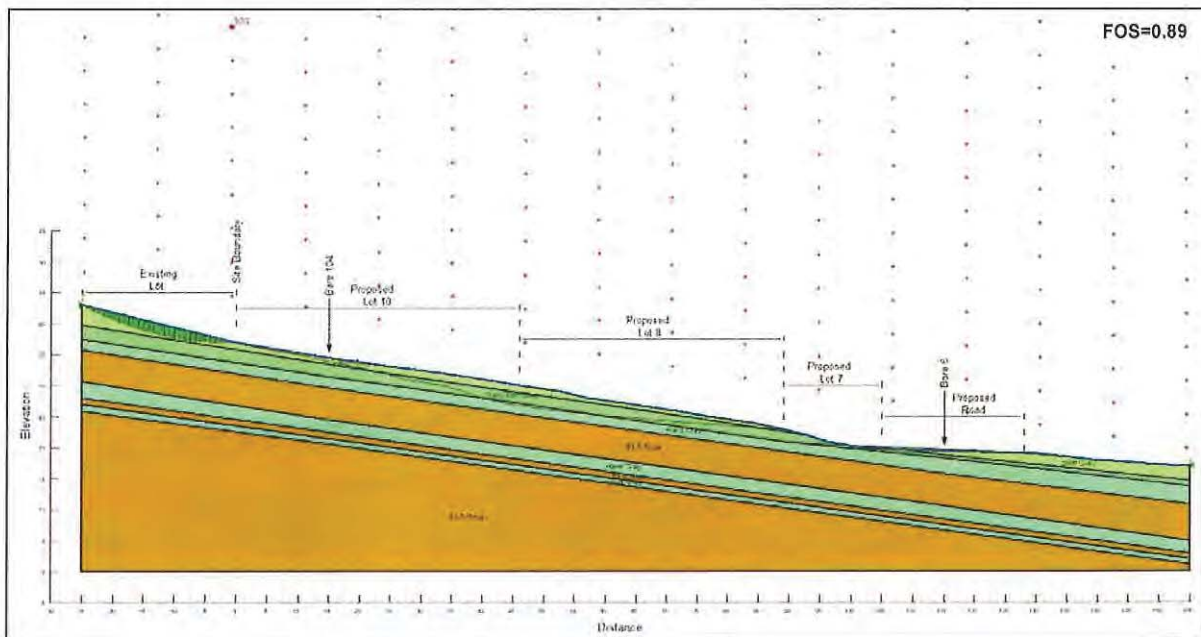
Figure 44: Analysis of near surface soils for the slope profile near Bore 104
