## STRUCTURAL INSPECTION REPORT

15 HAWTHORNE STREET, WOOLLOONGABBA

## Document Reference

23md106 - 2/SK  
Tuesday, 8 October 2024

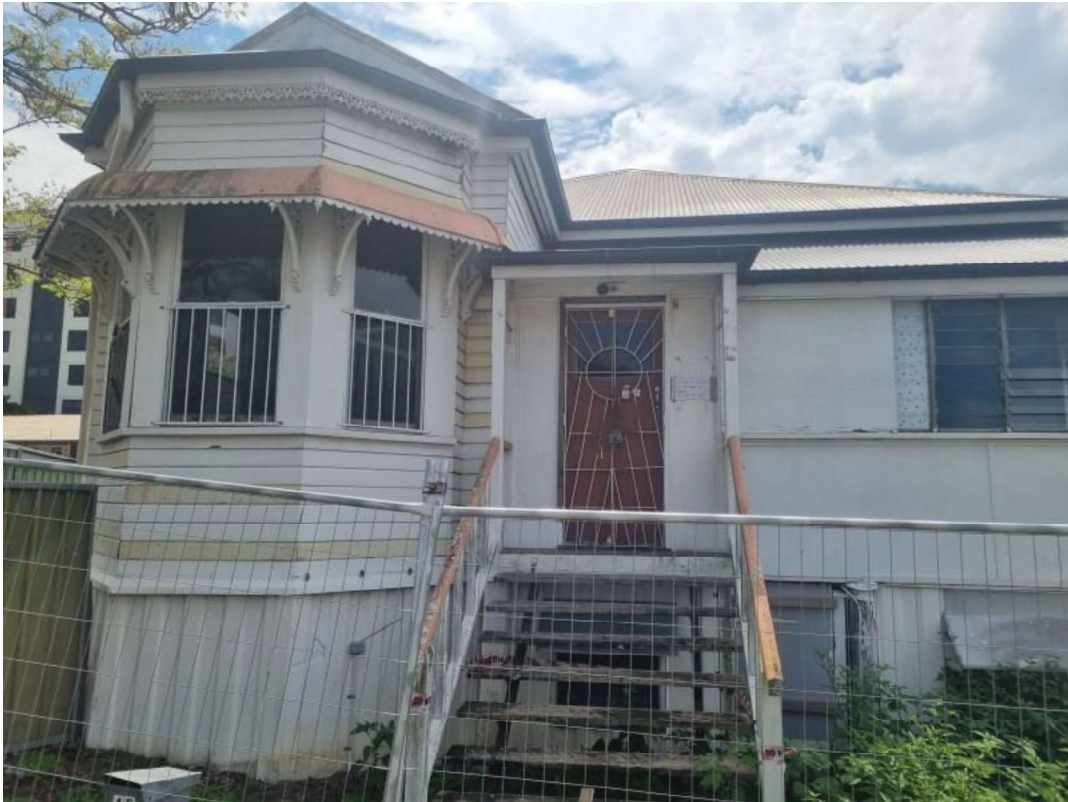
Photograph 1

The residence is a high-set timber framed and clad structure with timber stumps, a concrete slab on ground and a sheet metal roof (Photograph 1).

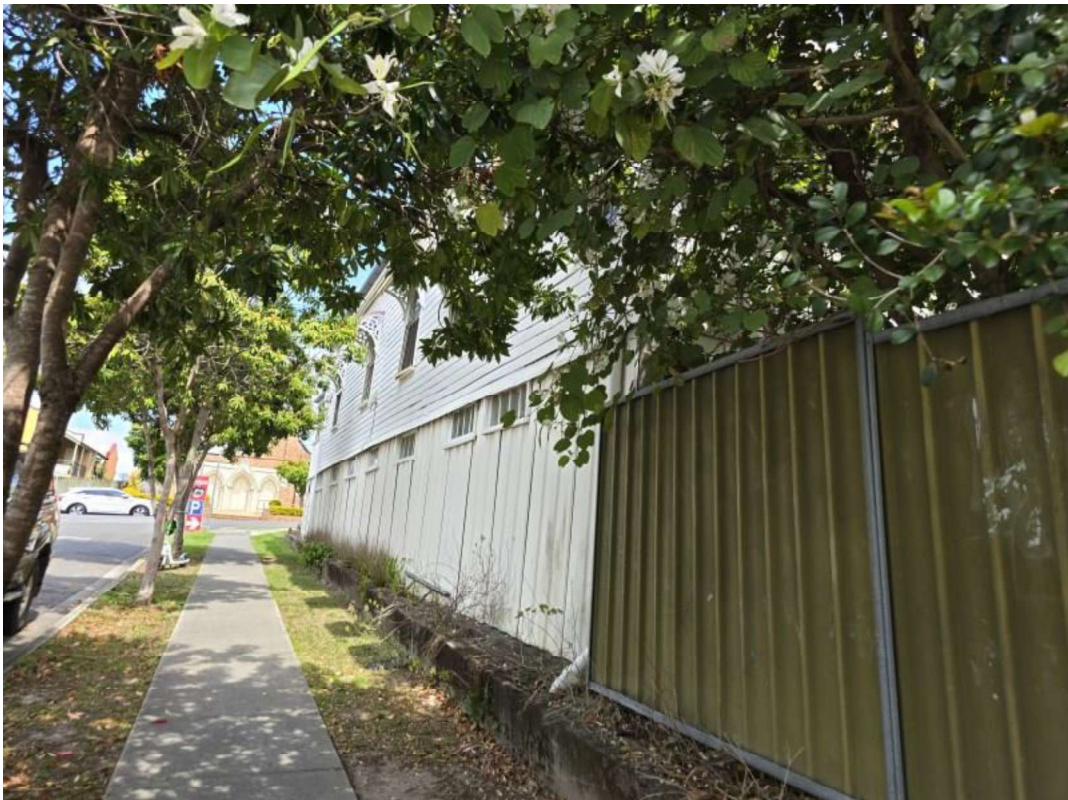
Photograph 2

The eastern wall of the residence was positioned on the eastern boundary of the property and was situated directly adjacent to a publicly accessible footpath (Photograph 2).

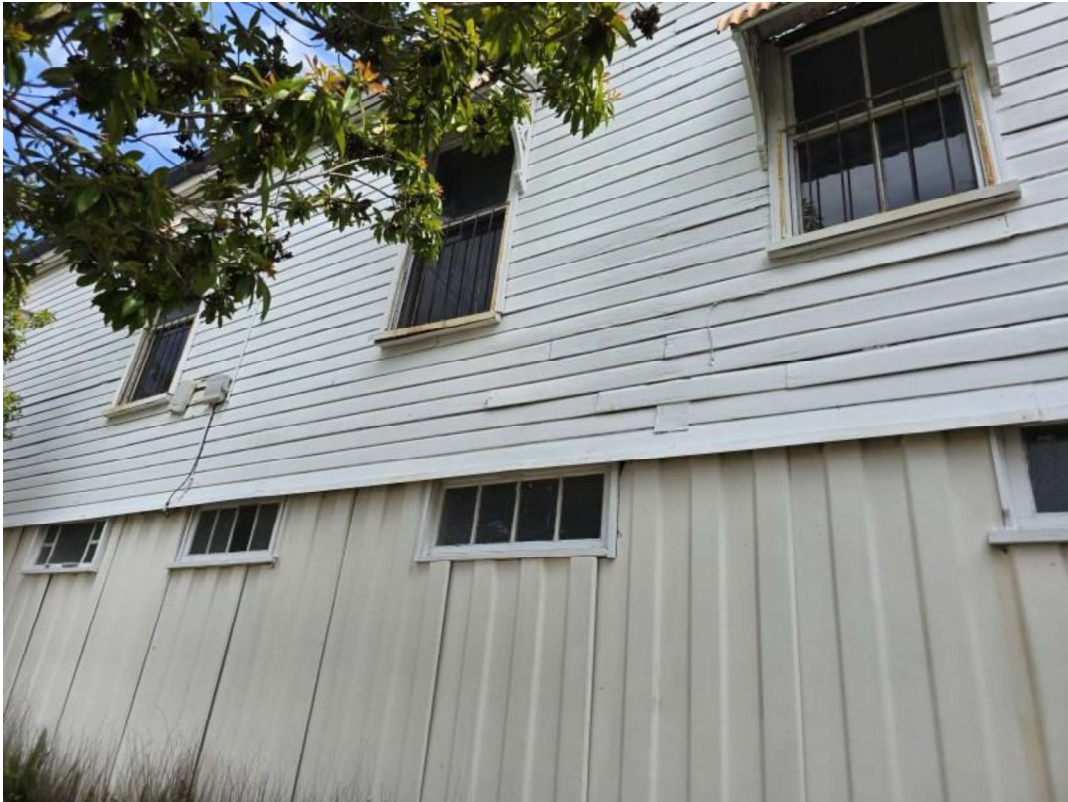
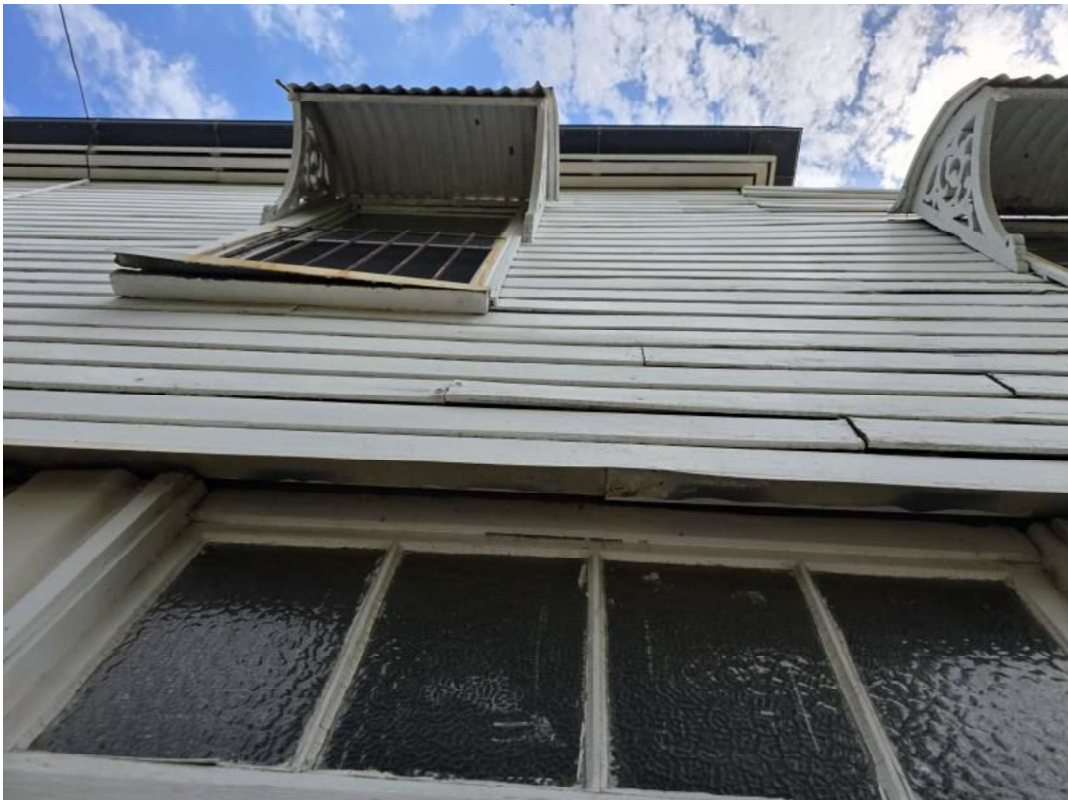
There were a number of bulging weatherboards along the eastern side of the residence (Photographs 3 and 4). There was evidence of pest tracks in the gaps between the weatherboards on this side of the residence (Photograph 5). There was rippling to a number of the weatherboards and window trims along the eastern and northern sides of the residence (Photographs 6 and 7). There were gaps between the weatherboards at the north-western corner of the residence (Photograph 8).

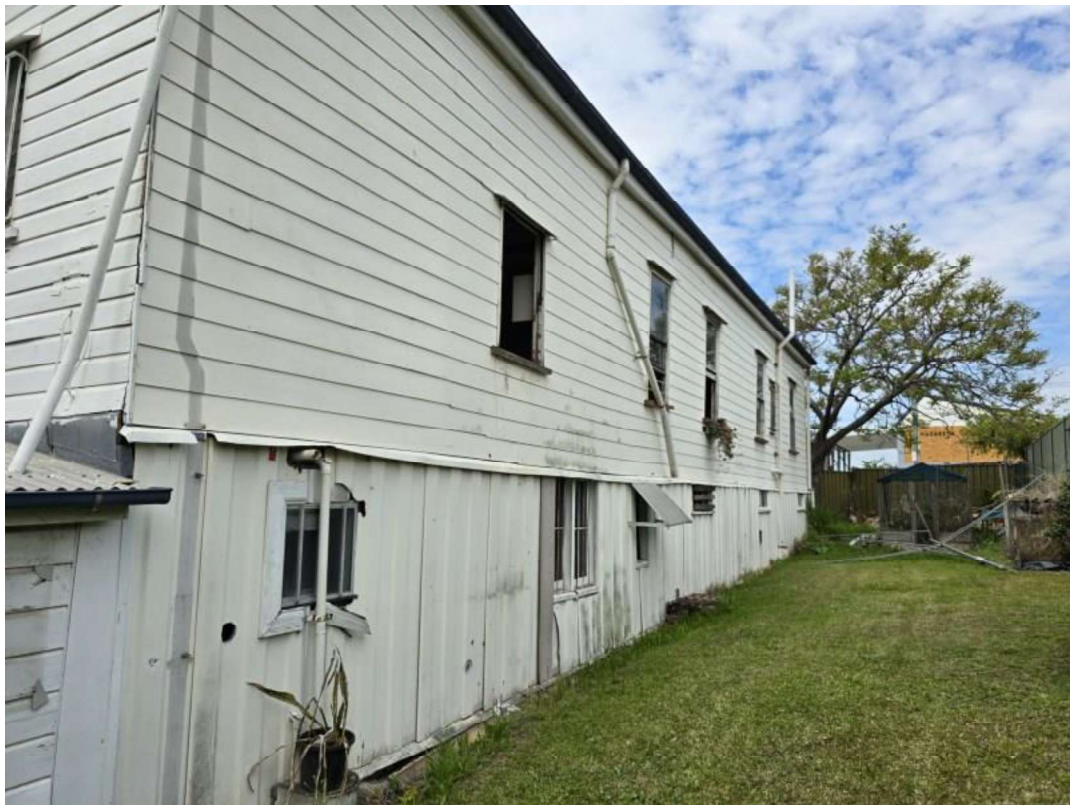
Photograph 9

There was warping and distortions to the external cladding on the western external wall of the residence (Photograph 9).

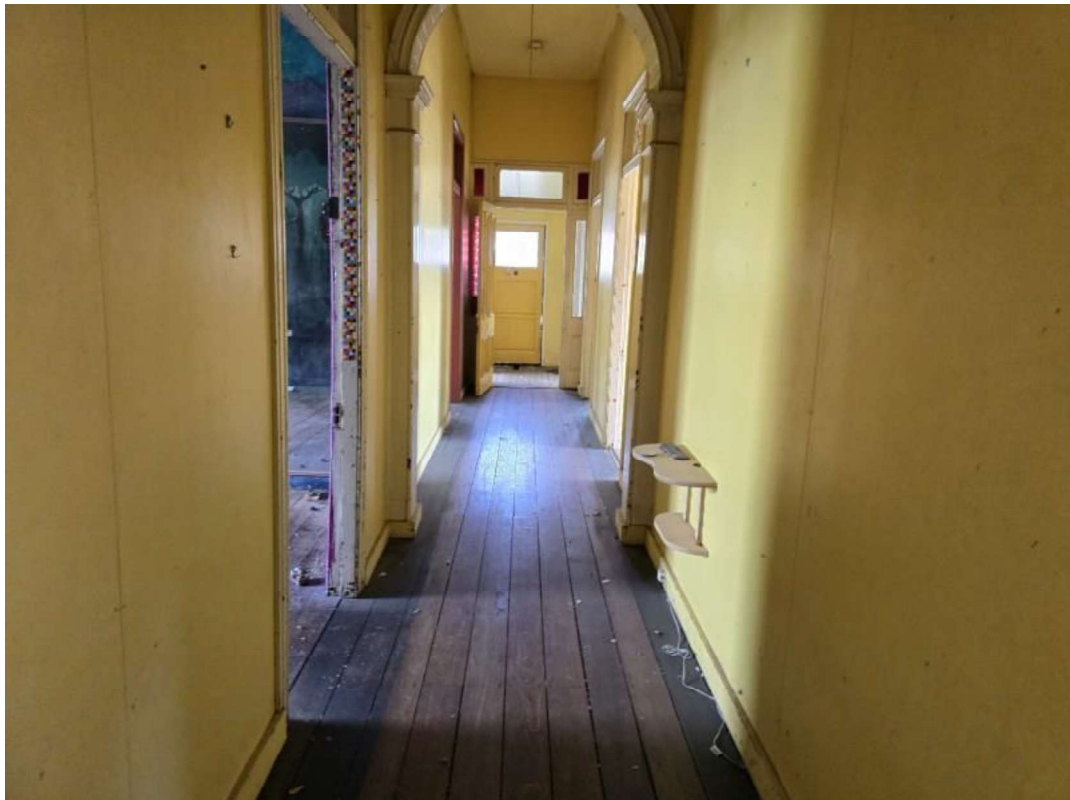
Photograph 10

The majority of the internal walls were lined with what appeared to be asbestos sheeting (Photograph 10). The asbestos sheeting has been installed on top of the existing VJ linings to the internal walls in some areas (Photograph 11).

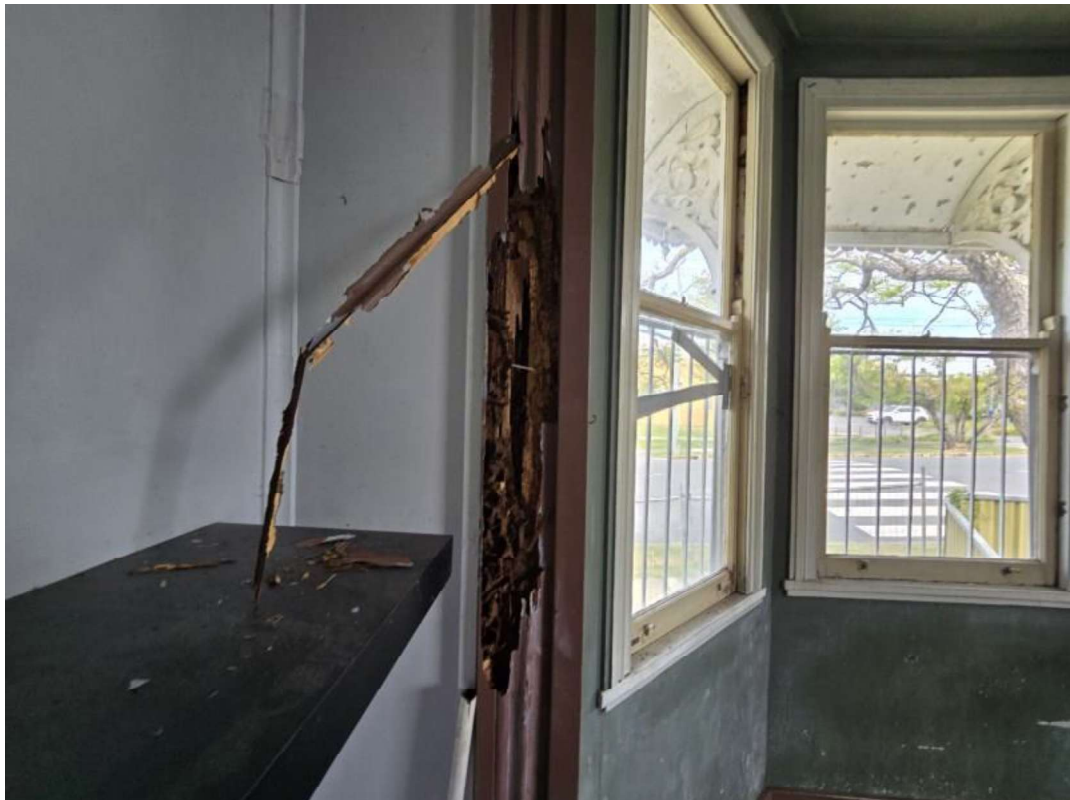
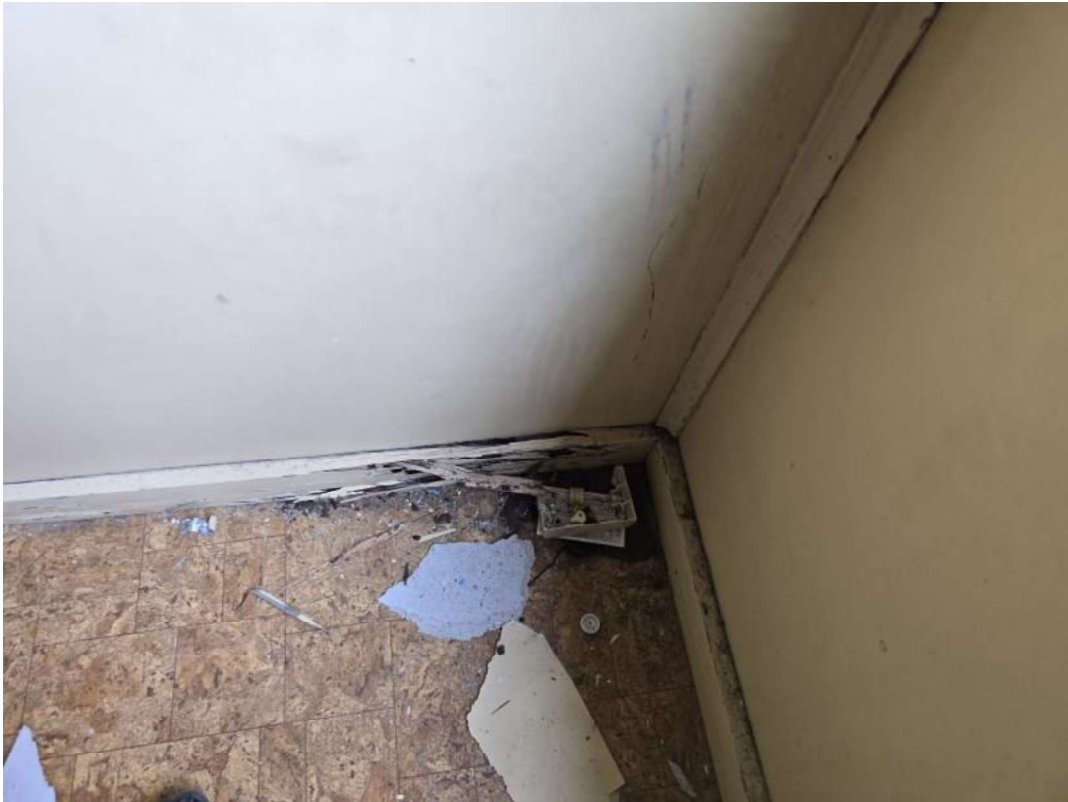
There was evidence of pest damage to the architraves and wall frames in the southern section of the residence, skirting boards in the western section and to the wall frames in the north-eastern section of the residence (Photographs 12, 13 and 14). There was also decay to the eastern wall frames in the north-eastern section of the residence (Photograph 14).

- Replace the leaning and decayed stumps in accordance with a structural engineer's design.
- Replace or repair the damaged and degraded wall frames in accordance with a structural engineer's design. If the rectifications to the walls are carried out prior to the rectifications to the floor framing elements, the props to the upper level would need to be aligned with the props to the subfloor to ensure that the existing floor structure is not being relied on to provide support while undertaking these works.

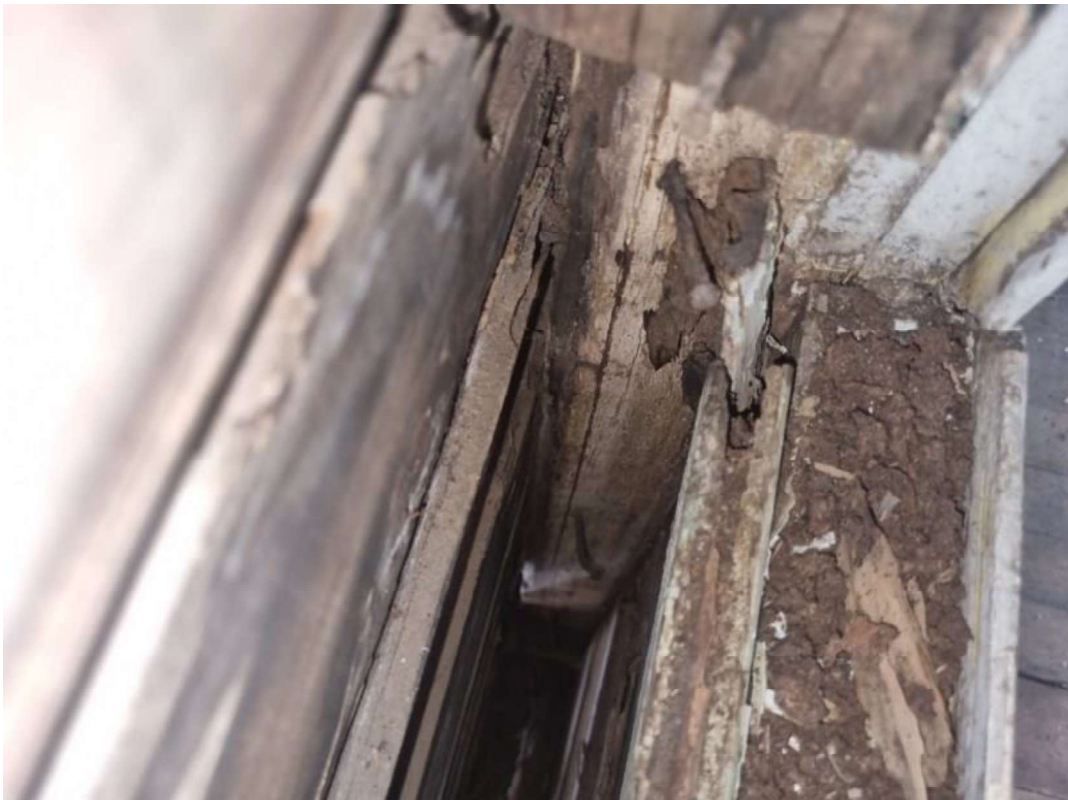
Photograph 14

The decay and pest damage to the eastern wall has resulted in a significant loss of structural integrity of this wall, enabling it to be moved under light hand pressure. As a result, it is expected that the eastern wall could collapse at any time. In addition, due to the proximity of this wall to the public footpath and road this wall's collapse would pose an unacceptable risk to the health and safety of the public in this area.

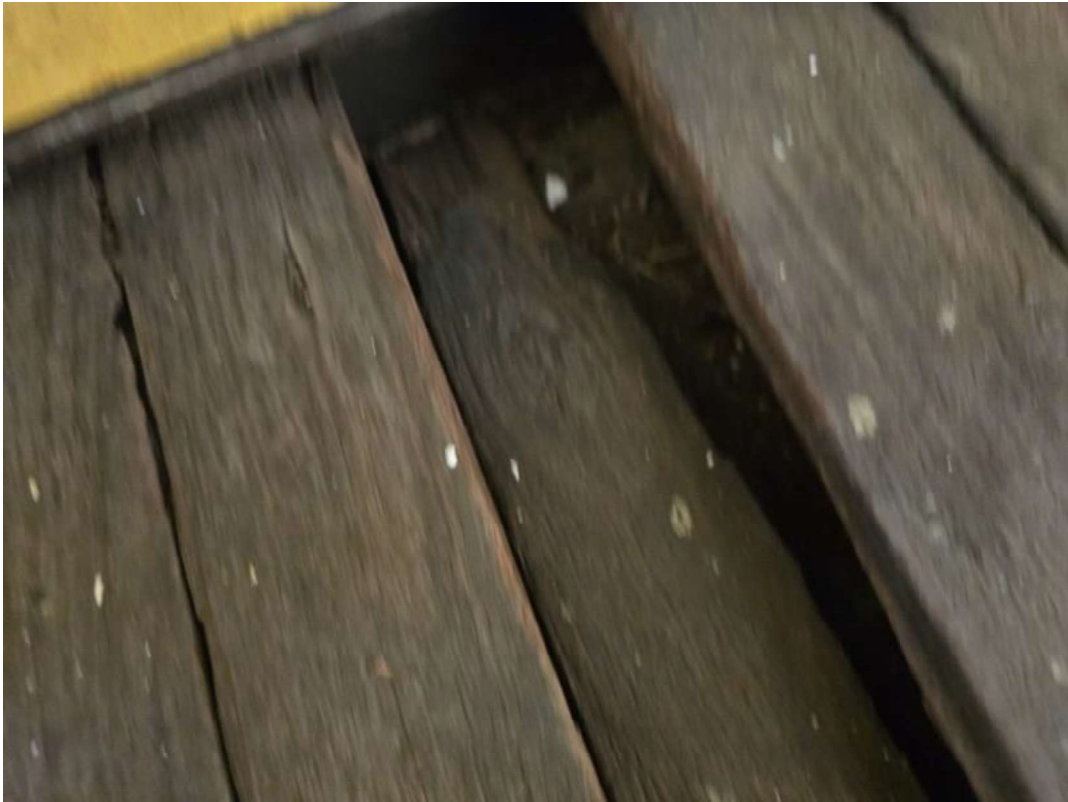
Photograph 15

One of the floor boards in the southern section of the residence had split (Photograph 15). The kitchen floor had a noticeable downward deflection (Photograph 16).

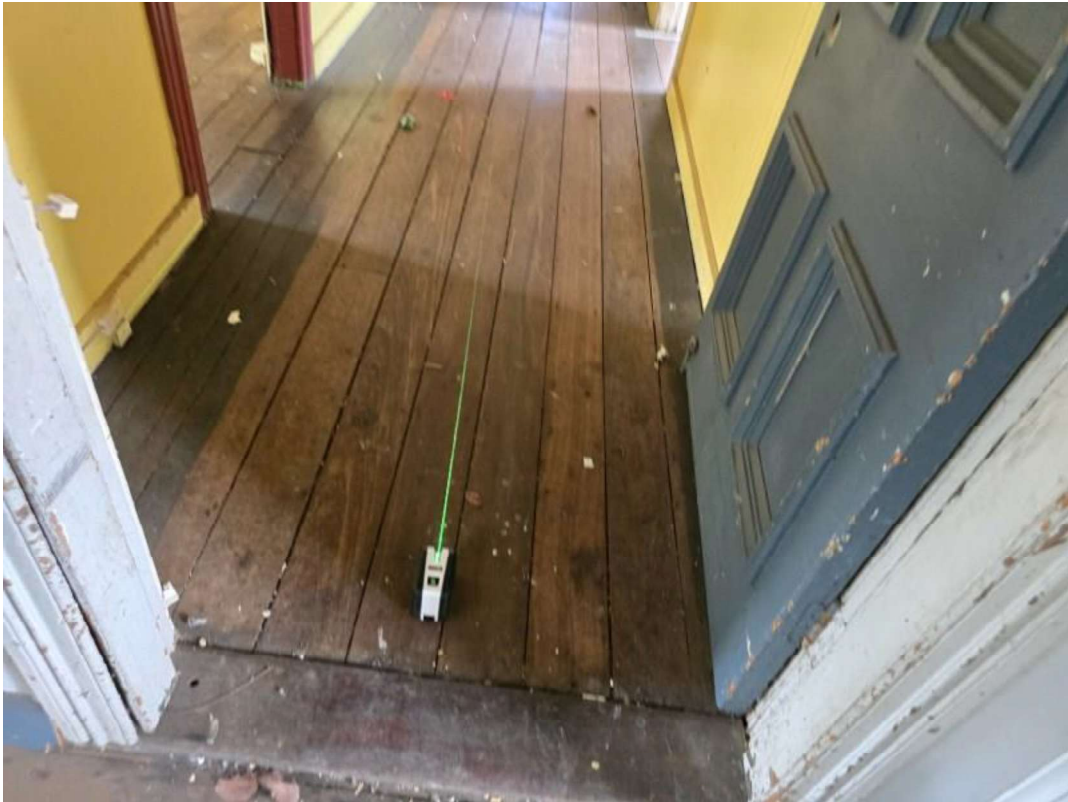
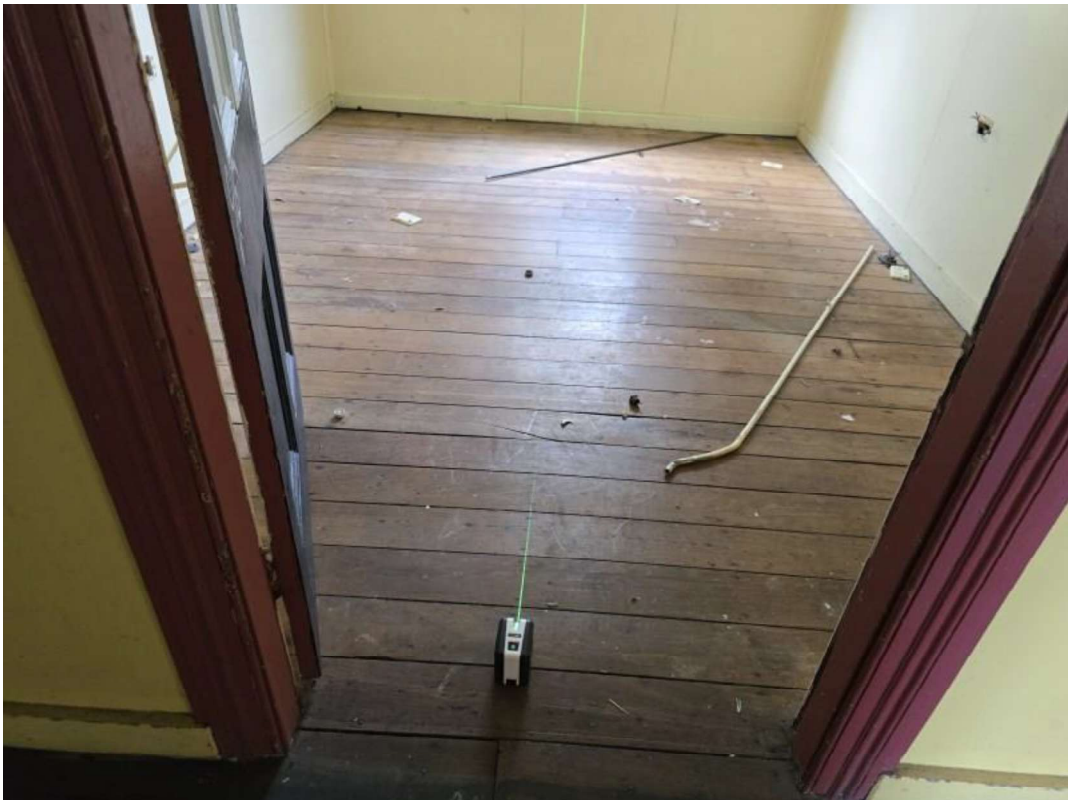
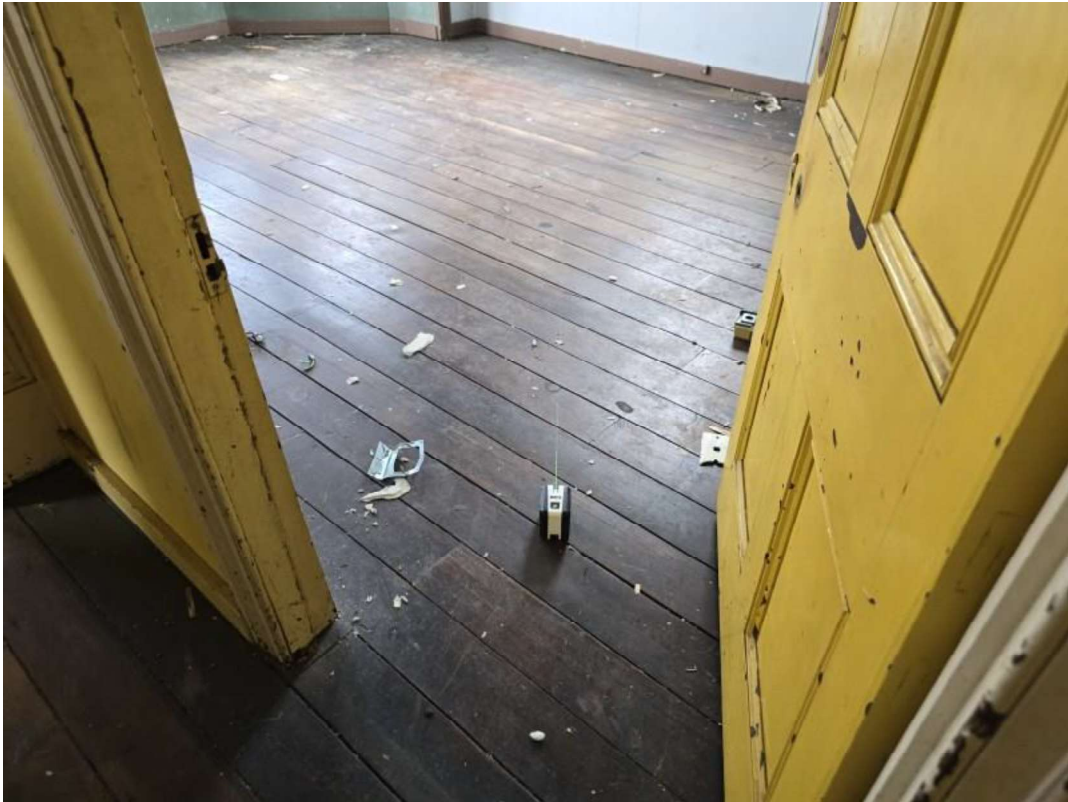
Laser level measurements otherwise indicated that there were significant undulations and high points in the floor throughout the residence (Photographs 17, 18 and 19).

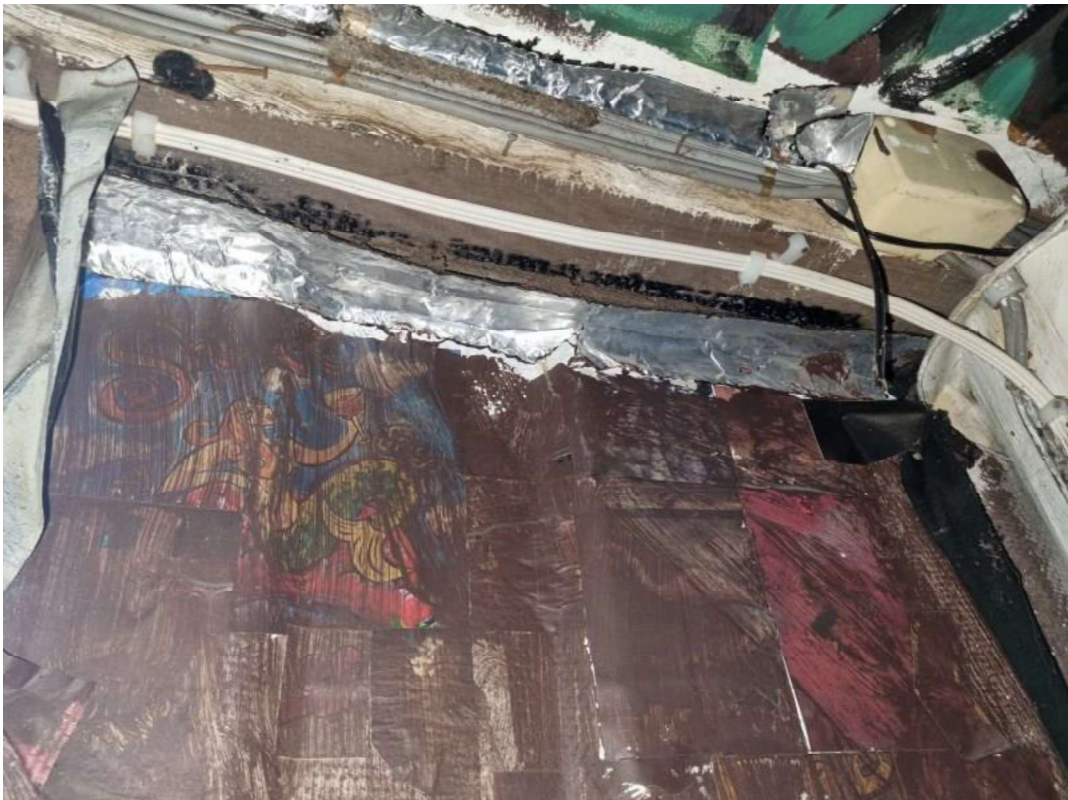
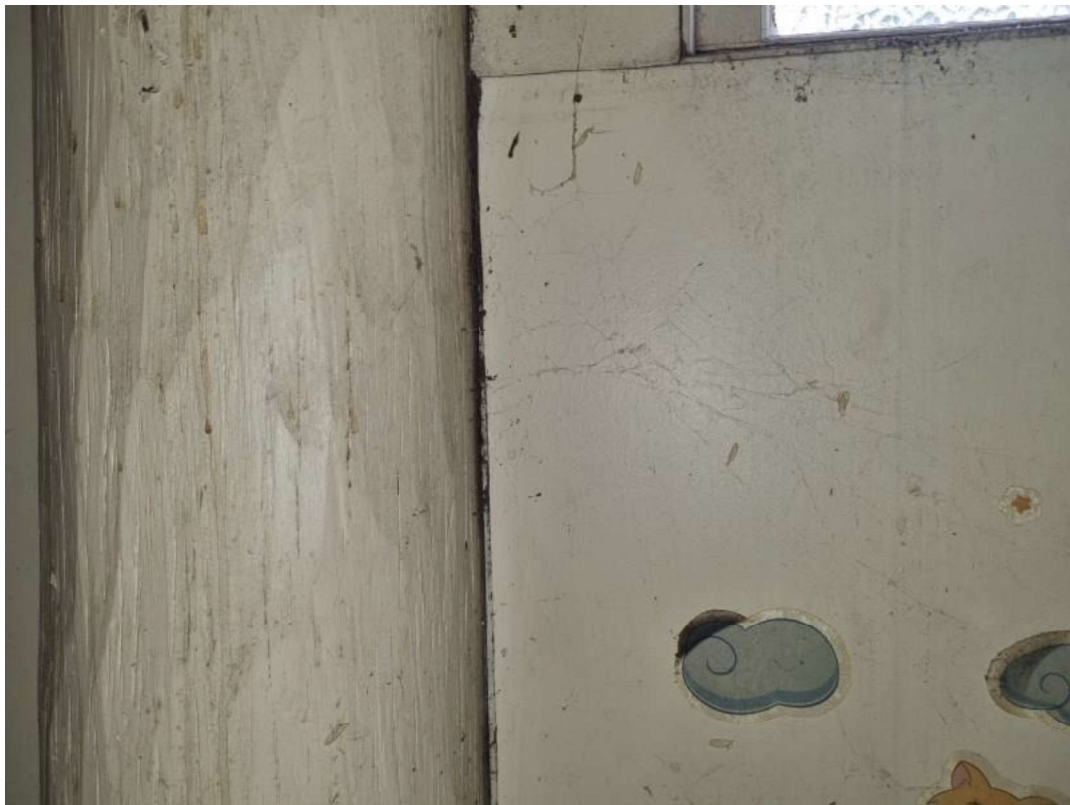
There were pest tracks along the lower section of the eastern wall visible from within the subfloor (Photographs 20 and 21). There was decay and loss of cross-section to one of the bearers at the north-eastern corner of the subfloor (Photograph 22). There was a build-up of what appeared to be termite mud on the underside of one of the bearers in the northern section of the subfloor (Photograph 23). There was what appeared to be a timber packer between the underside of this bearer and the stump (Photograph 23). The timber packer was soft and could easily be penetrated with a sharp object.

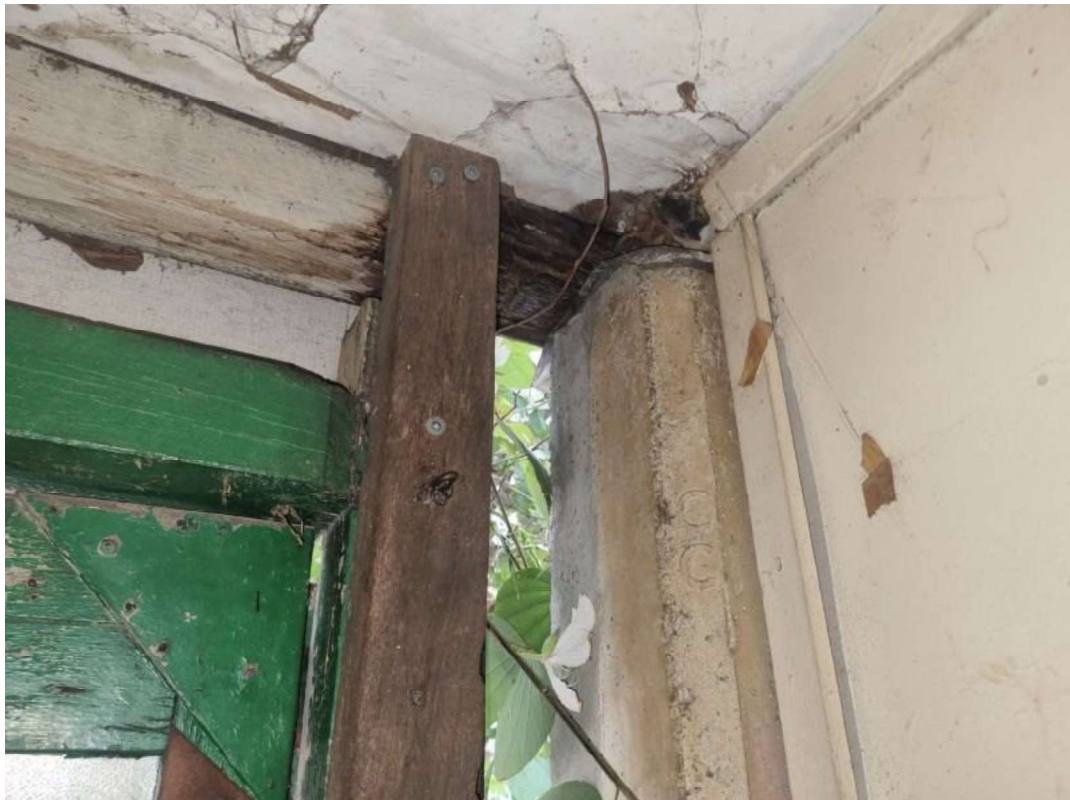
Photograph 22

The decay and distortion observed to a number of the bearers and stumps indicates that these elements are no longer structurally sound and should also be replaced in accordance with a structural engineer's design. As there were linings concealing the majority of the floor framing elements in the subfloor, it was not possible to visually confirm the presence of damage or degradation to the floor joists. However, considering the extent to which the level of the floor deviated, the damage to a number of the floor boards and the pest-related activity to the skirting boards, it is likely that a number of the joists are also damaged and would require replacement. We recommend that the linings in the subfloor are removed to confirm the extent or presence of damage to the floor joists and the extent of rectifications required in this regard.

- Replace the distorted, decayed and pest-damaged bearers in accordance with a structural engineer's design.
- Remove the linings in the subfloor, confirm the extent of damage to the floor joists and replace or rectify them as required.

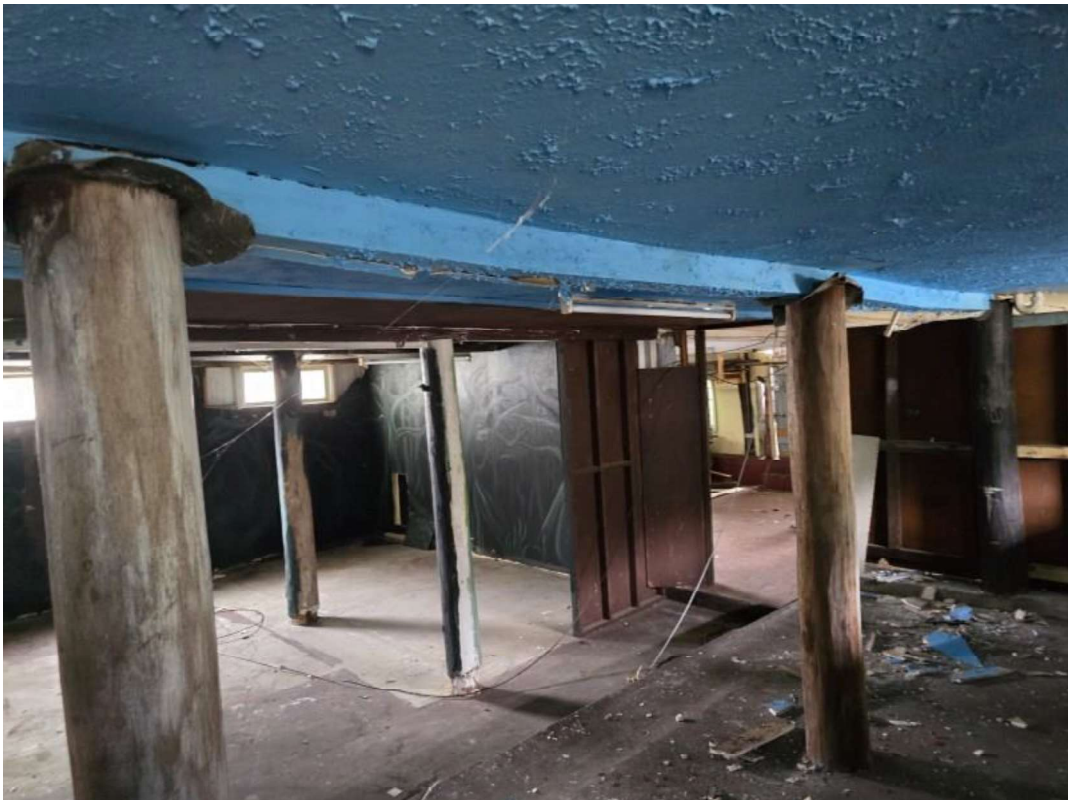
Photograph 24

One of the bearers in the western section of the subfloor was significantly distorted (Photograph 24).

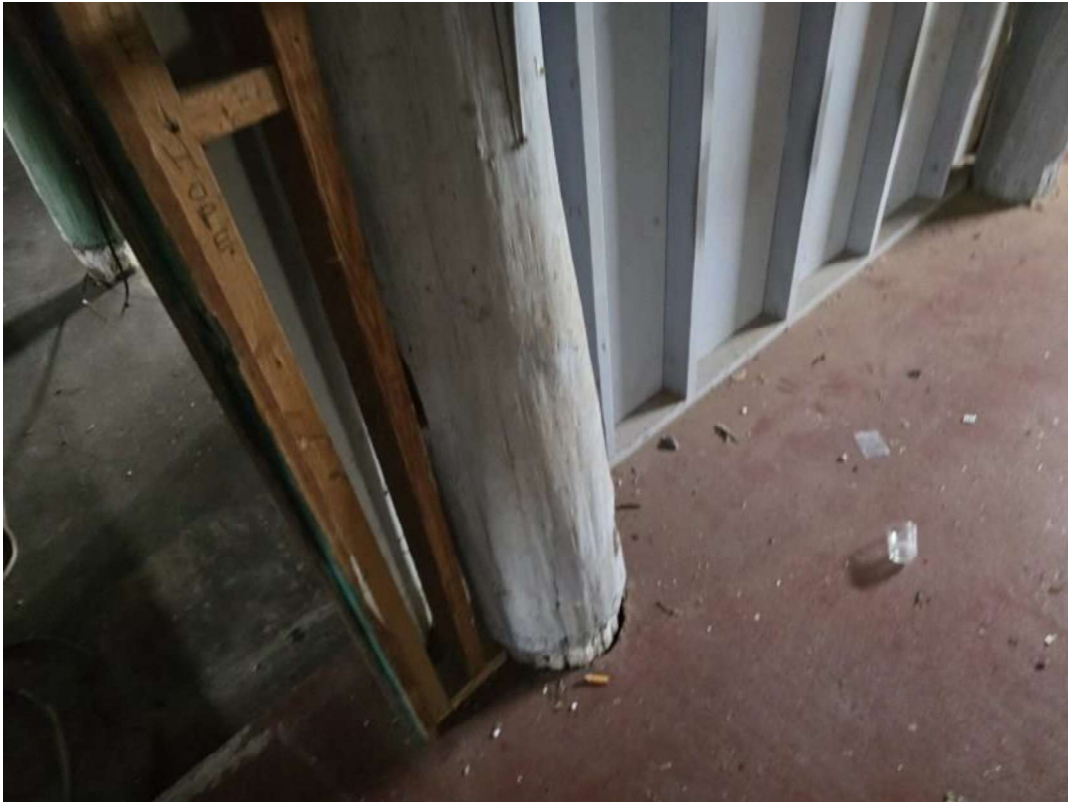
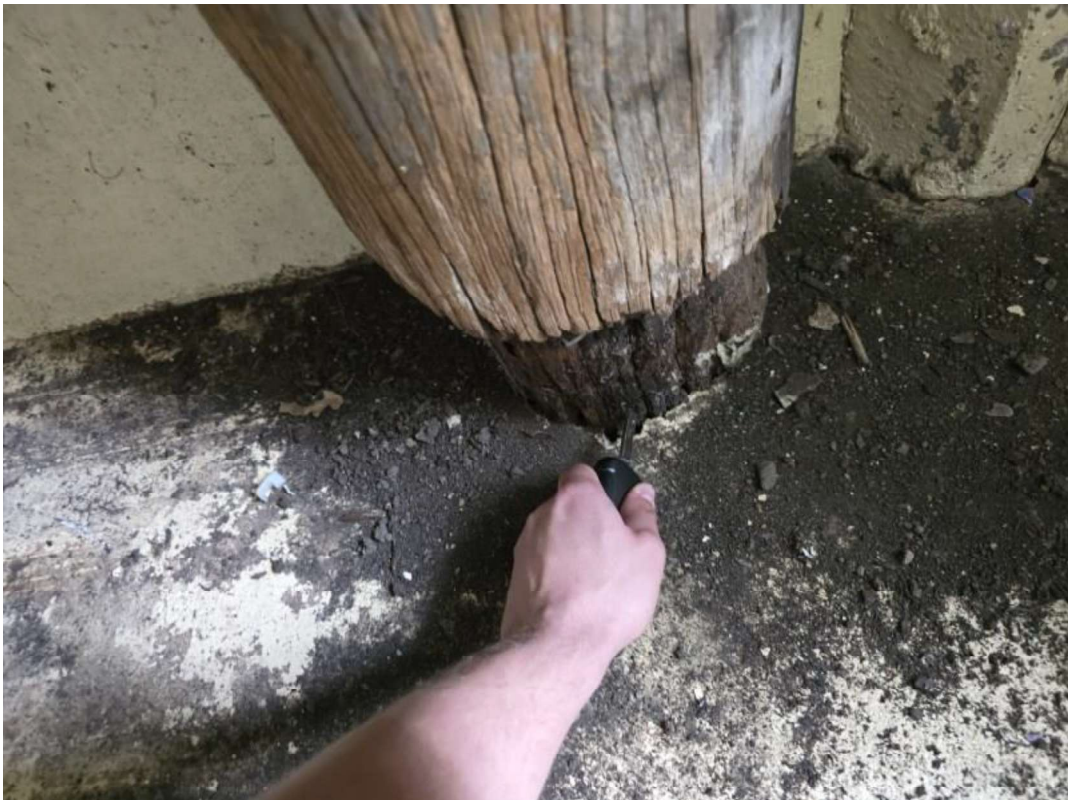
There was decay and loss of cross-section from the bases of a number of the timber stumps, particularly in the southern section of the subfloor (Photographs 25 and 26). One of the stumps in the south-western section of the subfloor had a noticeable lean (Photograph 27).
