# ARBORIST REPORT

260 MacArthur Avenue, Hamilton

7<sup>th</sup> March 2025

Report No. **J36890-V3**

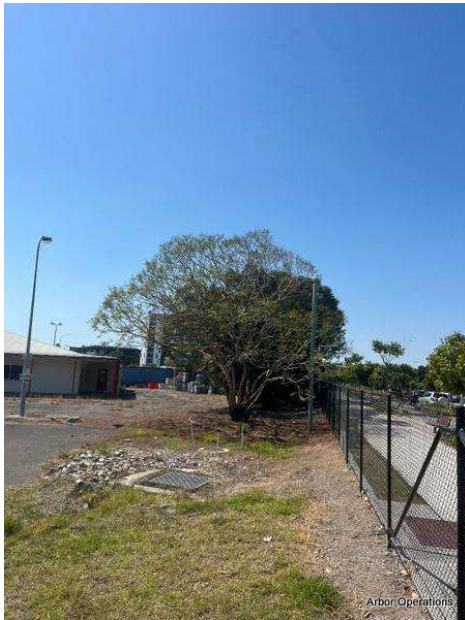
**Photo 1:** *Jacaranda mimosifolia*

Fair health and poor form with a broad structure. It was formerly a twin stem tree however the western most stem has been previously removed stimulating the development of epicormic shoots. Canopy shape is asymmetrical with a bias to the North West. Crown density, leaf colour and size, and tip growth extension are fair to good.

It is proposed to construct a carpark located to the east of the subject's location. Given the subjects location, retention is not compatible with the proposed design as indicated in the carpark layout plan on page 33.

Remove tree and grind stump.

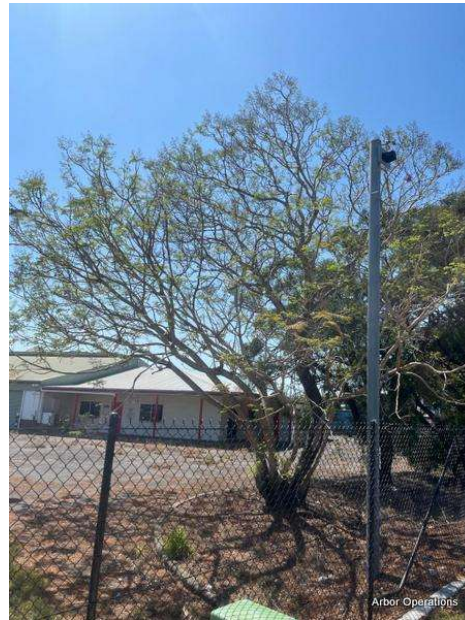
Epicormic shoots are present on the northeastern most side of the subject. These are weakly attached and prone to failure.

**Photo 2:** Epicormic shoots to NW

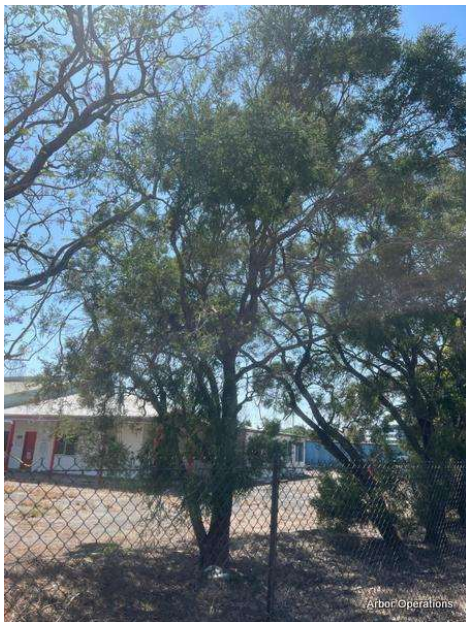
**Photo 1:** *Melaleuca bracteata*

Fair health and fair to poor form with a twin structure. Canopy shape is asymmetrical with a bias to the North East. Crown density, leaf colour and size, and tip growth extension are fair to good. It is a co-dominant tree with minor deadwood.

It is proposed to construct a carpark located to the north of the subject's location. Given the subjects location, retention is not compatible with the proposed design as indicated in the carpark layout plan on page 33.

Remove tree and grind stump.

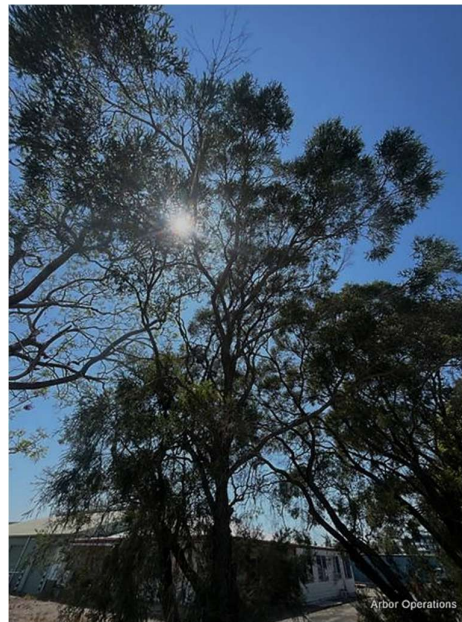
**Photo 2:** Crown

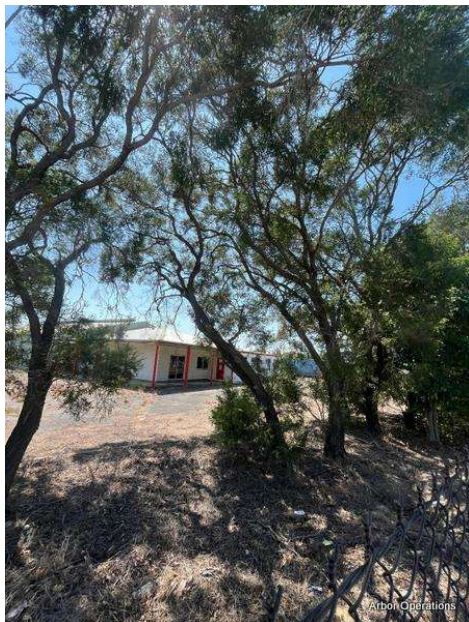
**Photo 1:** *Melaleuca bracteata*

Fair health and fair to poor form with a suppressed, twin-stem structure. Canopy shape is asymmetrical with a bias to the North West. Crown density, leaf colour and size, and tip growth extension are fair to good. Minor deadwood is noted.

Excavation has occurred within the TPZ at the edge of the SRZ to the South.

Remove tree and grind stump.

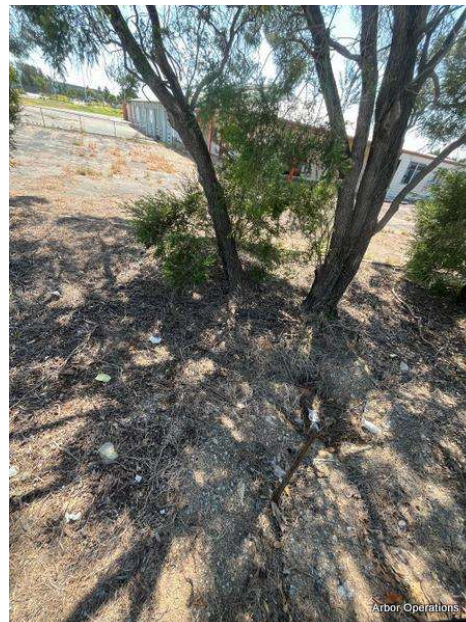
**Photo 2:** Leaning stem

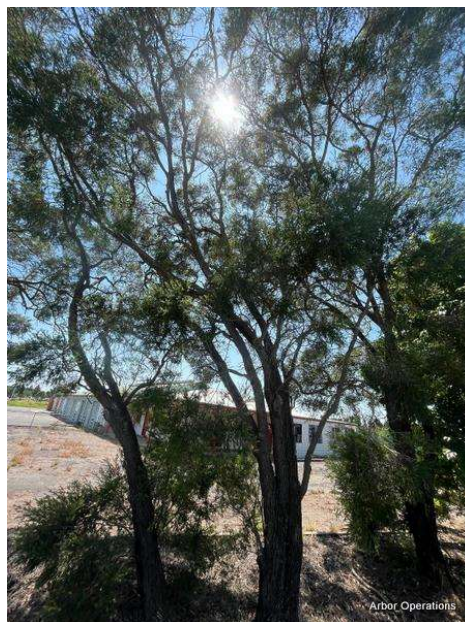
**Photo 1:**      *Melaleuca bracteata*

Fair health and fair form with a broad structure. Canopy shape is symmetrical. Crown density, leaf colour and size, and tip growth extension are fair to good. Minor deadwood is noted.

It is proposed to construct a carpark located to the north of the subject's location. Given the subjects location, retention is not compatible with the proposed design as indicated in the carpark layout plan on page 33.

Remove tree and grind stump.

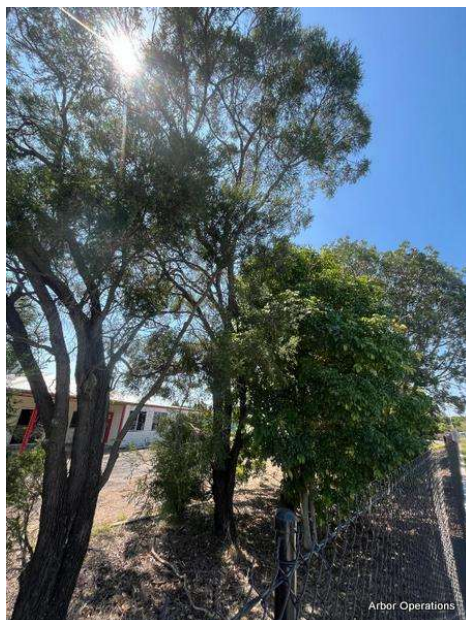
**Photo 1:**        *Melaleuca bracteata*

Fair health and fair to poor form with a broad structure. Canopy shape is asymmetrical with a bias to the North East. Crown density, leaf colour and size, and tip growth extension are fair to good. It is a co-dominant tree with minor deadwood is noted.

It is proposed to construct a carpark located to the north of the subject's location. Given the subjects location, retention is not compatible with the proposed design as indicated in the carpark layout plan on page 33.

Remove tree and grind stump.

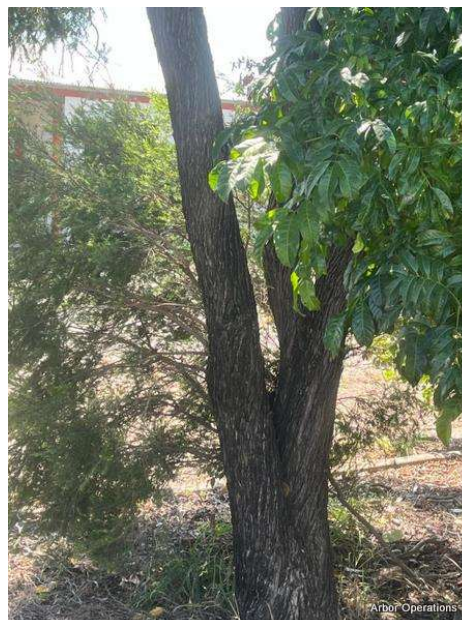
**Photo 2:**        Co-dominant union

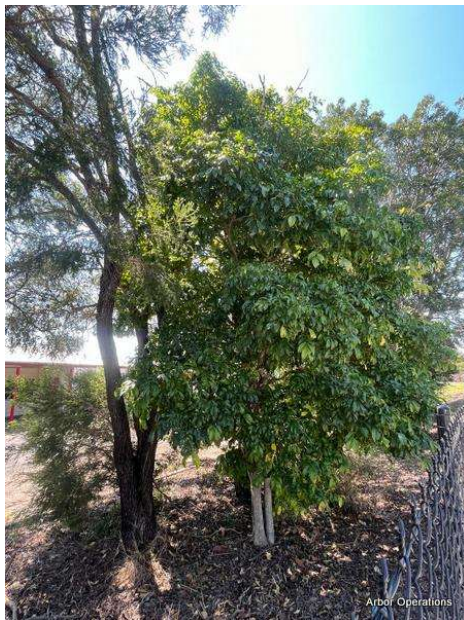
**Photo 1:**        *Harpullia pendula*

Fair health and fair to poor form with a squat, multi-stem structure. Canopy shape is symmetrical. Crown density, leaf colour and size, and tip growth extension are fair to good. It is co-dominant tree with minor deadwood noted.

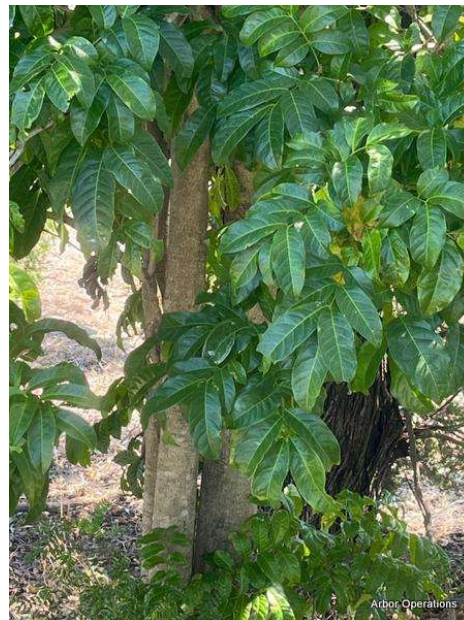
**Photo 2:**        Multi stem

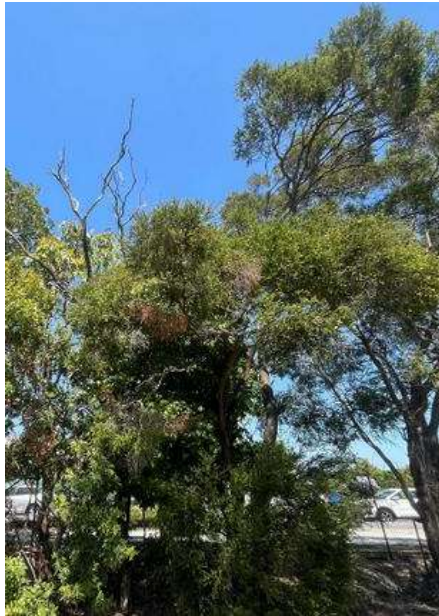
**Photo 1:** *Melaleuca bracteata*

Fair health and fair to poor form with a twin stem structure. Canopy shape is asymmetrical with a bias to the North West. Crown density, leaf colour and size, and tip growth extension are fair to good. It is a co-dominant tree with minor deadwood noted.

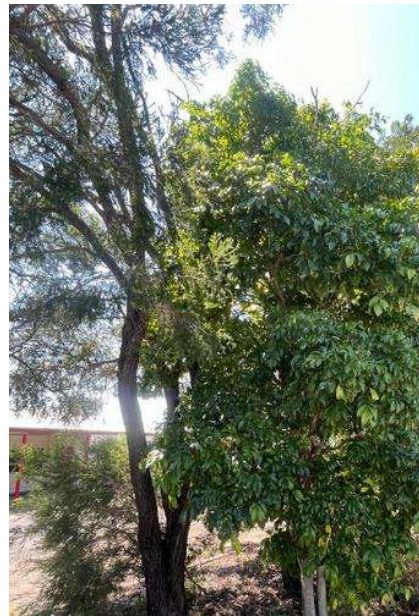
**Photo 2:** Bias to the north west

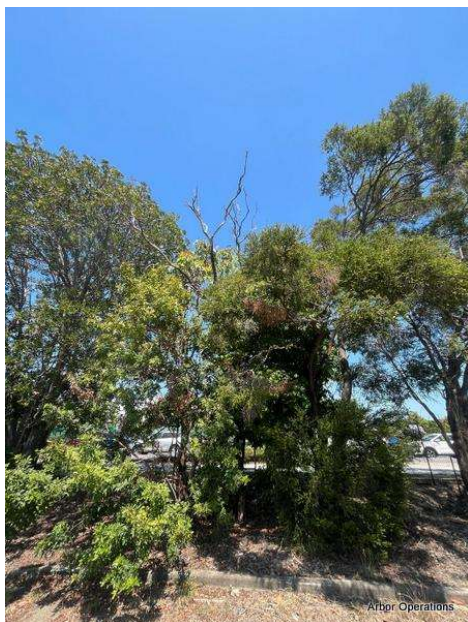
**Photo 1:**      *Unknown sp.*

The subject is dead with major deadwood noted within the crown.

Deadwood represents a fall hazard.

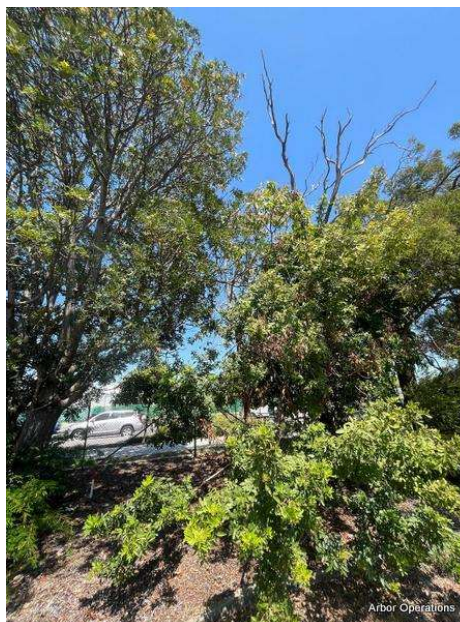
**Photo 2:**      Dead crown

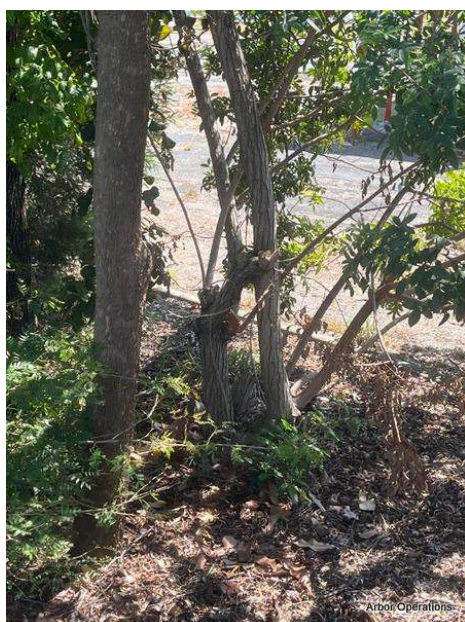
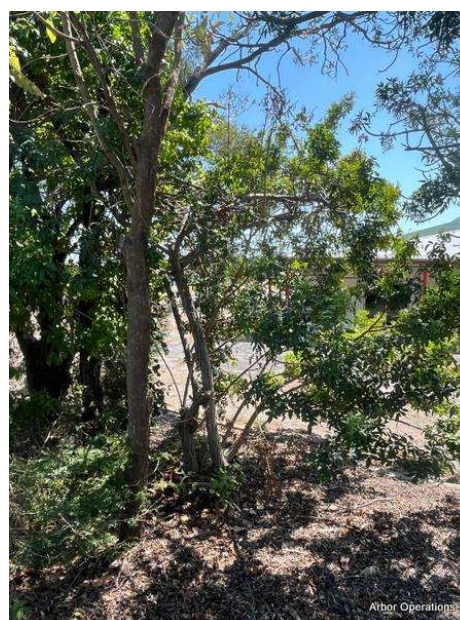
**Photo 3:**      Understorey pepperina

**Photo 4:**      Understorey pepperina

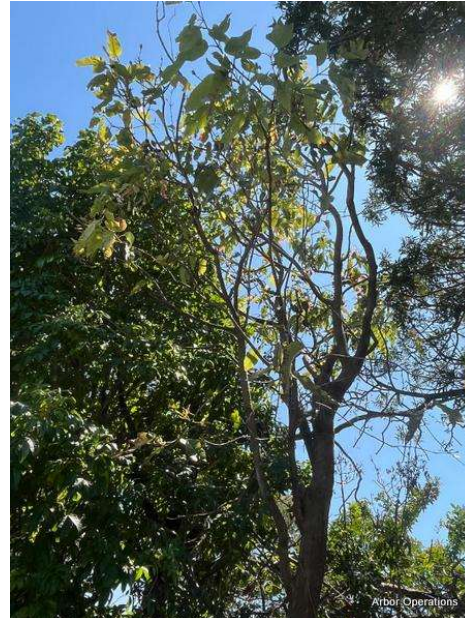
**Photo 2:** Crown bias South West

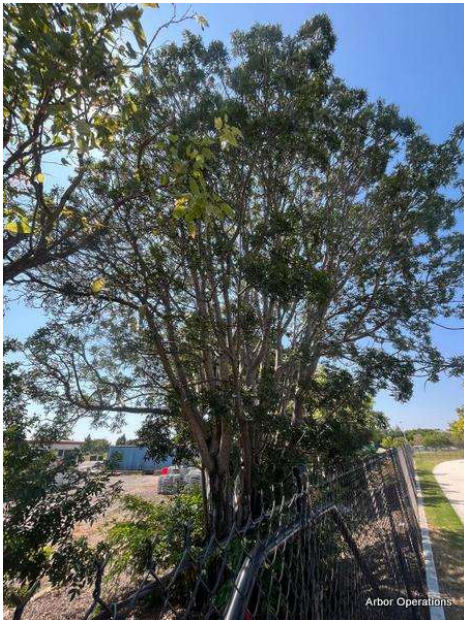
**Photo 1:** *Schotia brachypetala*

Fair health and fair form with a broad structure. Canopy shape is symmetrical with a bias to the South. Crown density, leaf colour and size, and tip growth extension are fair to good. It is a co-dominant tree with minor deadwood noted.

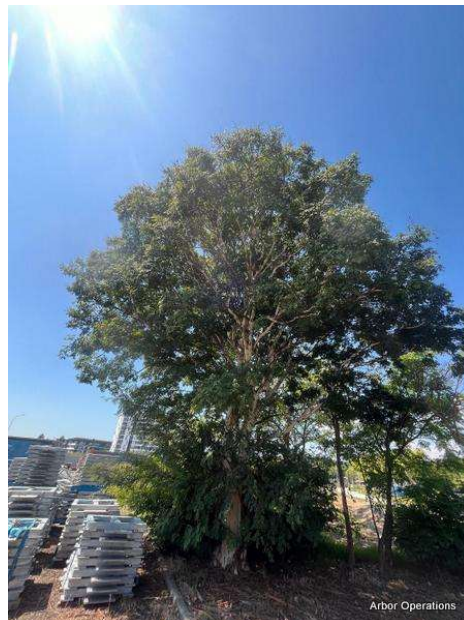
**Photo 2:** View east

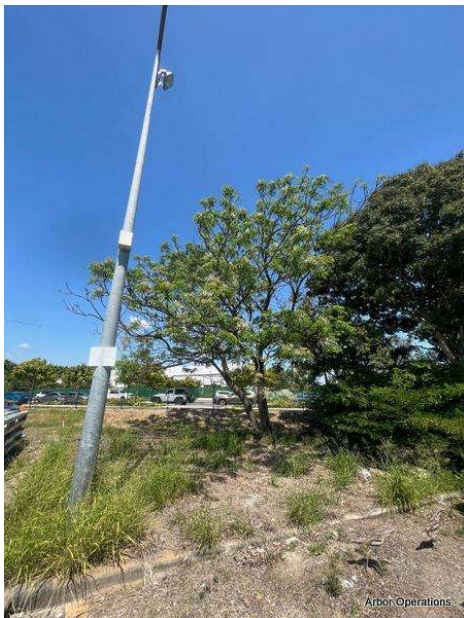
**Photo 1:** *Melia azederach*

Fair to poor health and fair form with a broad structure. Canopy shape is asymmetrical with a bias to the North East. Crown density, leaf colour and size, and tip growth extension are fair to good. It is a co-dominant tree with significant decay column present on the main leader. Minor deadwood is noted.

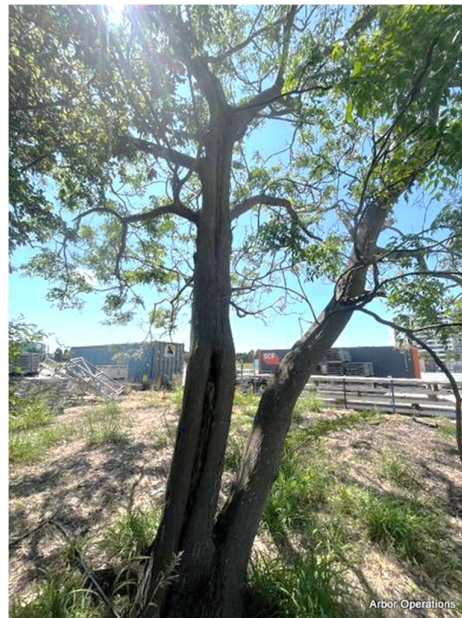
**Photo 2:** Decay column on central leader

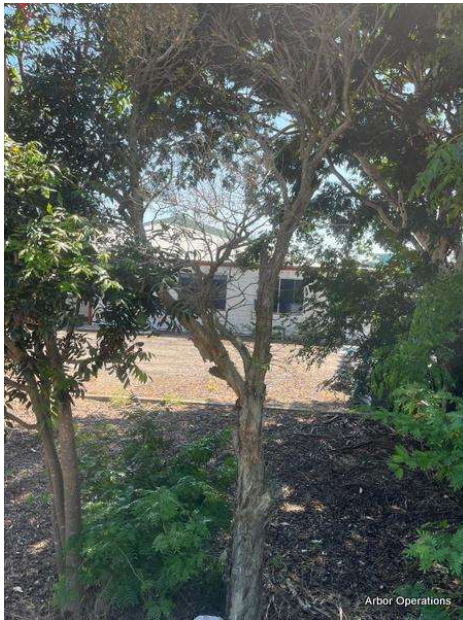
**Photo 1:** *Melaleuca linariifolia*

Fair health and fair to poor form with a squat structure. Canopy shape is asymmetrical with a bias to the South. Crown density, leaf colour and size, and tip growth extension are fair. Minor deadwood is noted.

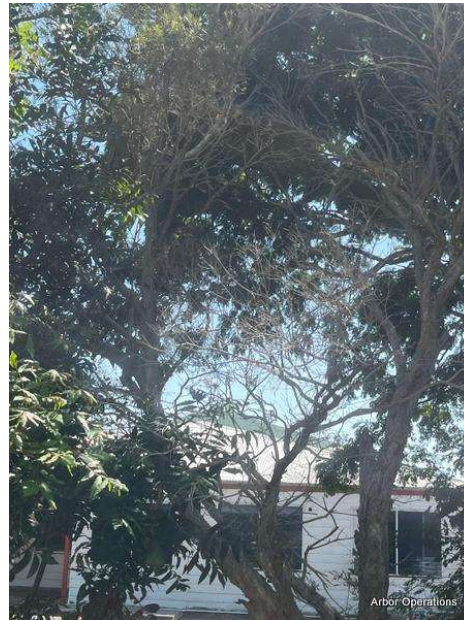
**Photo 2:** Sparse crown with tip dieback
