# STRUCTURAL DILAPIDATION REPORT

## FOR POST FIRE ASSESSMENT OF THE LUSSH WOOLLOONGABBA

LOCATED AT  
5 HUBERT STREET, WOOLLOONGABBA

PREPARED FOR TRACE PROJECT MANAGEMENT  
BY BORNHORST & WARD PTY LTD

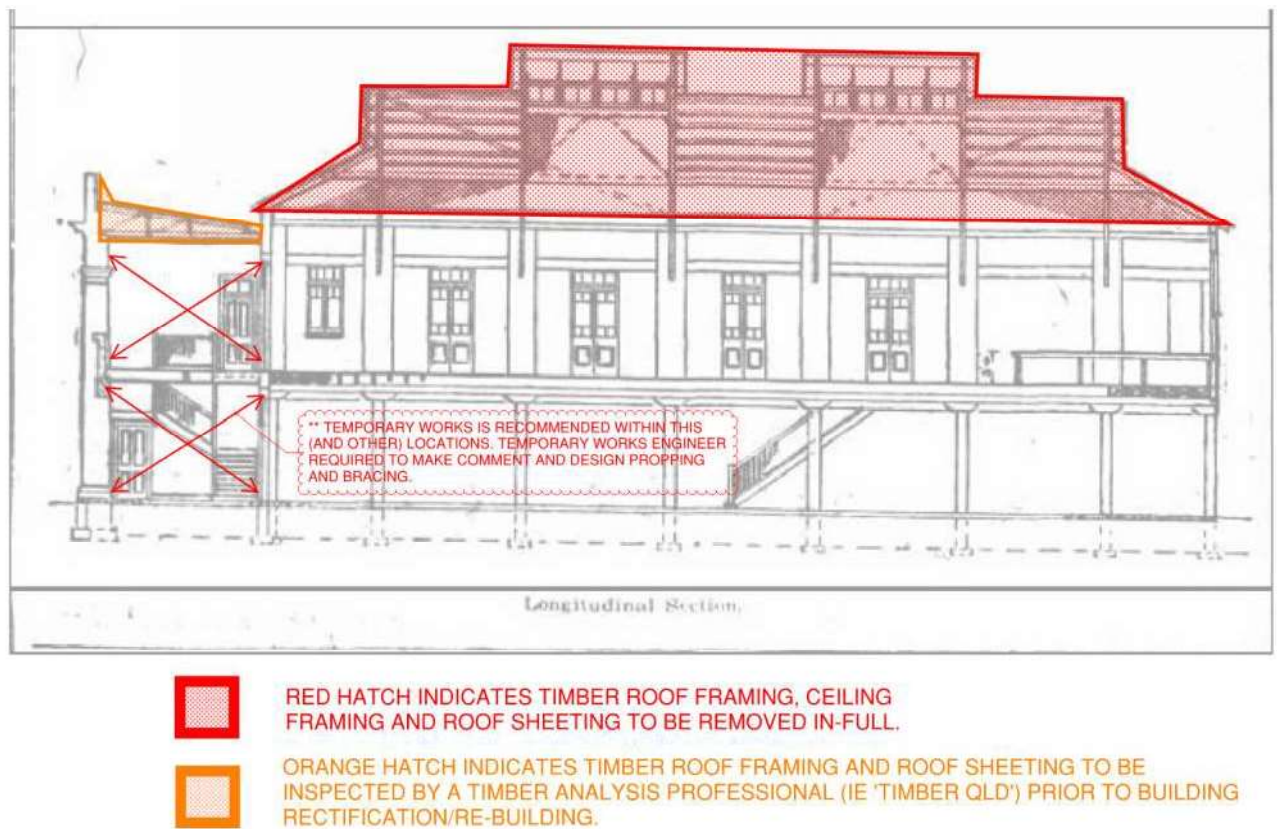
We recommend the full extents of the building's timber roof framing and roof sheeting be demolished and removed from site, refer Figure 2. During the fire event, the majority of the roof collapsed. At the time of inspection, it was unsafe to be under and around the location of the collapsed roof as several damaged elements appeared to be at risk of further collapse.

The below Figure 2 identifies in red hatch, the extents of roof framing and sheeting to be demolished and removed in-full. Following primary demolition works and a building 'make-safe', we recommend the location identified with orange hatch to be further inspected and analysed for localised damage, compliance with relevant Codes and Standards, and ability to support the Hubert Street clay masonry façade and parapet wall.

**\*\*Note:** The below Figure 2 is an illustration from 1925, and therefore may not convey the current layout and or profile of the roof and building prior to the fire event. At the time of inspection, we observed several locations about the Lush building had been renovated and altered from the original layout shown in the 1925 documents.

Figure 2 – Extents of Roof Framing and Roof Sheetting to be Demolished and Removed Due to Excessing Damage.

**Safety Note** – As the roof framing and sheeting appears to provide lateral support for several Upper-Level walls and beams, we strongly advise that a temporary works engineer provide a propping plan/layout to support each and all of the Upper-Level walls prior to, during and following demolition. Further, we believe the roof structure would be providing a 'diaphragm bracing' action to the building to resist loads and pressures. Once the roof is removed, we strongly recommend a temporary works engineer provide a temporary diaphragm bracing solution to the building in-full.

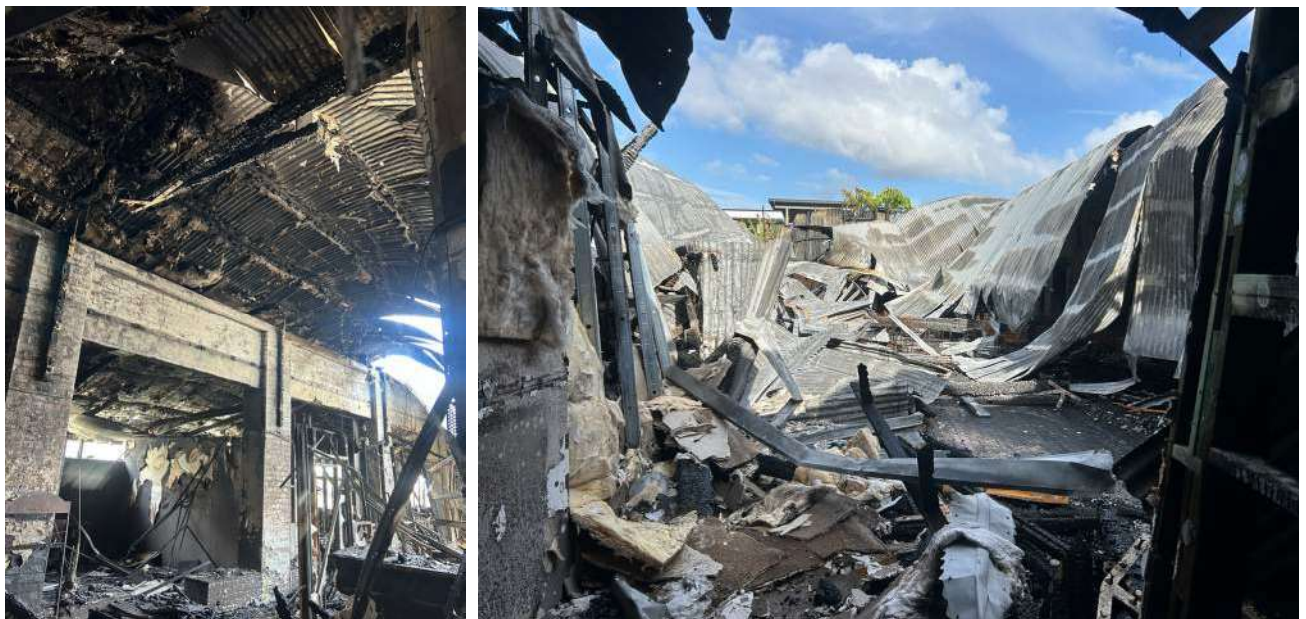
Figure 3 – Photos Taken Post Fire Event, Showing Full Roof Collapse and Extents of Damage.

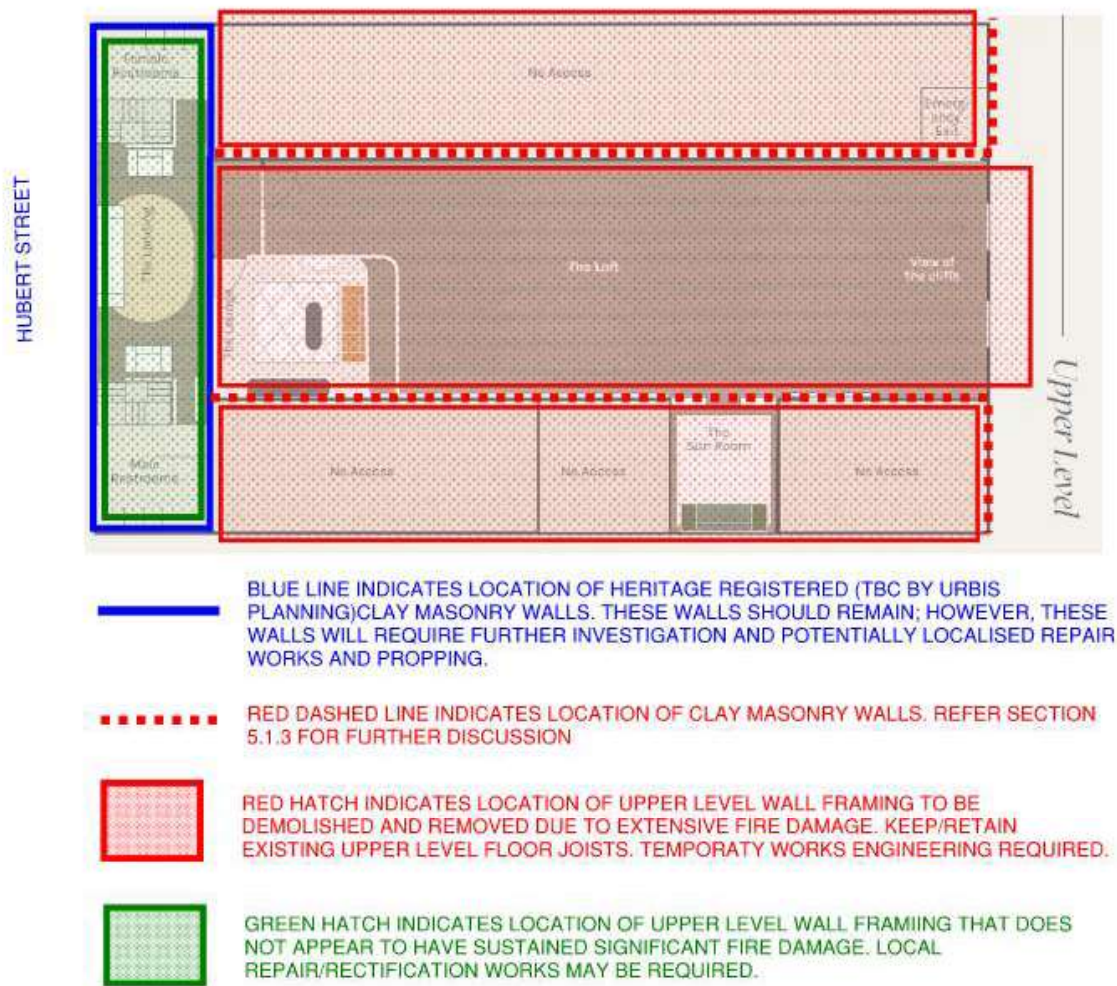
We recommend the full extents of the building's Upper-Level lightweight timber wall framing be demolished and removed from site, refer Figures 4 & 5. This will include the north and south external loadbearing façade walls (including non-structural glazing) and all internal non-loadbearing partition walls. The below Figures 4 & 5 identifies the extents of wall demolition required to the Upper-Level.

Figure 4 – Upper -Level Floor Plan, Identifying Locations of Timber Wall Framing to be Demolished/Removed.

**Safety Note** – As the roof framing and sheeting appears to provide lateral support for several Upper-Level walls and beams, we strongly advise that a temporary works engineer provide a propping plan/layout to support each/all of the Upper-Level walls. Utilising illustrations from 1928, we assume most of the timber framed walls and cladding to the upper level are from the 'original profile/facade' of the building; however, due to extensive fire damage, it is our professional opinion as RPEQ structural engineers, the timber framed walls and cladding to the Upper-Level are structurally compromised beyond repair and pose a significant safety concern due to the risk of collapse.

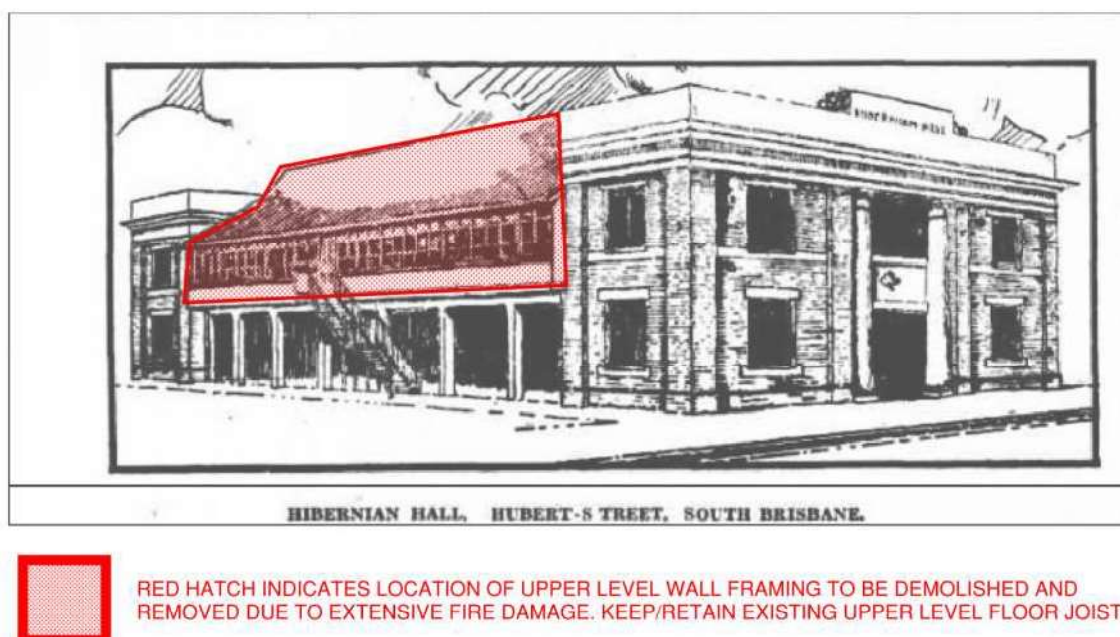
Figure 5 – Illustration of the South Elevation, Hatch Indicating Extents of Wall Framing to be Demolished.

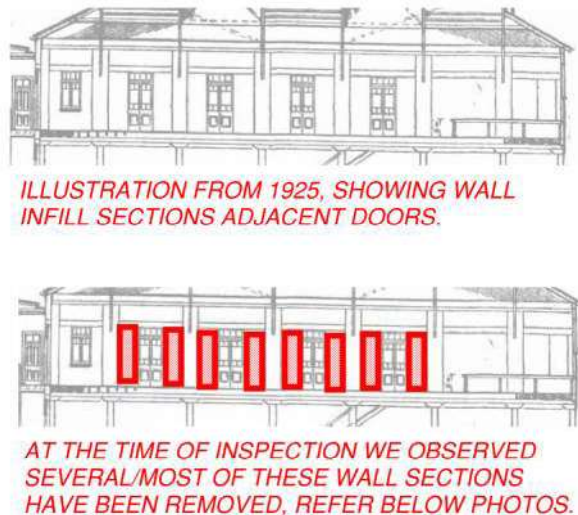
As part of this report, we have undertaken a desktop study on several structural elements. During this study, we have identified that large sections of the original clay masonry walls have been removed. We believe the sections of walls that have been removed were likely to be structurally load bearing and contributing to the lateral stability and overall bracing of the building. The concrete lintels above these locations appear to be unsupported and should be temporary propped until further assessed, or similar to the discussion regarding brick walls discussed in section 5.1.3, consideration should be given to demolition of these walls.. We recommend having an RPEQ structural engineer assess the overall stability of the building, as additional strengthening may be required to mitigate the removal of these walls, refer Figures 6 and 7.

Figure 6 – Upper -Level Clay Masonry with Sections of Clay Masonry Walls Removed Prior to Fire Event.

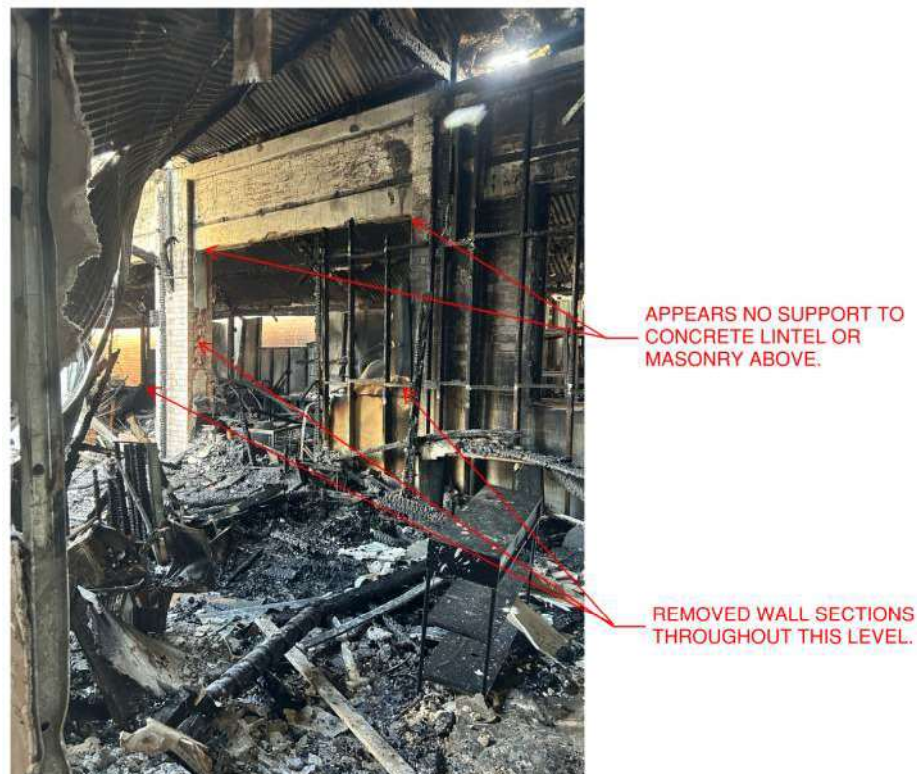
Figure 7 – Upper -Level Photo, Showing Evidence of Clay Masonry Walls Removed in Several Locations.

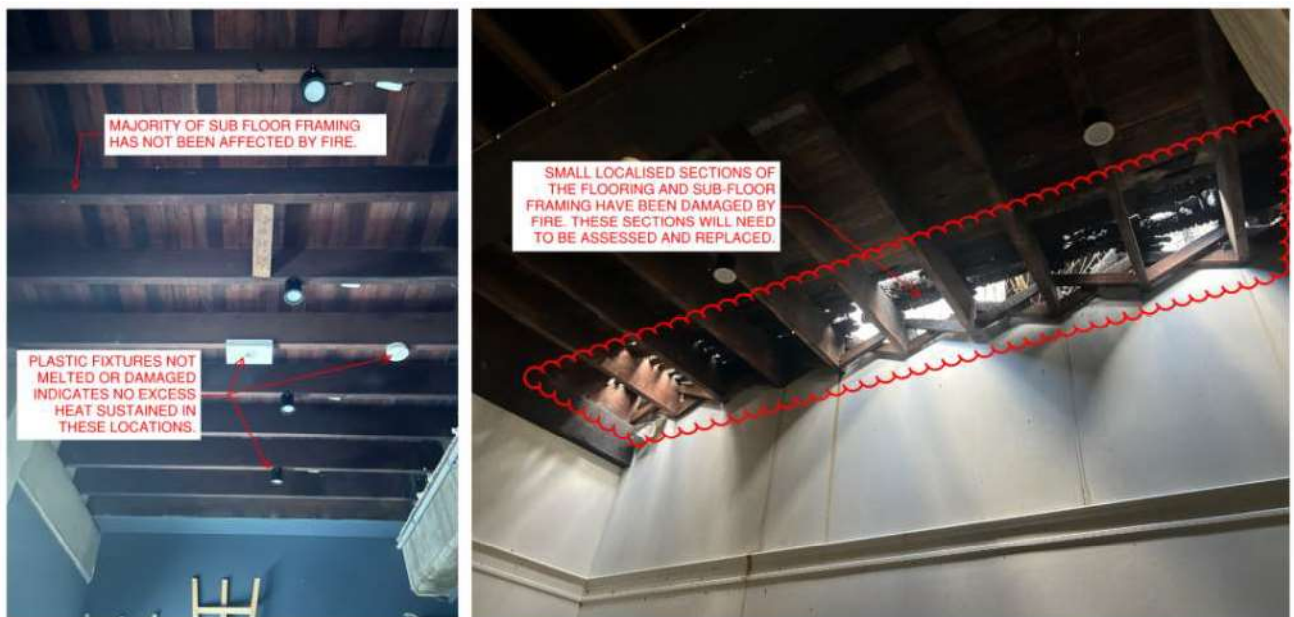
At the time of our inspection, we were able to walk-through and inspect the full extents of the Lower-Level. Inspecting from the Lower-Level, we were able to review the majority of the Upper-Level floor joists, floor bearers, nogging, bracing, floorboards and general floor framing. We do not believe the Upper-Floor framing has significantly been affected by fire or heat to the extent that any substantial demolition is required. However, we can confirm that small/local sections of the floorboards and floor framing have been burnt and charred. We believe these small, damaged locations can be locally assessed and replaced with new members. We assume that any replacement of timber floor joists would need to appear 'similar' in size and profile and should be confirmed for adequacy by a professional heritage consultant in conjunction with an expert in timber analysing. We recommend any replacement of timber sub-floor members should be designed by an RPEQ structural engineer.

Figures 8 & 9 – Upper -Level Sub-Floor Timber Framing, Figure 9 Shows Small Localised Damage to Joists, Nogging and Flooring.

**Safety Note** – As this report is our findings from a 'high level' inspection, we did not undertake any testing of materials, nor did we remove any materials for off-site testing. We recommend having a timber analysing expert assess the remaining (non-demolished, non-damaged) timber to confirm that it has not been affected by excessive heat of damaged during the demolition phase, in similar projects we have engaged Timber Qld to undertake this assessment. We recommend an RPEQ structural engineer oversee all redesign and rebuild works.

We recommend having the Upper-Level timber sub-floor framing which is proposed to be retained is further assessed by a timber analysis expert. We recommend Timber Queensland for this work.

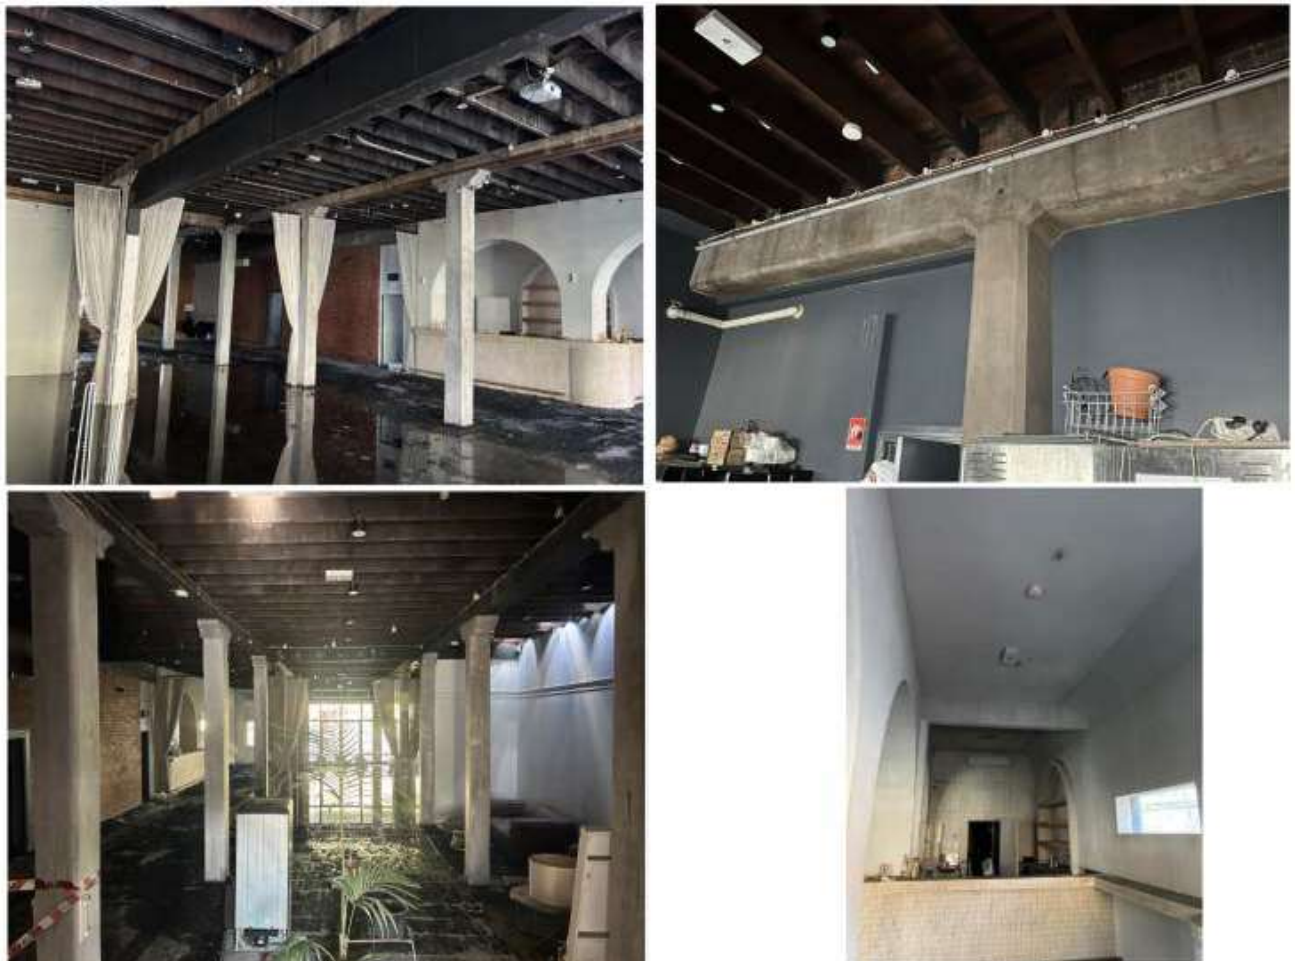
Throughout the entire Lower-Level we did not observe any location that had been significantly damaged or structurally compromised by the fire event (not including the damaged floor joists and flooring to the Upper-Level).

Figures 10, 11, 12 & 13 – Lower-Level Structural Elements, Mostly Undamaged/Unaffected by Fire.

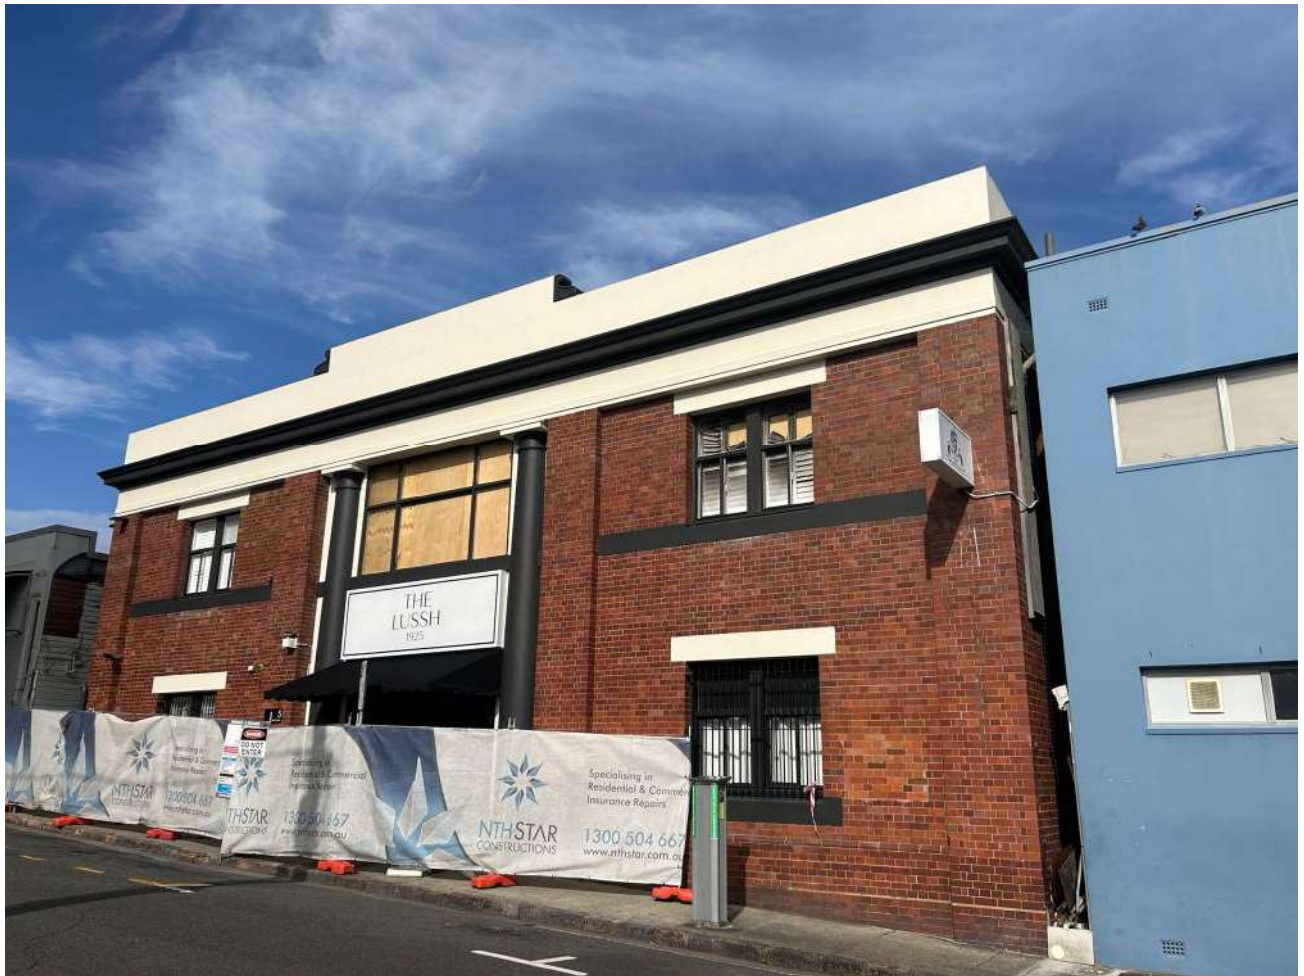
At the time of our inspection, we did not observe any significant structural damage caused by fire to the Hubert Street front facade. This front façade is a double-height double-skin clay brick masonry wall, with door and window openings. Two double-height concrete facade columns are located adjacent the front entrance.

We did observe heat damage to the blinds/furnishings in one window, and ply hoarding across another window opening. However, we consider each of these elements to be non-structural and thus not relevant to this report.

*Figure 14 – Hubert Street Front Building Façade, Structurally Undamaged from the Fire Event.*

**Safety Note** – As discussed in Chapter 5.1.1, the timber roof framing that provides lateral support to this front facade clay brick wall will need to be further assessed following initial demolition works. We recommend a temporary works engineer assess the stability of this front façade wall prior to, during and following demolition works.

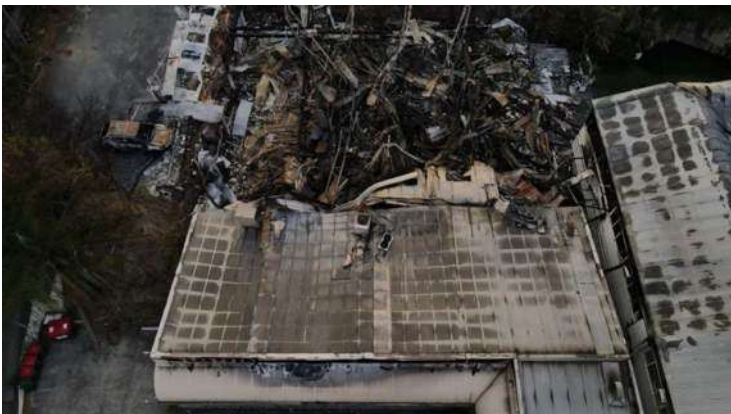
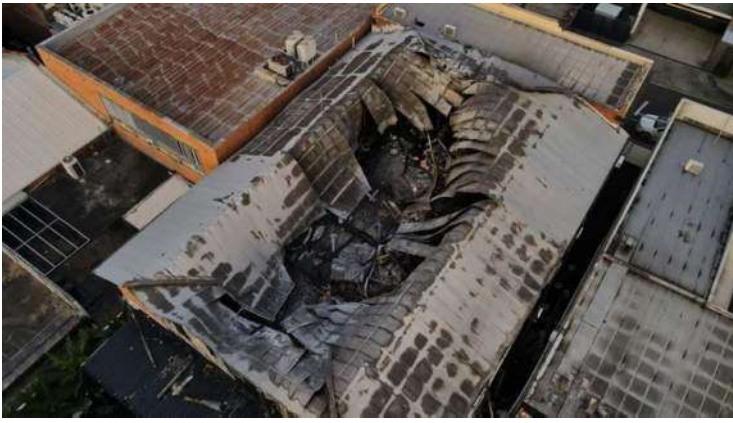
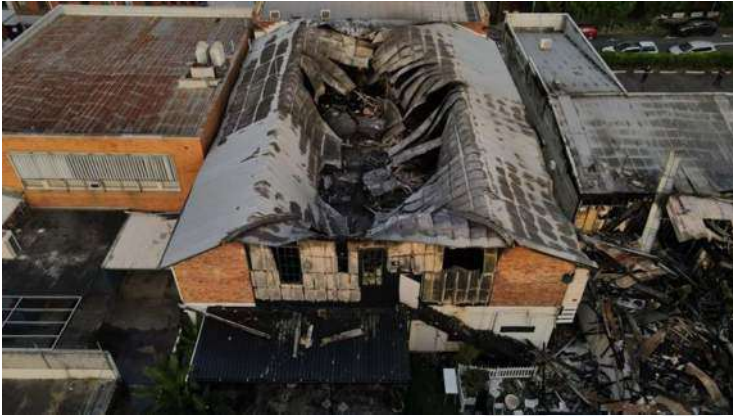
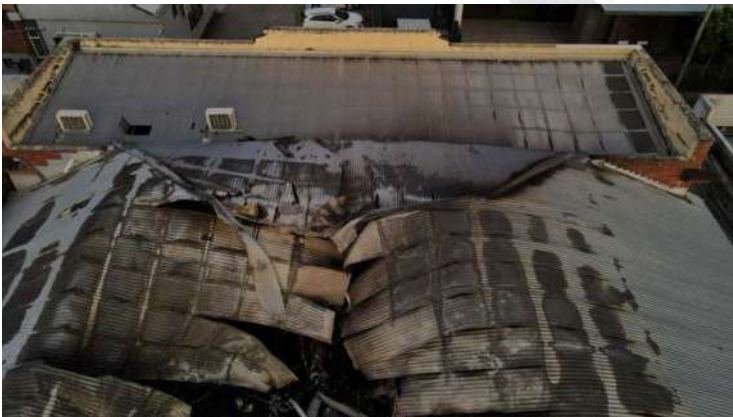
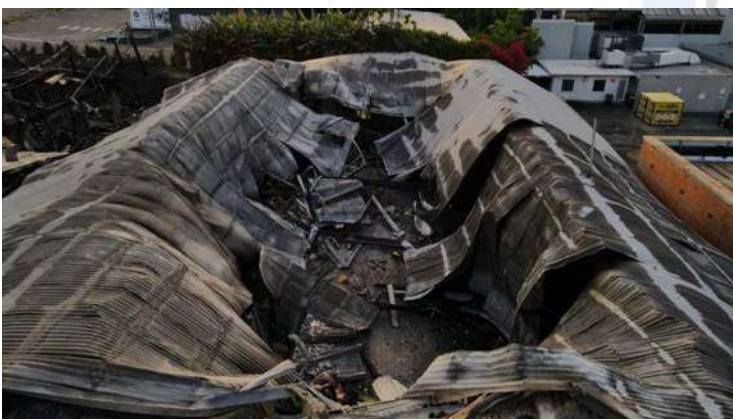
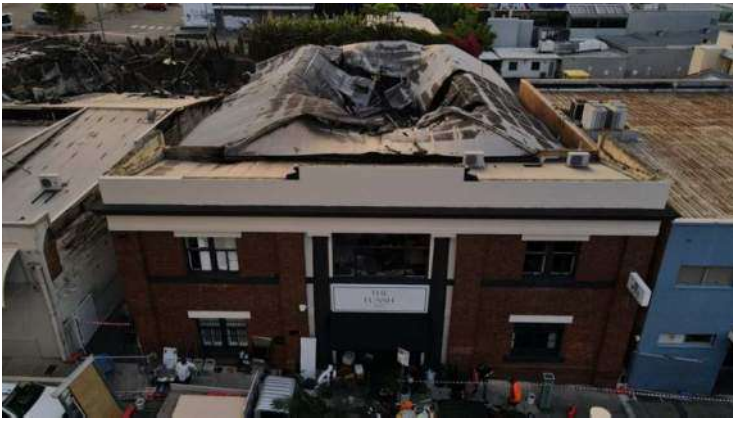
The property is potentially facing a total loss due to the extensive damage sustained. Unfortunately, we were unable to gain full physical access to the rear section of the property, which limits our direct assessment of the damage in that area. As a result, we are relying on aerial drone footage to make preliminary observations. The drone images provide a general view of the condition of the

Description: Drone Image of Damage

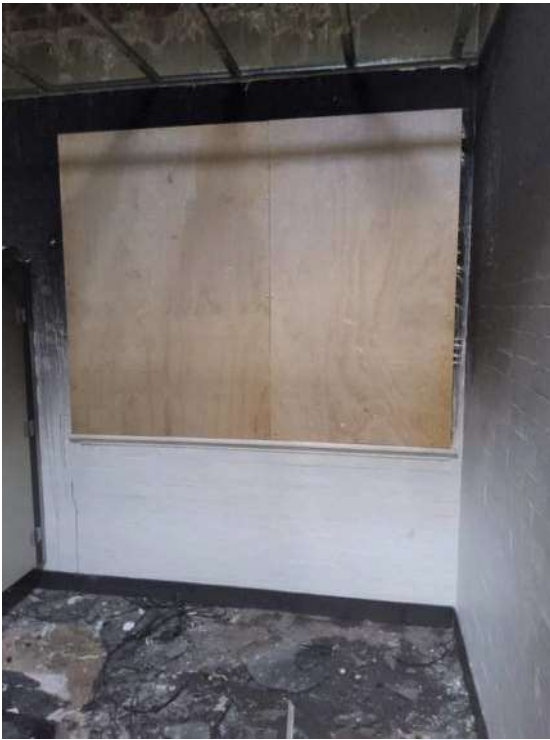
ID: 12

Description: Window boarded up from inside to prevent access

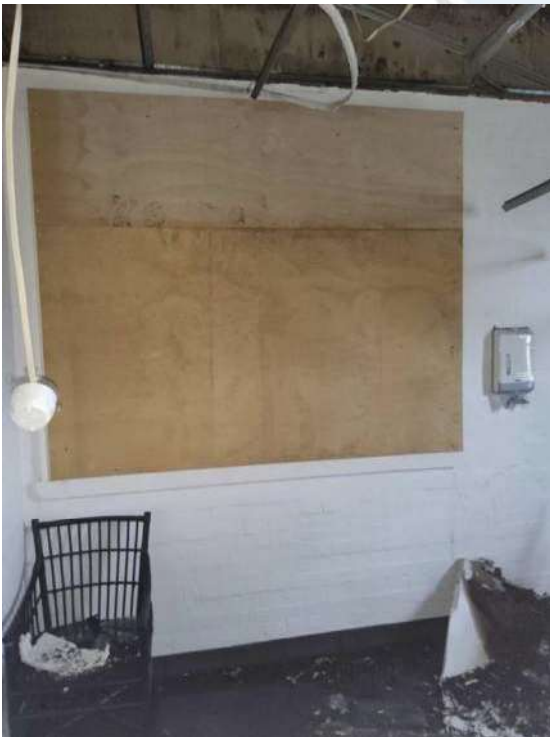
ID: 13

Description: Window boarded up from inside to prevent access

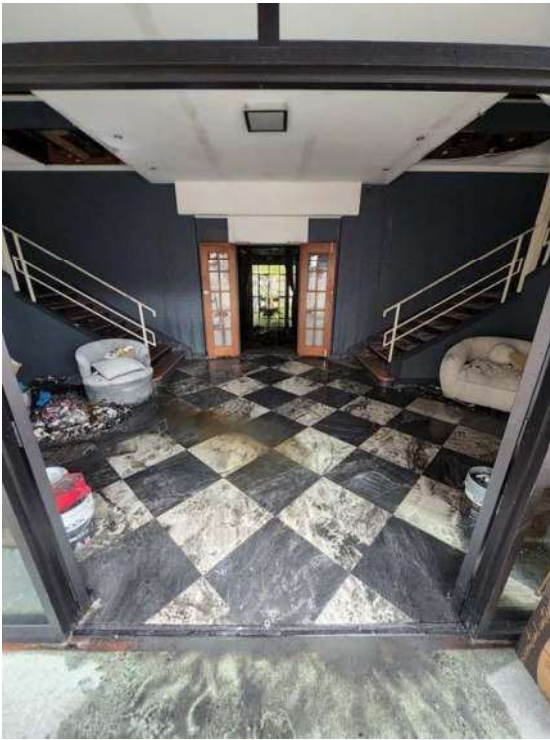
ID: 14

Description: Internal area cleaned and removed for safe access to different locations
