***BROADWAY HOTEL***  
**WOOLLOONGABBA**

CONSERVATION MANAGEMENT PLAN

Prepared by  
IVAN McDONALD ARCHITECTS  
for  
BROADWAY PROJECTS QLD PTY LTD

OCTOBER, 2022

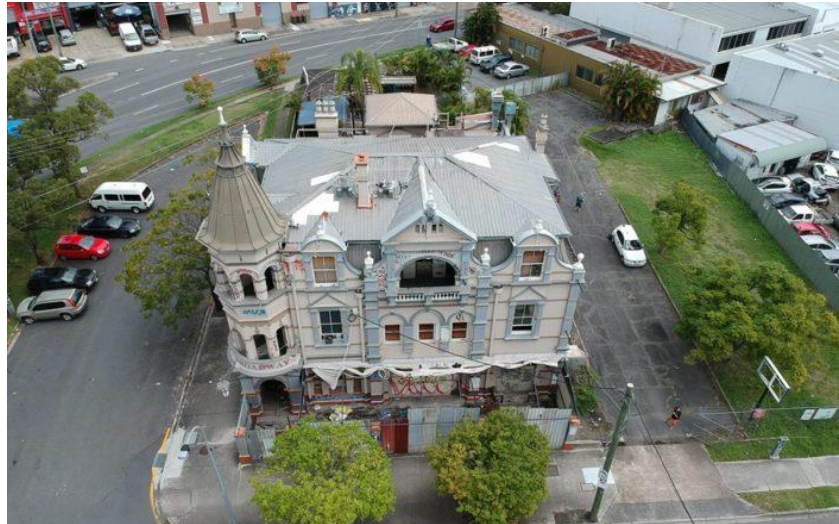
**Figure 25** Aerial view of the Broadway Hotel after the 2010 fire  
Source: Cr Jonathan Sri for the Gabba Ward/Facebook

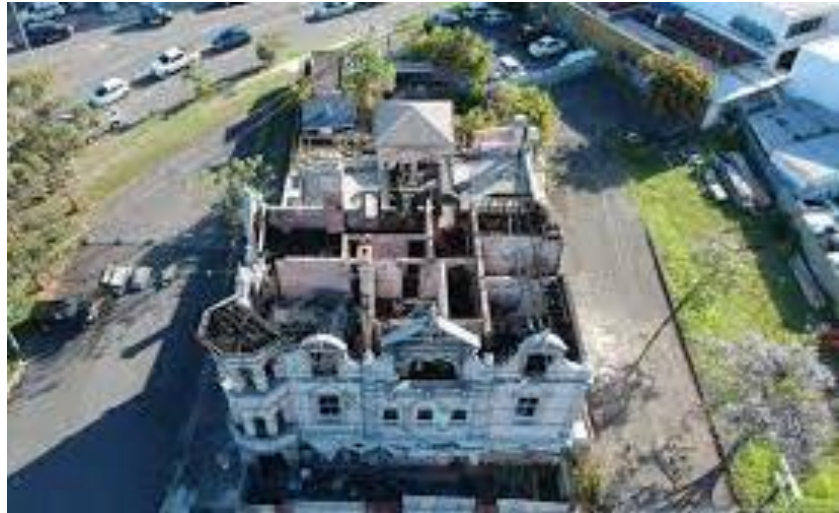
The fire collapsed the entire main building roof structure including the corner turret's spire and seriously damaged the remaining timber floor structures and internal finishes. The rear two-storey wing and the 1980s beer garden structures were also extensively damaged. An aerial view of the hotel after the 2018 fire is shown at **figure 27**.

**Figure 27** Aerial view of the Broadway Hotel after the 2018 fire  
Source: Brisbane Times (Jesse Harrison)

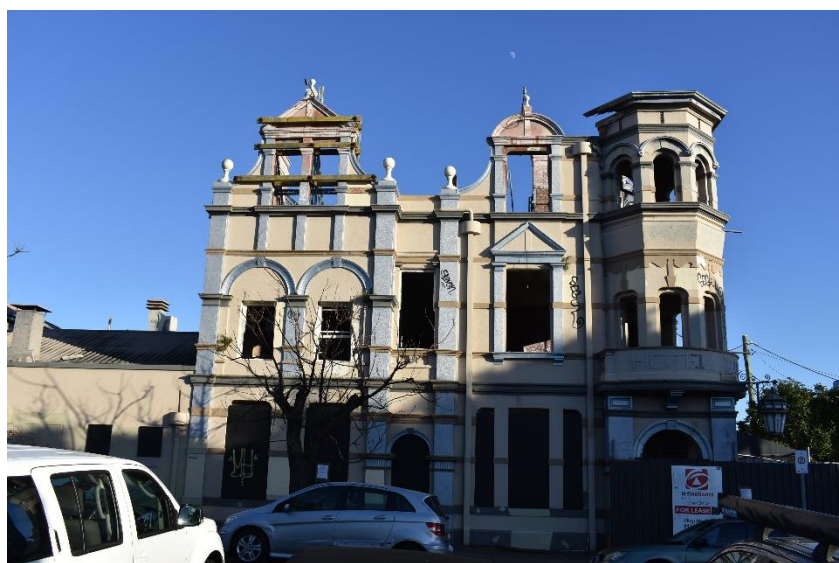
In 2022, the *Broadway Hotel* was purchased by Broadway Projects Qld Pty Ltd. The building is currently vacant, derelict, flooded and extensively damaged as shown generally at **figures 28 – 35**.

**Figure 28** Balaclava Street view of the Broadway Hotel in 2022

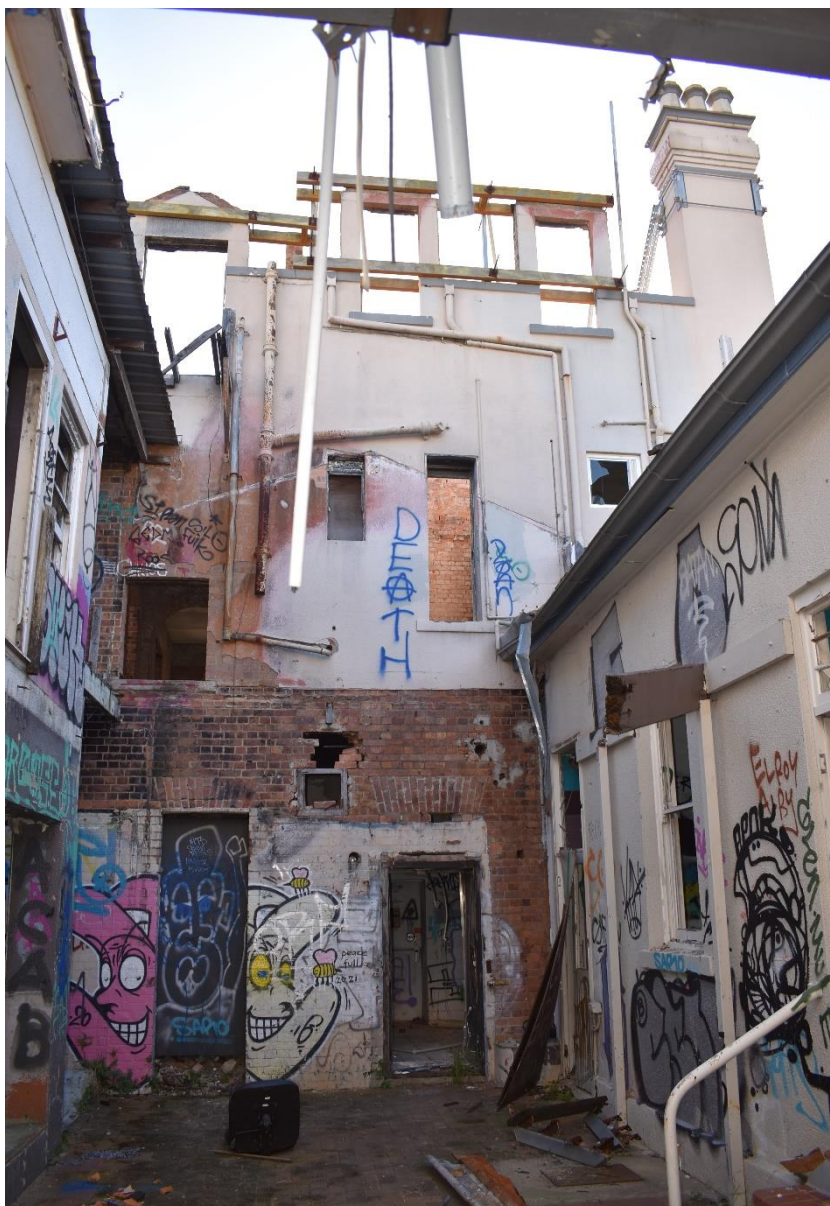
Figure 29 The rear courtyard in 2022

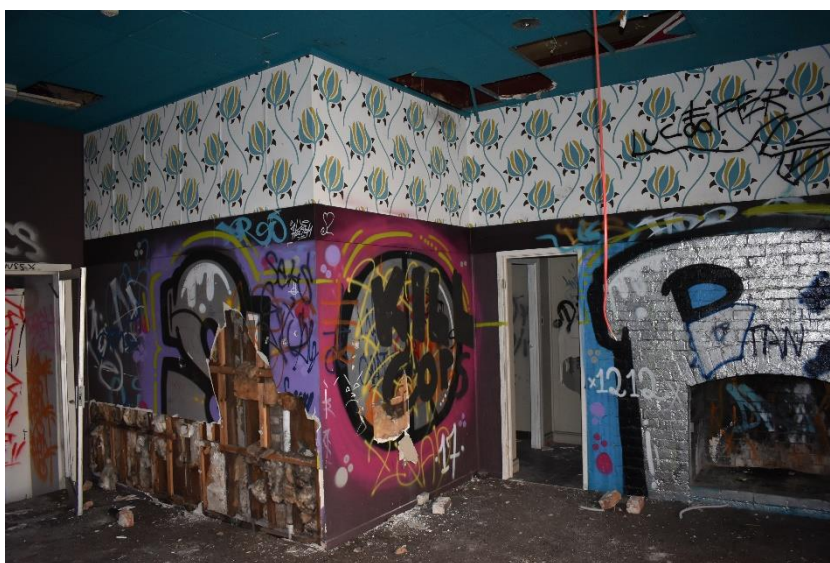
Figure 30 Interior of the rear single-storey wing in 2022

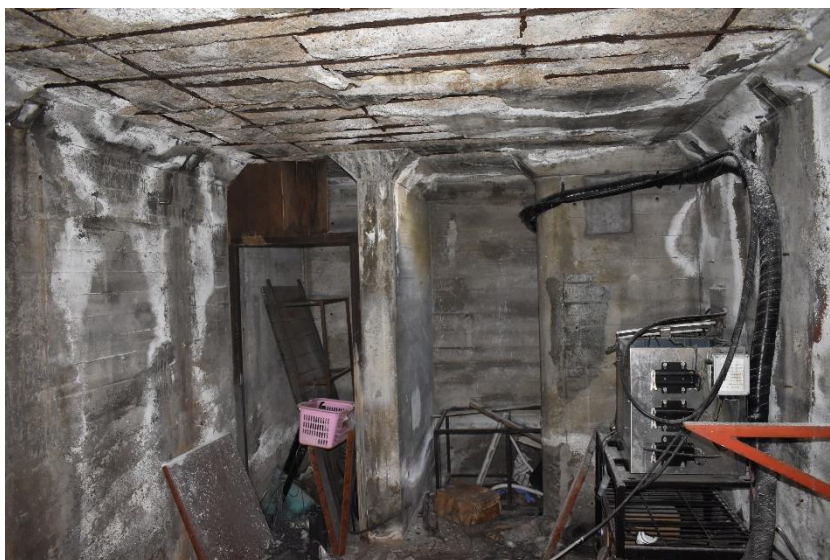
Figure 31 Interior of the 1942 air raid shelter in 2022

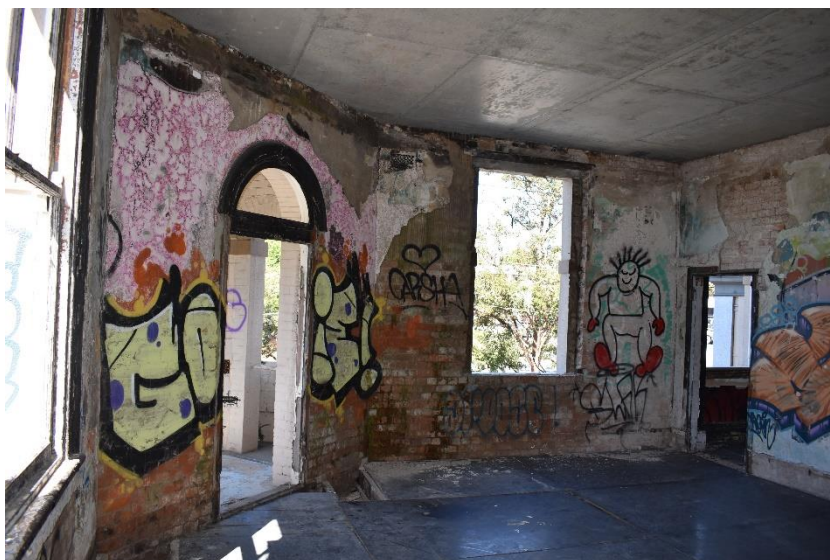
Figure 32 First floor corner room in 2022. Note the recent suspended concrete second floor slab above.

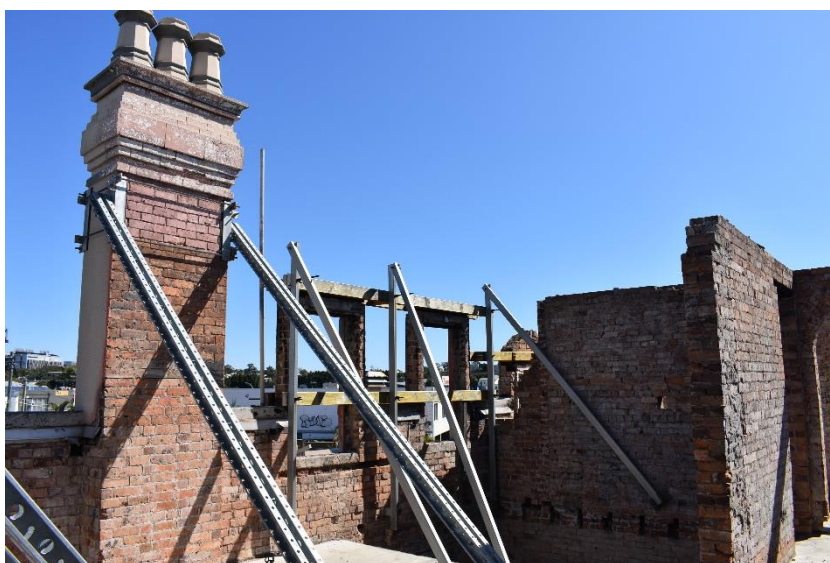
Figure 33 Second floor rear wall in 2022

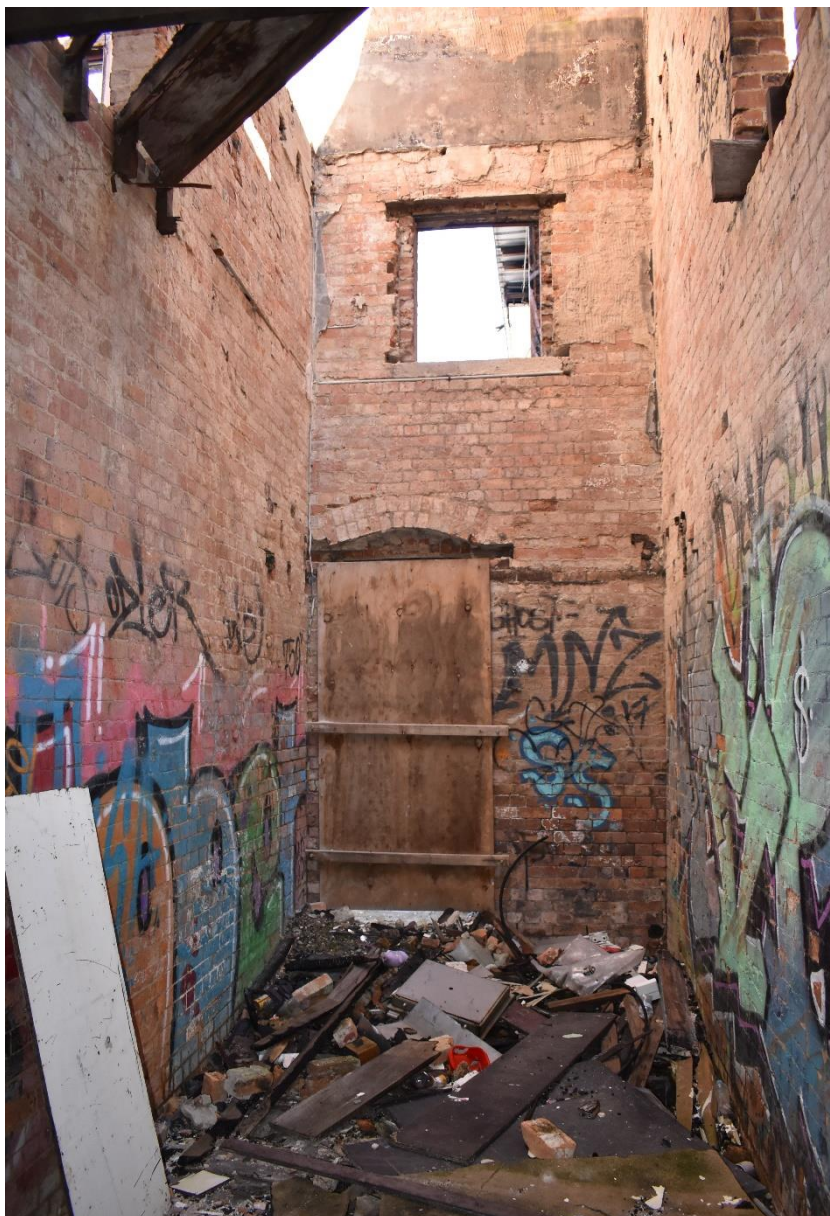
Figure 34 Ground floor stairwell in 2022

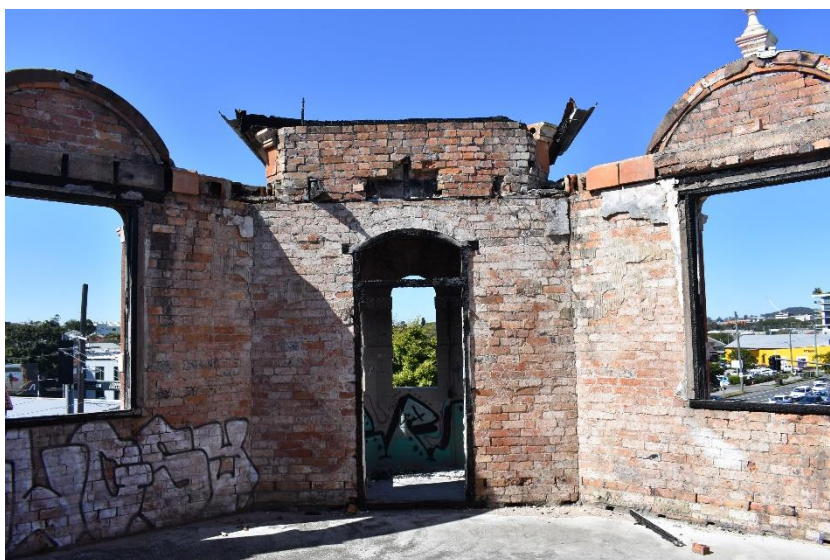
Figure 35 Second floor corner room and turret remnant in 2022

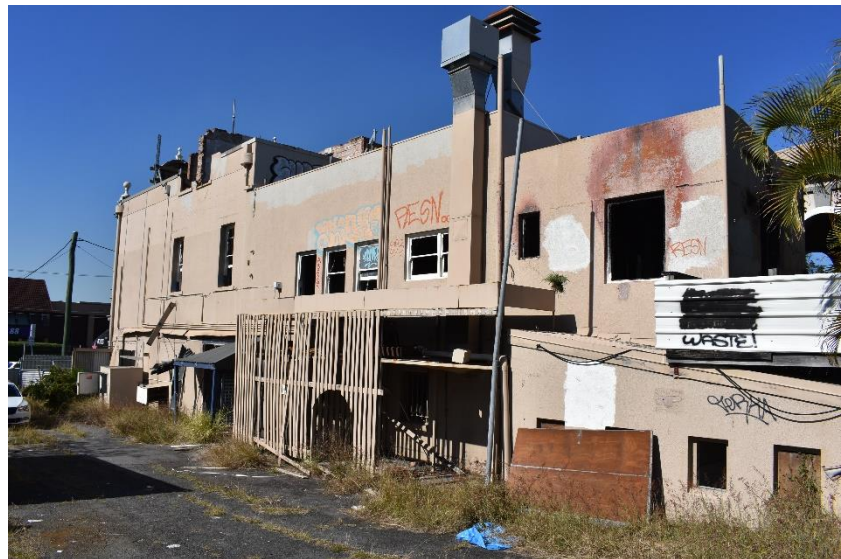
Figure 101

The early (but not original) two-storey rear wing (G12 & F11) was extensively altered in 1958 and the late-1980s by conversion to the hotel kitchen (firstly on the first floor in 1958 and then on the ground floor in the late-1980s). The original hip roof evident in the **figure 5** aerial photograph was replaced with the current parapeted skillion roof in 1958. The original L-shaped verandahs shown on the 1922 detail plan at **figure 2** were also replaced with the current G11 & F10 landings in 1958. The current rear toilets (G13-G15) and former staff dining room (F12) were constructed in 1960 and altered in the late-1980s. This wing was severely damaged in the recent fires and generally has a very low level of intactness (**figures 53 & 101**).

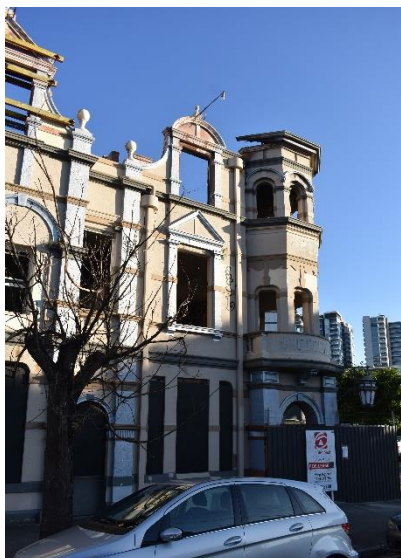
The *Broadway Hotel* can only be described as being in extremely poor condition and remains under high threat of further deterioration. **Figures 116 – 125** show the general condition of the building which is also illustrated in **section 4**.

Figure 116 Balaclava Street facade

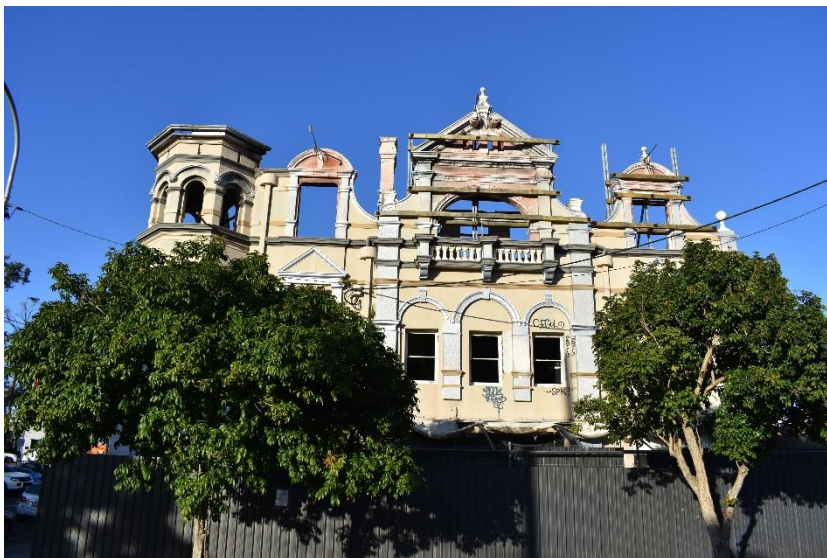
Figure 117 Logan Road facade

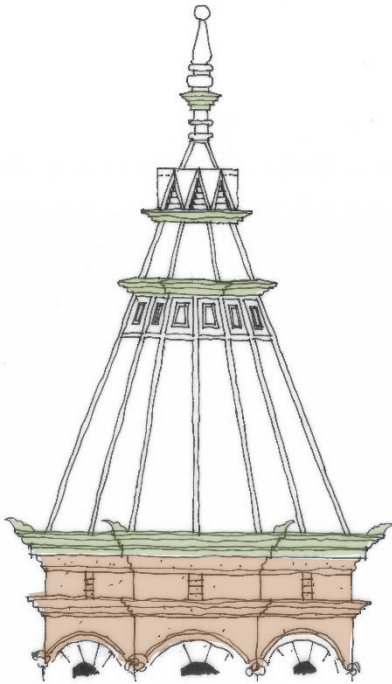
Figure 129 Turret spire

- The original corner turret spire was a steeply pitched octastyle roof with tapered “pan-and-rib”-profile galvanised sheeting embellished by sheet metal decorative bands and finial. Although the spire was destroyed by fire down to the eaves lines, sufficient documentary evidence exists on which to base an accurate reconstruction.

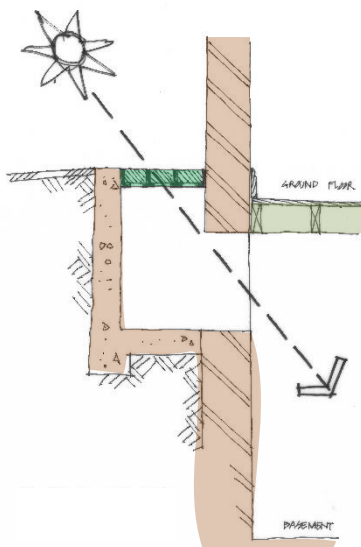
Figure 130 Basement "floor lights"

- The original basement is flooded and its condition is currently unknown. When accessible, the basement fabric should be inspected. Two original basement lights in B1 currently have non-weatherproof steel grilles at the Balaclava Street footpath level. These openings should be made weatherproof and could introduce basement "floor lights" to continue to admit light to the space. If required for an adaptive re-use, the basement floor level could be lowered to provide suitable head height, provided that existing masonry walls and cast iron columns are not undermined. Future basement access may be provided in accordance with **policy 56**.
