PLANS AND DOCUMENTS
referred to in the PDA
DEVELOPMENT APPROVAL

Approval no: DEV2025/1682

Arboricultural Report

Site Inspections Undertaken	19.03.2025 & 07.08.2025
Client	Shakti Gahlot
Site Address	28 Whipbird Place Oxley QLD 4075
Lot and Plan Number	Lot 16 on SP 322408
Report Prepared by	Tim Scott assisted by a student arborist

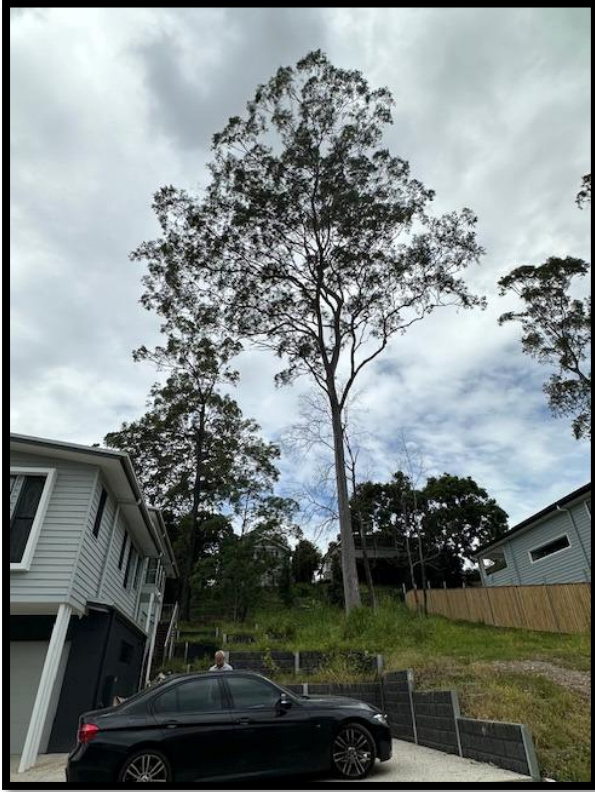
Plate 2: 19.03.2025; looking southeast at the subject tree.

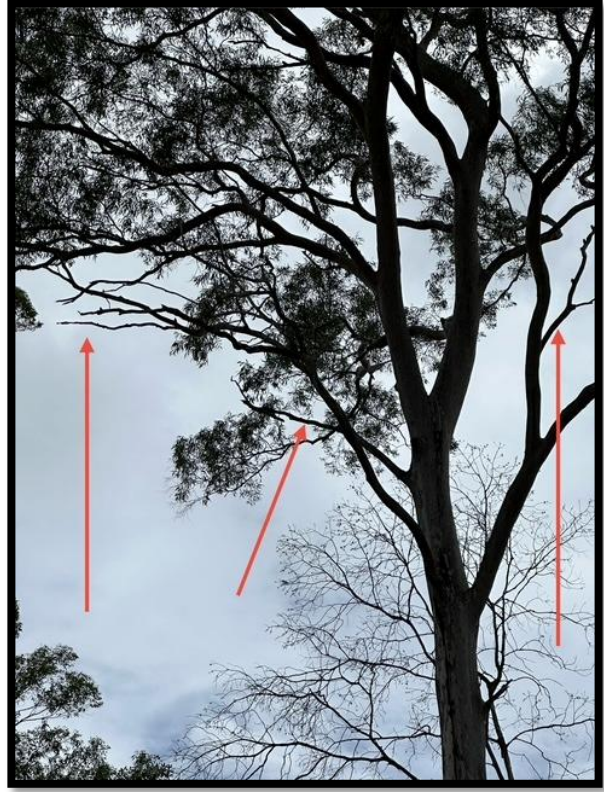
6.1 First visit: The arborist first visited the site in March 2025 and work including excavation of soil and installation of retaining walls had been completed within the TPZ and SRZ of the subject tree. There was long grass around the base of the subject tree and it was difficult to determine excavation depths, although no visible root damaged was noted, soil appeared to be raised around the trunk of the tree and the Tree Keeper was advised to remove this. The DSH of the subject tree was measured as being 785mm, the canopy of the tree held some deadwood and slight over extension of branches favoured the Tree Keepers dwelling. Minor pruning was advised, including reduction pruning of the over-extended branches and the removal of deadwood.

Plate 3: Arrows indicate deadwood.

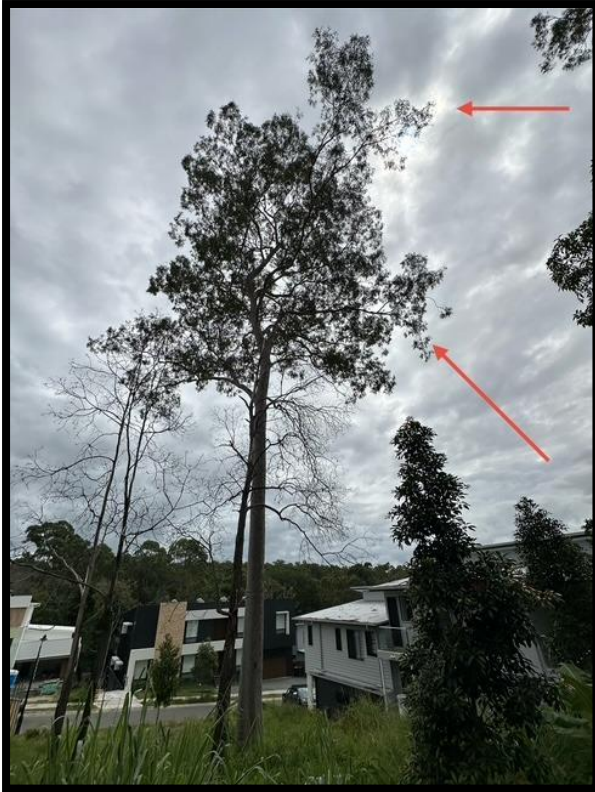
Plate 4: Note over extension in canopy.

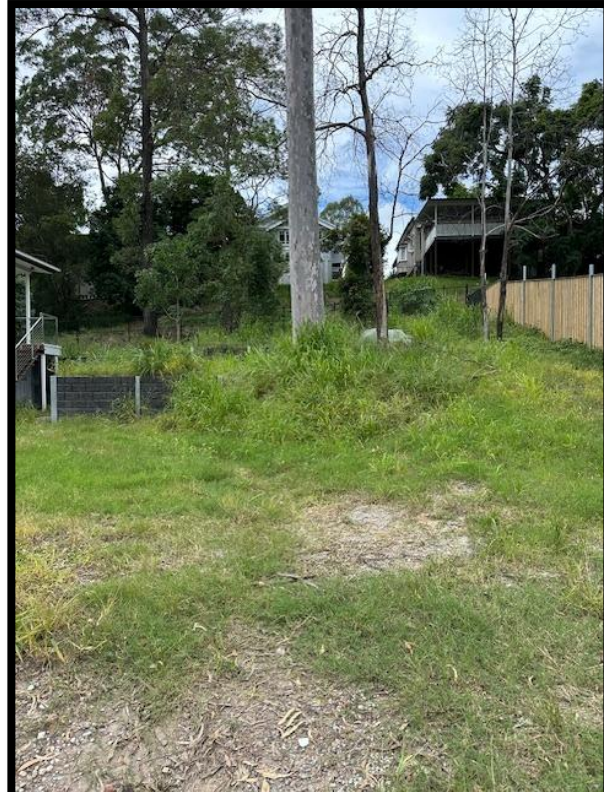
Plate 5: Long grass around the base of the subject tree.

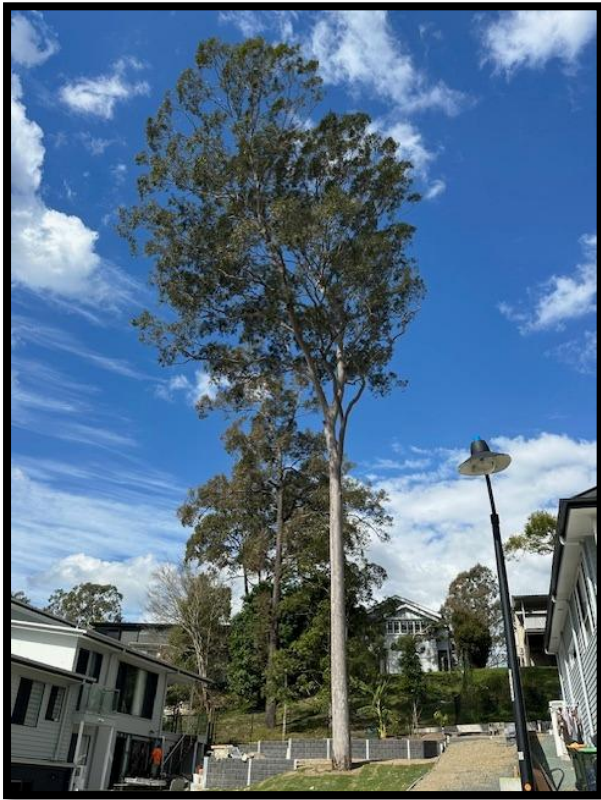
Plate 6: Looking east at the subject tree, 07.08.2025

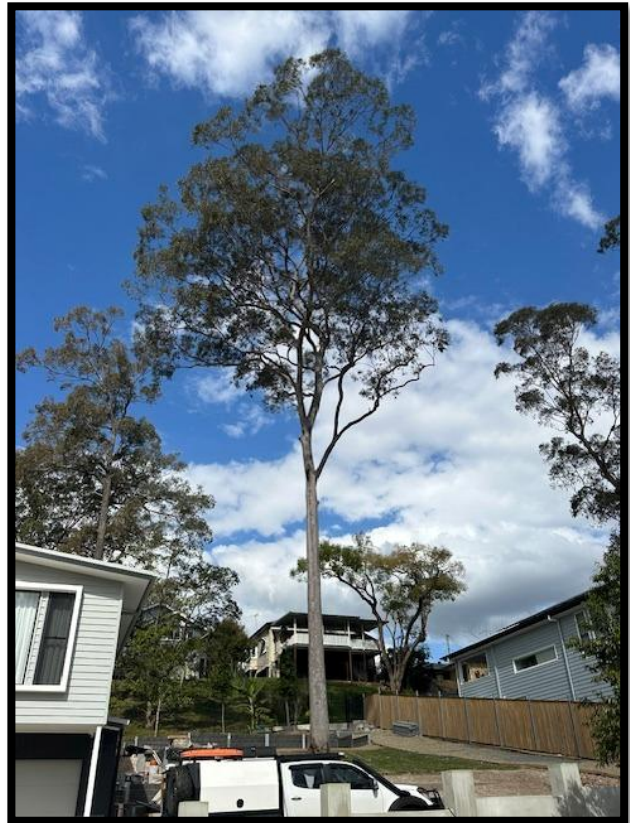
6.2 Second Visit: The arborist made his second visit to site on the 07.08.2025 under fine weather conditions. The visit confirmed that the site had been tidied and the final landscaping was near completion, turf had been installed and was being irrigated. It appeared that minor removal of excess soils and leveling and grading had occurred with the use of machinery within the TPZ, it appeared that no visible mechanical injury was sustained by the subject tree. The DSH of the subject tree measured 801mm, indicating that it is actively growing and appears to have good health and vitality. The pruning advised to be completed by the arborist, post the first visit, had been undertaken. The pruning appears to have been completed as per the Australian Standard.

Plate 7: Looking southeast at the subject tree, post pruning.

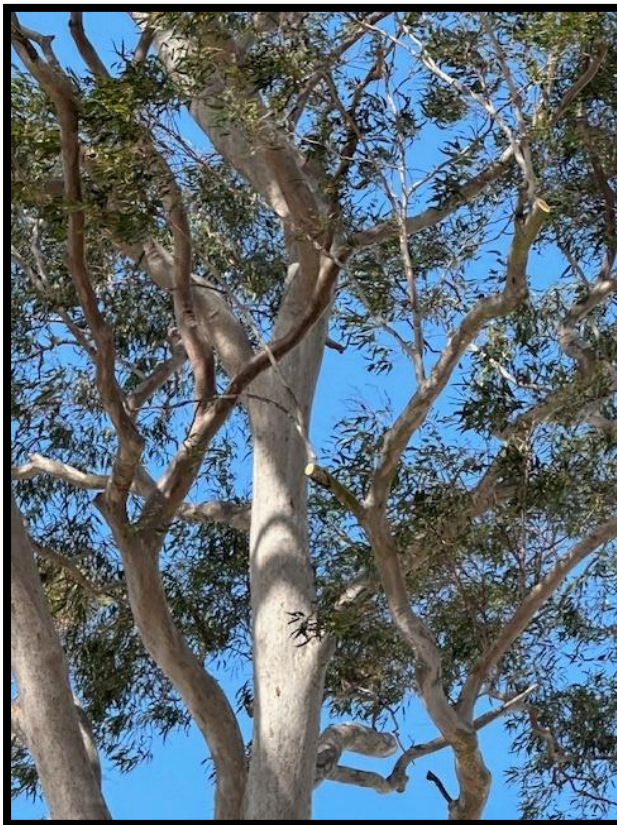
Plate 8: Small reduction cuts noted within canopy.

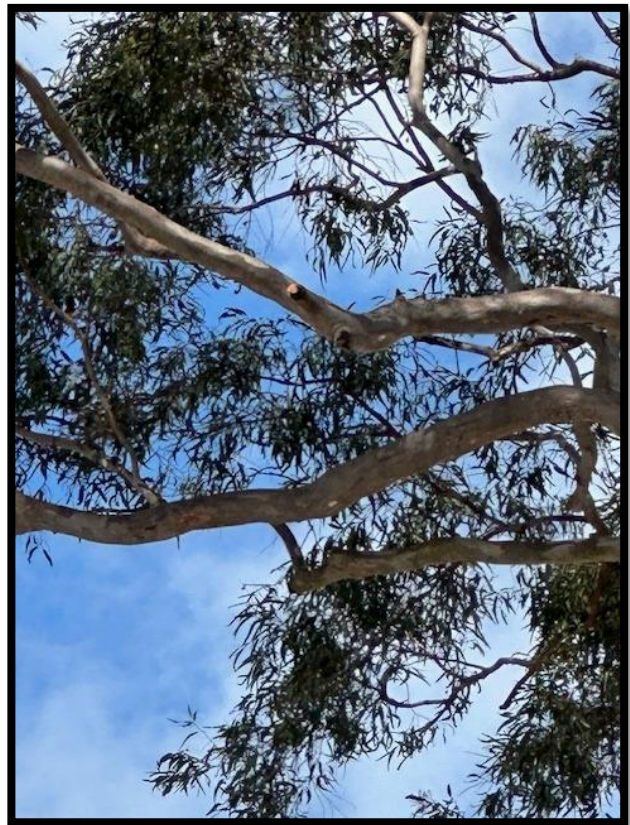
Plate 9: Small pruning cuts in northern canopy

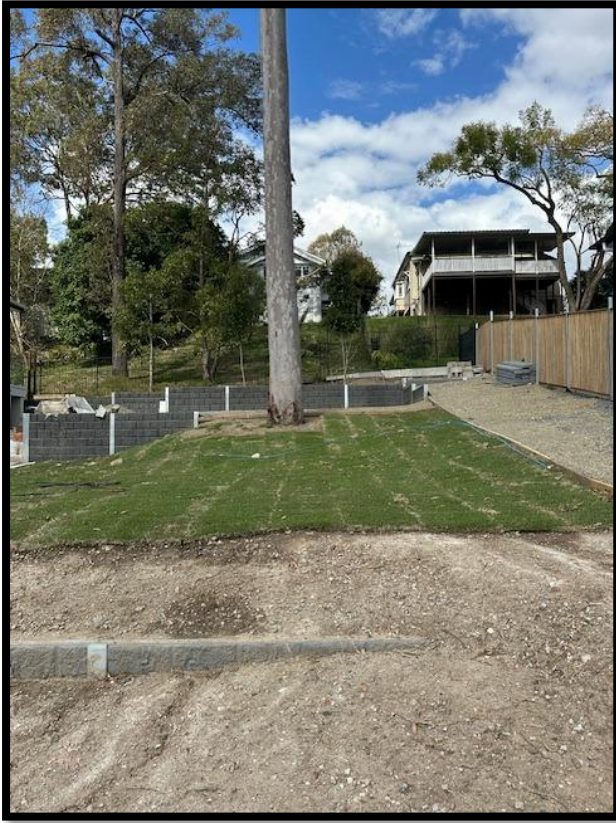
6.3 Current tree health: The tree appears to be in good health at present; however, tree decline and or damage from work undertaken within trees TPZ's can take up to 5 years to become apparent, post completion of work. As turf was being laid at the time of the site visit, it appears that no further machinery or excavation will likely occur within the TPZ, thus no TPZ fencing is advised to be installed. However, should any work, other than minor landscaping work, be planned within the TPZ, an AQF Level 5 Arborist must be consulted and be onsite to supervise work.

Plate 10: Turf being laid.

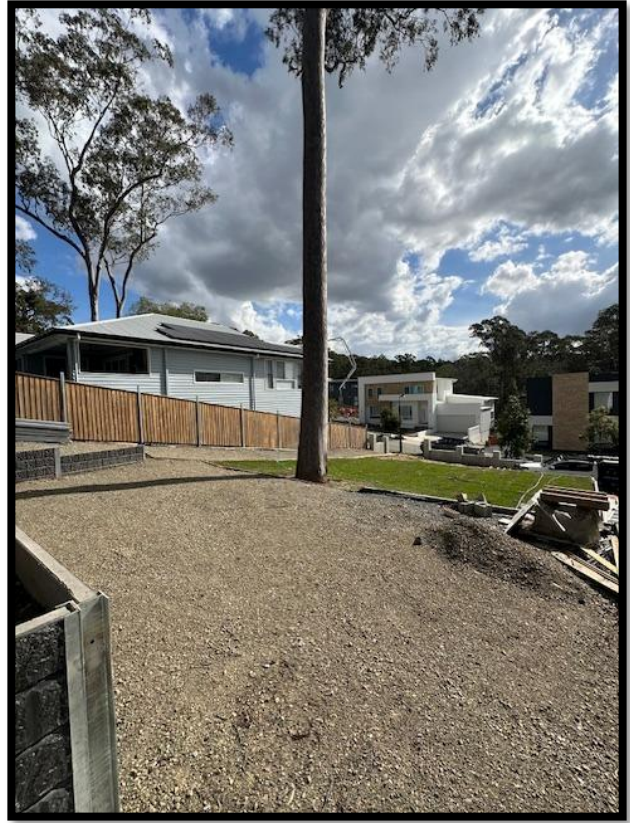
As stated previously, the arborist was not engaged to supervise work on site alongside the subject tree. This work likely included grade changes, benching and leveling and or excavation within the TPZ and SRZ of the subject tree.

The arborist was not engaged to supervise work on site alongside the subject tree. This work likely included grade changes, benching work and or excavation within the TPZ and SRZ of the subject tree.

Plate 11: Grade changes have likely occurred.

As there was no arboricultural supervision of work within the subject trees TPZ, it is recommended that the tree is inspected by an AQF Level 5 Arborist, every 6 months for a period of five years, to document any changes in its health, should they occur. Should the subject tree show signs of decline, multiple soil injections, including organic biologicals and inoculated bio-chars should be administered. The visual inspection of the subject tree will be documented and the site findings including photographs, will be provided to EDQ in a brief letter. This recommendation has been revised post communication with EDQ.

6.4 Recommendations: The arborist understands that no arboricultural supervision of work within the subject trees TPZ was undertaken and thus it is recommended that the tree is inspected by an AQF Level 5 Arborist, every 6 months for a period of two years, to document any changes in its health, should they occur. Should the subject tree show signs of decline, multiple applications of soil injections, including organic biologicals and inoculated bio-chars should be administered. The visual inspection of the subject tree will be documented and the site findings including photographs, will be provided to council in a brief letter.
