BROADWAY HOTEL WOOLLOONGABBA

CONSERVATION MANAGEMENT PLAN

Prepared by
IVAN McDONALD ARCHITECTS
for
BROADWAY PROJECTS QLD PTY LTD

OCTOBER, 2022

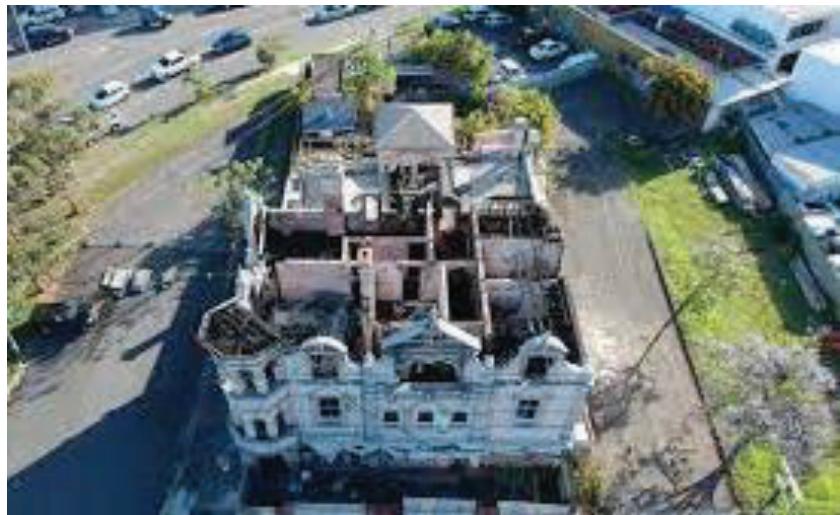
The fire collapsed the entire main building roof structure including the corner turret's spire and seriously damaged the remaining timber floor structures and internal finishes. The rear two-storey wing and the 1980s beer garden structures were also extensively damaged. An aerial view of the hotel after the 2018 fire is shown at **figure 27**.

Figure 27 Aerial view of the Broadway Hotel after the 2018 fire
Source: Brisbane Times (Jesse Harrison)

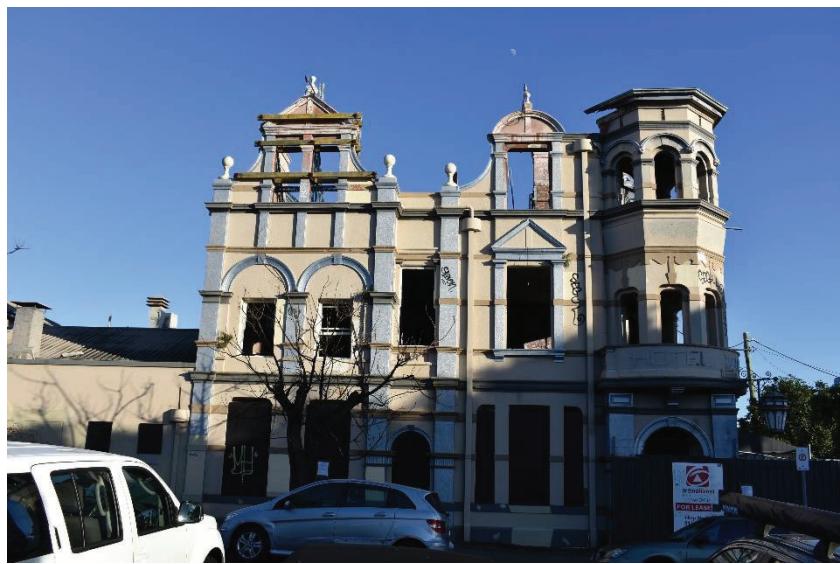
In 2022, the *Broadway Hotel* was purchased by Broadway Projects Qld Pty Ltd. The building is currently vacant, derelict, flooded and extensively damaged as shown generally at figures 28 – 35.

Figure 28 Balaclava Street view of the Broadway Hotel in 2022

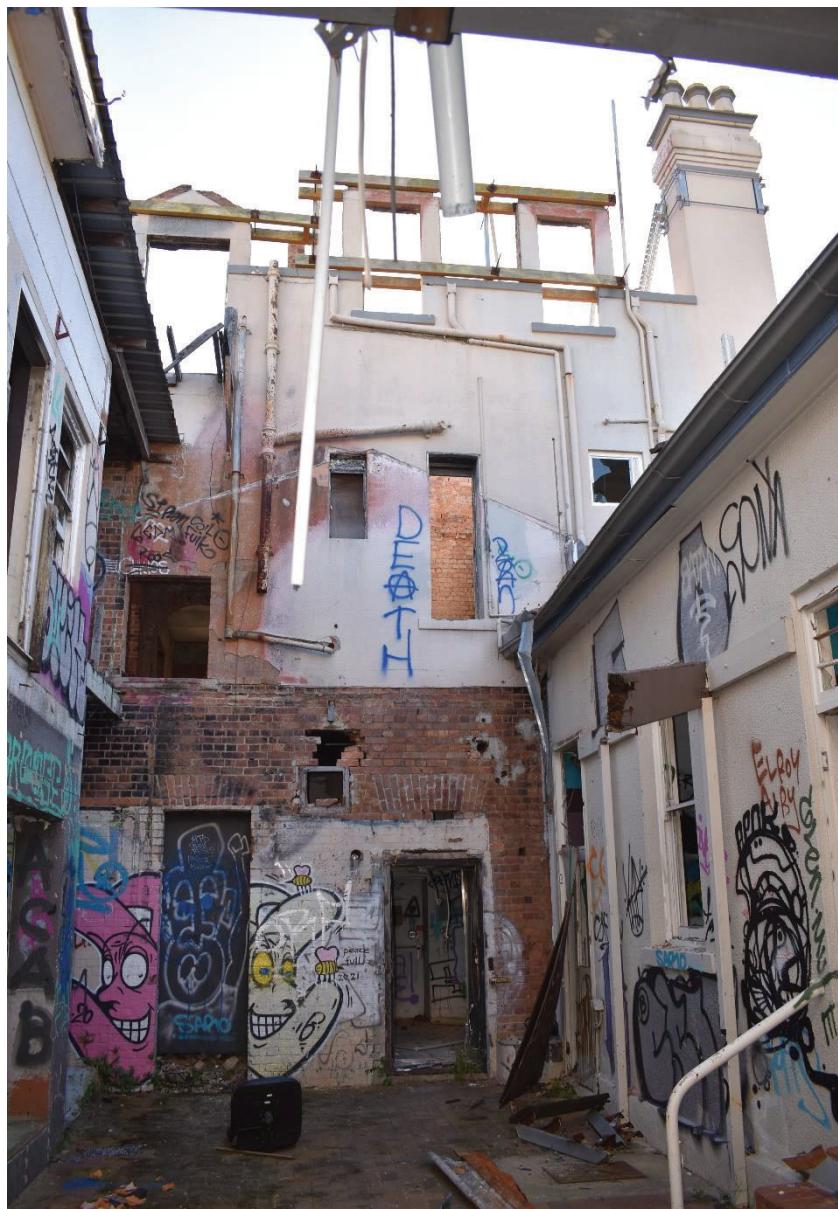
Figure 29 The rear courtyard in 2022

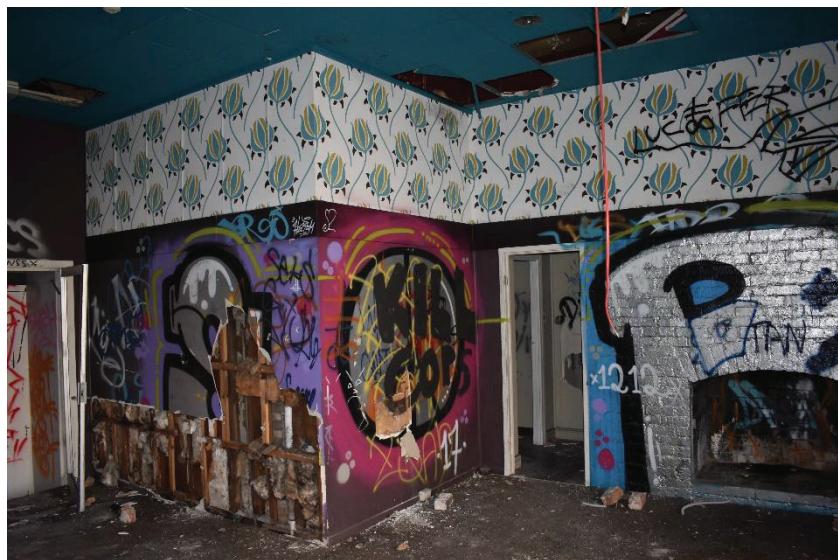
Figure 30 Interior of the rear single-storey wing in 2022

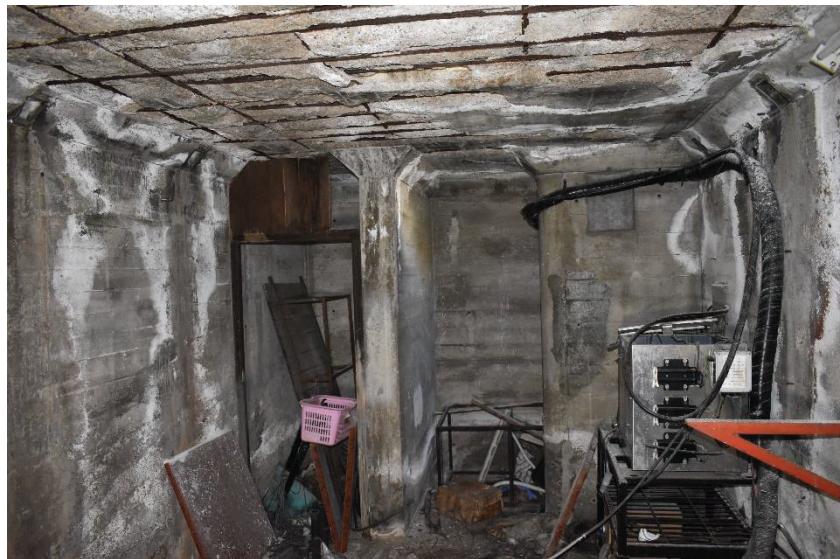
Figure 31 *Interior of the 1942 air raid shelter in 2022*

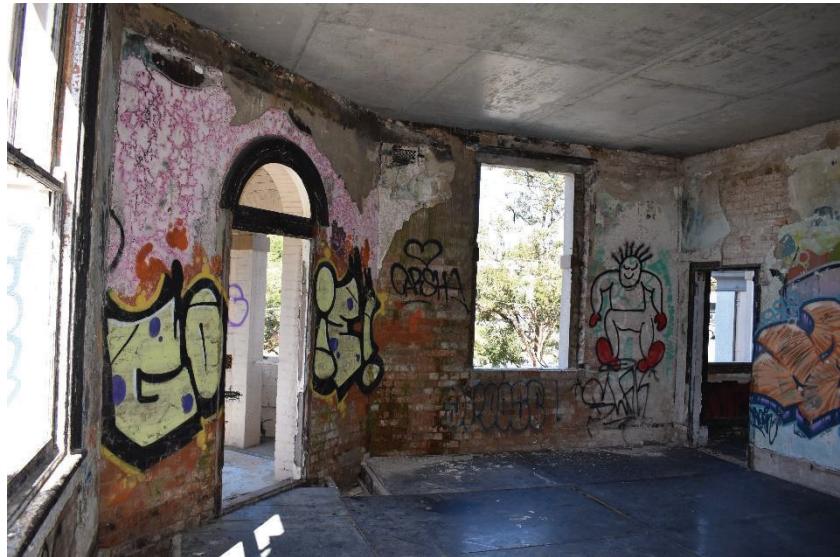
Figure 32 *First floor corner room in 2022. Note the recent suspended concrete second floor slab above.*

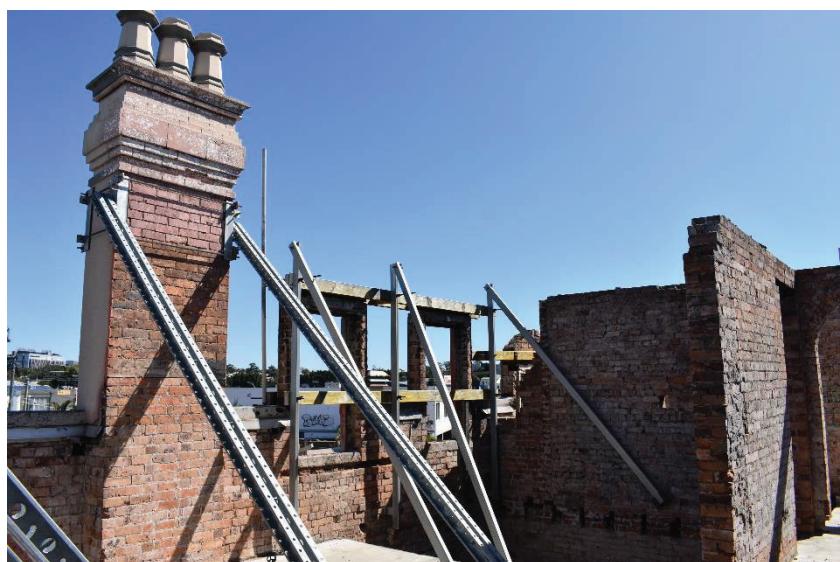
Figure 33 *Second floor rear wall in 2022*

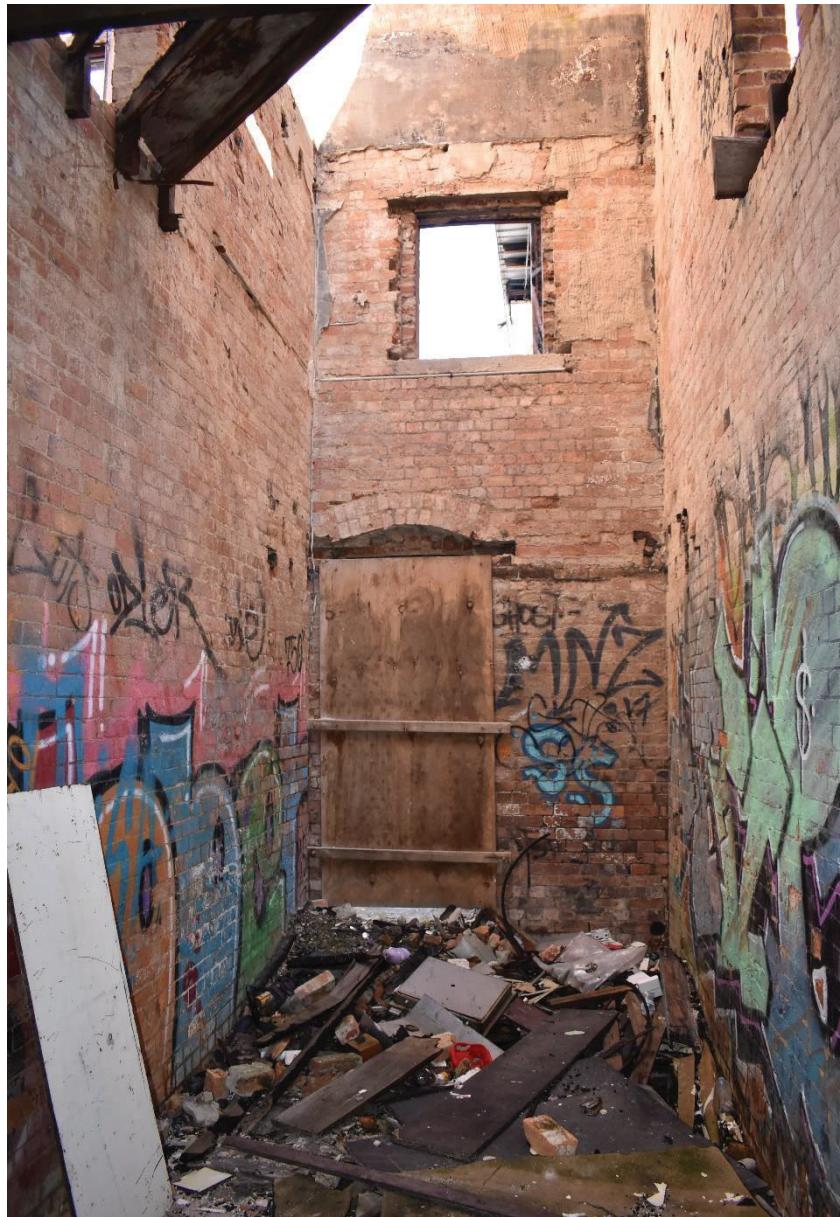
Figure 34 Ground floor stairwell in 2022

The original internal stairwell is now an open void with no roof, no windows, no staircase and only a remnant section of unsafe stair landing on the second floor.

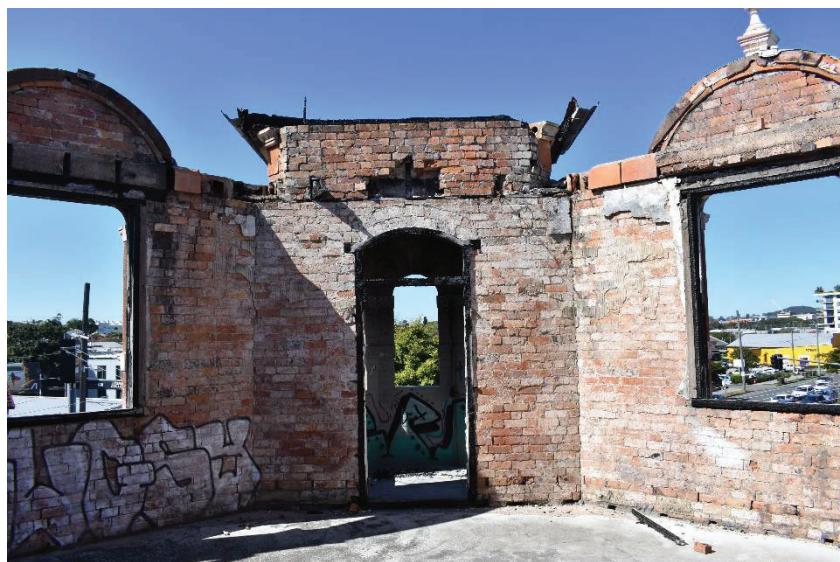
Figure 35 Second floor corner room and turret remnant in 2022

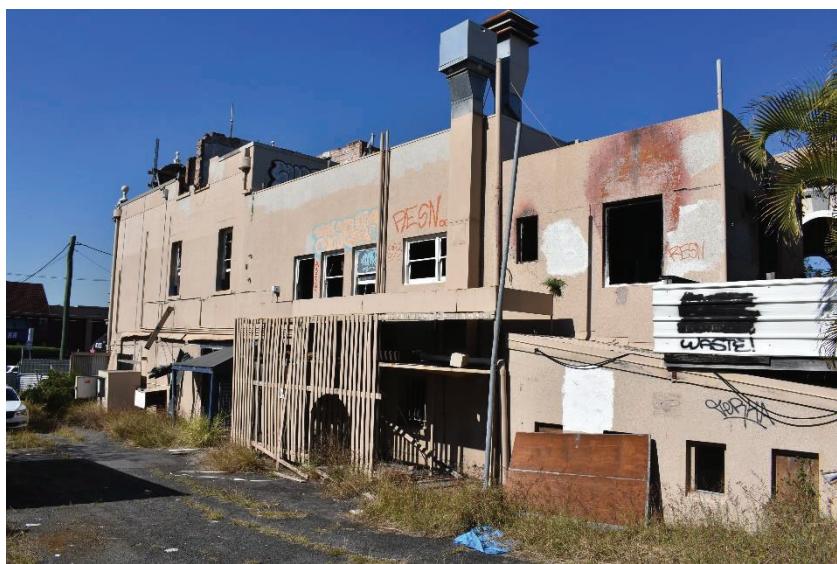
Figure 101

The early (but not original) two-storey rear wing (G12 & F11) was extensively altered in 1958 and the late-1980s by conversion to the hotel kitchen (firstly on the first floor in 1958 and then on the ground floor in the late-1980s). The original hip roof evident in the **figure 5** aerial photograph was replaced with the current parapeted skillion roof in 1958. The original L-shaped verandahs shown on the 1922 detail plan at **figure 2** were also replaced with the current G11 & F10 landings in 1958. The current rear toilets (G13-G15) and former staff dining room (F12) were constructed in 1960 and altered in the late-1980s. This wing was severely damaged in the recent fires and generally has a very low level of intactness (**figures 53 & 101**).

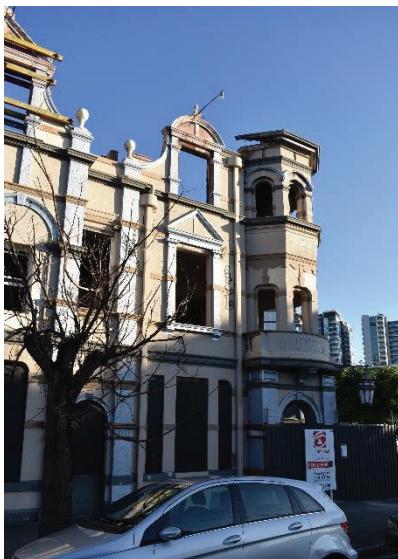
The *Broadway Hotel* can only be described as being in extremely poor condition and remains under high threat of further deterioration. **Figures 116 – 125** show the general condition of the building which is also illustrated in **section 4**.

Figure 116 Balaclava Street facade

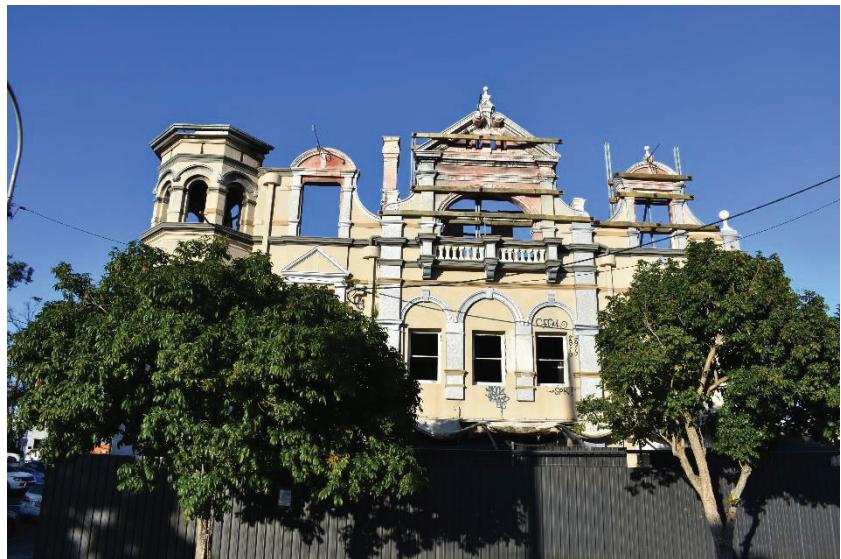
Figure 117 Logan Road facade

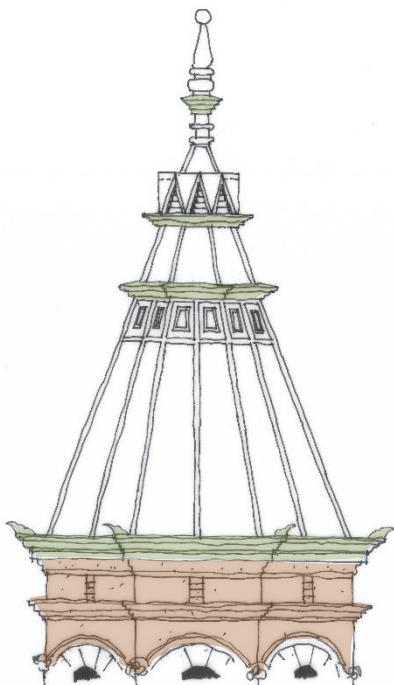
Figure 129 Turret spire

- The original corner turret spire was a steeply pitched octastyle roof with tapered “pan-and-rib”-profile galvanised sheeting embellished by sheet metal decorative bands and finial. Although the spire was destroyed by fire down to the eaves lines, sufficient documentary evidence exists on which to base an accurate reconstruction.
