To: Phillip Usher Constructions
Attention: Ryan MacLellan <rmaclellan@thereforgroup.com.au>
Date: Tuesday, 28 April 2026
Ref: G250158 – M001 (v.3)
Re: Technical Memorandum – Structural conditions assessment
38 Mark Lane, Kangaroo Point

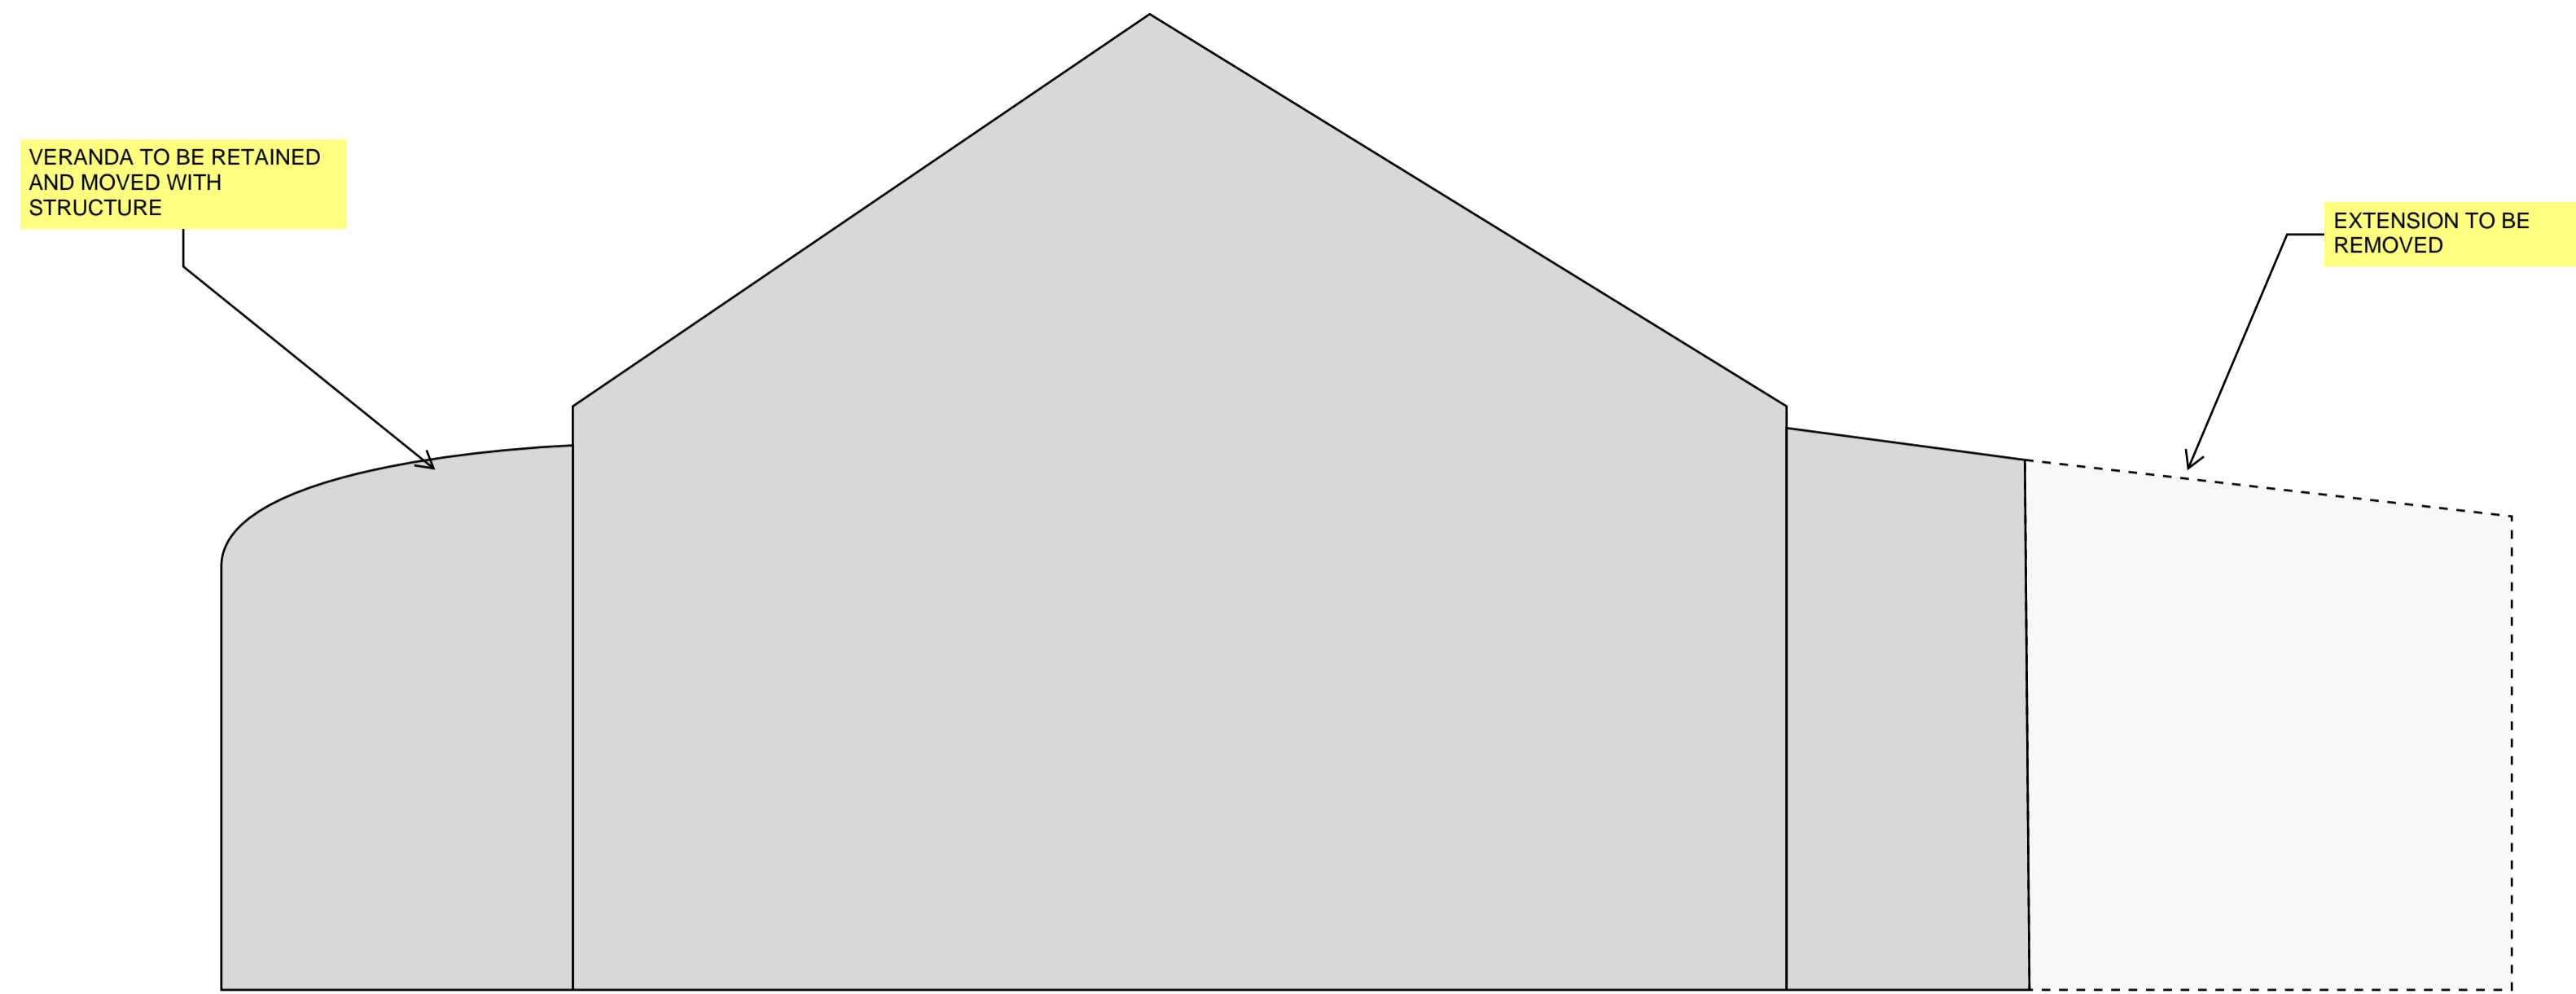
PLAN VIEW - CURRENT

FLOOR STRUCTURE IS IN VERY GOOD CONDITION AND APPEARS TO BE HAVE BEEN REPLACED
JOIST AND BEARER SPAN IS LARGER THAN THAT OF A BUILDING OF THIS AGE. STUMPS ARE NEW STEEL POSTS
