# PARADISE WATERS, DEEBING HEIGHTS PRECINCT A

## PRELIMINARY WATERWAY STABILITY ASSESSMENT

DesignFlow  
Prepared for Stockland  
December 2010

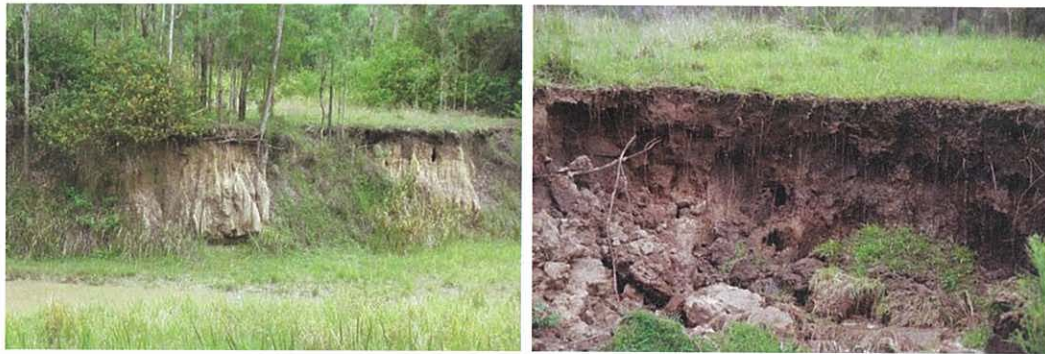
Figure 2: Indicative soil profiles in Precinct A

The site inspections confirmed the dispersive nature of the soil and the erodible nature of the waterway banks. The photos shown in Figure 2 identify the shallow topsoil overlaying dispersive soils below which are commonly found along the waterway and gullies adjacent to Precinct A.

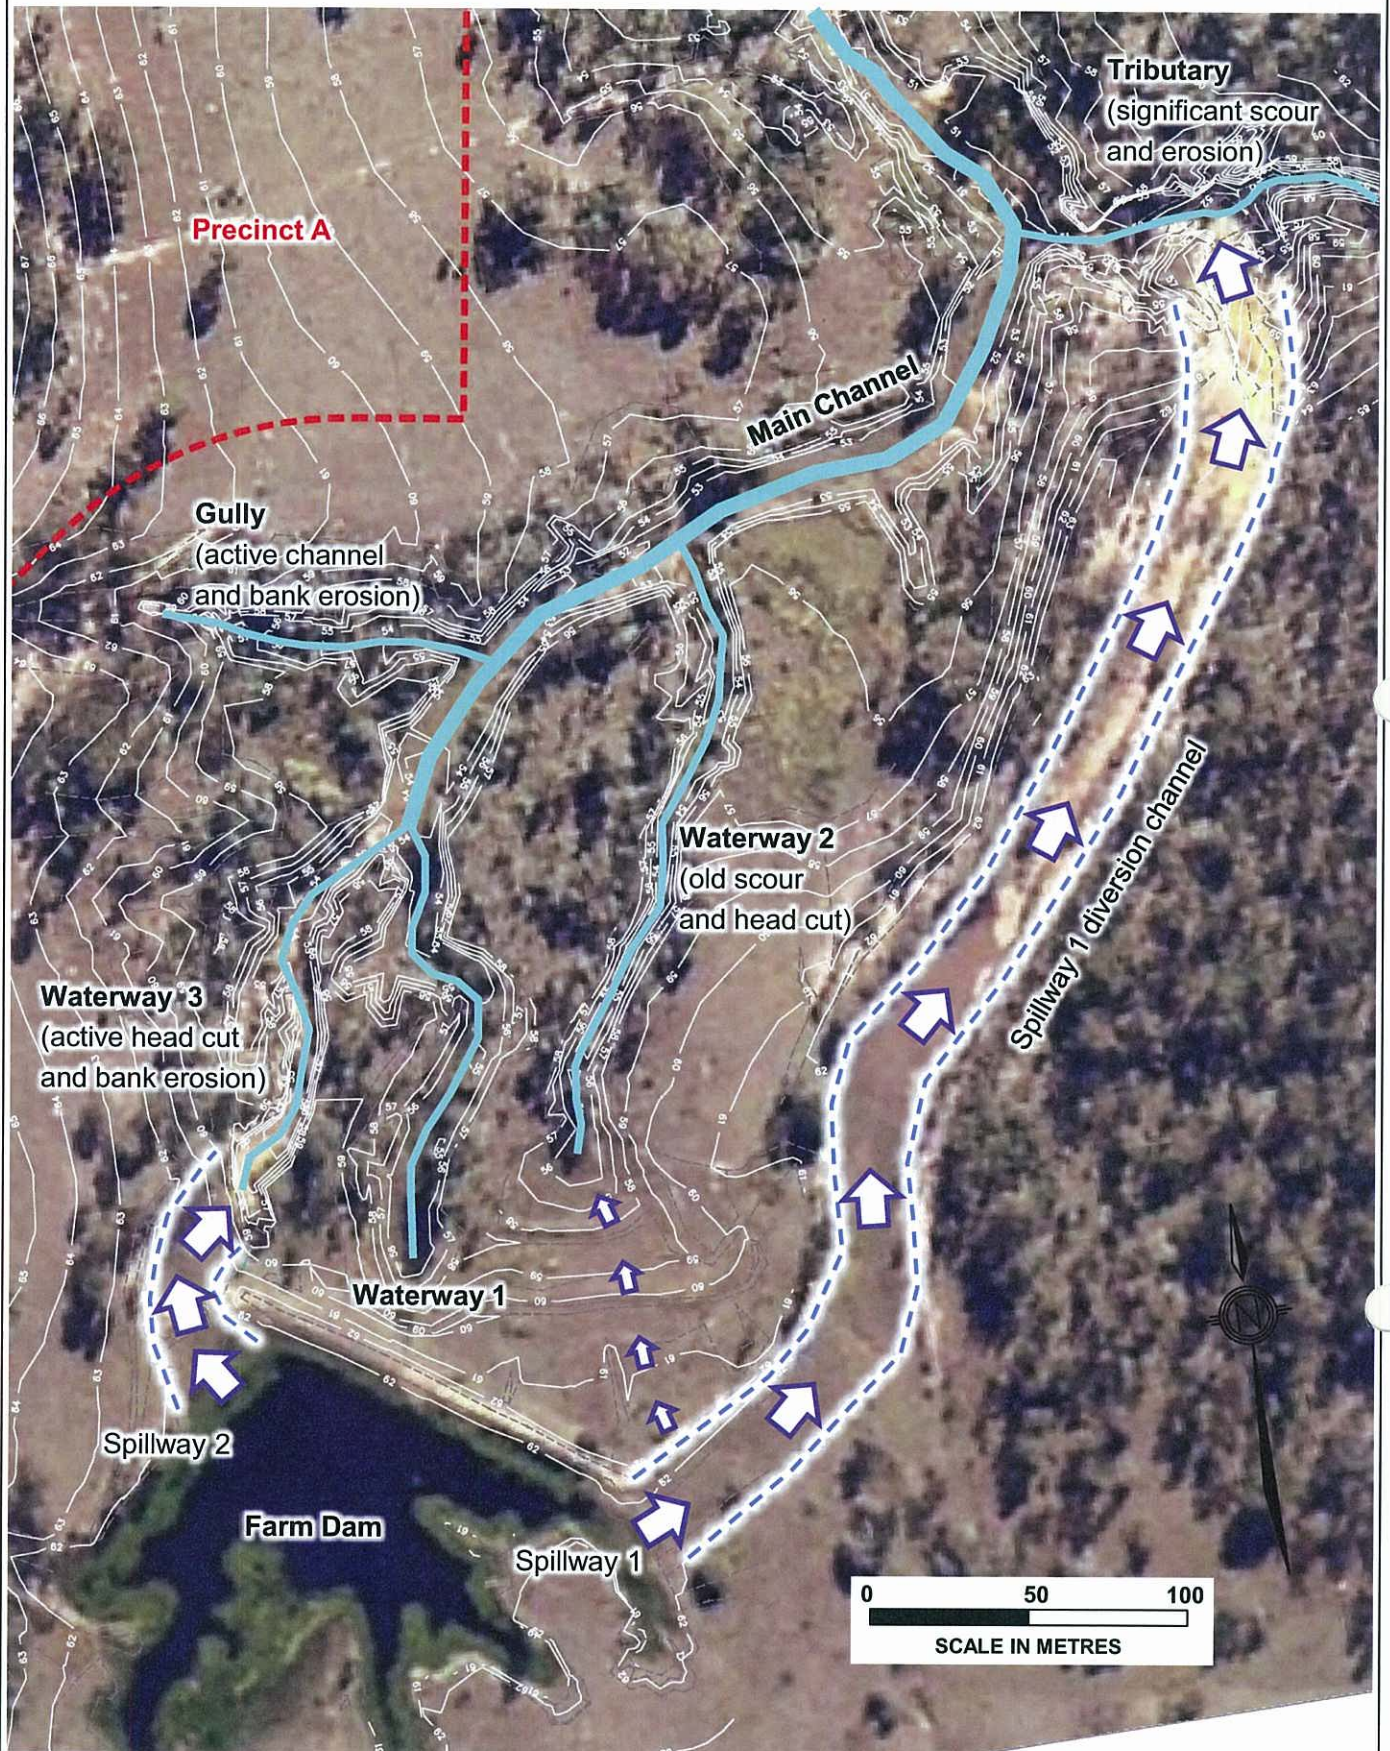
Sketch No.:  
FIGURE 5

An existing farm dam upstream of Precinct A forms a primary hydraulic feature within the lower portion of the main drainage line through the site. The dam receives flows from over 75% of the upstream contributing catchment (360ha +). It is unclear if the dam was constructed prior to or in response to the migration of head cut erosion within the waterway (refer Section 2.7) but is it clearly having major impacts on the hydrology and general morphology of the downstream channel. A number of actions have been taken to manage these impacts but rather than improving the situation that have cause further scour and erosion within the downstream waterways.

The dam forms an important feature in the drainage and waterway stability adjacent to Precinct A and must be considered in the overall strategy to manage the future flows through the site.

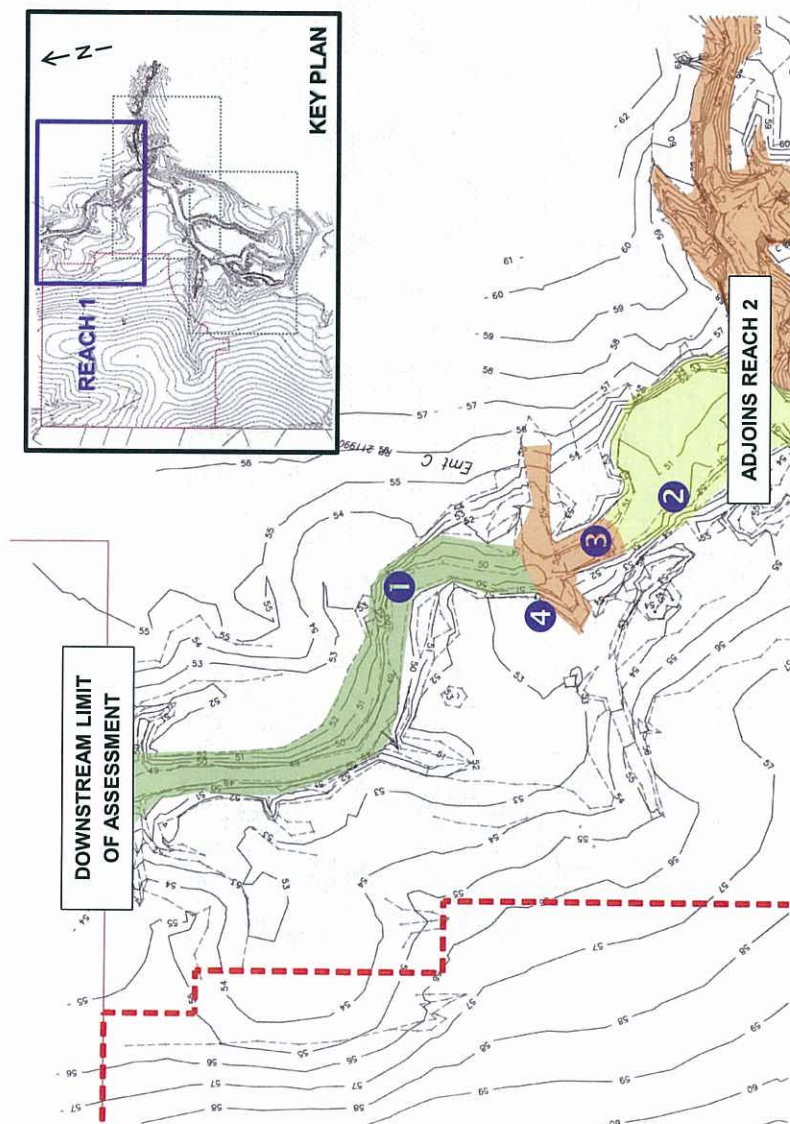
| | <b>Project:</b> PARADISE WATERS PRECINCT A<br>WATERWAY STABILITY ASSESSMENT<br><br>REACH ASSESSMENT – REACH 1 | <b>Date:</b><br>10/12/10<br><br><b>Scale:</b><br>NTS | <b>Sketch No.:</b><br><br><br><br><br><br><b>FIGURE 8</b> |

This reach appears to be in a reasonably good state of recovery with low stream bed gradient and dense vegetation on lower and upper banks. Localised areas of bank (toe) scour and minor head cut indicate potential for further damage where stream hydrology is altered.

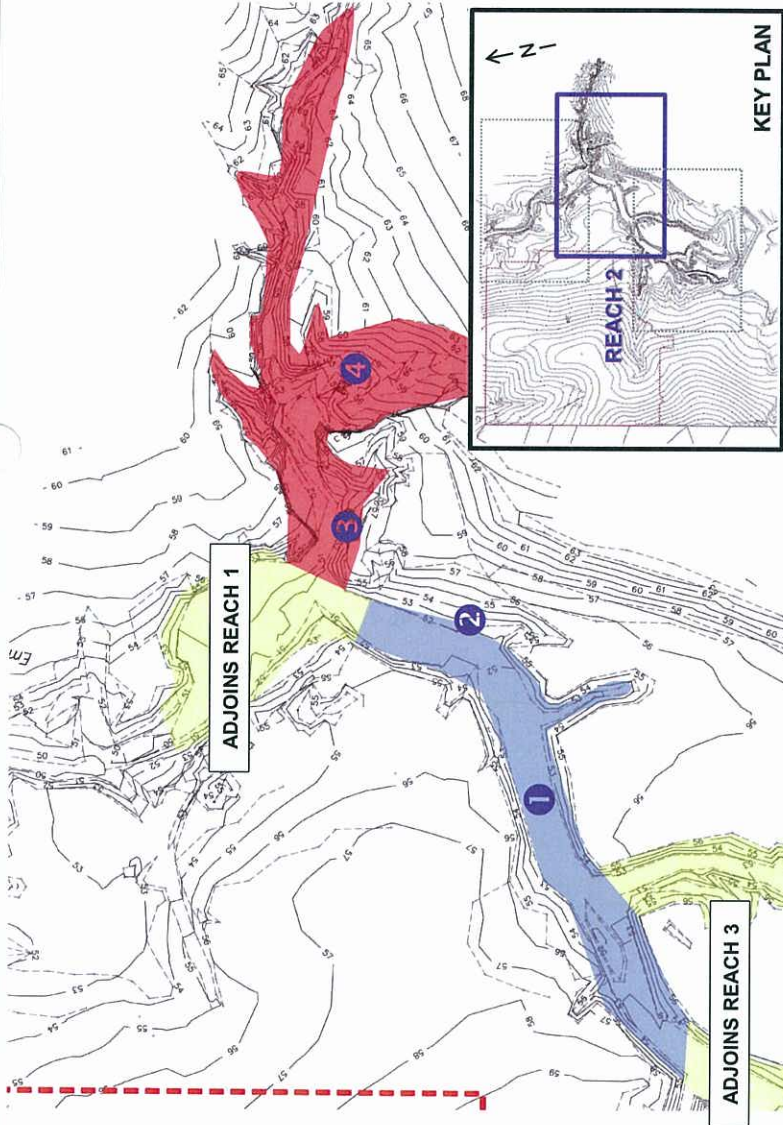
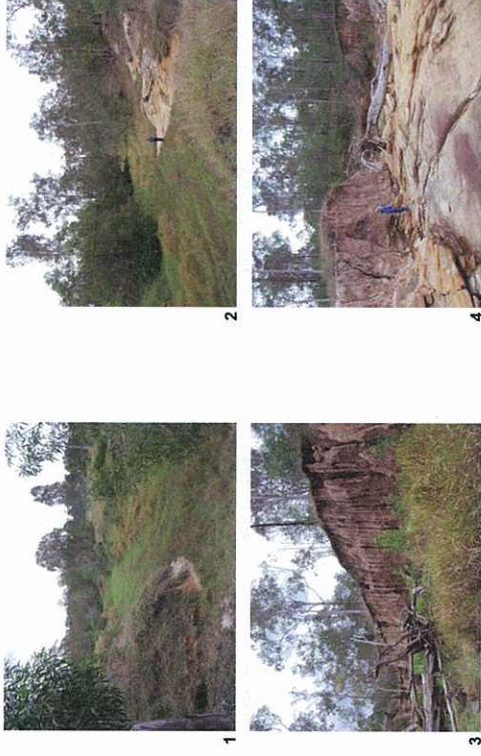
FIGURE 9

The main channel is in state of recovery from historical bed incision and appears in relatively stable condition while the side gully is undergoing significant erosion. Being on the outside of the main channel bend, the gully is further prone to erosive flows and bank failure.

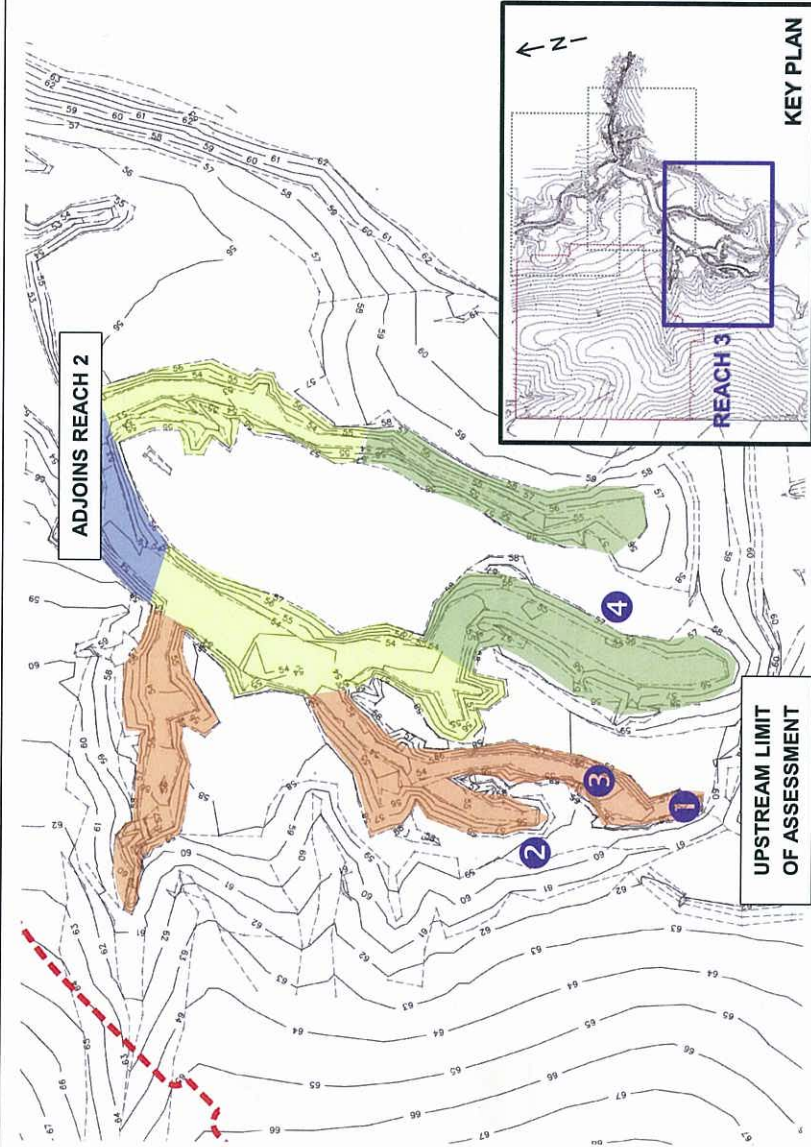
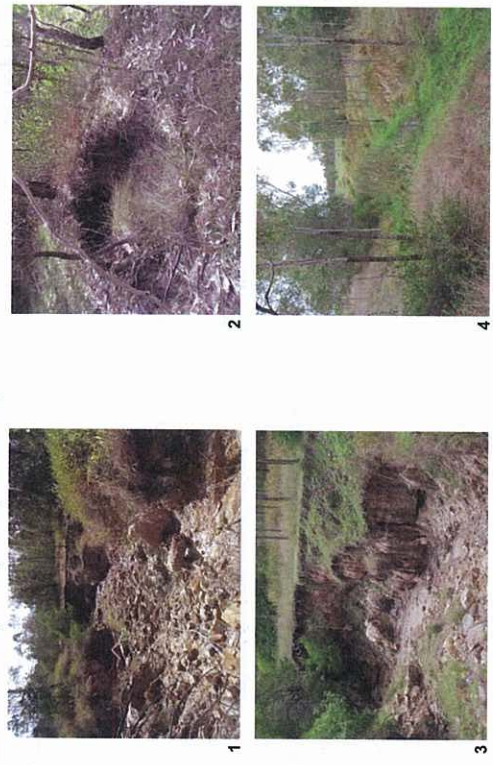
- Main channel forks into numerous channels as a result of overflows/spillways from upstream dam.
- Western branch (western spillway from dam) undergoing significant incision/head-cut erosion which has extended up to the toe of the dam wall (photo 1 & 3).

- Tunnelling occurring behind top of western bank with sinkholes forming at up to 5m behind bank (photo 2).
- Central branch (photo 4) in stable condition and vegetated. Assumed to be former main channel of waterway. Currently not receiving flow from dam (some seepage may be occurring through dam wall)

This forms the upper reach of Precinct A and appears to be the active front for the main channel head cut erosion/channel incision. Numerous smaller channels branch here potentially indicating the previous watercourse (prior to dam). The western spillway discharge from existing dam appears to be the primary cause of incision with overbank surface flows contributing to channel instability. Secondary 'branch' channels from main channels are relatively stable and appear to receive only minor flows (inflows cut off by dam wall and eastern spillway bunds).
