**RE: YERONGA TAFE VEGETATION SURVEY**

## ARBORIST REPORT

**Project Address:** Yeronga TAFE  
70 Park Road  
Yeronga, QLD, 4104

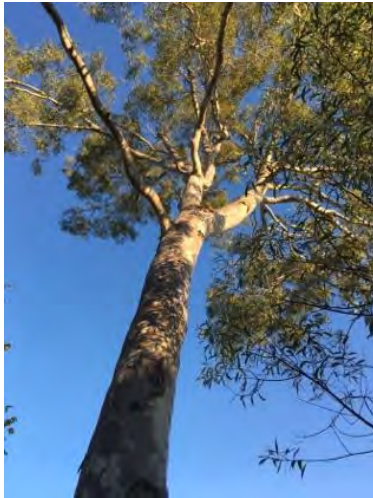
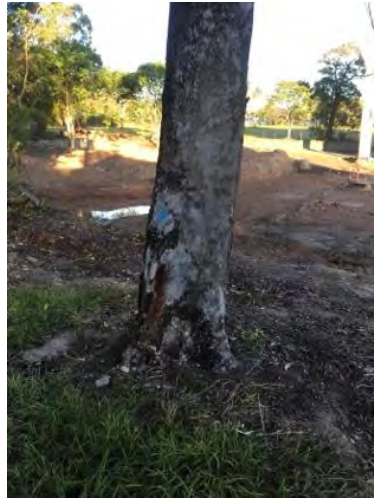
| ID # | Botanical Name | Common Name | Height (m) | Crown Spread (m) | DBH (m) | TPZ (m) | SRZ (m) | Age | Health | Structure | Comments | Vegetation Status |
|---|---|---|---|---|---|---|---|---|---|---|---|---|
| 1 | Corymbia tessellaris | Moreton Bay ash | 16 | 10 | 0.55 | 6.6 | 2.8 | Mature | Good | Good | Leaning trunk | Native |

Picture 1: Tree 1

Picture 2: Tree 1

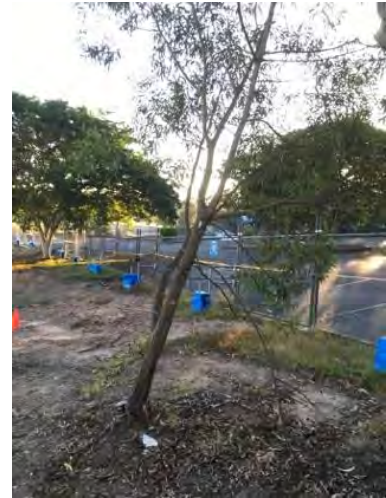
| ID # | Botanical Name | Common Name | Height (m) | Crown Spread (m) | DBH (m) | TPZ (m) | SRZ (m) | Age | Health | Structure | Comments | Vegetation Status |
|---|---|---|---|---|---|---|---|---|---|---|---|---|
| 2 | Acacia leiocalyx | Black wattle | 4 | 3 | 0.15 | 2 | 1.5 | Young | Good | Fair | Self-seeded | Native |

Picture 3: Tree 2

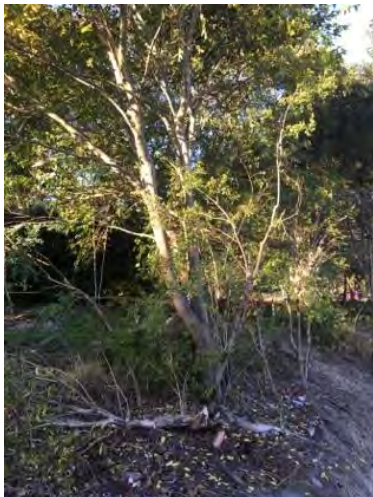
| ID # | Botanical Name | Common Name | Height (m) | Crown Spread (m) | DBH (m) | TPZ (m) | SRZ (m) | Age | Health | Structure | Comments | Vegetation Status |
|---|---|---|---|---|---|---|---|---|---|---|---|---|
| 3 | Celtis sinensis | Chinese elm | 6 | 5 | 0.25 | 3 | 2 | Early mature | Good | Fair | Self-seeded | Cat 3 weed |

Picture 4: Tree 3

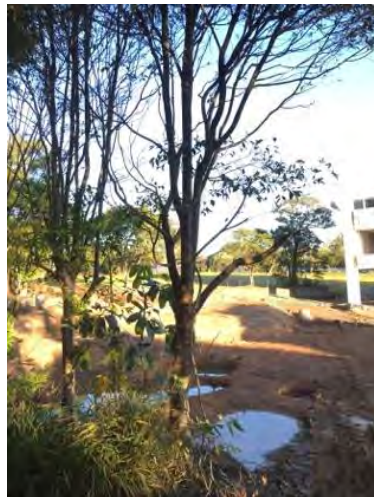
| ID # | Botanical Name | Common Name | Height (m) | Crown Spread (m) | DBH (m) | TPZ (m) | SRZ (m) | Age | Health | Structure | Comments | Vegetation Status |
|---|---|---|---|---|---|---|---|---|---|---|---|---|
| 4 | Syzygium paniculatum | Magenta cherry | 5 | 3 | 0.22 | 2.64 | 1.9 | Early mature | Good | Fair | Previously topped | Native |

Picture 5: Tree 4

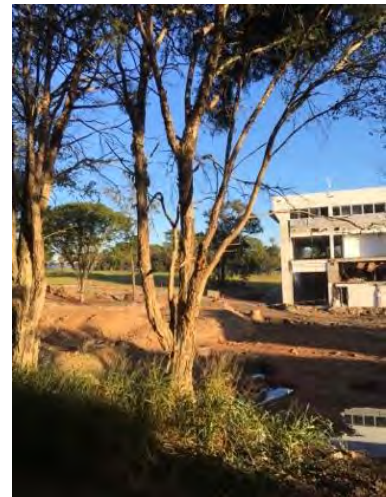
| ID # | Botanical Name | Common Name | Height (m) | Crown Spread (m) | DBH (m) | TPZ (m) | SRZ (m) | Age | Health | Structure | Comments | Vegetation Status |
|---|---|---|---|---|---|---|---|---|---|---|---|---|
| 6 | Melaleuca styphelioides | Prickly-leaved paperbark | 7 | 5 | 0.28 | 3.36 | 2.1 | Mature | Good | Fair | | Native |

Picture 6: Tree 6

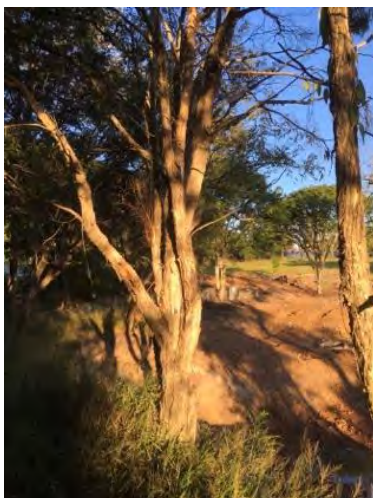
| ID # | Botanical Name | Common Name | Height (m) | Crown Spread (m) | DBH (m) | TPZ (m) | SRZ (m) | Age | Health | Structure | Comments | Vegetation Status |
|---|---|---|---|---|---|---|---|---|---|---|---|---|
| 7 | Melaleuca styphelioides | Prickly-leaved paperbark | 7 | 4 | 0.3 | 3.6 | 2.2 | Early mature | Good | Fair | | Native |

Picture 7: Tree 7

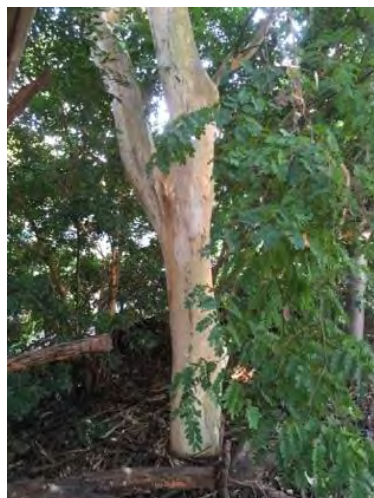
| ID # | Botanical Name | Common Name | Height (m) | Crown Spread (m) | DBH (m) | TPZ (m) | SRZ (m) | Age | Health | Structure | Comments | Vegetation Status |
|---|---|---|---|---|---|---|---|---|---|---|---|---|
| 8 | Libidibia ferrea | Leopard tree | 9 | 5 | 0.25 | 3 | 2 | Early mature | Good | Fair | | Exotic |

Picture 8: Tree 8

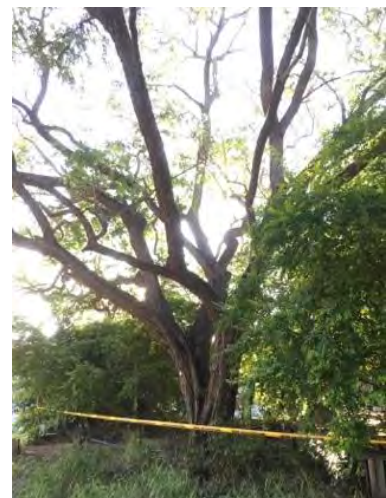
| ID # | Botanical Name | Common Name | Height (m) | Crown Spread (m) | DBH (m) | TPZ (m) | SRZ (m) | Age | Health | Structure | Comments | Vegetation Status |
|---|---|---|---|---|---|---|---|---|---|---|---|---|
| 9 | Tipuana tipu | Pride of Bolivia | 16 | 20 | 1+ | 12 | 3.6 | Mature | Fair | Fair | Spreading - multi stems | Weed |

Picture 9: Tree 9

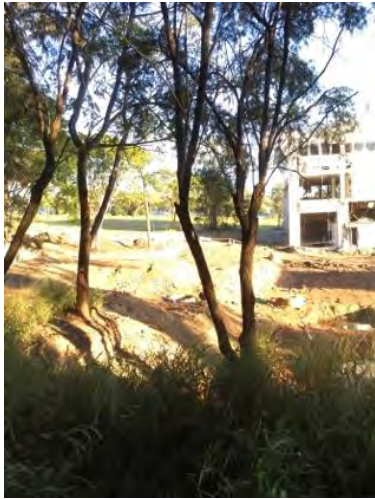
| ID # | Botanical Name | Common Name | Height (m) | Crown Spread (m) | DBH (m) | TPZ (m) | SRZ (m) | Age | Health | Structure | Comments | Vegetation Status |
|---|---|---|---|---|---|---|---|---|---|---|---|---|
| 10 | Callistemon viminalis | Weeping Bottlebrush | 5 | 3 | <0.1 | 2 | 1.5 | Early mature | Good | Fair | Suppressed | Native |

Picture 10: Tree 10

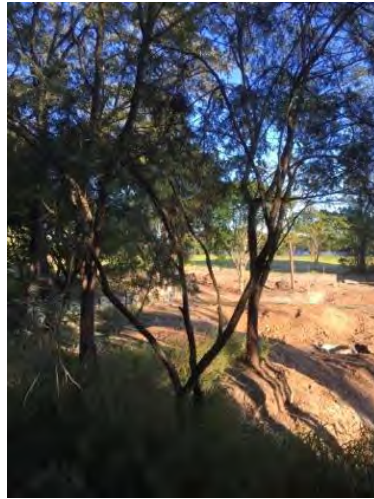
| ID # | Botanical Name | Common Name | Height (m) | Crown Spread (m) | DBH (m) | TPZ (m) | SRZ (m) | Age | Health | Structure | Comments | Vegetation Status |
|---|---|---|---|---|---|---|---|---|---|---|---|---|
| 11 | Callistemon viminalis | Weeping Bottlebrush | 4 | 4 | <0.1 | 2 | 1.5 | Early mature | Fair | Fair | Suppressed | Native |

Picture 11: Tree 11

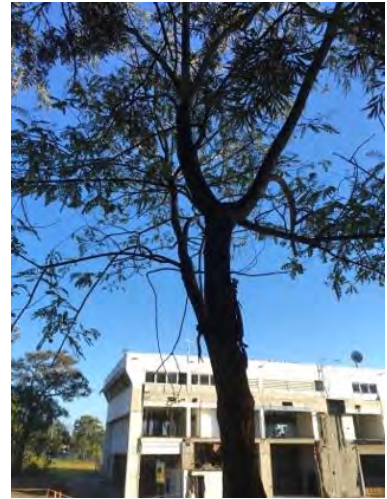
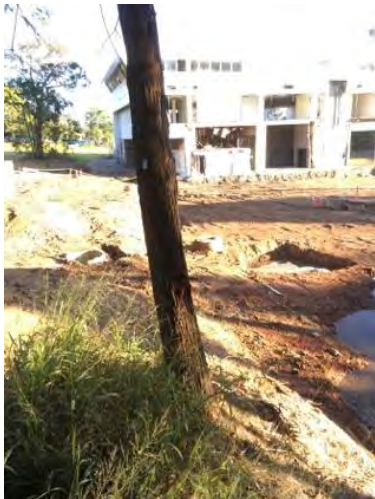
| ID # | Botanical Name | Common Name | Height (m) | Crown Spread (m) | DBH (m) | TPZ (m) | SRZ (m) | Age | Health | Structure | Comments | Vegetation Status |
|---|---|---|---|---|---|---|---|---|---|---|---|---|
| 12 | Tipuana tipu | Pride of Bolivia | 7 | 5 | 0.25 | 3 | 2 | Early mature | Fair | Fair | Root sucker | Weed |

Picture 12: Tree 12

Picture 13: Tree 12

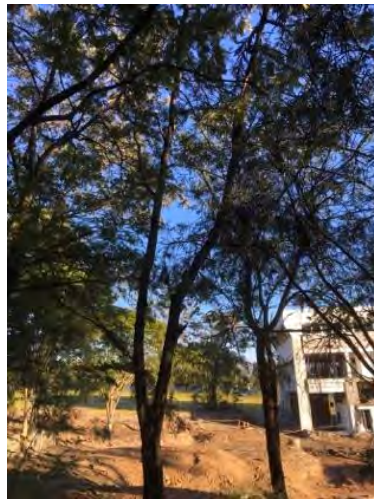
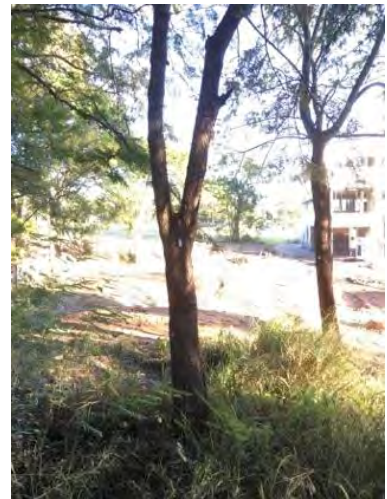
| ID # | Botanical Name | Common Name | Height (m) | Crown Spread (m) | DBH (m) | TPZ (m) | SRZ (m) | Age | Health | Structure | Comments | Vegetation Status |
|---|---|---|---|---|---|---|---|---|---|---|---|---|
| 13 | Grevillea robusta | Silky oak | 7 | 5 | 0.27 | 3.24 | 2.1 | Early mature | Fair | Fair | Declining health | Native |

Picture 14: Tree 13

Picture 15: Tree 13

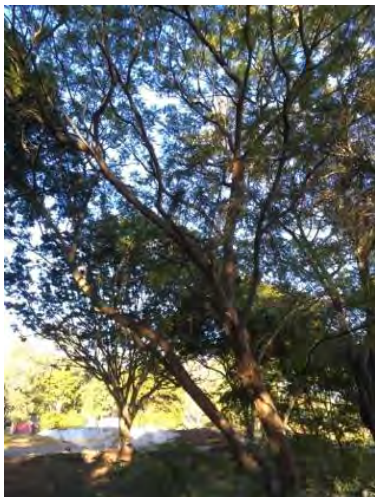
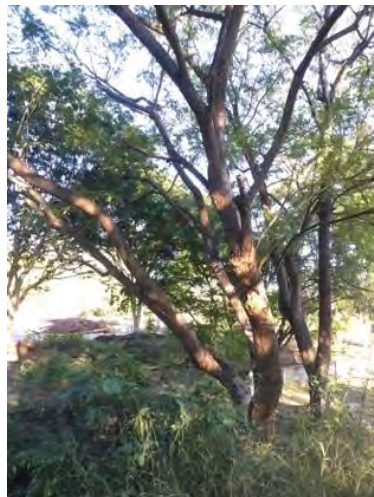
| ID # | Botanical Name | Common Name | Height (m) | Crown Spread (m) | DBH (m) | TPZ (m) | SRZ (m) | Age | Health | Structure | Comments | Vegetation Status |
|---|---|---|---|---|---|---|---|---|---|---|---|---|
| 14 | Jacaranda mimosaeifolia | Jacaranda | 8 | 8 | 0.36 | 4.32 | 2.3 | Mature | Fair | Fair | Twin stem - .3m, .2m | Exotic |

Picture 16: Tree 14

Picture 17: Tree 14

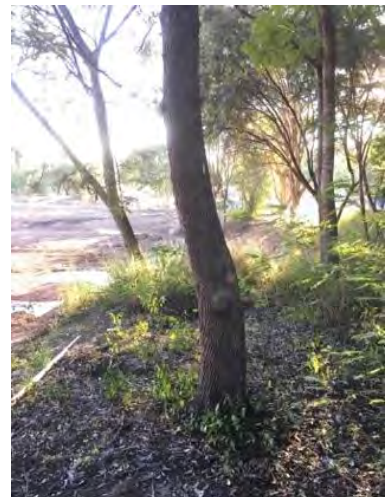
| ID # | Botanical Name | Common Name | Height (m) | Crown Spread (m) | DBH (m) | TPZ (m) | SRZ (m) | Age | Health | Structure | Comments | Vegetation Status |
|---|---|---|---|---|---|---|---|---|---|---|---|---|
| 15 | Grevillea robusta | Silky oak | 8 | 4 | 0.3 | 3.6 | 2.2 | Early mature | Fair | Fair | Declining health | Native |

Picture 18: Tree 15

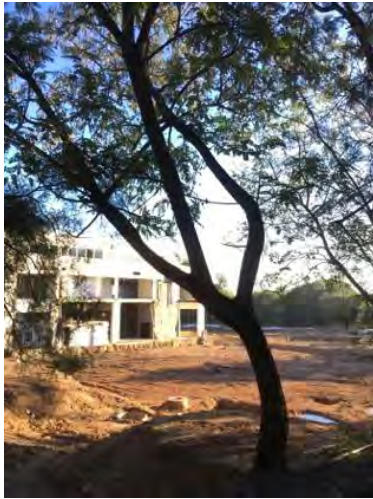
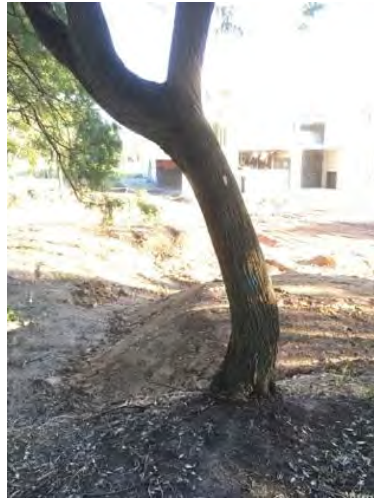
| ID # | Botanical Name | Common Name | Height (m) | Crown Spread (m) | DBH (m) | TPZ (m) | SRZ (m) | Age | Health | Structure | Comments | Vegetation Status |
|---|---|---|---|---|---|---|---|---|---|---|---|---|
| 16 | Tipuana tipu | Pride of Bolivia | 9 | 7 | 0.38 | 4.56 | 2.4 | Early mature | Good | Poor | Root sucker | Weed |

Picture 19: Tree 16

Picture 20: Tree 16

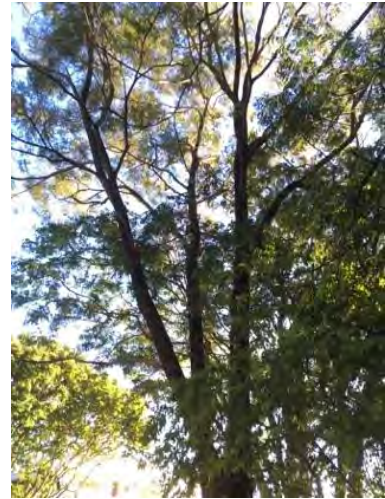
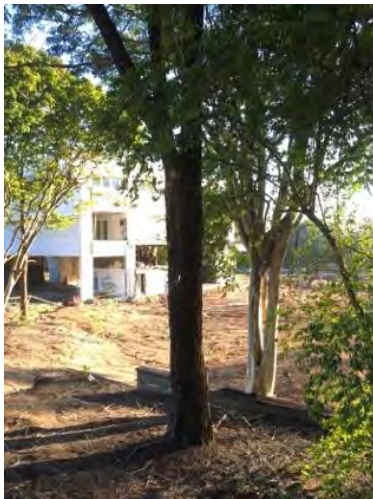
| ID # | Botanical Name | Common Name | Height (m) | Crown Spread (m) | DBH (m) | TPZ (m) | SRZ (m) | Age | Health | Structure | Comments | Vegetation Status |
|---|---|---|---|---|---|---|---|---|---|---|---|---|
| 18 | Melaleuca bracteata | River tea tree | 9 | 6 | 0.38 | 4.56 | 2.4 | Mature | Good | Fair | | Native |

Picture 21: Tree 18

Picture 22: Tree 18
