22 November 2019  
Our File Ref: B19289EL001 Revised  
Contact: Joseph Toon

**RE: YERONGA TAFE VEGETATION SURVEY**

## ARBORIST REPORT

**Project Address:** Yeronga TAFE  
70 Park Road  
Yeronga, QLD, 4104

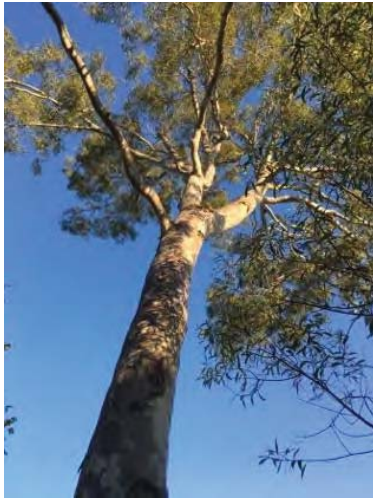
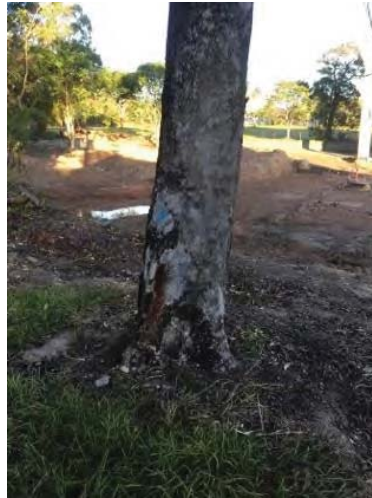
Picture 1: Tree 1

| ID # | Botanical Name | Common Name | Height (m) | Crown Spread (m) | DBH (m) | TPZ (m) | SRZ (m) | Age | Health | Structure | Comments | Vegetation Status |
|---|---|---|---|---|---|---|---|---|---|---|---|---|
| 1 | Corymbia tessellaris | Moreton Bay ash | 16 | 10 | 0.55 | 6.6 | 2.8 | Mature | Good | Good | Leaning trunk | Native |

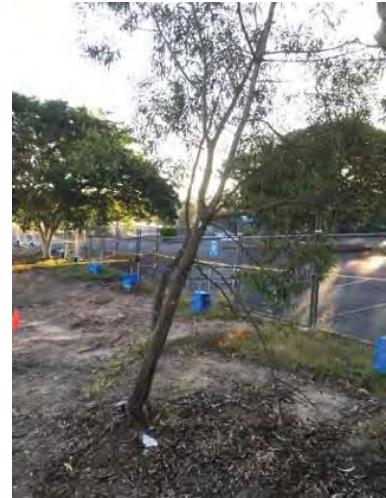
Picture 3: Tree 2

| ID # | Botanical Name | Common Name | Height (m) | Crown Spread (m) | DBH (m) | TPZ (m) | SRZ (m) | Age | Health | Structure | Comments | Vegetation Status |
|---|---|---|---|---|---|---|---|---|---|---|---|---|
| 2 | Acacia leiocalyx | Black wattle | 4 | 3 | 0.15 | 2 | 1.5 | Young | Good | Fair | Self-seeded | Native |

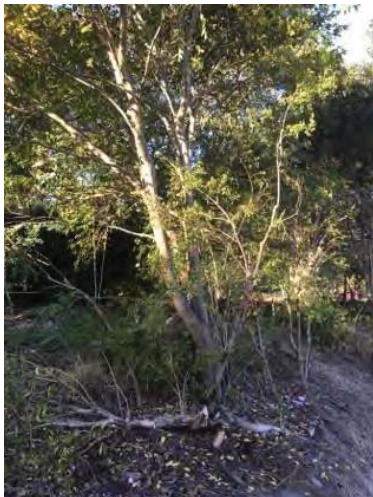
Picture 4: Tree 3

| ID # | Botanical Name | Common Name | Height (m) | Crown Spread (m) | DBH (m) | TPZ (m) | SRZ (m) | Age | Health | Structure | Comments | Vegetation Status |
|---|---|---|---|---|---|---|---|---|---|---|---|---|
| 3 | Celtis sinensis | Chinese elm | 6 | 5 | 0.25 | 3 | 2 | Early mature | Good | Fair | Self-seeded | Cat 3 weed |

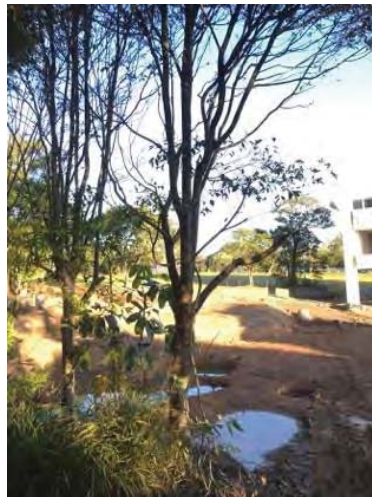
Picture 5: Tree 4

| ID # | Botanical Name | Common Name | Height (m) | Crown Spread (m) | DBH (m) | TPZ (m) | SRZ (m) | Age | Health | Structure | Comments | Vegetation Status |
|---|---|---|---|---|---|---|---|---|---|---|---|---|
| 4 | Syzygium paniculatum | Magenta cherry | 5 | 3 | 0.22 | 2.64 | 1.9 | Early mature | Good | Fair | Previously topped | Native |

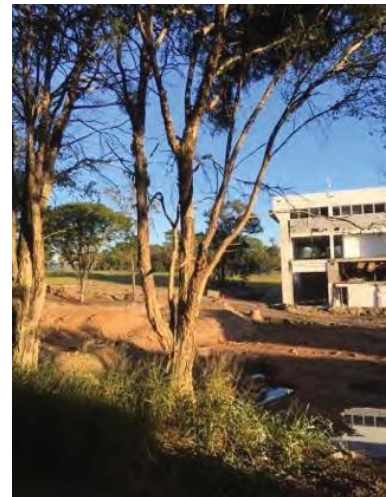
Picture 6: Tree 6

| ID # | Botanical Name | Common Name | Height (m) | Crown Spread (m) | DBH (m) | TPZ (m) | SRZ (m) | Age | Health | Structure | Comments | Vegetation Status |
|---|---|---|---|---|---|---|---|---|---|---|---|---|
| 6 | Melaleuca styphelioides | Prickly-leaved paperbark | 7 | 5 | 0.28 | 3.36 | 2.1 | Mature | Good | Fair | | Native |

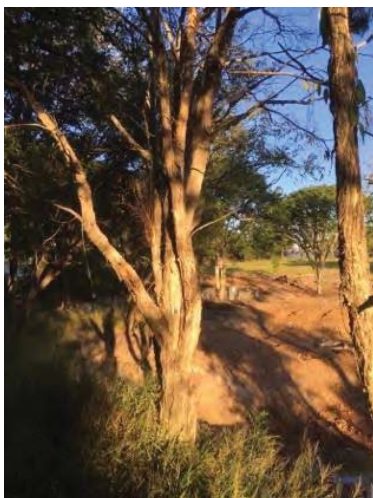
Picture 7: Tree 7

| ID # | Botanical Name | Common Name | Height (m) | Crown Spread (m) | DBH (m) | TPZ (m) | SRZ (m) | Age | Health | Structure | Comments | Vegetation Status |
|---|---|---|---|---|---|---|---|---|---|---|---|---|
| 7 | Melaleuca styphelioides | Prickly-leaved paperbark | 7 | 4 | 0.3 | 3.6 | 2.2 | Early mature | Good | Fair | | Native |

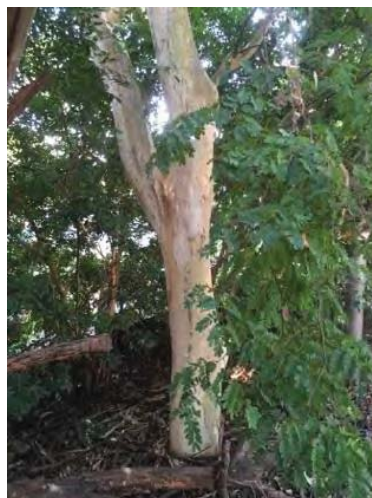
Picture 8: Tree 8

| ID # | Botanical Name | Common Name | Height (m) | Crown Spread (m) | DBH (m) | TPZ (m) | SRZ (m) | Age | Health | Structure | Comments | Vegetation Status |
|---|---|---|---|---|---|---|---|---|---|---|---|---|
| 8 | Libidibia ferrea | Leopard tree | 9 | 5 | 0.25 | 3 | 2 | Early mature | Good | Fair | | Exotic |

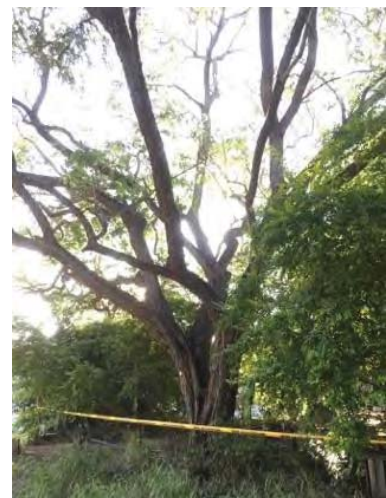
Picture 9: Tree 9

| ID # | Botanical Name | Common Name | Height (m) | Crown Spread (m) | DBH (m) | TPZ (m) | SRZ (m) | Age | Health | Structure | Comments | Vegetation Status |
|---|---|---|---|---|---|---|---|---|---|---|---|---|
| 9 | Tipuana tipu | Pride of Bolivia | 16 | 20 | 1+ | 12 | 3.6 | Mature | Fair | Fair | Spreading - multi stems | Weed |

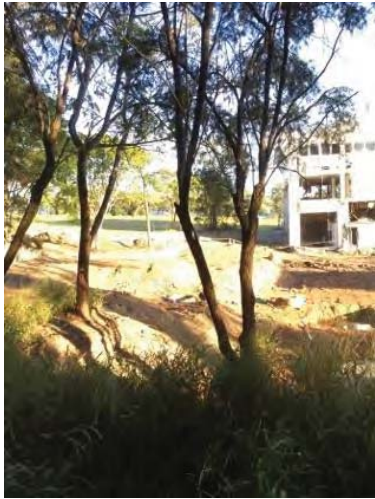
Picture 10: Tree 10

| ID # | Botanical Name | Common Name | Height (m) | Crown Spread (m) | DBH (m) | TPZ (m) | SRZ (m) | Age | Health | Structure | Comments | Vegetation Status |
|---|---|---|---|---|---|---|---|---|---|---|---|---|
| 10 | Callistemon viminalis | Weeping Bottlebrush | 5 | 3 | <0.1 | 2 | 1.5 | Early mature | Good | Fair | Suppressed | Native |

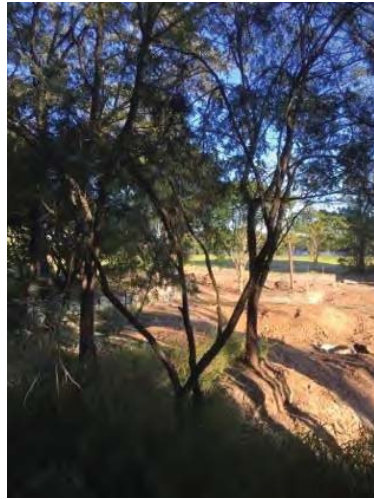
Picture 11: Tree 11

| ID # | Botanical Name | Common Name | Height (m) | Crown Spread (m) | DBH (m) | TPZ (m) | SRZ (m) | Age | Health | Structure | Comments | Vegetation Status |
|---|---|---|---|---|---|---|---|---|---|---|---|---|
| 11 | Callistemon viminalis | Weeping Bottlebrush | 4 | 4 | <0.1 | 2 | 1.5 | Early mature | Fair | Fair | Suppressed | Native |

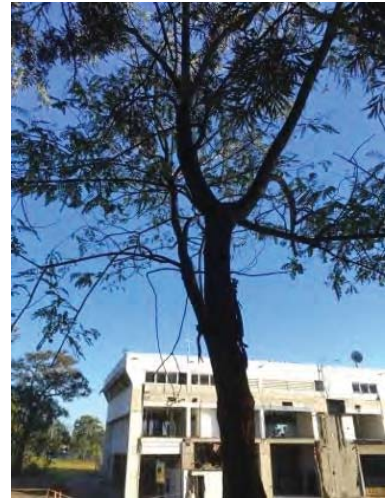
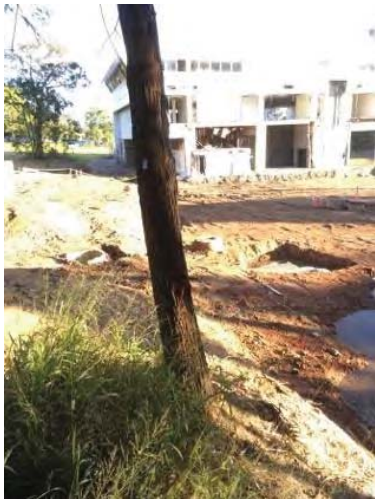
Picture 12: Tree 12

| ID # | Botanical Name | Common Name | Height (m) | Crown Spread (m) | DBH (m) | TPZ (m) | SRZ (m) | Age | Health | Structure | Comments | Vegetation Status |
|---|---|---|---|---|---|---|---|---|---|---|---|---|
| 12 | Tipuana tipu | Pride of Bolivia | 7 | 5 | 0.25 | 3 | 2 | Early mature | Fair | Fair | Root sucker | Weed |

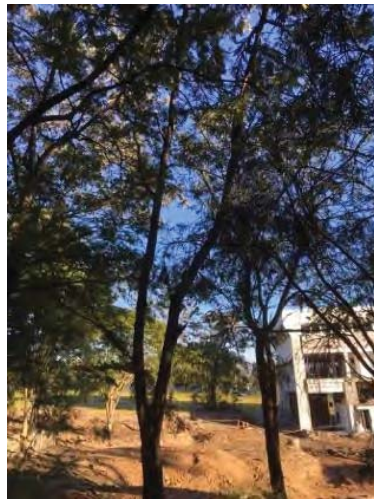
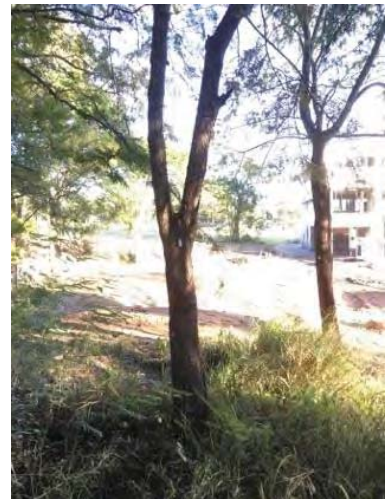
Picture 14: Tree 13

| ID # | Botanical Name | Common Name | Height (m) | Crown Spread (m) | DBH (m) | TPZ (m) | SRZ (m) | Age | Health | Structure | Comments | Vegetation Status |
|---|---|---|---|---|---|---|---|---|---|---|---|---|
| 13 | Grevillea robusta | Silky oak | 7 | 5 | 0.27 | 3.24 | 2.1 | Early mature | Fair | Fair | Declining health | Native |

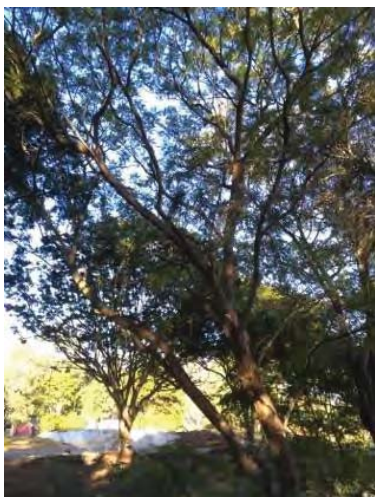
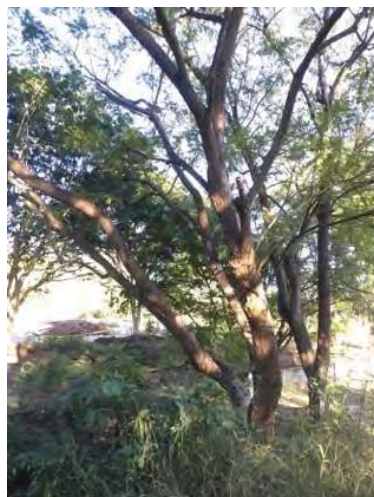
Picture 16: Tree 14

| ID # | Botanical Name | Common Name | Height (m) | Crown Spread (m) | DBH (m) | TPZ (m) | SRZ (m) | Age | Health | Structure | Comments | Vegetation Status |
|---|---|---|---|---|---|---|---|---|---|---|---|---|
| 14 | Jacaranda mimosaeifolia | Jacaranda | 8 | 8 | 0.36 | 4.32 | 2.3 | Mature | Fair | Fair | Twin stem - .3m, .2m | Exotic |

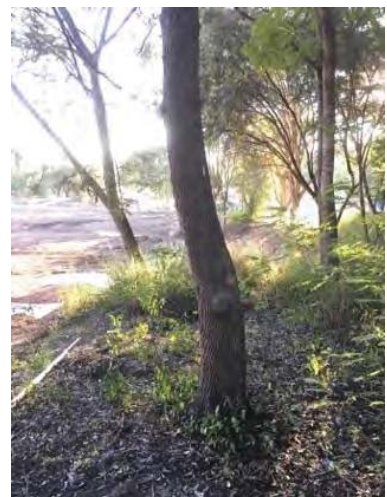
Picture 18: Tree 15

| ID # | Botanical Name | Common Name | Height (m) | Crown Spread (m) | DBH (m) | TPZ (m) | SRZ (m) | Age | Health | Structure | Comments | Vegetation Status |
|---|---|---|---|---|---|---|---|---|---|---|---|---|
| 15 | Grevillea robusta | Silky oak | 8 | 4 | 0.3 | 3.6 | 2.2 | Early mature | Fair | Fair | Declining health | Native |
