Independent Arboricultural Services

Arboricultural Impact Assessment

11-23 Macarthur Avenue
Hamilton QLD 4007

IAS11653

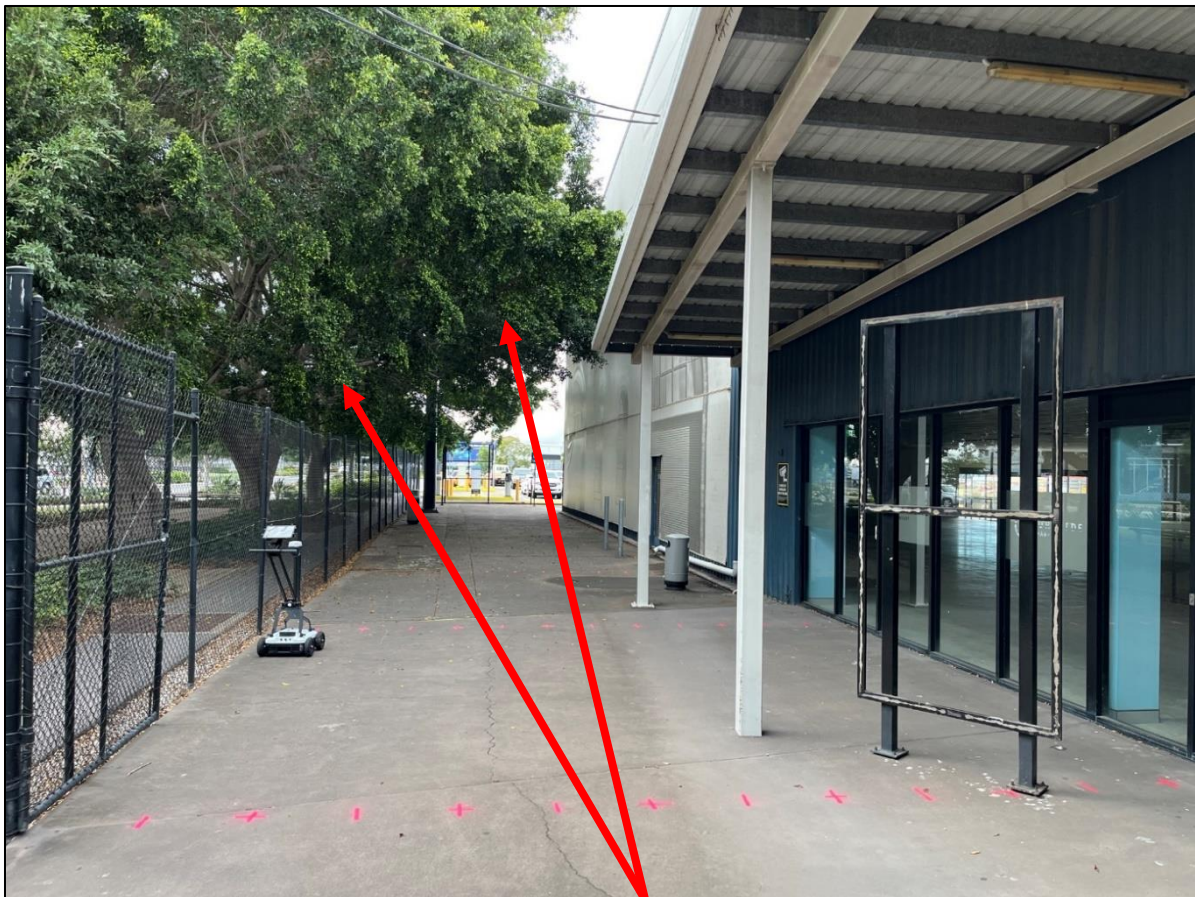
Crown lift and directional pruning is required to facilitate the piling machinery and scaffolding (close to boundary)

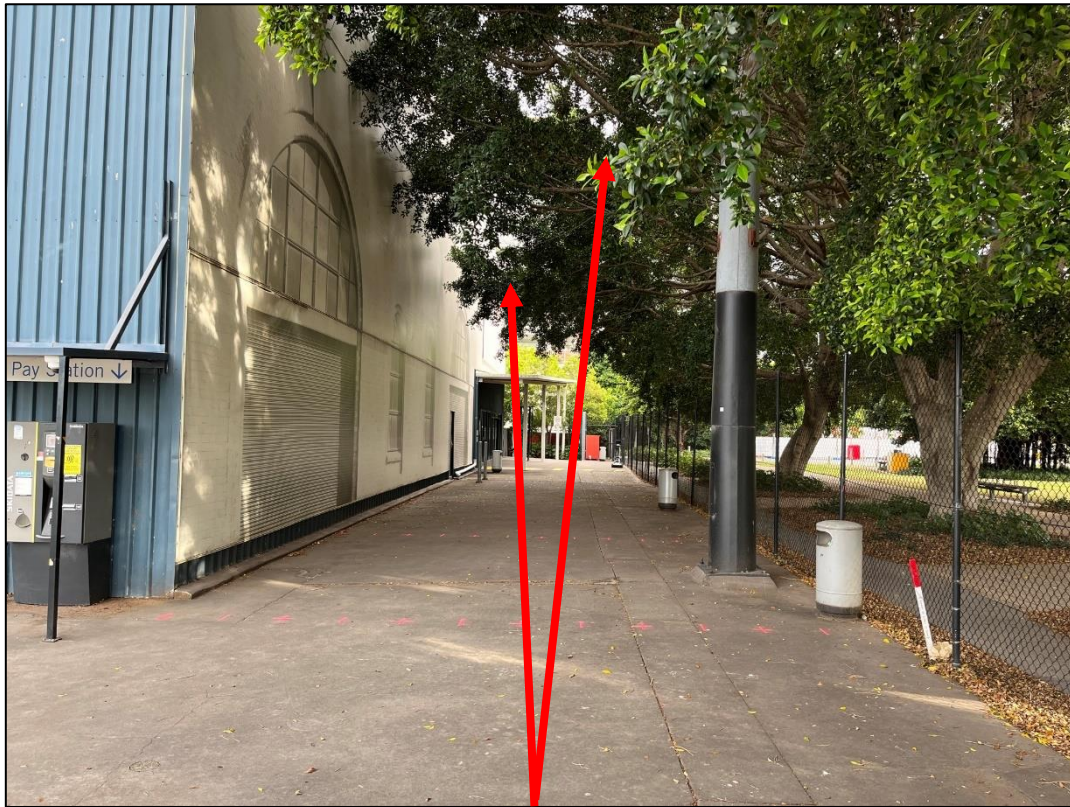
Crown lift and directional pruning is required to facilitate the piling machinery and scaffolding (close to boundary)

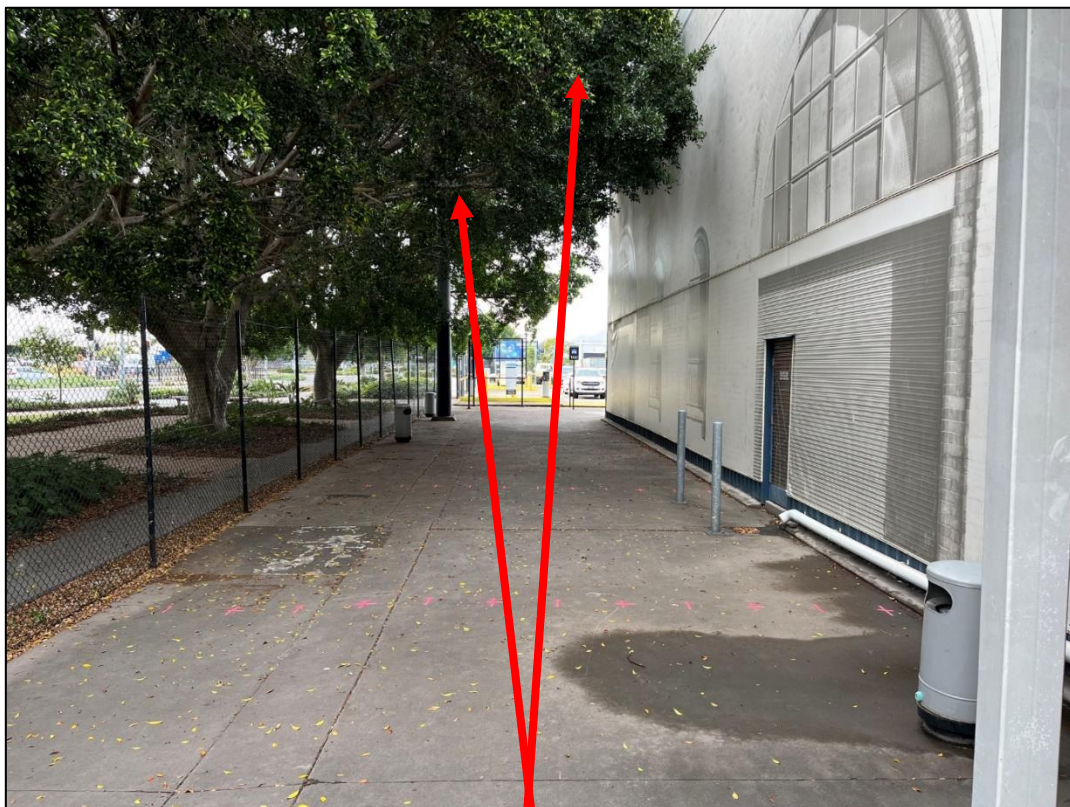
Crown lift and directional pruning is required to facilitate the piling machinery and scaffolding (close to boundary)

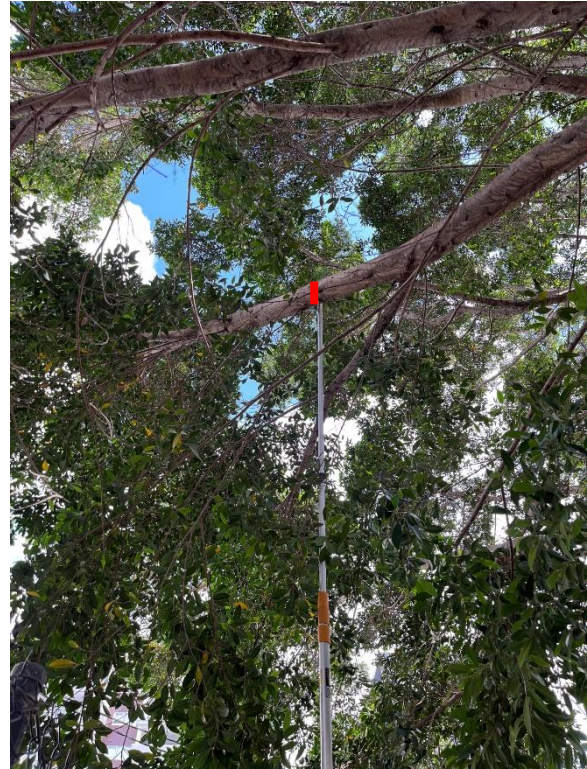
Tree 1 – 100mm branch to be pruned

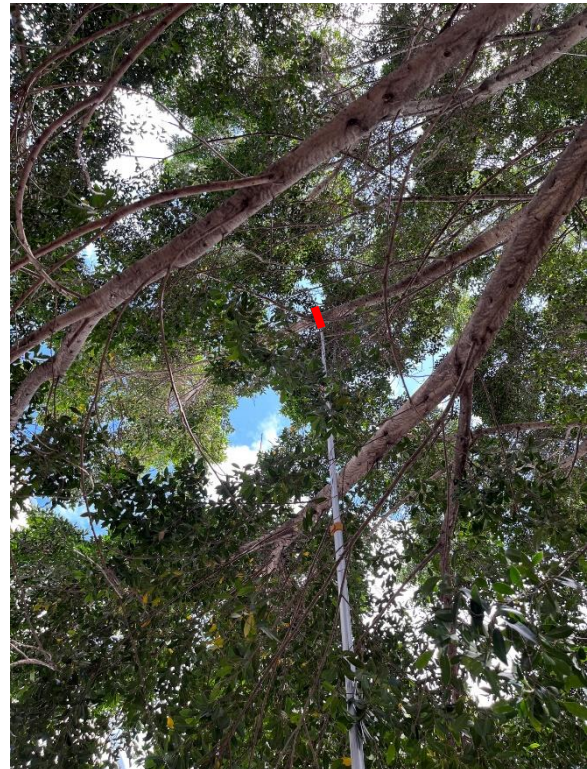
Tree 1 – 150mm branch to be pruned

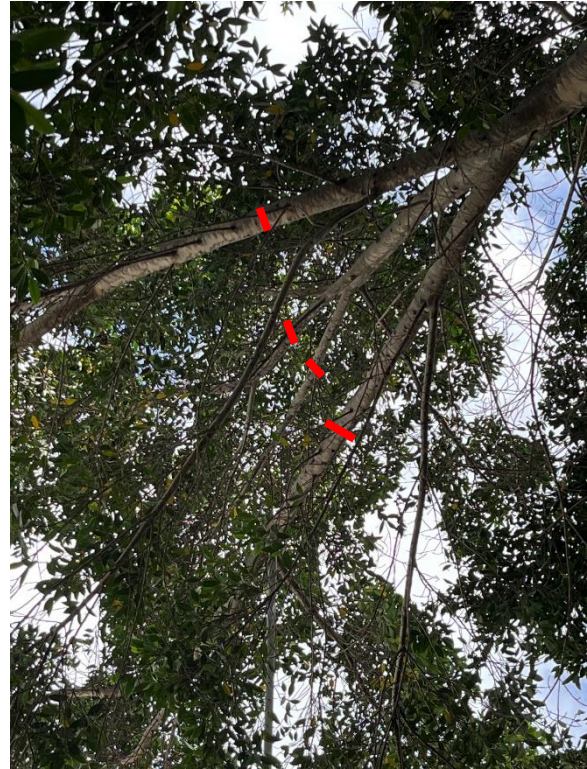
Tree 1 - 2 x 80 and 2 x 40mm branches to be pruned

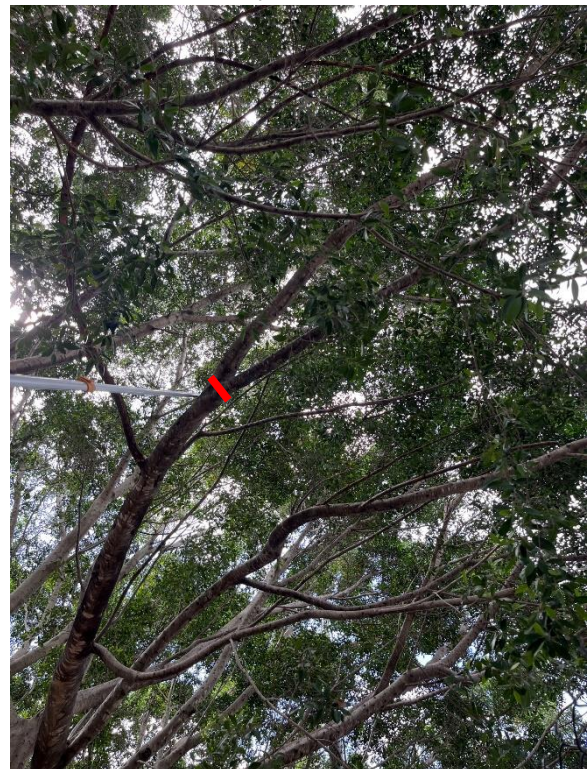
Tree 2 - 100mm branch to be pruned

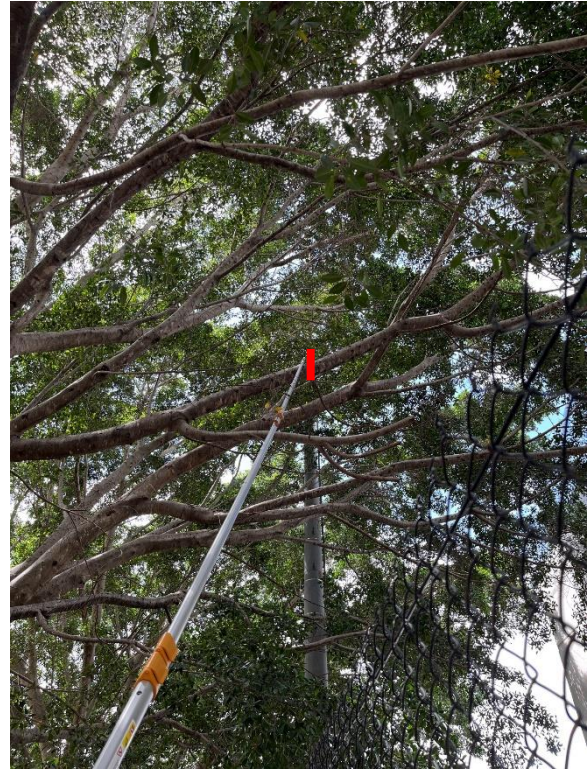
Tree 2 - 80mm branch to be pruned

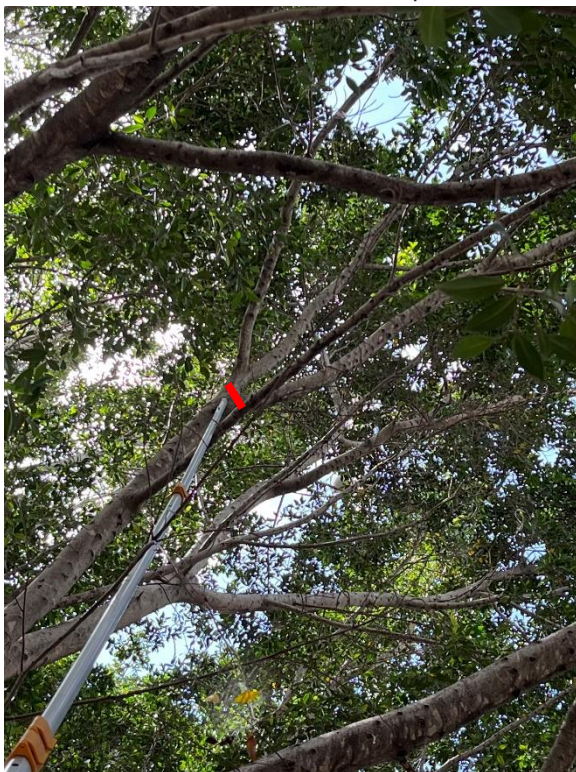
Tree 2 - 150mm branch to be pruned

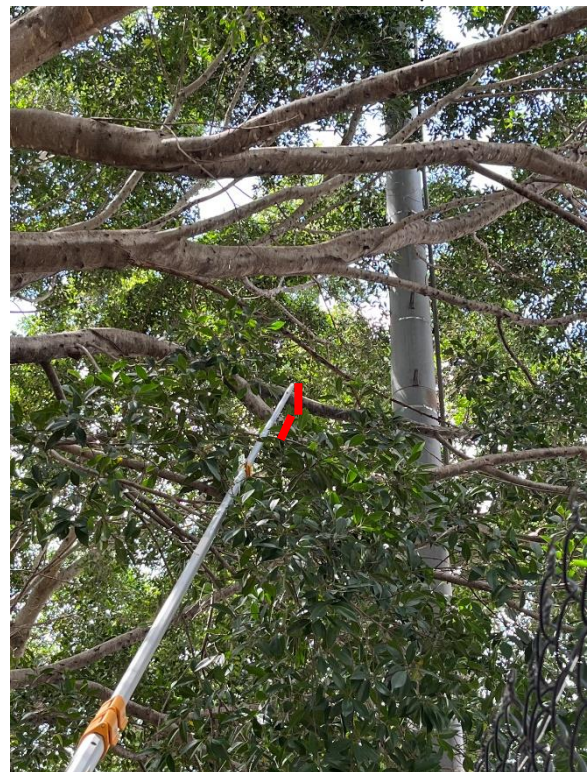
Tree 2 – 100mm and 80mm branch to be pruned

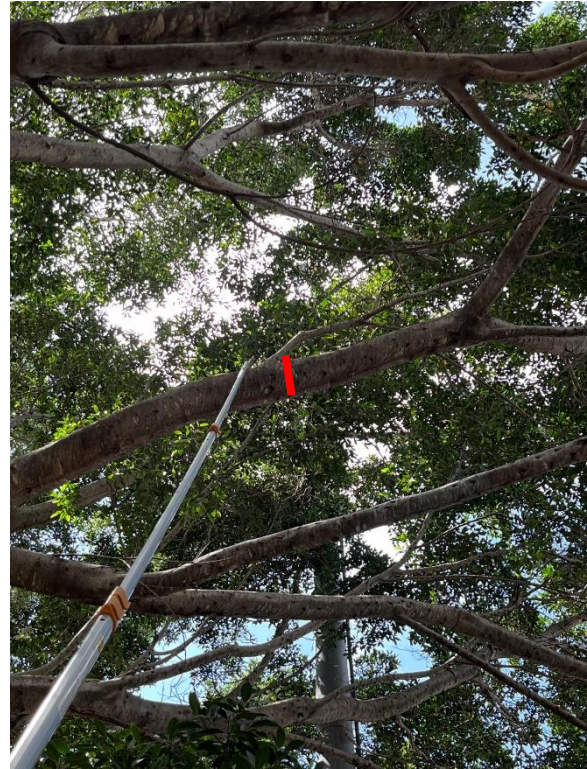
Tree 2 - 250mm branch to be pruned

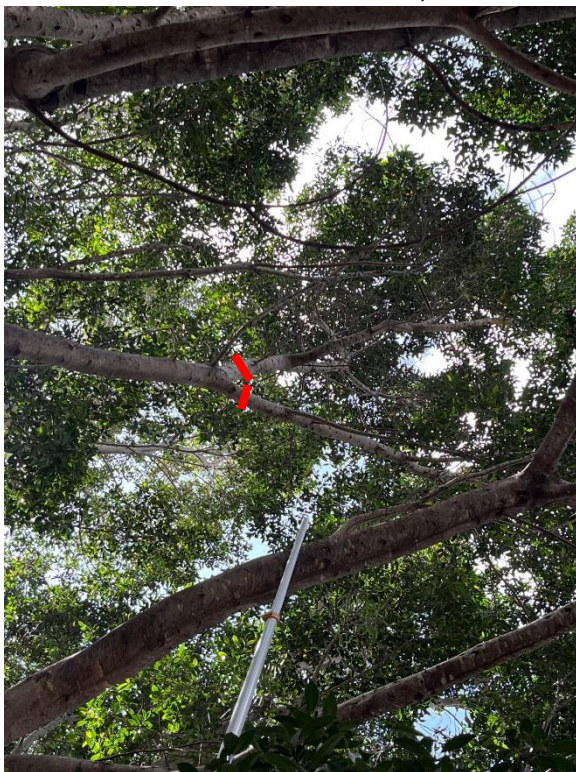
Tree 2 – 100mm and 150mm branch to be pruned

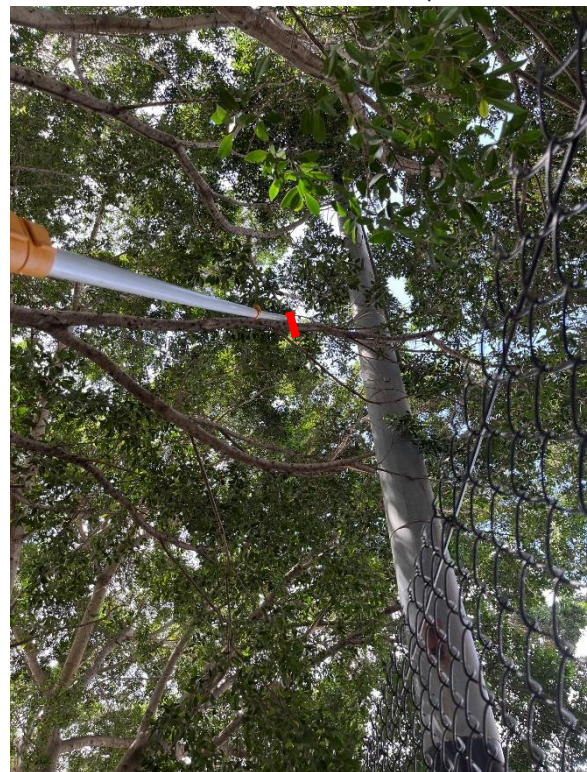
Tree 2 - 80mm branch to be pruned

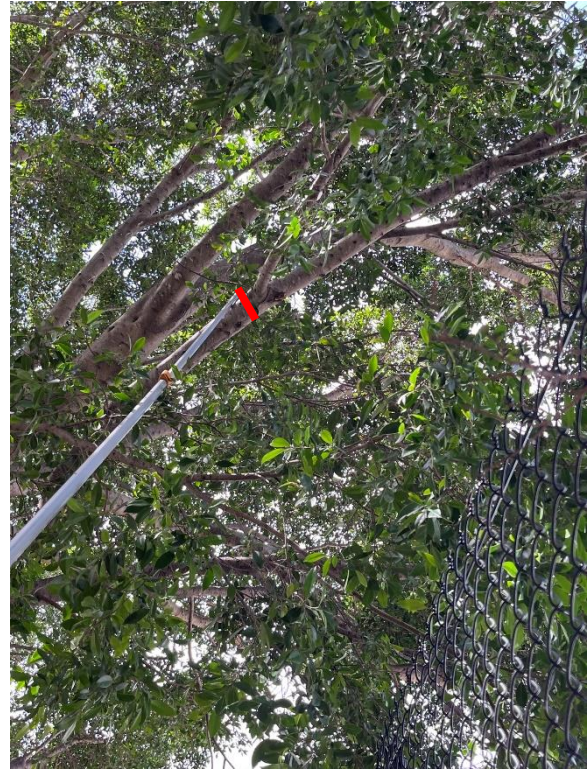
Tree 3 - 150mm branch to be pruned

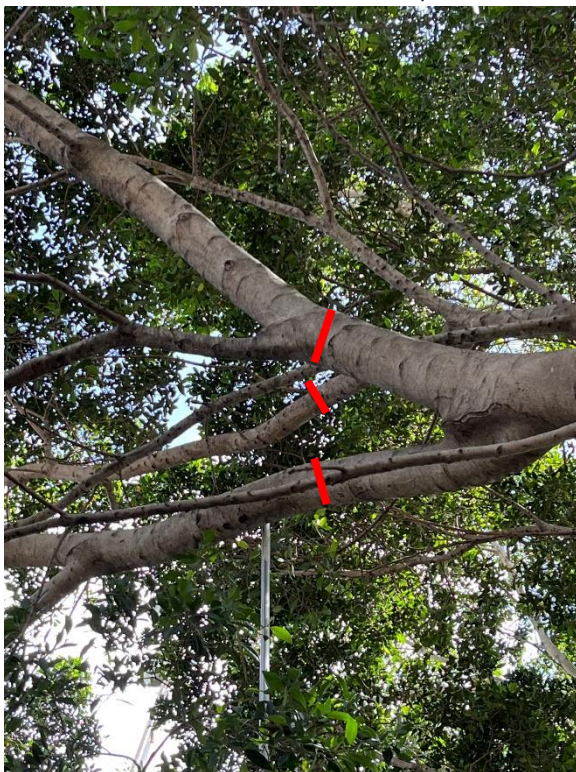
Tree 3 - 2x 150mm and 80mm branches to be pruned

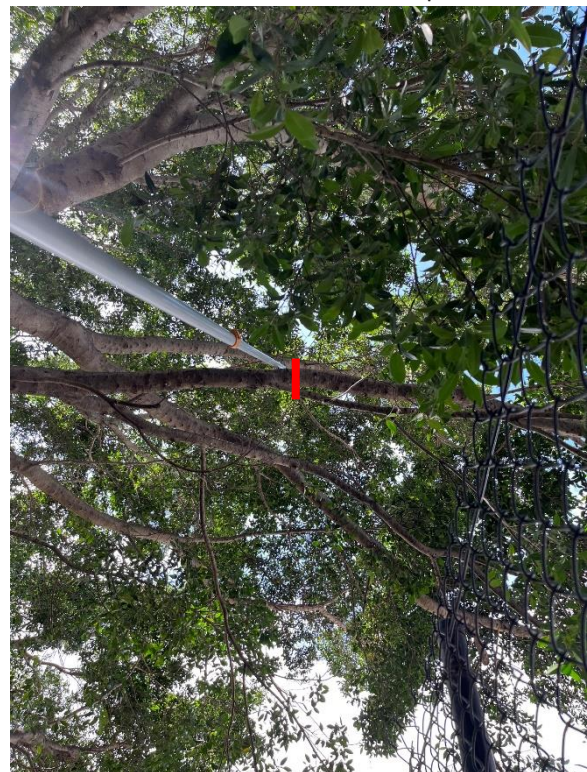
Tree 3 - 100mm branch to be pruned

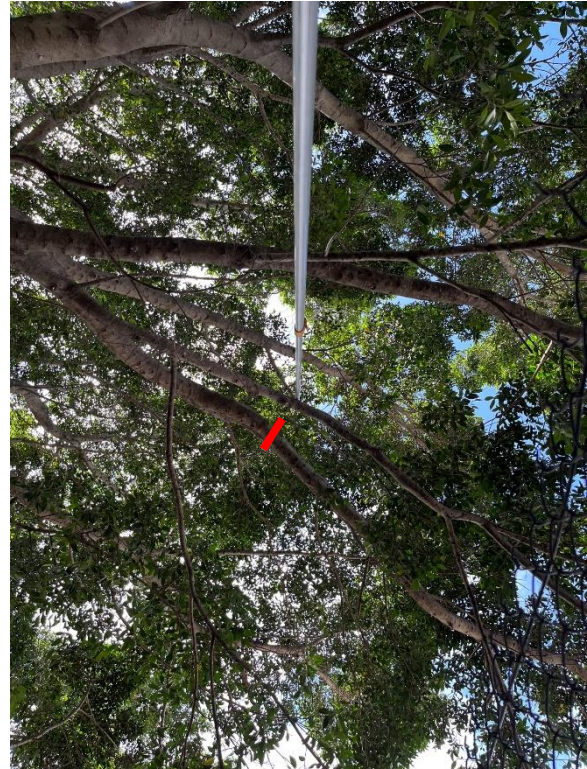
Tree 3 - 150mm branch to be pruned

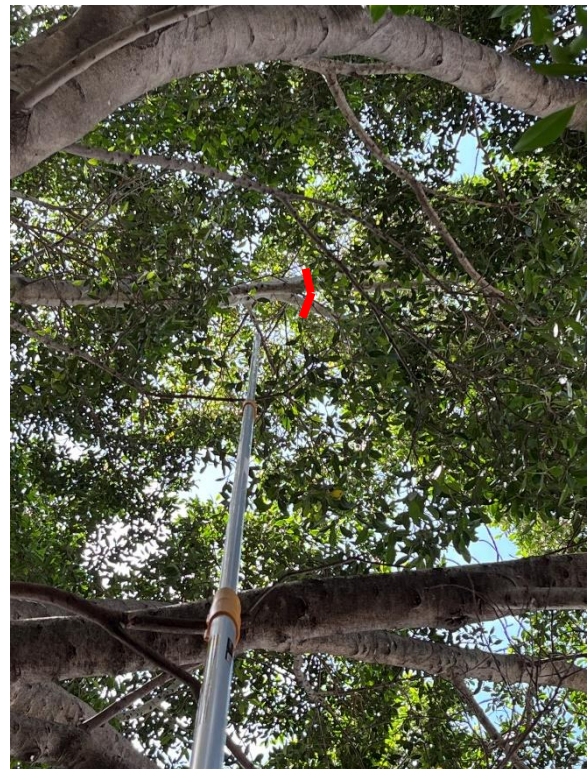
Tree 3 - 2x 50mm branches to be pruned

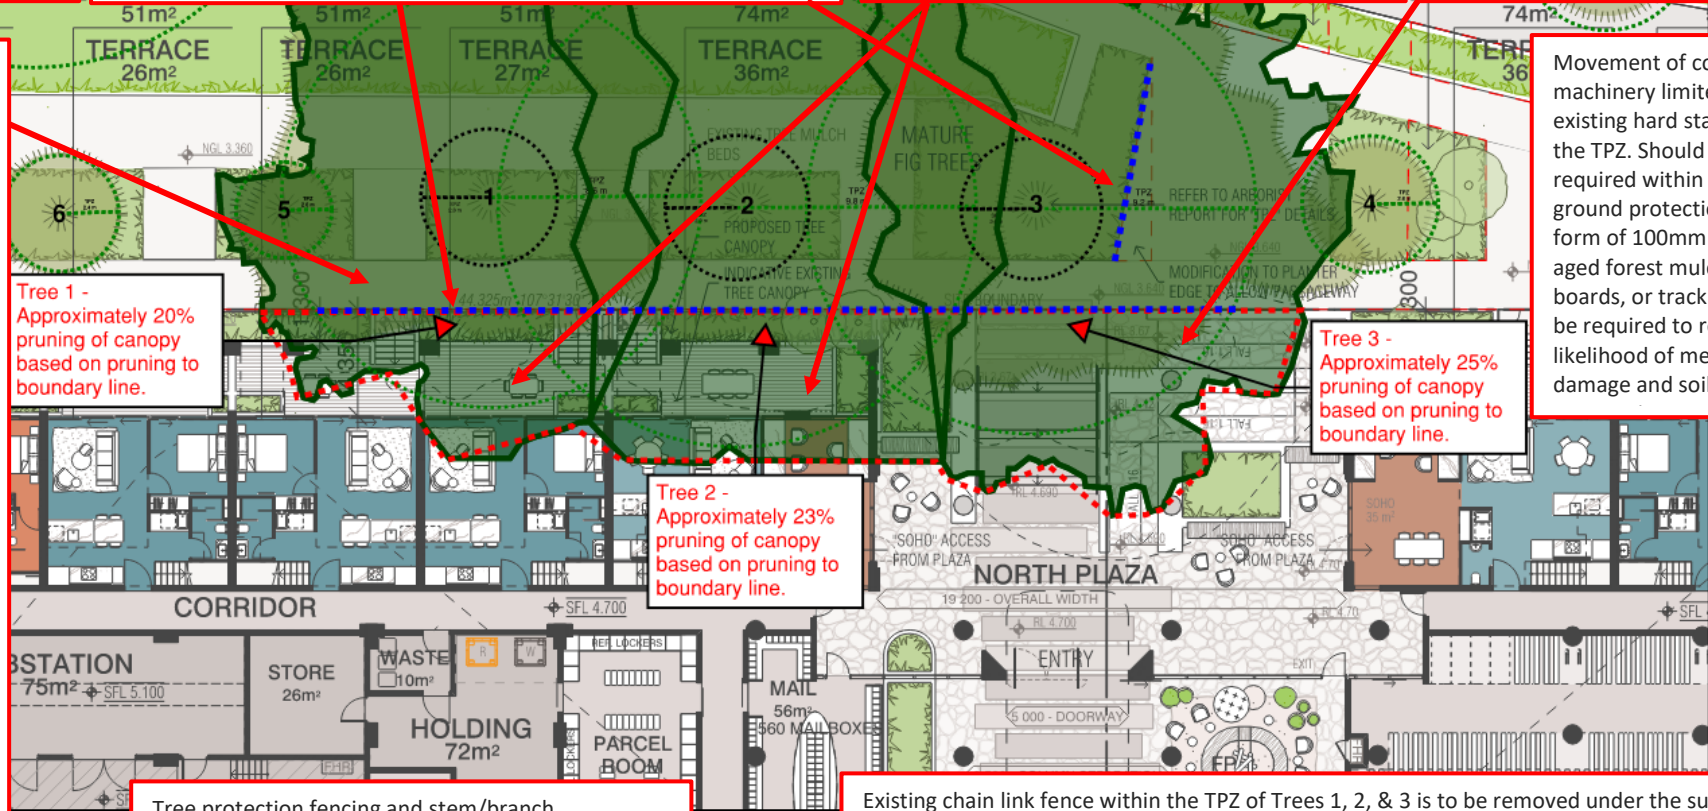
Tree 1 -
Approximately 20% pruning of canopy based on pruning to boundary line.

Tree 2 -
Approximately 23% pruning of canopy based on pruning to boundary line.

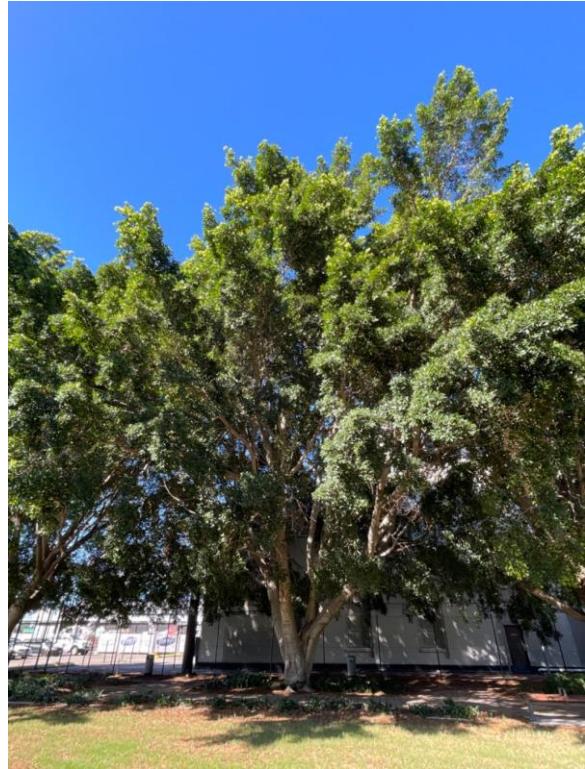
Tree 1 – Clearance to existing structure within the *Subject Site*.

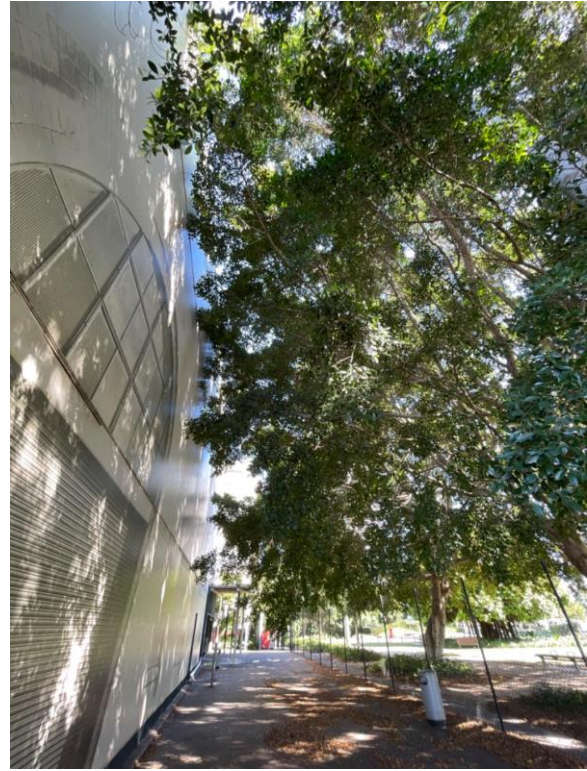
Tree 2 – Clearance to existing structure within the *Subject Site*.

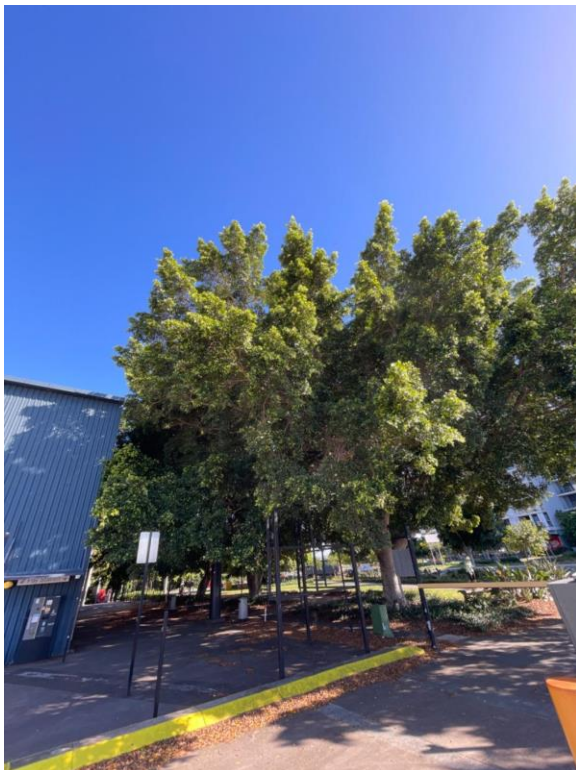
Tree 3 – Clearance over existing vehicle access

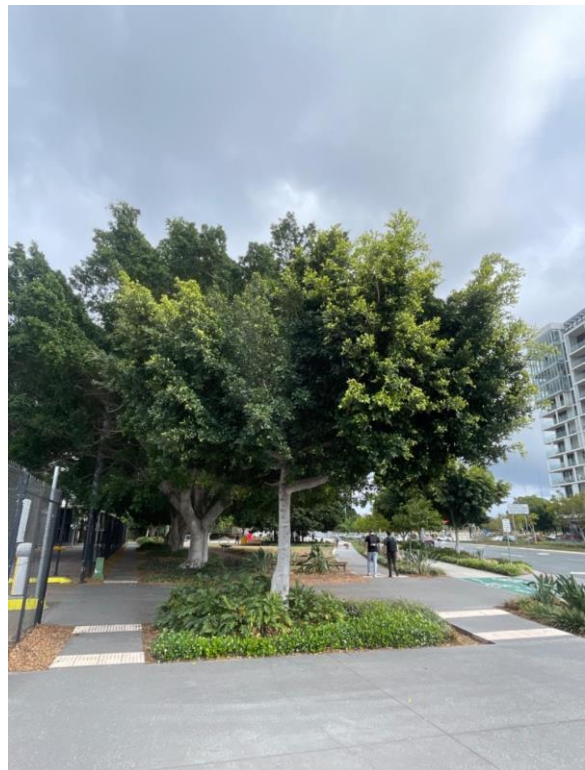
Tree 3 - Clearance to existing structure within the *Subject Site*.

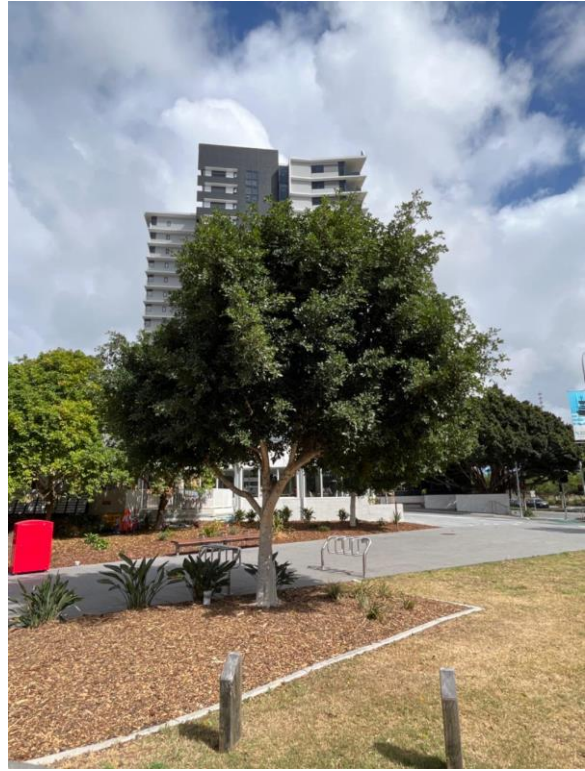
Tree 14 - Wound
