**RE: EVERLEIGH ROL13 – STORMWATER QUANTITY AND STORMWATER QUALITY ANALYSIS**

Project:	QC4060_007 Everleigh ROL13	Date:	9 July 2024
To:	MIRVAC	From:	Engeny
ATT:	Jason Augustine	CC:	Nick Sommerville
Subject:	ROL13 Rapid Waterway Geomorphic Assessment

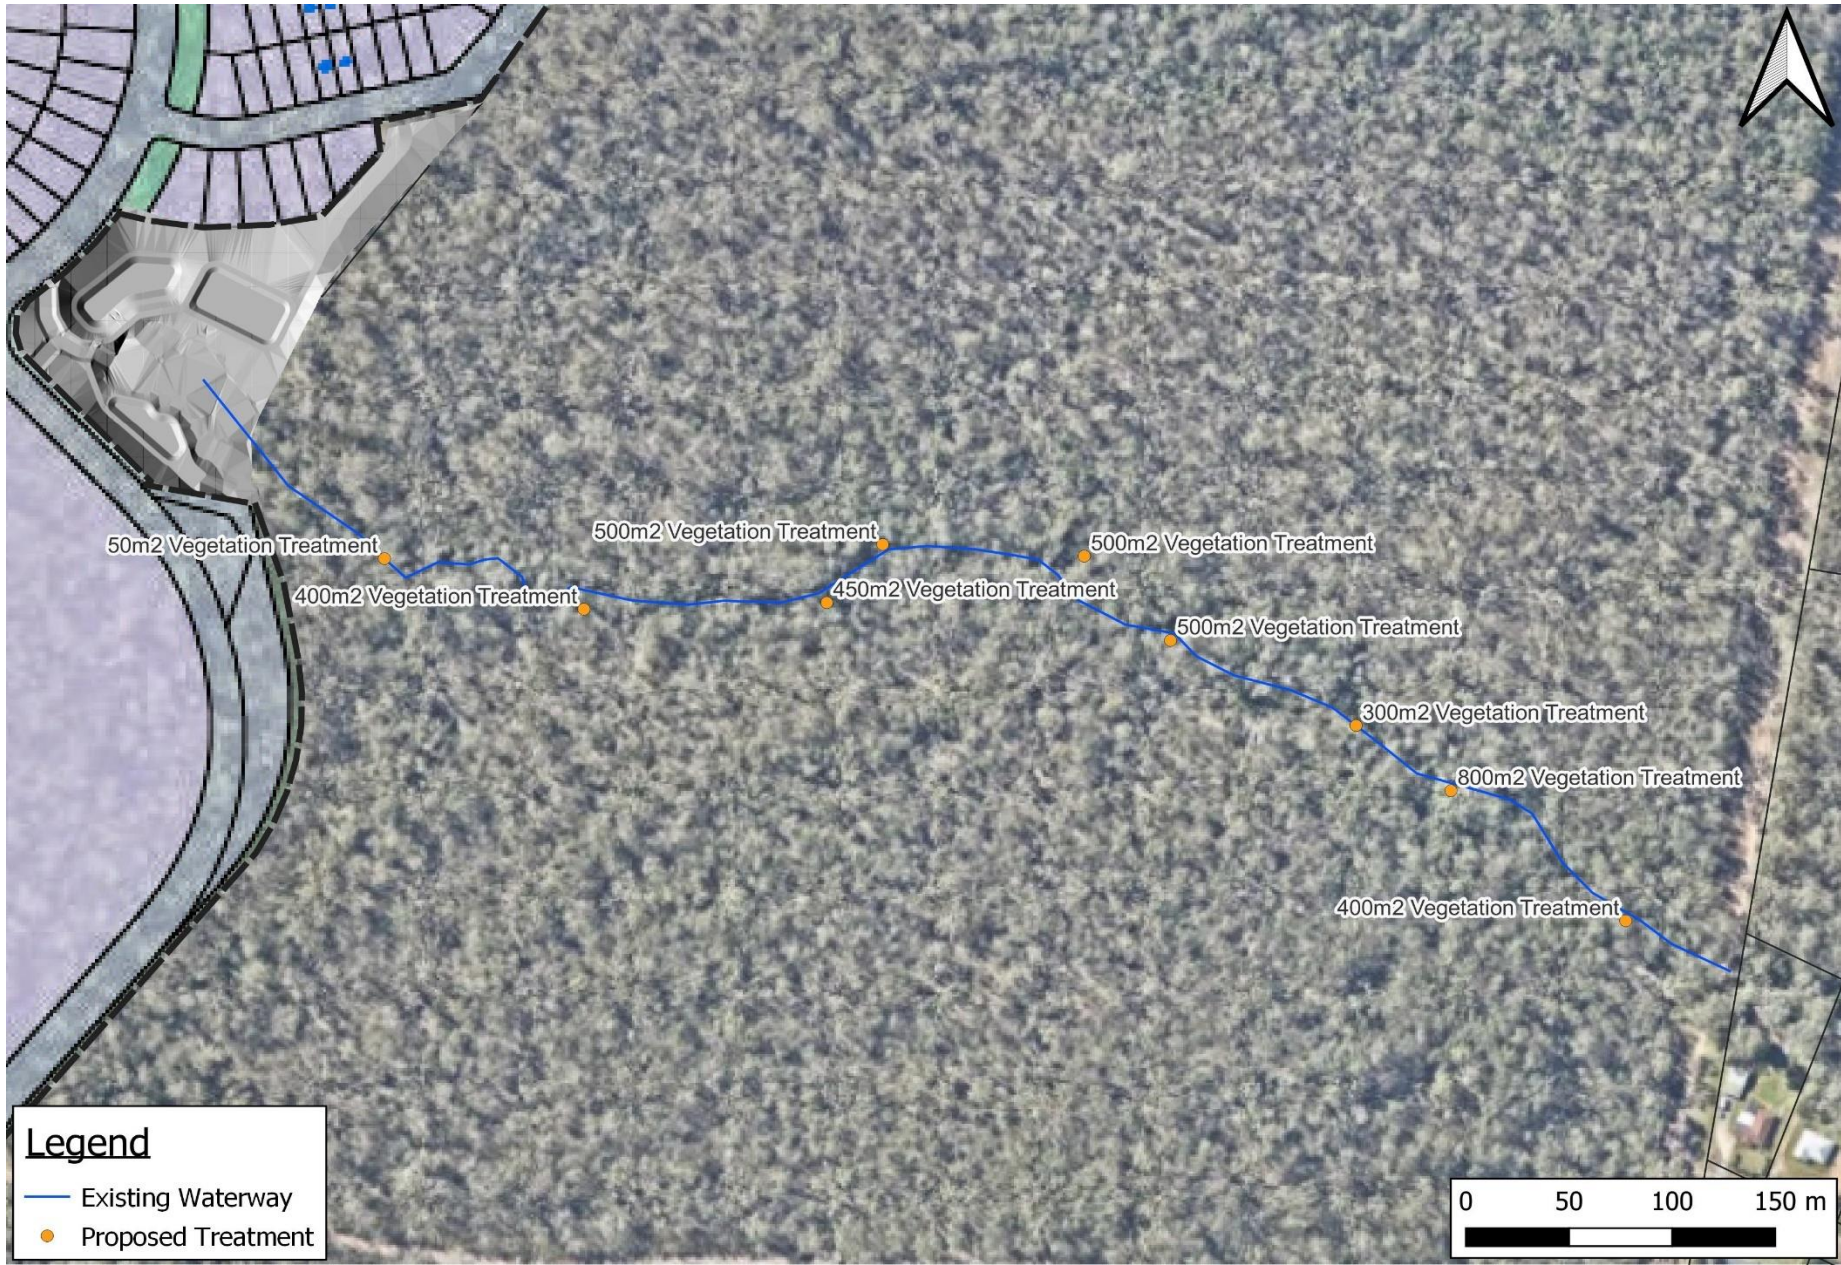
Figure 3: Proposed Treatment Locations

A high levels vegetative assessment was conducted as part of the geomorphic risk assessment. Several areas of erosion were identified which can be attributed to lack of vegetation within the bed and bank of the waterway. Several instances of bank slumping and headcuts were observed during the site inspection. Areas of instability generally correlated with areas where vegetation was lacking, suggesting the waterway stability would be improved, from additional vegetation. Figure 3 specifies the areas in which would benefit the most.

Reaches A and B of the waterway downstream to the project site have experienced a large amount of erosion. The stability recommendations have been divided across several sections throughout both reaches and the locations of such treatment is specified in Figure 3 and typical details of the treatment are specified in Attachment B.

In lieu of major works, it is proposed to retain the natural formation of reaches A and B, by stabilising the area through planting and monitoring for further erosion. The following points outline the proposed strategy from the downstream reaches:

- Incorporate a 10m riparian buffer to the waterway in key locations to stabilise the eroding banks.
  - 4 groundcovers per 1m<sup>2</sup> – Tubestock Planting.

- Combination of trees and shrubs at an approximate density of 1 plant per 10 m<sup>2</sup> (Densities may vary depending on existing canopy cover) – Tubestock and 100mm pots with consideration for deep stem planting on edges of eroded banks.

- Retain existing vegetation, where possible, and enhance native riparian vegetation within the proposed buffer. Consideration should be given to establishment of vegetation within the channel to stabilise the bed.

- Identify strategic locations for the placement of coir logs with vegetation planted either side. These locations will primarily be within the low flow channel. Coir logs are to be anchored to their position by wooden stakes. The coir mesh logs will assist in reducing velocities and promoting deposition within the low flow channel. As the lomandra plants take hold they will reinforce the stability of the surrounding banks and anchor the coir logs in their position.

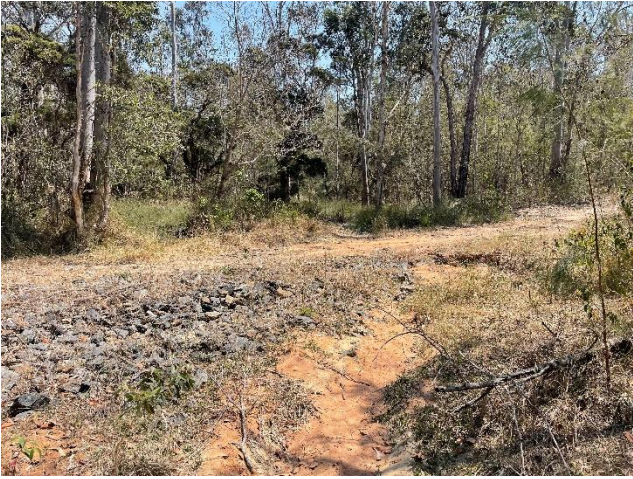
**Location 1 – Proposed Basin Location**

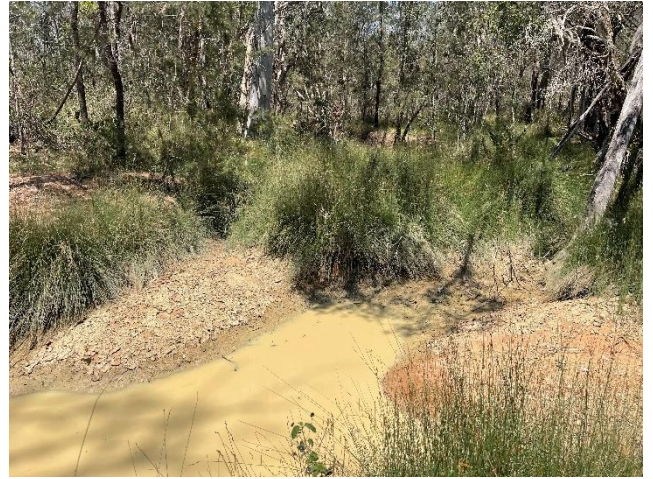
**Erosion** - There is significant bank and batter erosion present throughout the study area, most noticeable in Locations 2 and 11. Bank erosion is a common cause of sediment within waterways, impacting water quality and resulting in blockages within the waterway.

**Location 2 – Confluence Location**

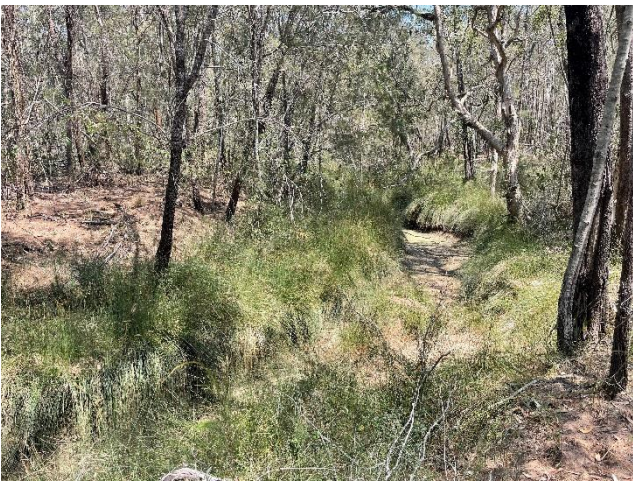
**Location 3 – Significant Deposition**

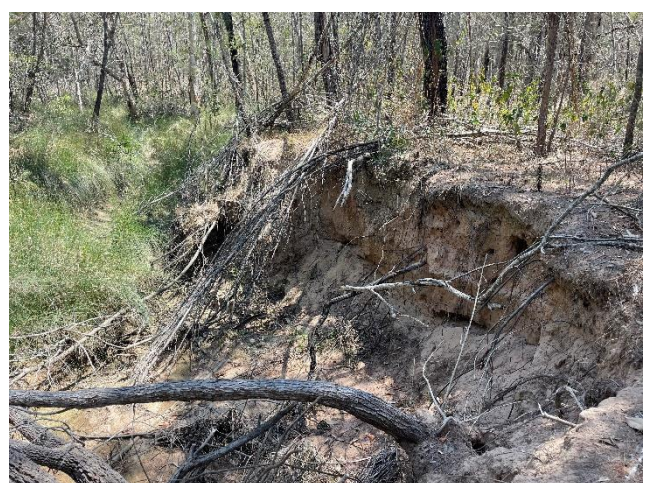
**Location 4 – Scour and Dispersive Soils**

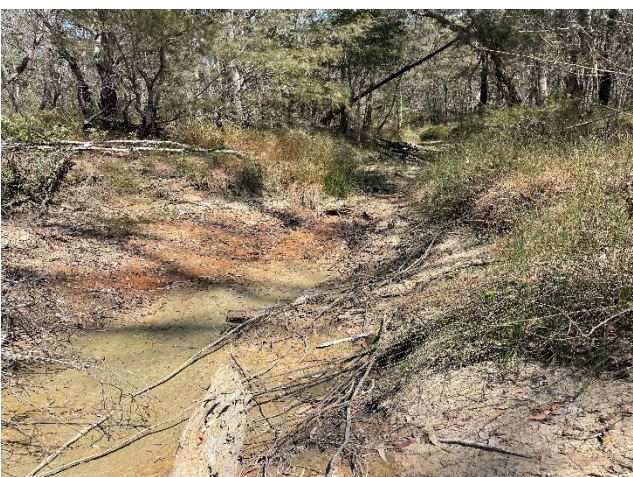
**Location 5 – Limited Vegetation**

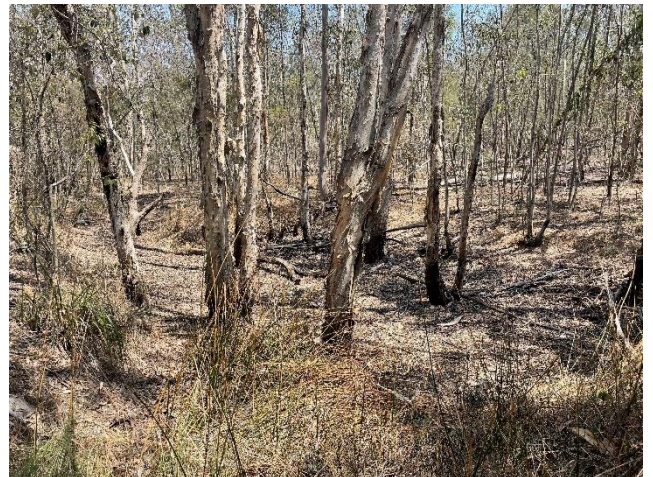
**Location 6 – Dry Wetland off Channel**

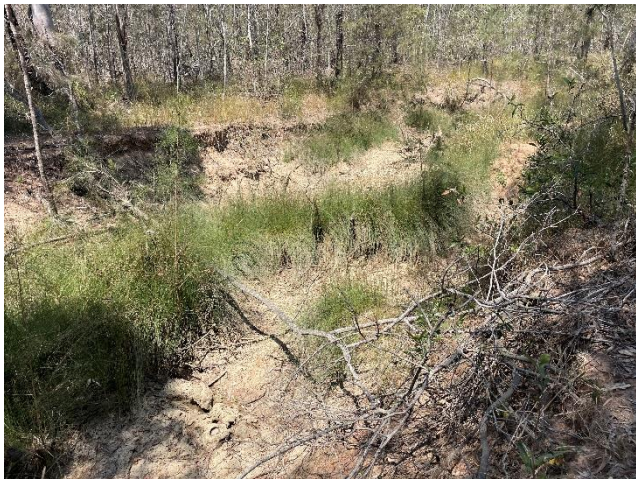
**Location 7 – Waterway Widened with Exposed Banks**

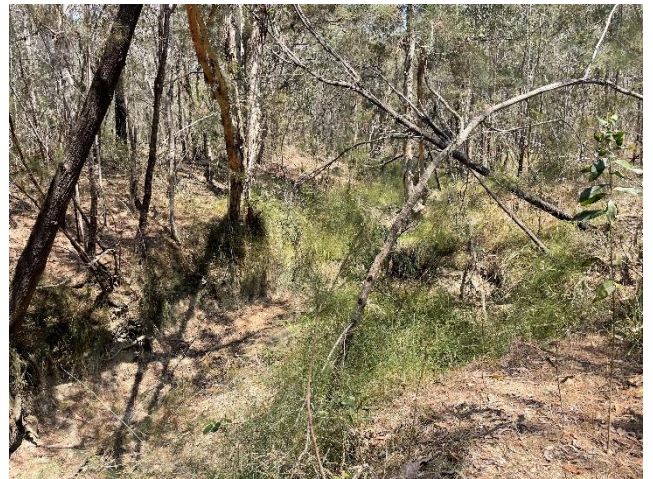
**Location 8 – Bank Erosion Evident**

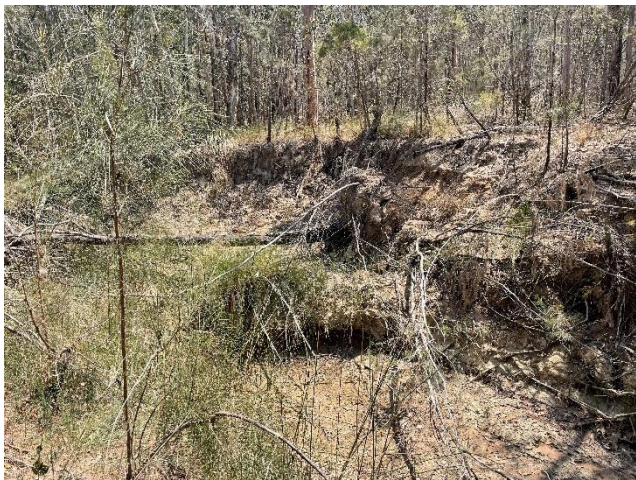
**Location 9 – Bank Erosion to Outside Bend**

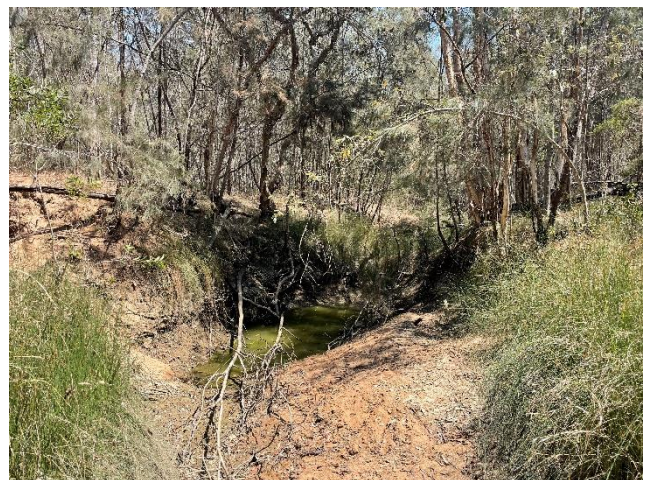
**Head Cuts** - Head cuts have been identified in Locations 10, 14 and 16, as noted in Figure 2. There is potential for these head cuts to continue to migrate further upstream, deepening and widening the waterway. This could result in significant sediment transport to downstream environs and loss of native vegetation adjoining the waterway which provides habitat.

**Location 10 – Headcut Location 1**

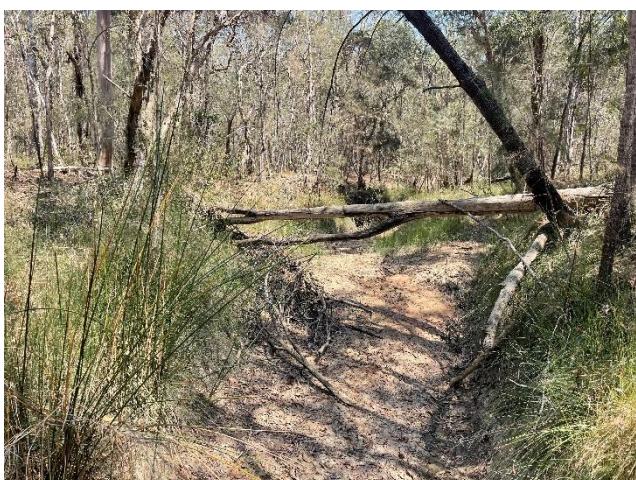
**Location 11 – Bank Erosion and Split Waterway**

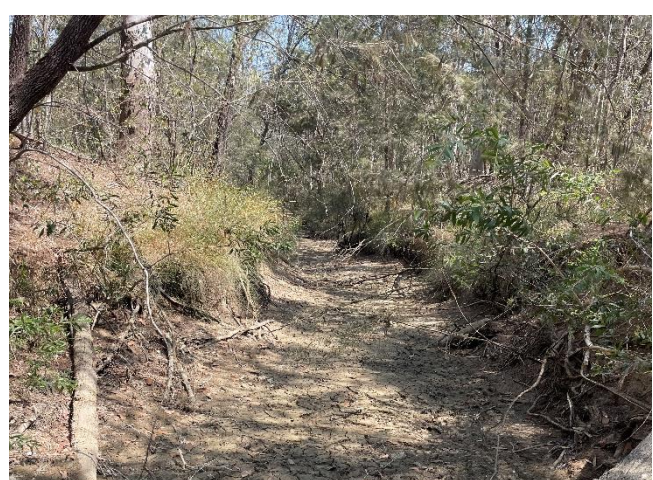
**Location 12 – Incised Low Flow Channel Deepens**

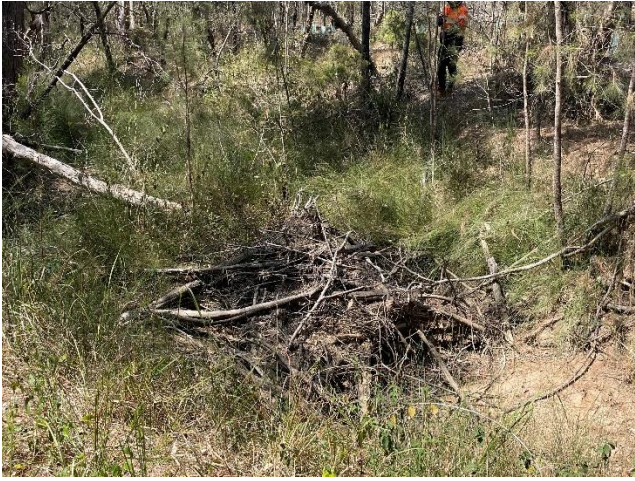
**Location 13 – Instream Pond**

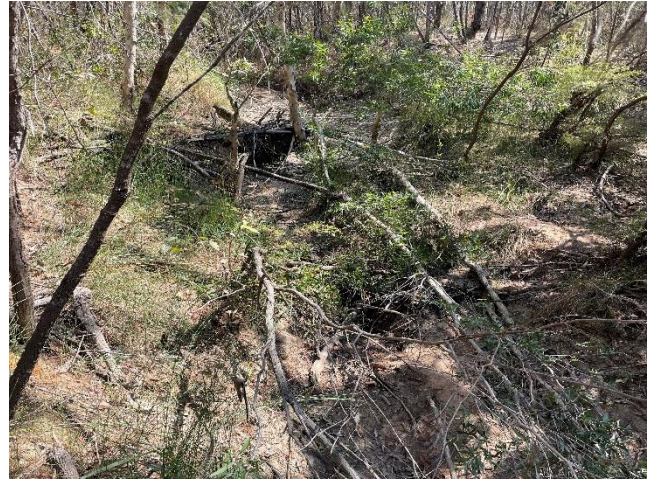
**Location 14 – Headcut Location 2**

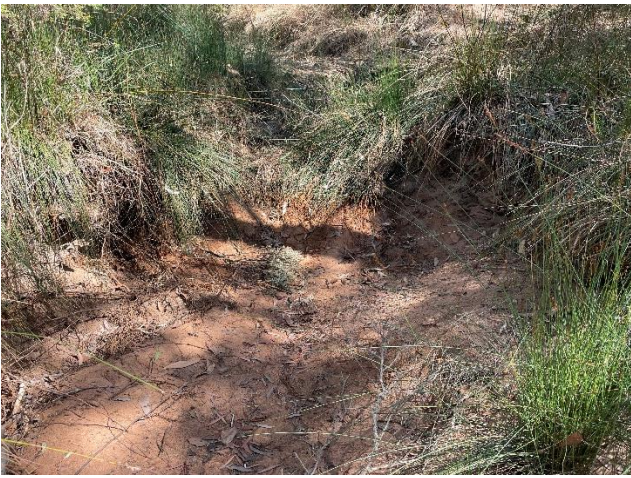
**Location 15 – Bank Erosion and Split Waterway**

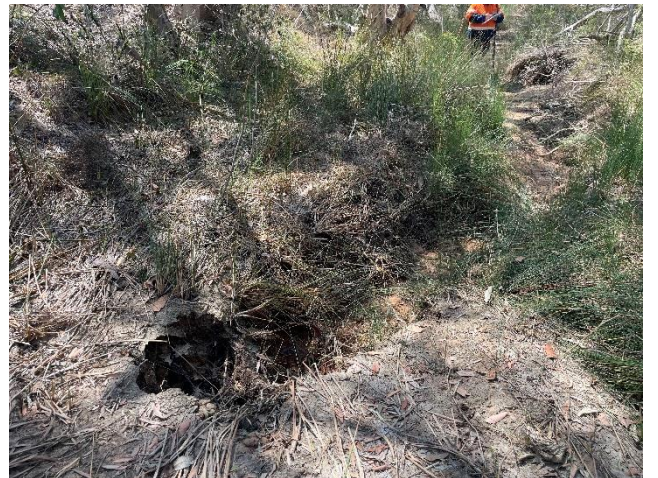
**Location 16 – Headcut Location 3**
