**PLANS AND DOCUMENTS  
referred to in the PDA  
DEVELOPMENT APPROVAL**

**Approval no: DEV2024/1495**

**RE: Proposed Viewing Decks within Moreton Bay Marine Park.**

# Arboricultural Report

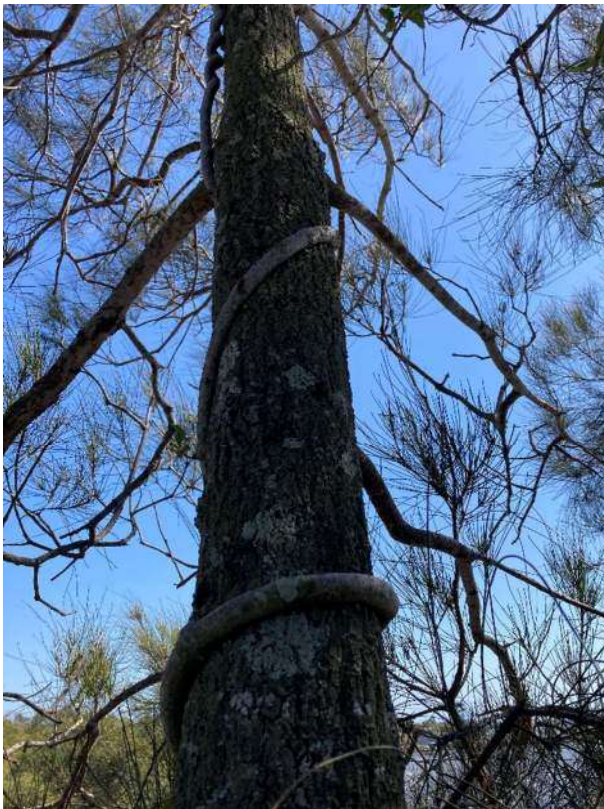
Tree 113

Trees 113 and 114 are subject to the growth of a *Parsonsea* vine. At this stage this is not impacting the health of the specimens, but in future it may contribute to trunk girdling and competition for light resources, leading to tree decline. The vine should be removed to promote the long term health of these two trees.

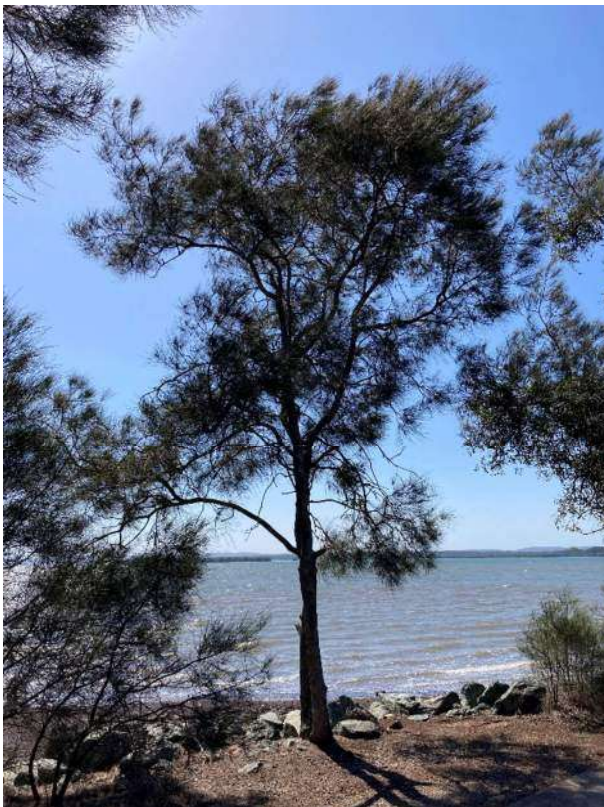
The deck will be constructed on pier footings and cantilevered towards the waterfront. The footings should not be installed within the Structural Root Zone of retained trees where damaged roots may lead to tree failure in the exposed, windy conditions. The current deck design allows for the cut-out of sections of the deck to accommodate tree retention. This treatment could be applied to two sections of vegetation – Tree 115 and the clump of trees inclusive of Trees 116 – 119.

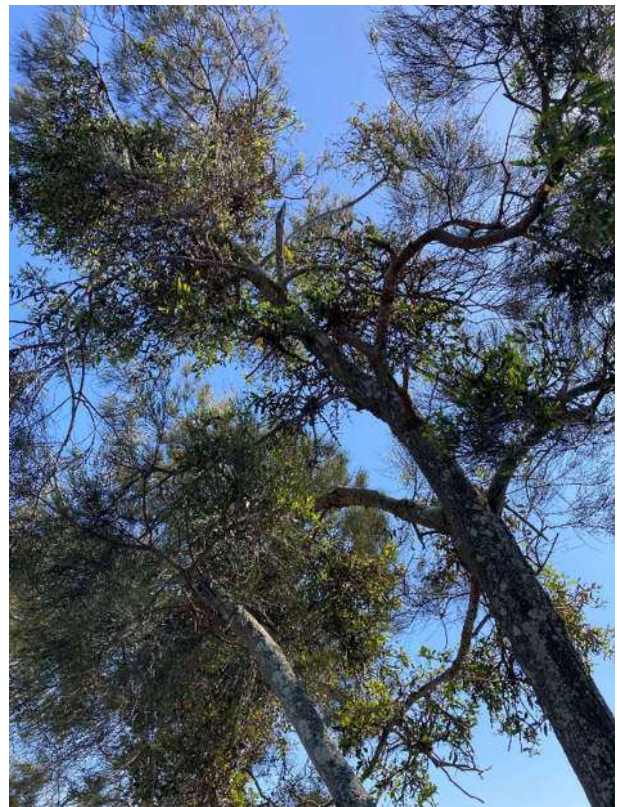
Trees 116

Note, specimens within the clump of trees 116-119 are in fair health. Tree 116 is subject to over 10 mistletoe parasites and the number of branch stubs implies a history of branch failures. A recent

pruning cut at the base of the tree suggests a main leader was removed, possibly following decline. Tree 117 displays poor form with one trunk snapped at 1.8 metres, while Trees 118 and 119 display fair health and form. Retention of these trees may not be a valuable option with consideration of the long term maintenance required and potential whole or partial failures posing a hazard to users.
