RE: EVERLEIGH ROL13 – STORMWATER QUANTITY AND STORMWATER QUALITY ANALYSIS

QC4060_007-LTR-001-2-Everleigh ROL13 SW Analysis

Project:	QC4060_007 Everleigh ROL13	Date:	9 July 2024
To:	MIRVAC	From:	Engeny
ATT:	Jason Augustine	CC:	Nick Sommerville
Subject:	ROL13 Rapid Waterway Geomorphic Assessment

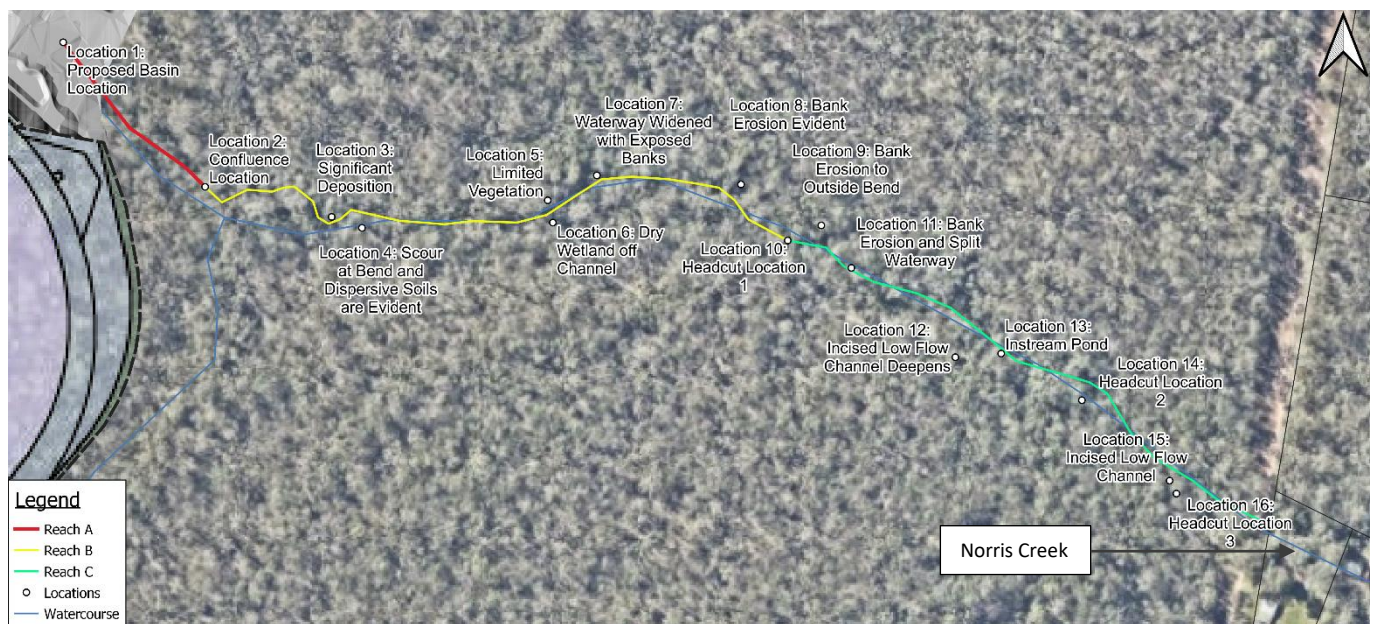
Figure 2: Project Study Area

- Generally single Incised low flow channel within wider floodplain.
- Incision generally stabilised where ground covers are present.
- Small headcuts.
- Bank erosion with dispersive soils evident.
- Historical tree clearance (lack of mature trees), likely due to grazing practices.
- Sandy substrate within the channel bed.
- Sinuosity calculation = 1.1 (therefore is considered a straight waterway).

Reach	Observations
A – Upstream Reach	<p>Reach A is approximately 100m long and is located immediately downstream of the proposed development. Location 1 is considered the most upstream point of the defined waterway. The reach consisted of a small incised ephemeral low flow channel within the greater floodplain. Surrounding vegetation consisted of small trees, long grass and lomandra. However, vegetation was sparse in a number of areas and the batters of the upstream portion of the reach had limited vegetation cover. Location 2 shows the confluence of the reach with the main waterway, which presents as a more defined channel. It was evident that the batters were eroding in this area.</p>
B – Mid Reach	<p>Reach B is approximately 370m long and commences at location 2. The waterway appeared to be much more defined through Reach B and consisted of deepening to the channel where natural ponds have been formed and are holding water. Throughout the entirety of the reach, several features and instabilities were observed. At Location 4 scour to the bank was located at a bend with dispersive soils being evident. The channel was approximately 3m deep in this area. Several small trees were found at the top of both sides of the banks however, there are limited ground covers to assist the trees in establishing and stabilising the embankment. The combination of dispersive soils and limited ground covers has resulted in the widening of the channel, and the ongoing erosion of the embankment.</p> <p>Further downstream, dispersive soils continued to be evident, with limited vegetation on the banks of the waterway. The lack of vegetation and presence of exposed dispersive soils has resulted in the significant scour and erosion of the banks where the roots of trees had been exposed (locations 7, 8 & 9).</p> <p>A head cut was observed at location 10. The head cut is partially stabilised by lomandra and long grass. Several ponds were also found in the vicinity of location 10 which appeared to be hydrating vegetation.</p>

C – Downstream Reach	<p>Reach C is approximately 340m long and commences downstream of the first head cut. Similar to the mid reach the downstream reach consisted of small trees located at the top of batter with limited ground covers to stabilise the embankment. At Location 11 the primary channel had eroded and blocked the channel resulting in a secondary channel forming through deposition on the inside bench. The confluence of the primary and secondary channel occurs approximately 20-30m downstream of where the split occurred. The main channel continued at a consistent depth of approx. 1m from location 10 to location 12 where the incised low flow channel deepened to 1.5-2.0m. Two (2) additional head cuts were observed at location 14 and location 16 which were partially stabilised by native grasses.</p>

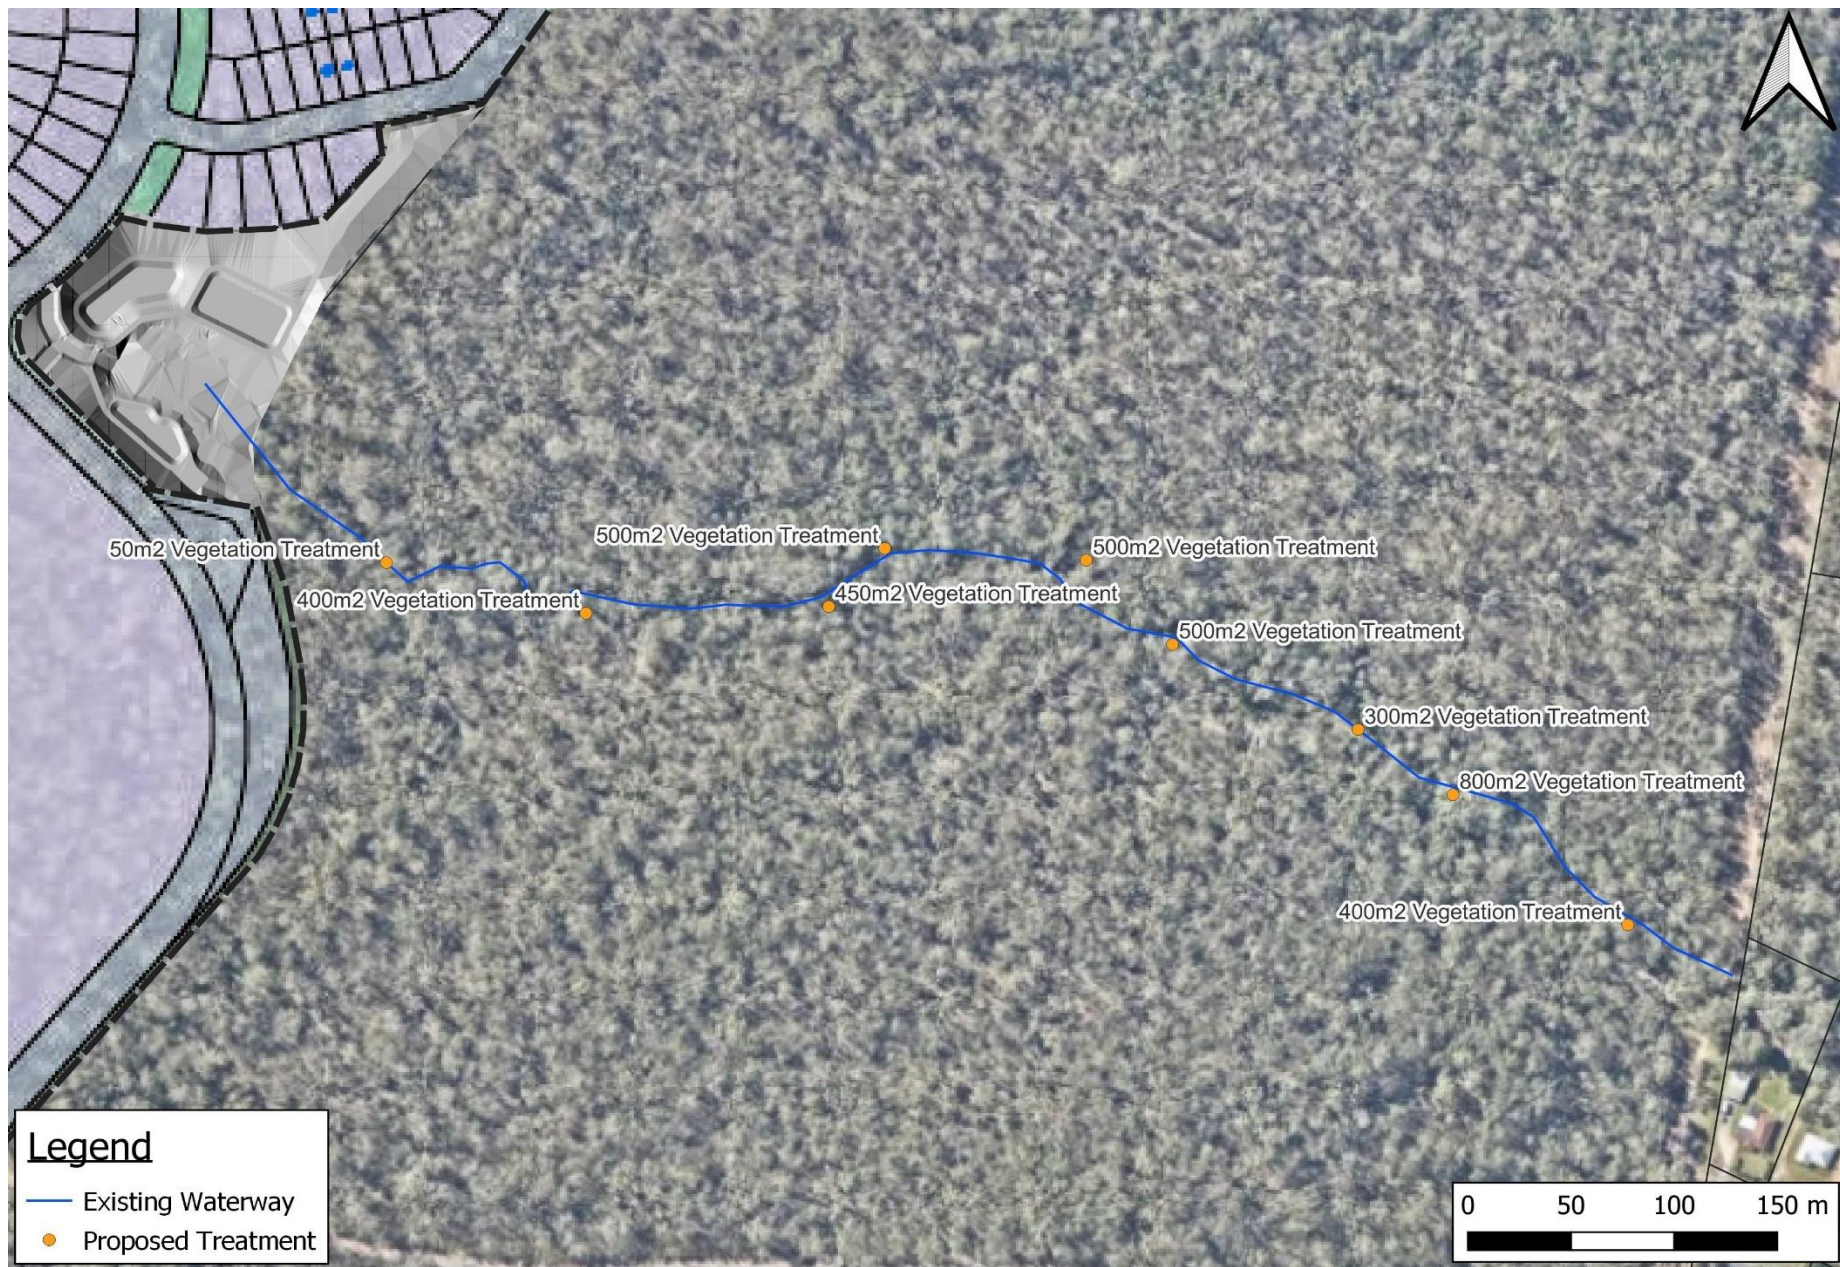
Figure 3: Proposed Treatment Locations

Reaches A and B of the waterway downstream to the project site have experienced a large amount of erosion. The stability recommendations have been divided across several sections throughout both reaches and the locations of such treatment is specified in Figure 3 and typical details of the treatment are specified in Attachment B.

- Incorporate a 10m riparian buffer to the waterway in key locations to stabilise the eroding banks.
 - 4 groundcovers per 1m² – Tubestock Planting.
 - Combination of trees and shrubs at an approximate density of 1 plant per 10 m² (Densities may vary depending on existing canopy cover) – Tubestock and 100mm pots with consideration for deep stem planting on edges of eroded banks.

- Retain existing vegetation, where possible, and enhance native riparian vegetation within the proposed buffer. Consideration should be given to establishment of vegetation within the channel to stabilise the bed.

- Identify strategic locations for the placement of coir logs with vegetation planted either side. These locations will primarily be within the low flow channel. Coir logs are to be anchored to their position by wooden stakes. The coir mesh logs will assist in reducing velocities and promoting deposition within the low flow channel. As the lomandra plants take hold they will reinforce the stability of the surrounding banks and anchor the coir logs in their position.

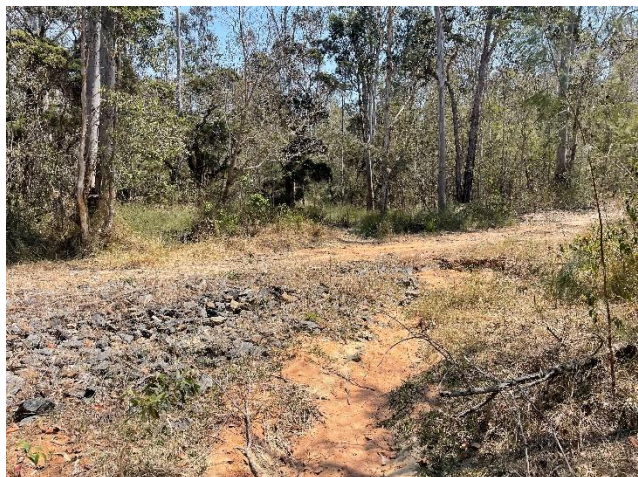
Location 1 – Proposed Basin Location

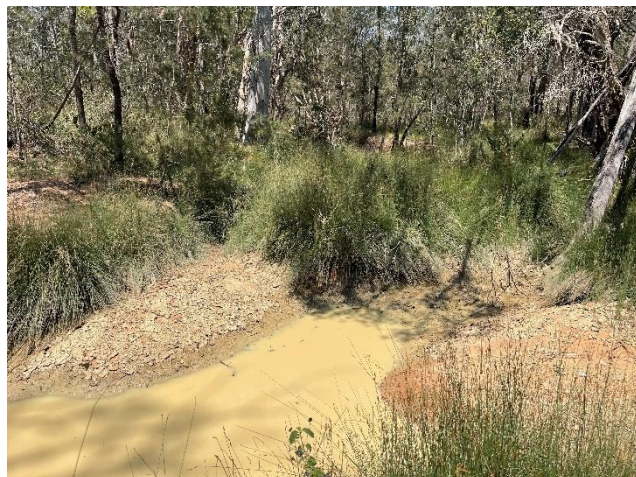
Erosion - There is significant bank and batter erosion present throughout the study area, most noticeable in Locations 2 and 11. Bank erosion is a common cause of sediment within waterways, impacting water quality and resulting in blockages within the waterway.

Location 2 – Confluence Location

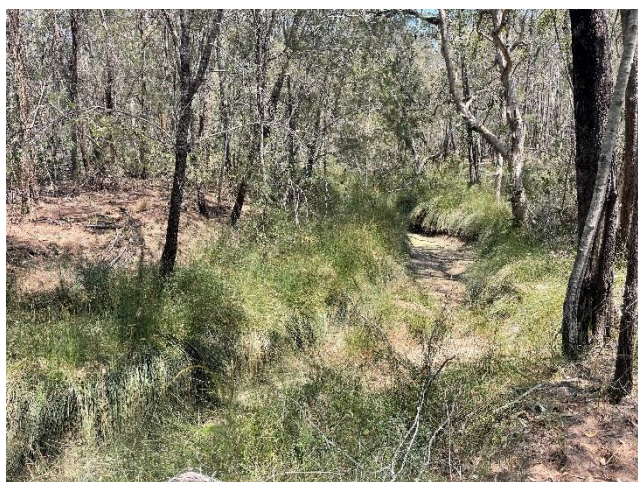
Location 3 – Significant Deposition

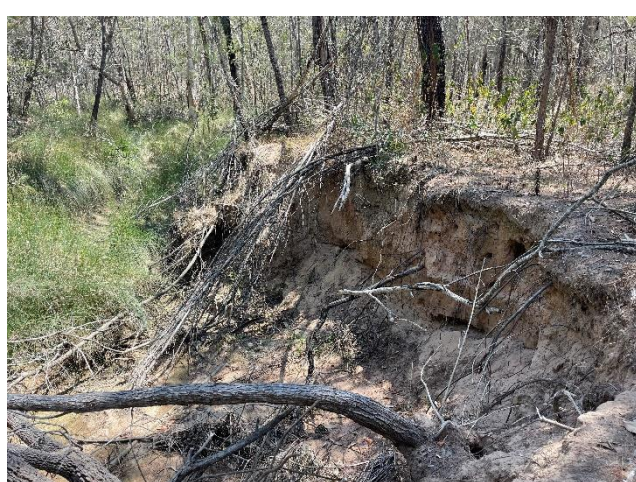
Location 4 – Scour and Dispersive Soils

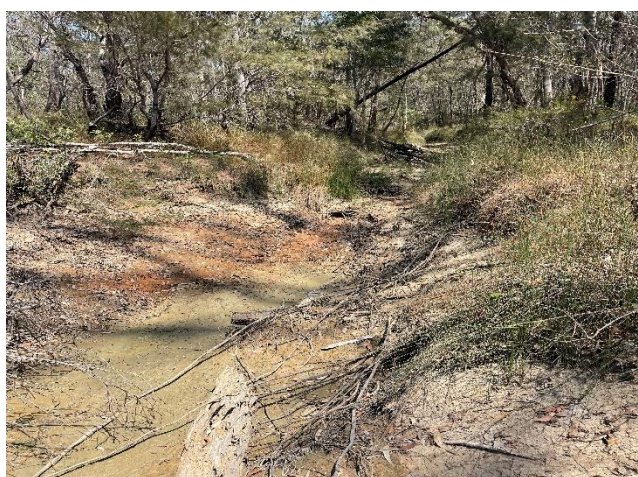
Location 5 – Limited Vegetation

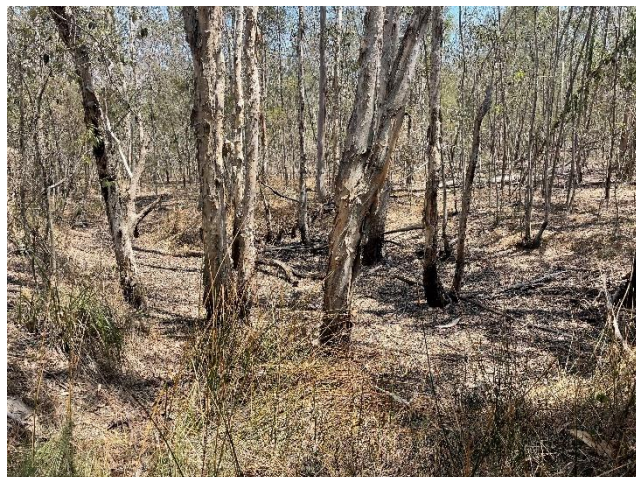
Location 6 – Dry Wetland off Channel

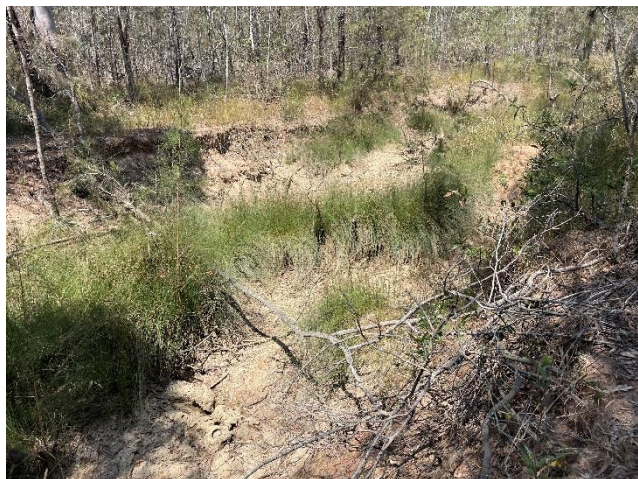
Location 7 – Waterway Widened with Exposed Banks

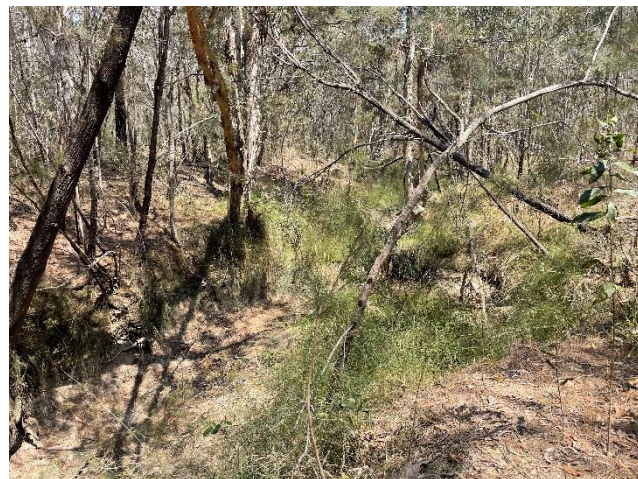
Location 8 – Bank Erosion Evident

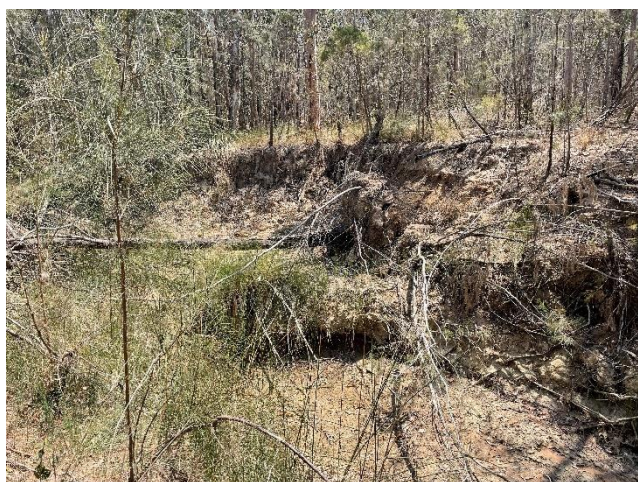
Location 9 – Bank Erosion to Outside Bend

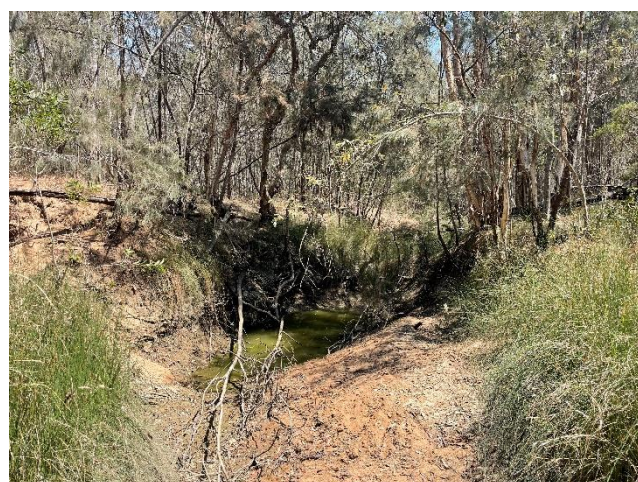
Head Cuts - Head cuts have been identified in Locations 10, 14 and 16, as noted in Figure 2. There is potential for these head cuts to continue to migrate further upstream, deepening and widening the waterway. This could result in significant sediment transport to downstream environs and loss of native vegetation adjoining the waterway which provides habitat.

Location 10 – Headcut Location 1

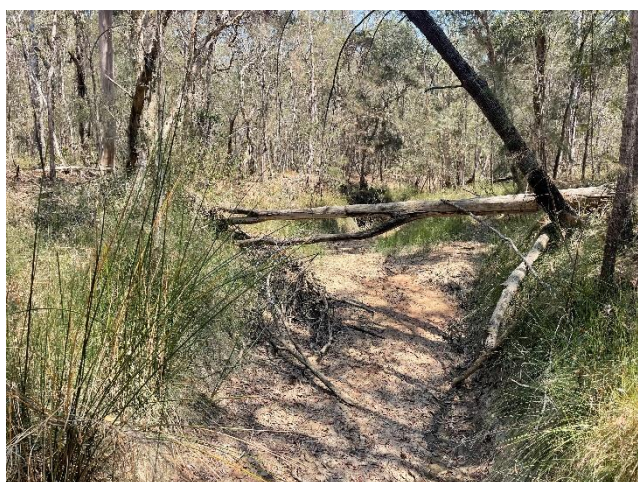
Location 11 – Bank Erosion and Split Waterway

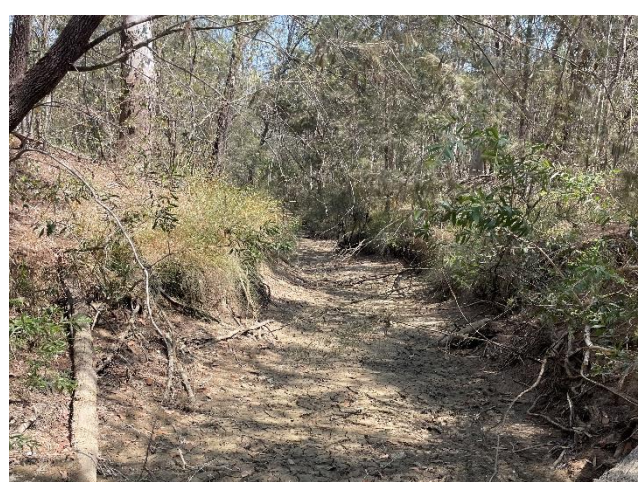
Location 12 – Incised Low Flow Channel Deepens

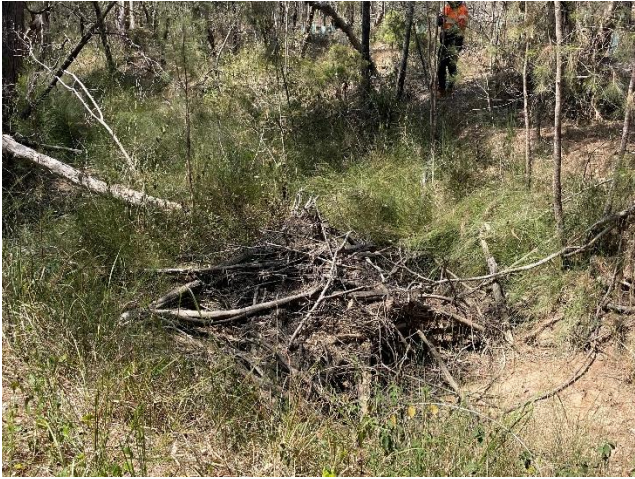
Ponds - The site inspection noted the presence of small ponds that are currently hydrating the surrounding landscape and enhancing vegetation. Increased riparian densities around the fringes of these ponds will enhance stability and habitat value reducing the risk of erosion occurring around and within these ponds.

Location 13 – Instream Pond

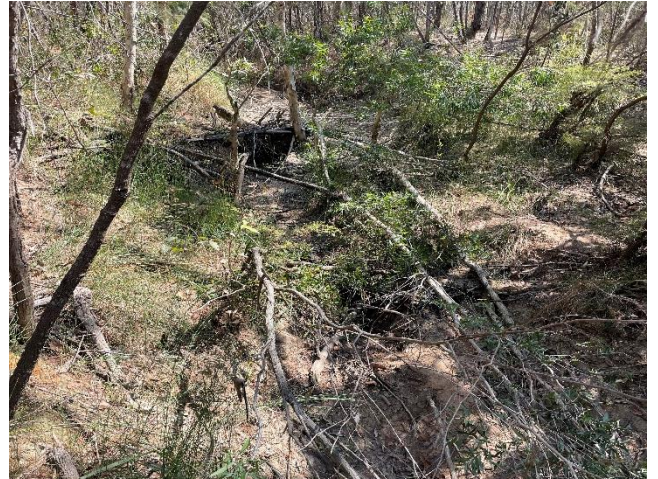
Location 14 – Headcut Location 2

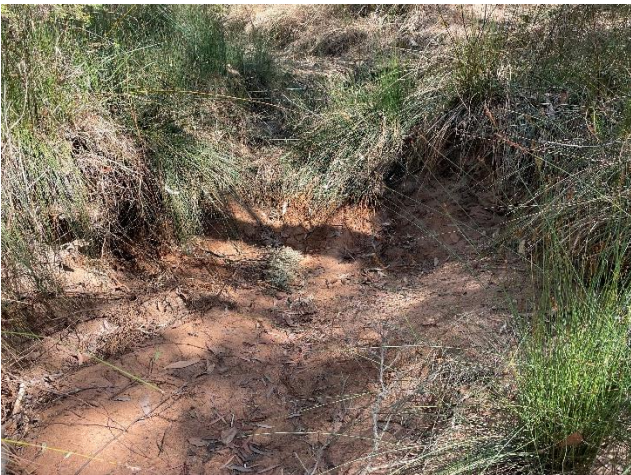
Location 15 – Bank Erosion and Split Waterway

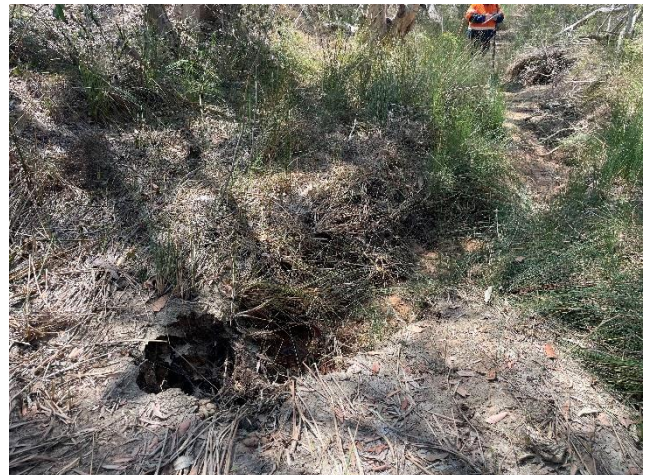
Location 16 – Headcut Location 3
