Waterway investigation within Lot 4 SP332712, Olsen Road New Beith

Date: 29 July 2024

From: Fishology Consulting Pty Ltd

Project: Waterway investigation within Lot 4 SP332712, New Beith.

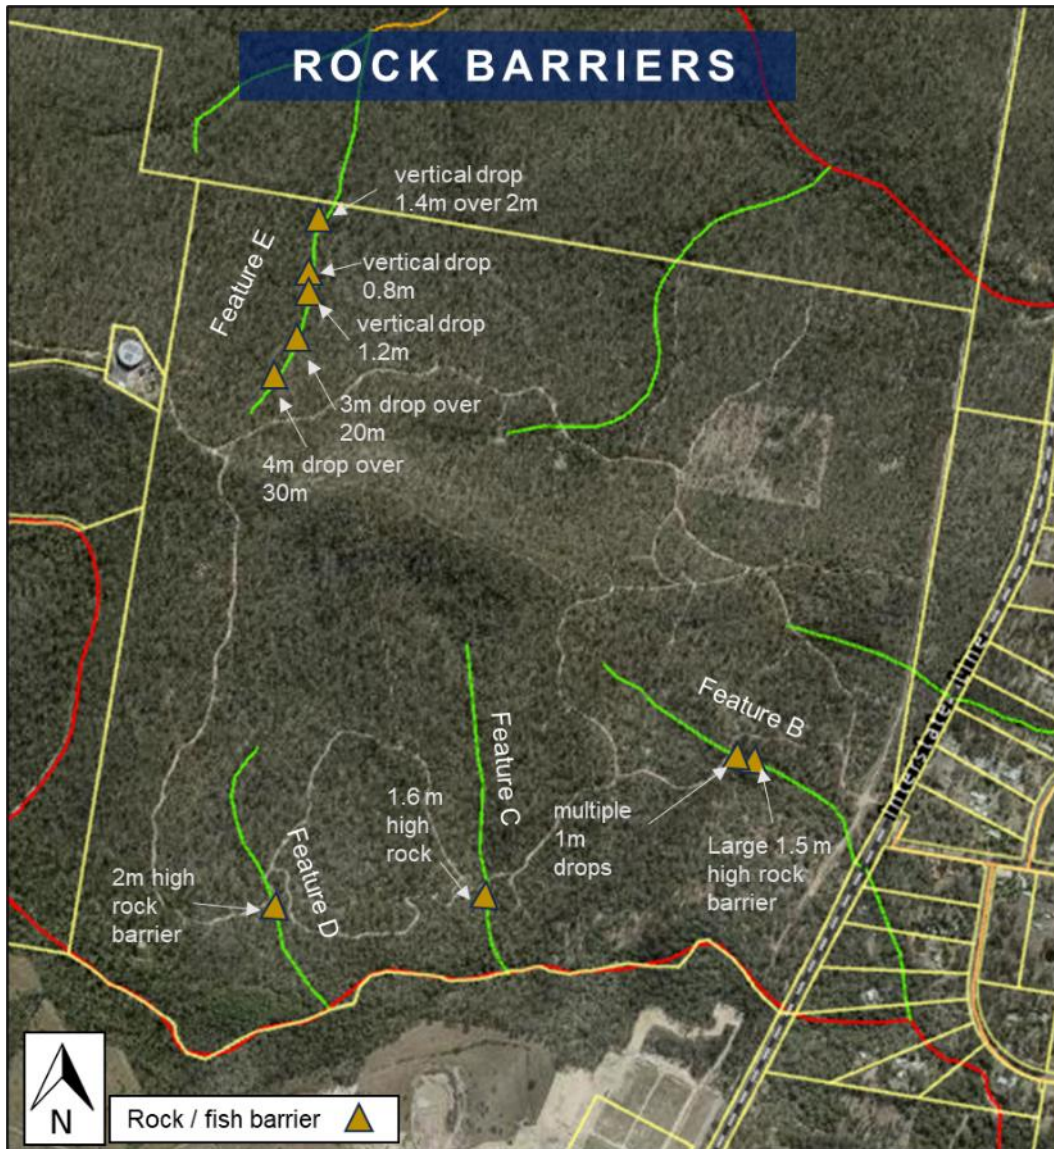
Figure 3. Rock barriers observed during site walkovers.

Of all the mapped waterways, Feature E had the highest number of rock barriers with five general areas observed. Within most of these areas there were often a series of rock structures. For example, at the upper rock barrier site there were four separate rock drop-offs over a distance of 30m. Despite the other mapped features having fewer rock barriers, the ones that were observed in the other mapped features (B, C and D) were very large and would prohibit fish passage.

- All of the mapped waterway features (except Flagstone Creek) had large natural rock outcrops that would act to restrict the migration of fish above these features (Figure 3, Appendix B). Most of the mapped waterways were also very steep or had steep sections that would act to further prevent fish migration, especially features B, C and E (Table 2).

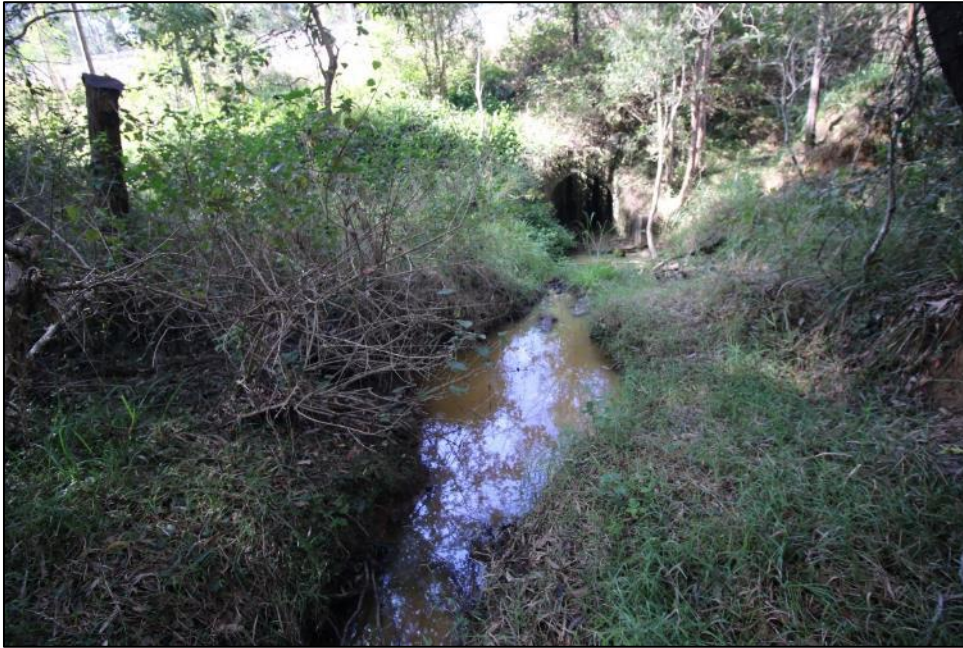
- Feature B retained water within pools in the lower portion of the mapped waterway and a single pool in the middle reach. However, the ponded water was anoxic and lacked maintaining inflows to provide suitable conditions for fish. Upper features were also above rock barriers. No fish were captured.
- Some water was retained (2 areas of ponded water within the middle of mapped feature C). As per the above these were anoxic and lacked maintaining flows to provide suitable conditions for fish. Upper features were also above rock barriers. No fish were captured.

Site B3. Fish habitat in lower section of mapped waterway with no fish. Anoxic water present in pool.

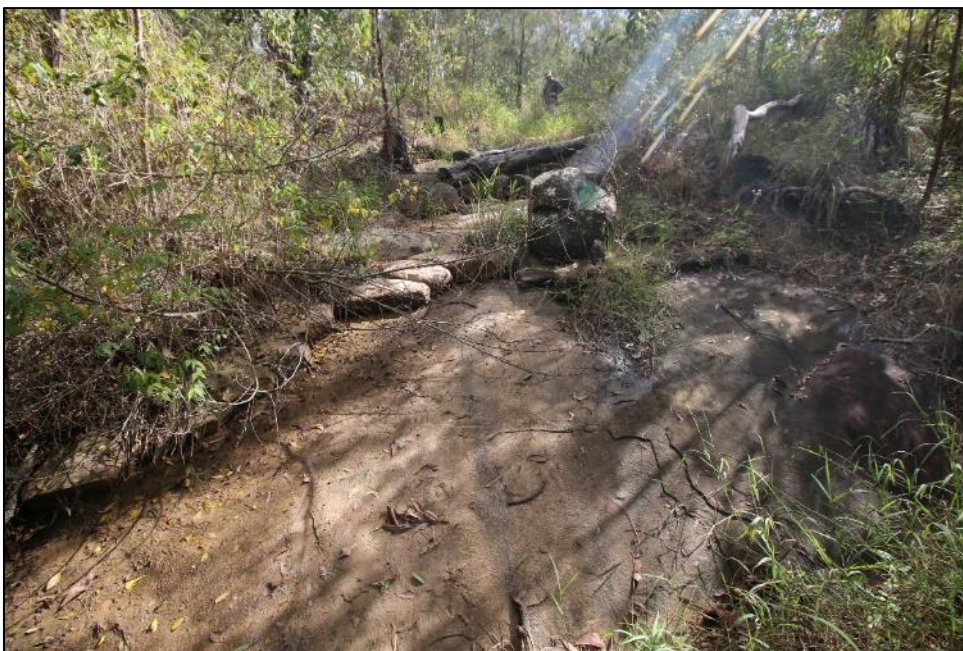
Site B2. Large 1.5m high rock barrier with several additional 1m rock drop offs above in the middle of mapped waterway (27.7849, 152.9560). Natural barrier to fish in a dry section of mapped waterway with no fish.

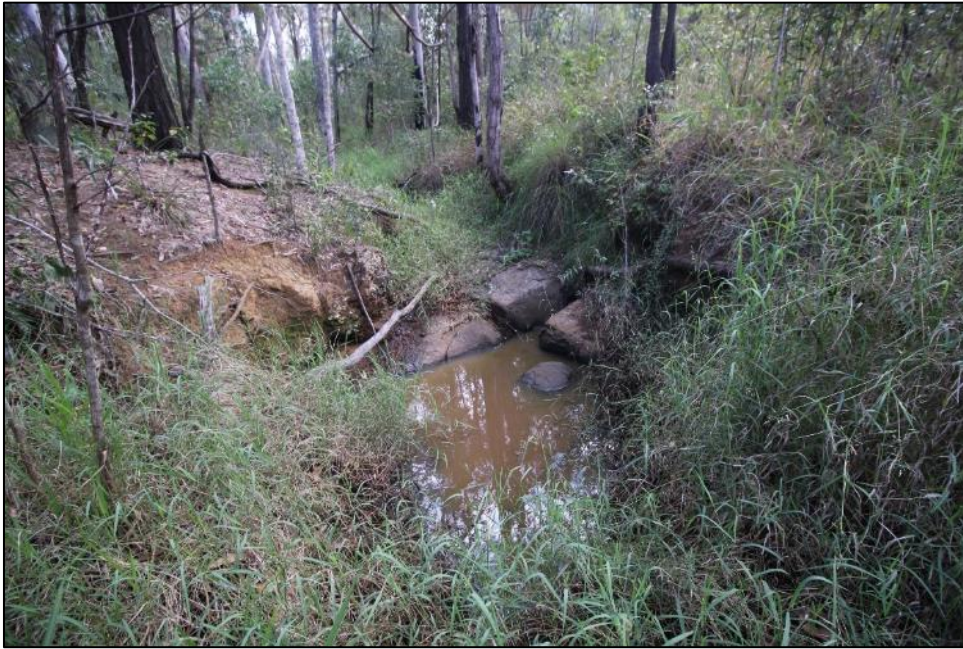
Site B1. Upper isolated pool within rock basin with no fish. Sandy area above B1 was completely dry. Water quality in isolated pool was poor and anoxic.

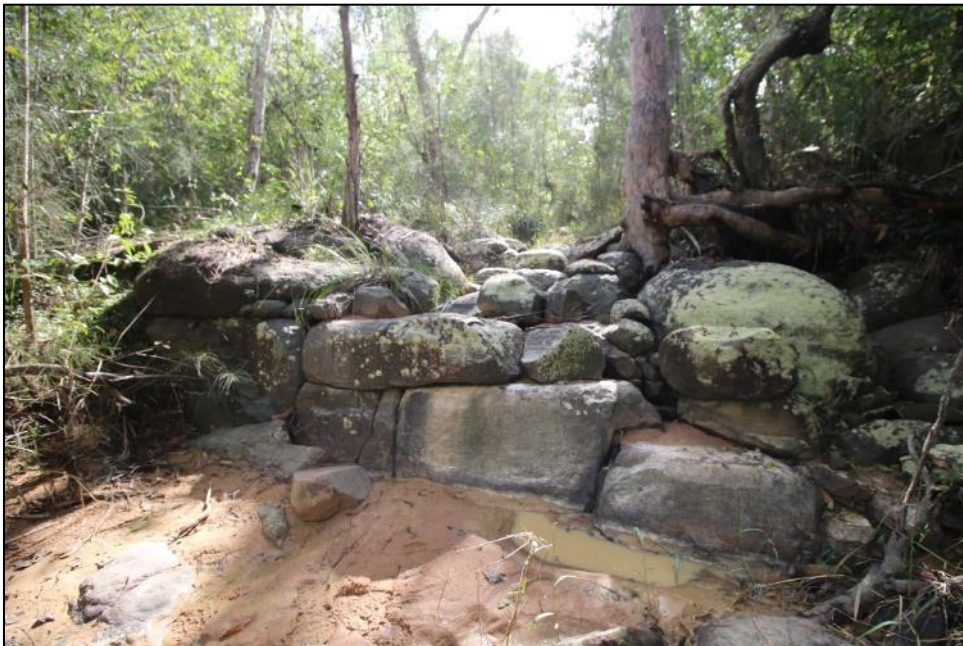
Site C3. Large rock barrier (single 0.9m vertical drop and 1.6m drop overall) that is a significant barrier to fish in the middle of the dry mapped waterway (other than the occasional very small puddle from recent rain).

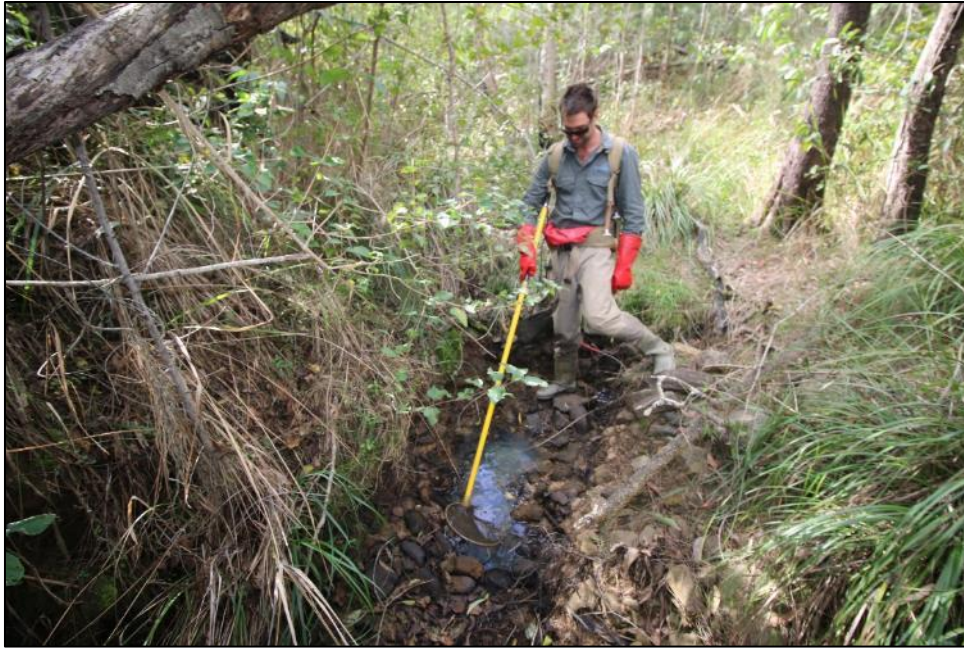
Site C2. Isolated pool. Only two small pools were found in the upper area of feature C that contained water. No fish were recorded.

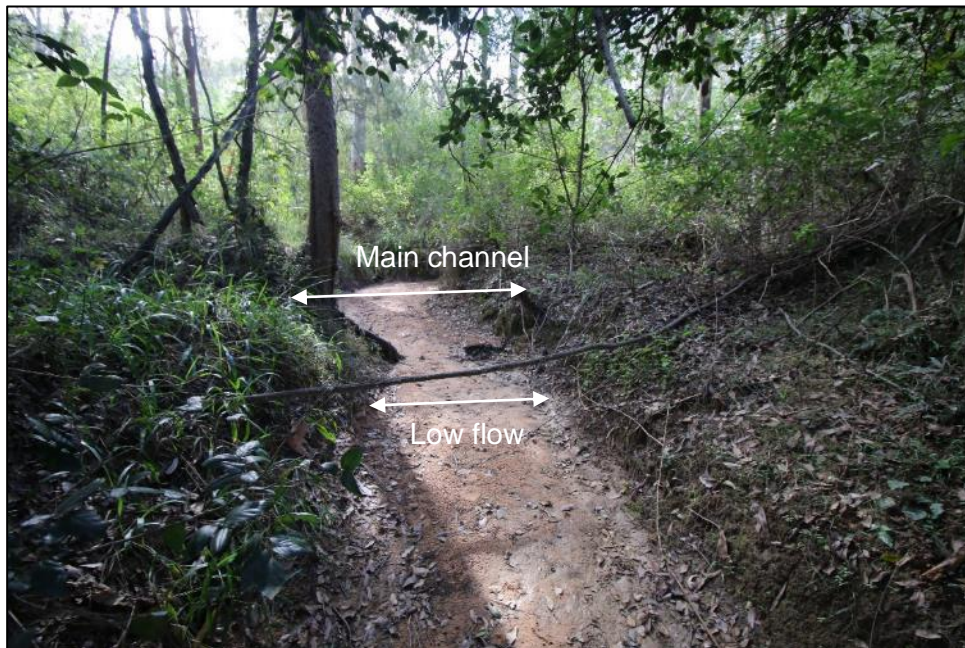
Below C3. Mapped waterway near Flagstone Creek was dry although had defined low flow and main channel features.

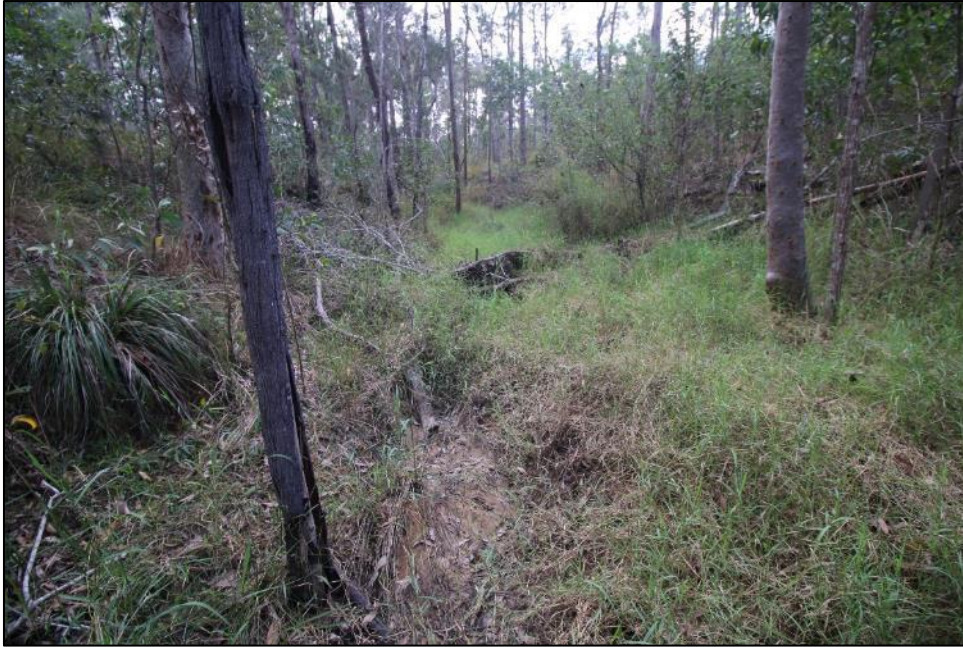
Site D2. Mapped waterway feature that was completely dry with grass growing throughout the mapped feature.

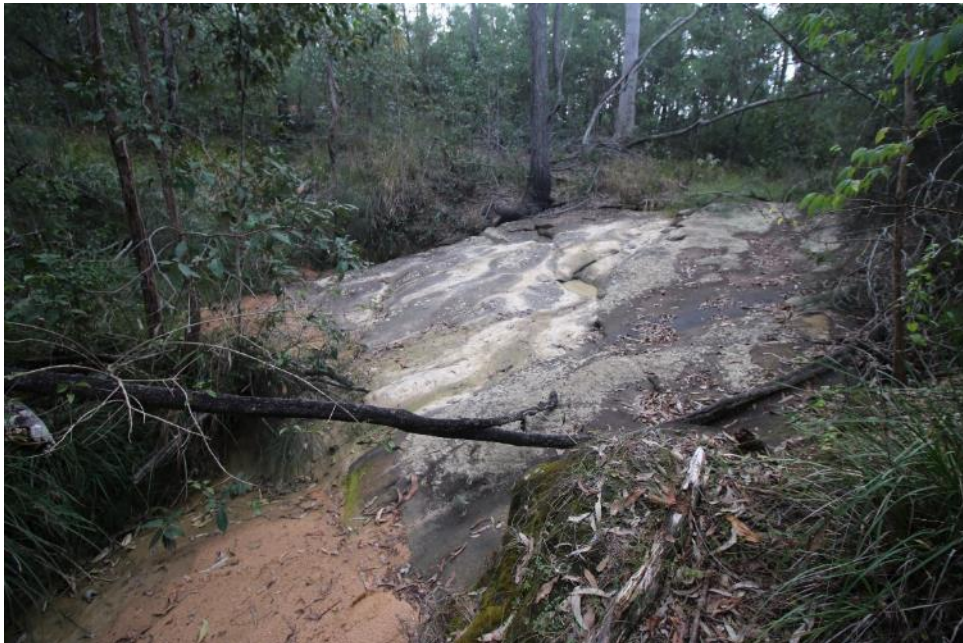
Site D1. Large rock barrier (estimated to be 2.0m high) within the channel of the mapped waterway. A major barrier to fish.

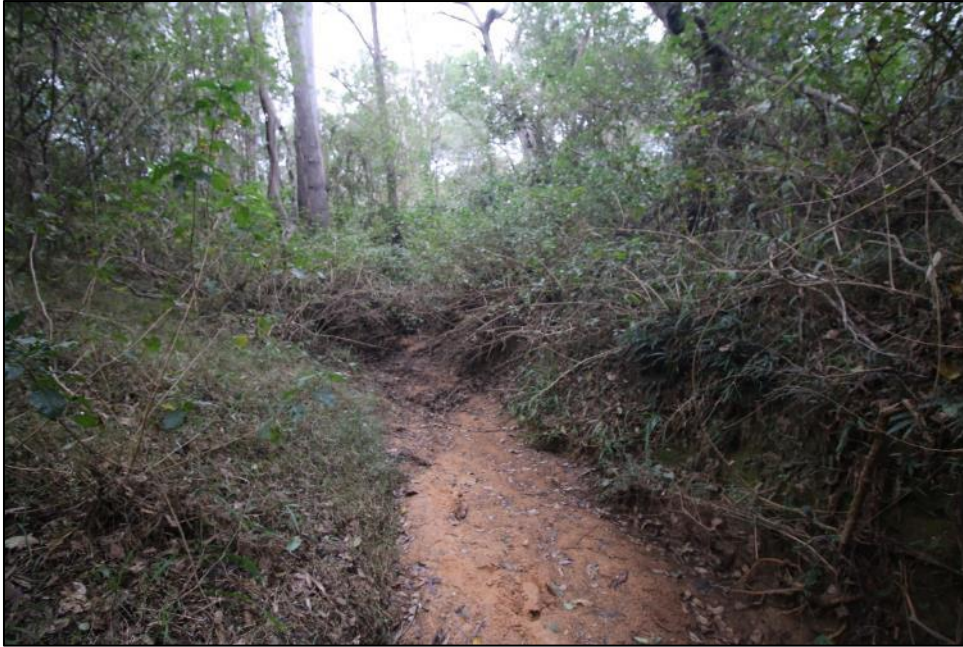
Site D2. Dry channel at the bottom of feature D near Flagstone Creek. The lower portion of this mapped feature had defined bed and bank features. Site was completely dry and contained no fish or fish habitats.

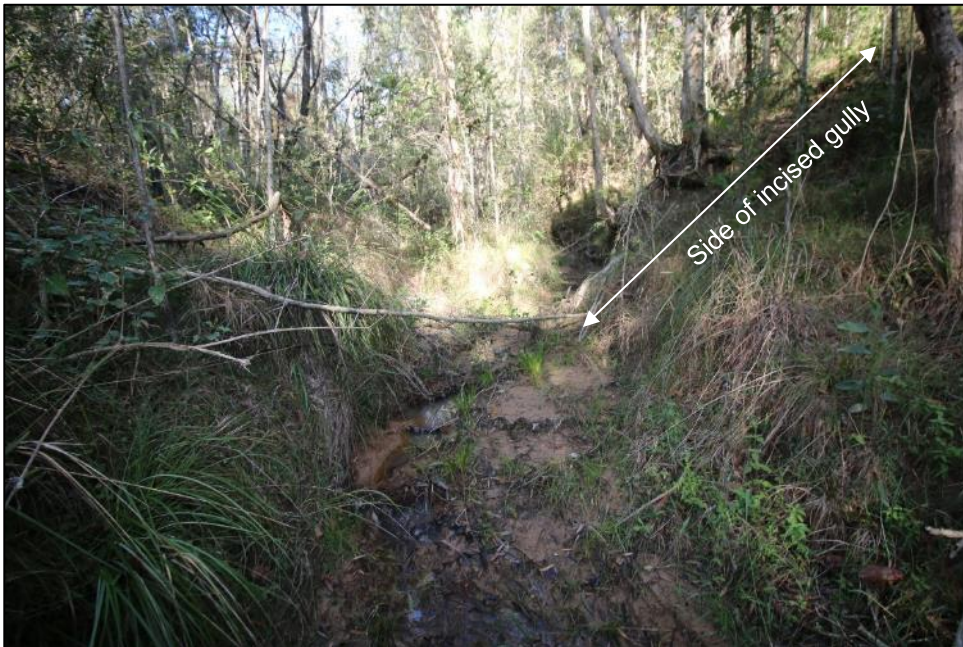
Site E3. Lower portion of feature E near site boundary. Site was mostly dry and had sandy low flow channel within in a highly incised valley. This portion of the site had a low flow channel but a poorly defined main channel.

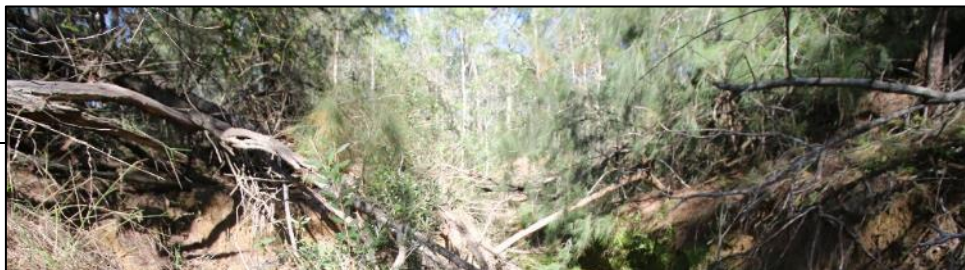
Site E3. First major rock barrier in feature E located at 27.7752, 152.9470. Several rock features measured 1.2m high over 4m. A barrier for fish during both low and high flows.

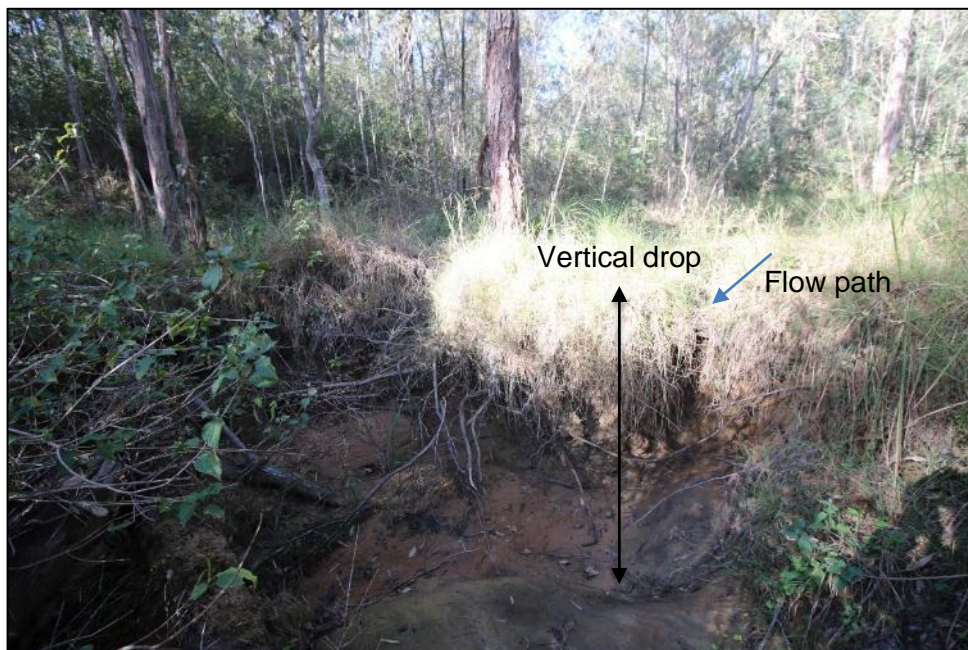
Site E2. Third major waterway barrier within feature E measured at 1.2m high (27.778115, 152.946167). There were other additional rock barriers located immediately below this area.

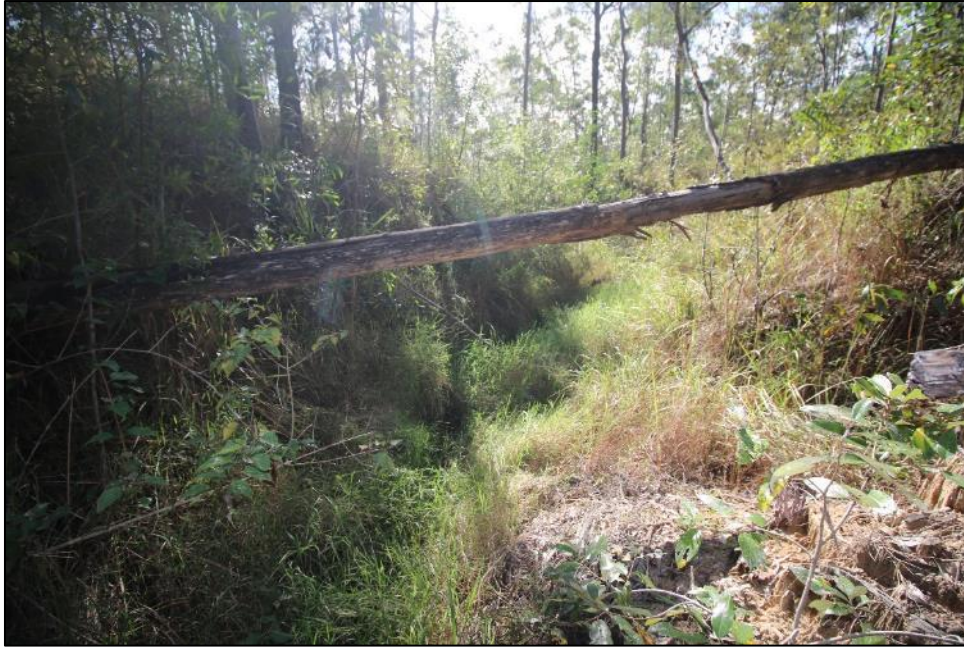
Site E3. Upper area of mapped waterway. Terrestrial grasses growing in poorly defined high gradient gully.

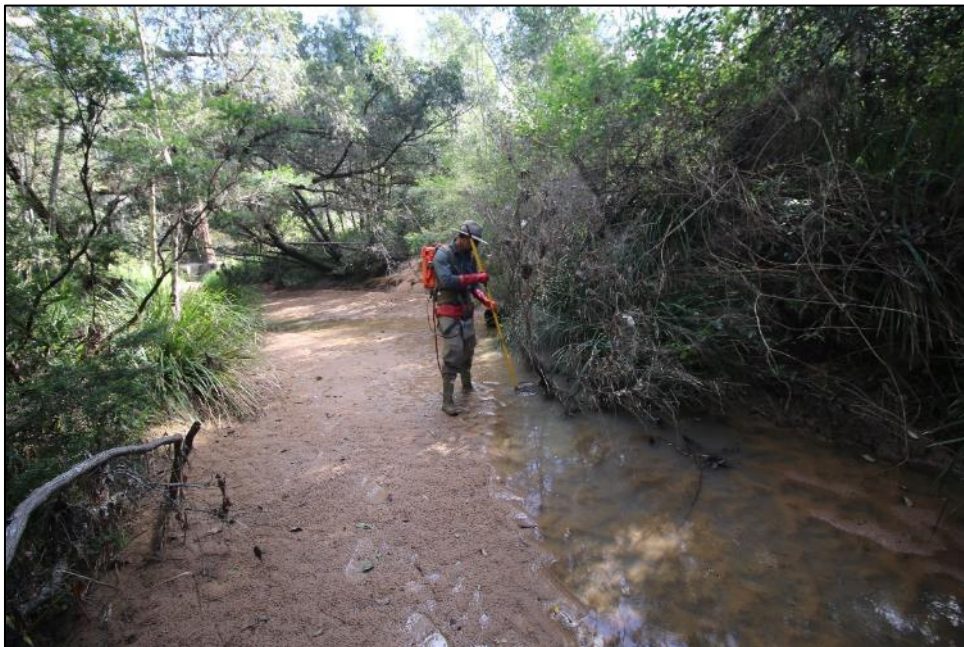
- For fish to colonise the southern portion study area they would have to come from Flagstone Creek. Backpack electrofishing surveys undertaken in both February and July are yet to locate a single fish in this section of the creek (site G1). It is likely that this portion of the creek is highly ephemeral due to the sand slug that is present in this area. The sand has smothered all instream habitat features and no refugia is present. This sand slug is also acting as a natural barrier to fish passage. During baseflow conditions it is likely that flows are sub-surface and no fish habitats are present.

Site G1. Flagstone creek fish sampling. Despite some water being present no fish were recorded during two sampling events. Large sand slug covers the bed and smothers habitat.

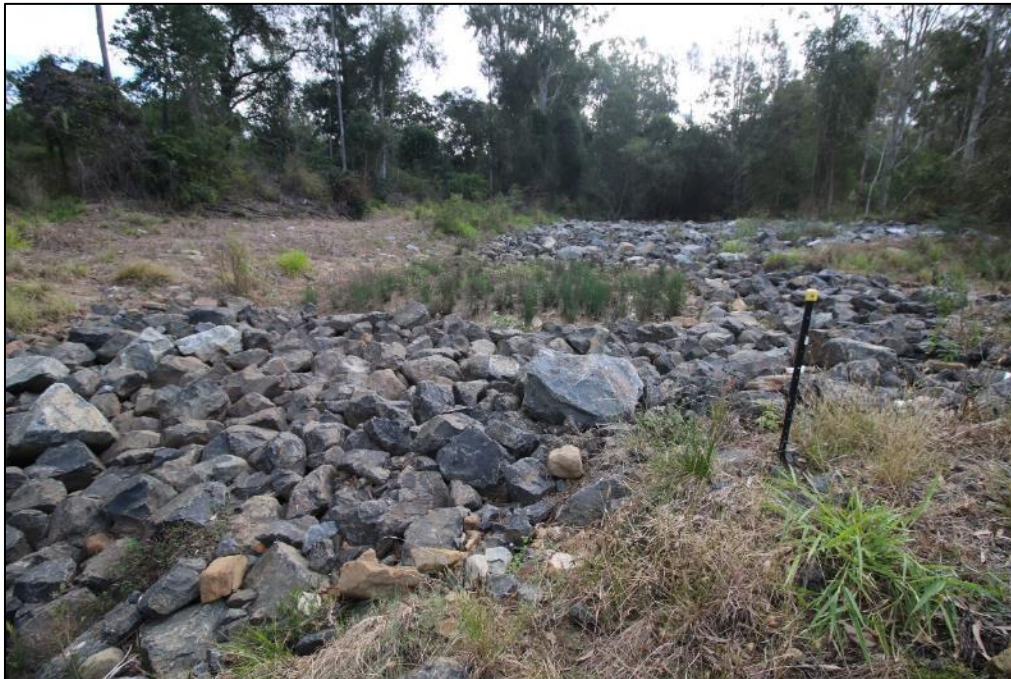
Above site G2. Part of the rock structure in Flagstone Creek is a likely to be a considerable barrier fish passage.
