Geotechnical Investigation Report

Precinct A Subdivision

Mountain Ridge Road, New Beith

Report Number: J001800-002-R-Rev0

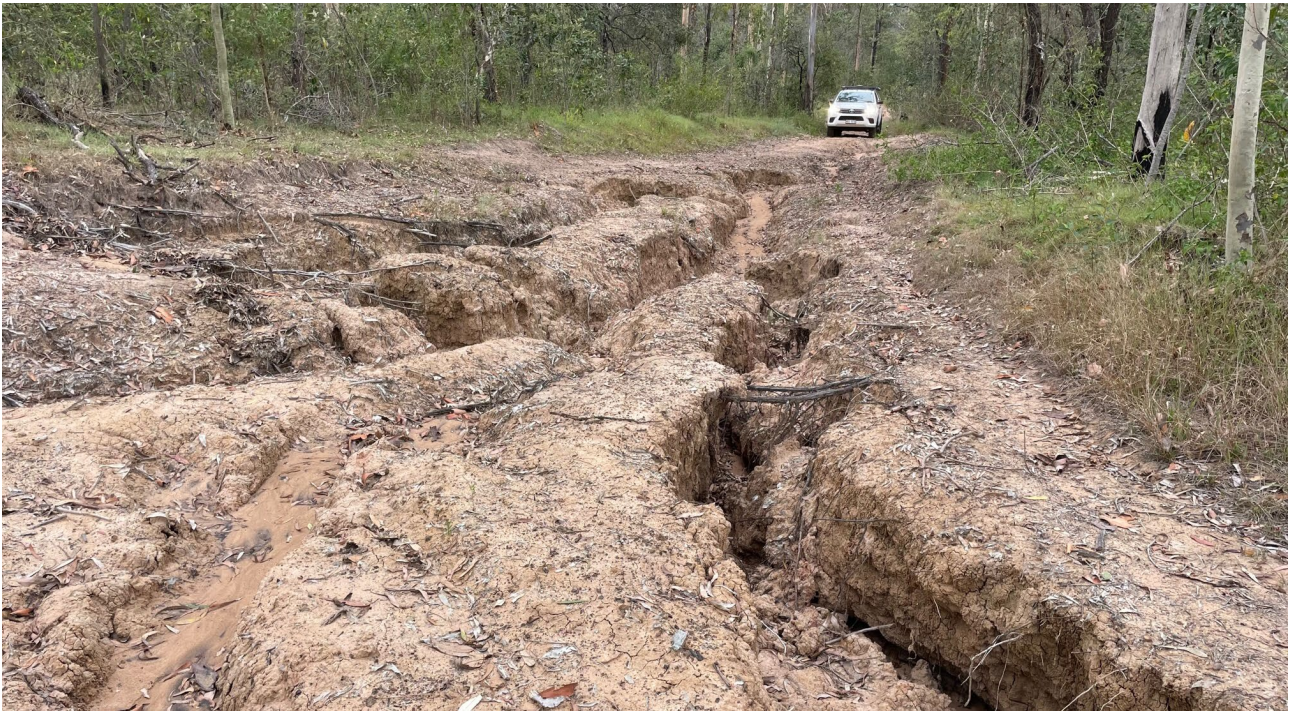
Photograph 4: Unsealed track in western parts of Precinct A displaying signs of significant erosion.
