# Oonoonba Site

## Geotechnical Assessment of Land Suitability for Residential Development

16 July2010

60158509

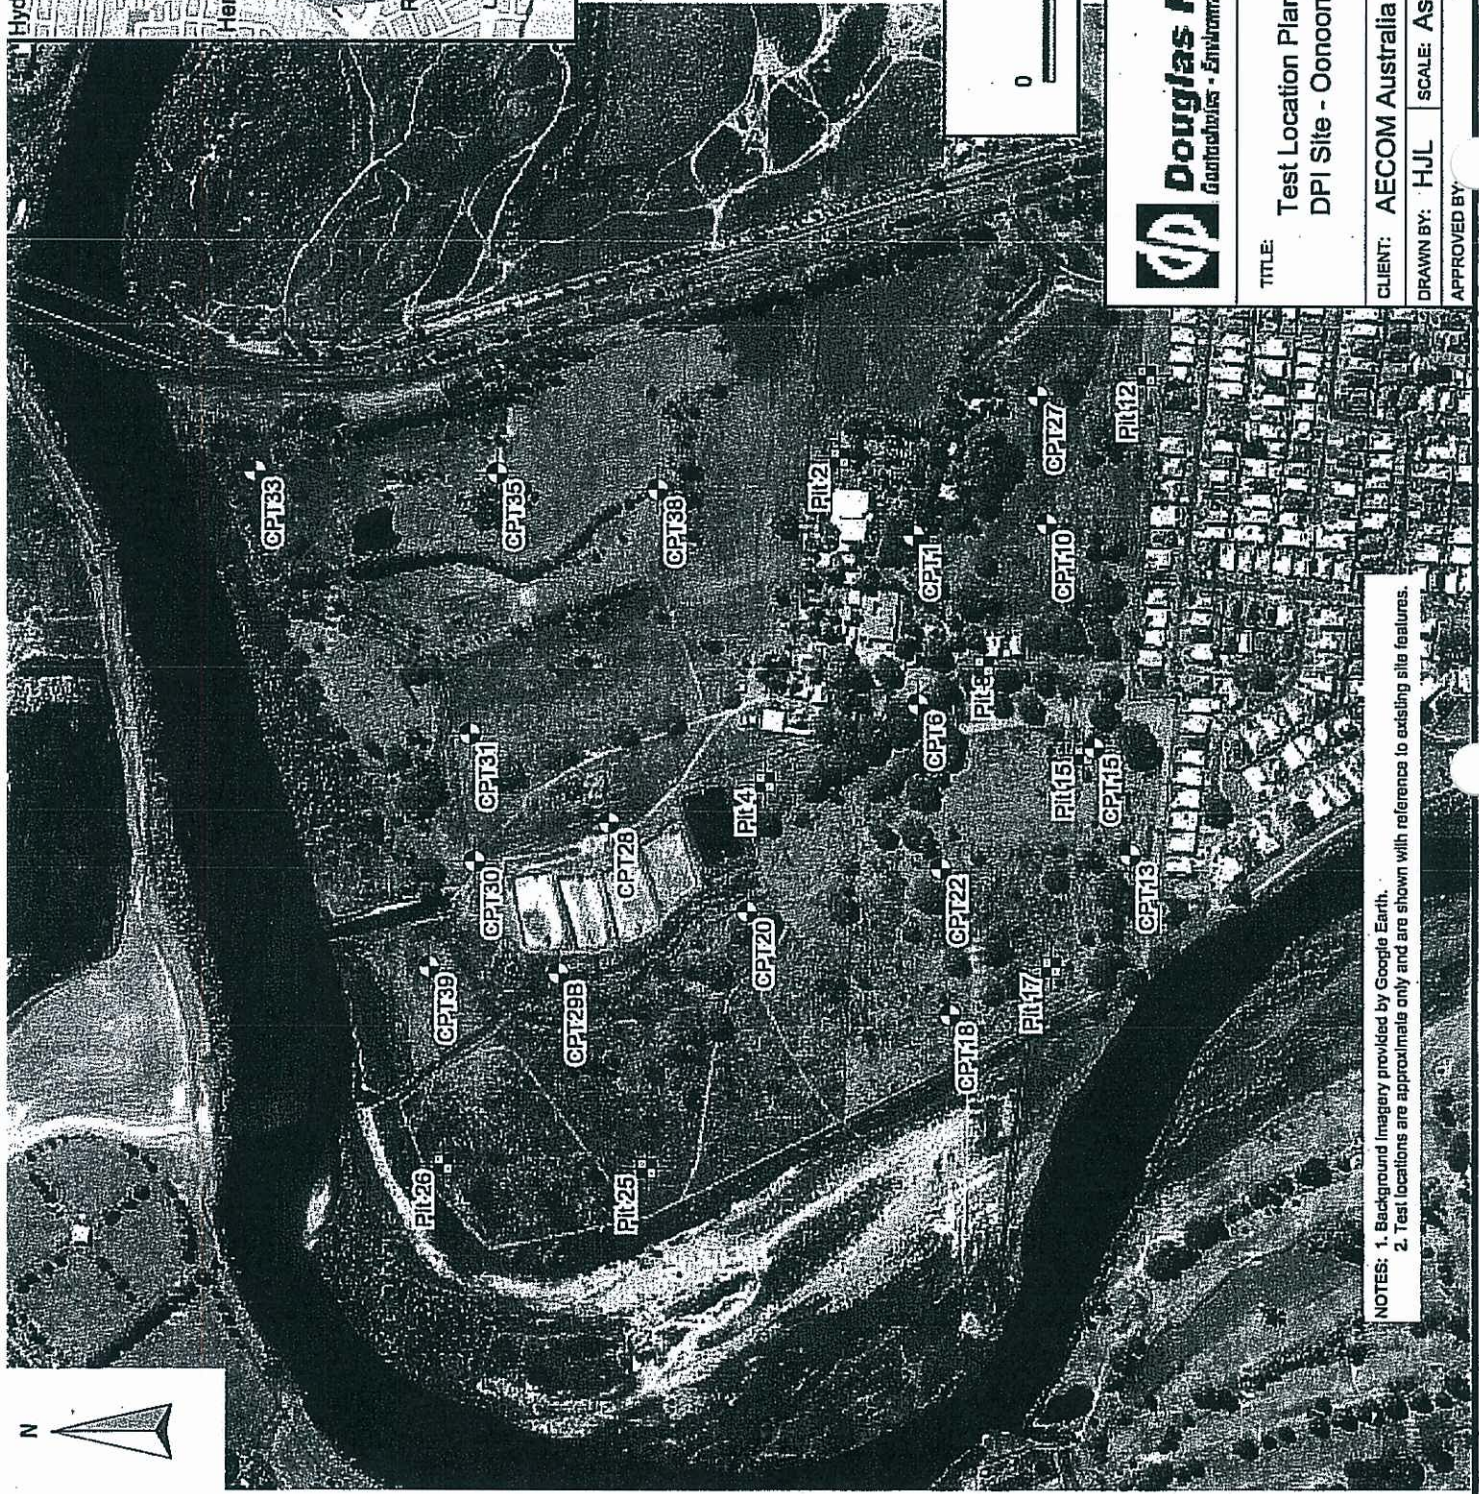
CPT Location

NOTES: 1. Background imagery provided by Google Earth.  
 2. Test locations are approximate only and are shown with reference to existing site features.

Geotechnical investigations were integrated with the environmental (contamination, UXO and Acid Sulphate Soils) investigations, for efficiency and economy. The environmental assessment assigned a total of 39 test locations where backhoe pits were carried out to establish ground profile and allow subsoil sampling. Figure 2 identifies the location of all 39 test points.
