# YARRABILBA PRECINCT 3

## WATERWAY STABILITY ASSESSMENT

Prepared for Lend Lease

| Report Title: | Yarrabilba Precinct 3 - Preliminary Waterway Stability Assessment |

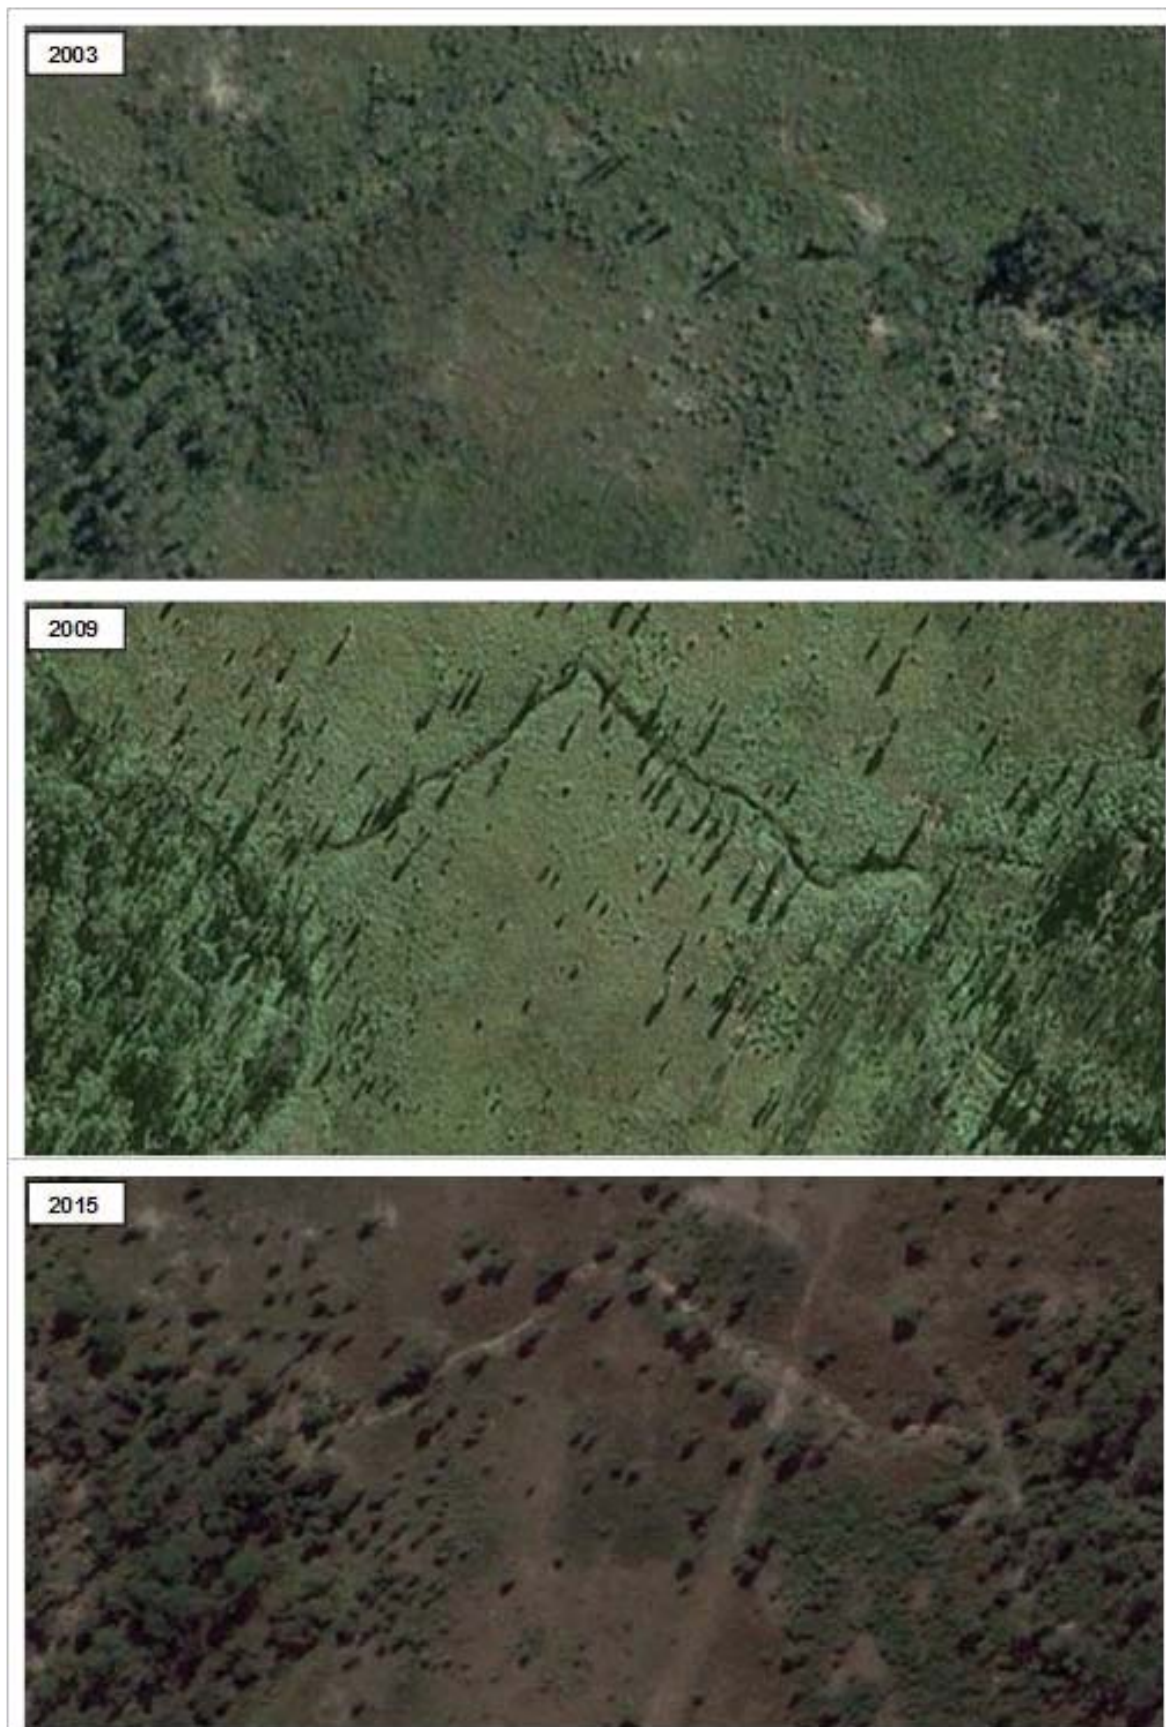
Figure 11 Historical aerial imagery Stream 5 (source: Google Earth)

Any historical changes along the lengths of the waterways were masked by dense vegetation along the channel margins. As such, little could be deduced about their long-term stability. One section of Stream 5 downstream of its confluence with Stream 4 was visible in multiple images with different acquisition dates (2003, 2009, 2015). These are shown in Figure 11. They show a small meandering stream across an unconfined landscape. It is also evident from the sequence of photographs that the channel has been in a phase of degradation/deepening (2003-2009) and combined degradation/deepening and widening (2009-2015), suggesting that there has been upstream migration of incision, since 2003 at least. The channel appears to have incised into an 'outwash' zone at the base of the Stream 5 valley. Lidar analysis and field assessments support the incision theory, with multiple head cuts and over-steepened sections observed. These are discussed further in ensuing sections.

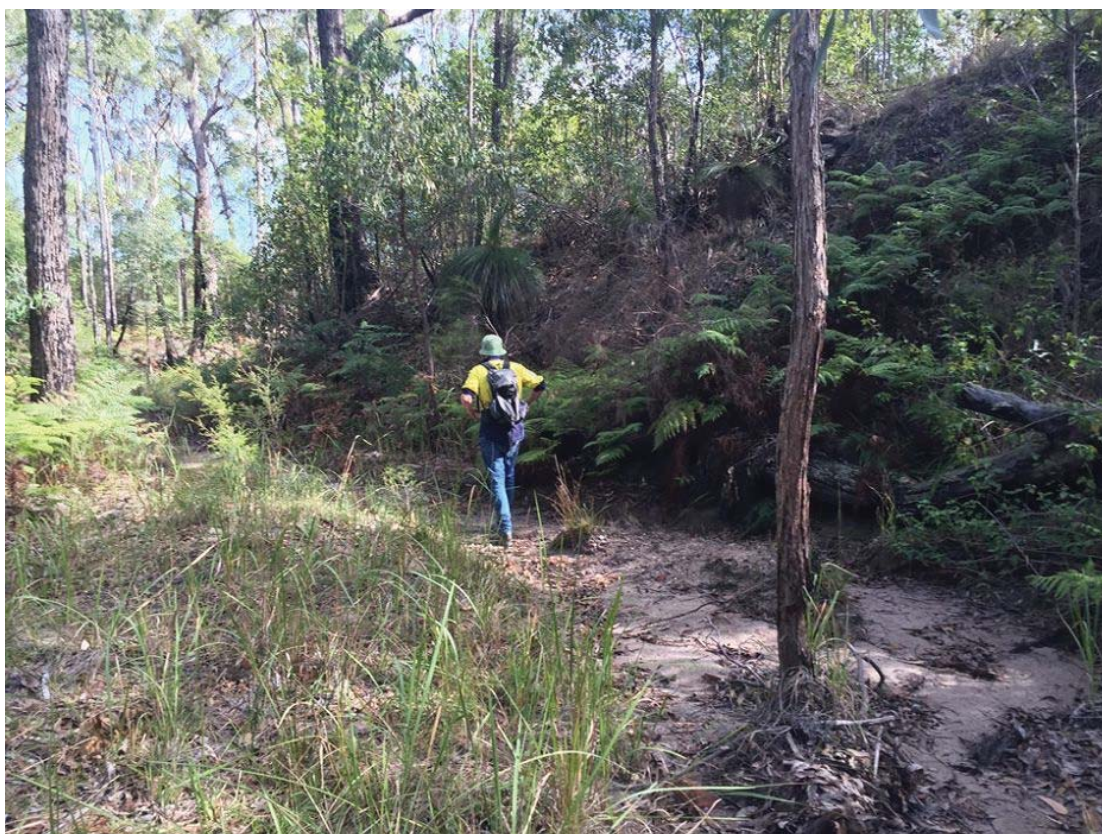
Figure 21 Example of low flow channel with stable adjacent bank along Precinct 3 streams

In general the banks along the streams within Precinct 3 are relatively stable and there are only likely to be isolated areas of bank instability. An observational approach is initially proposed, monitoring stability as development occurs.

**Note:** Field observations indicated little evidence of bank undercutting along the length of streams within the study area. This indicates that future bank stability risks are most likely related to unmanaged overland flows, that subsequently erode dispersive soils, causing rilling and unstable banks. Management of overland flows will be critical to minimising future bank stability issues. Retention of minimum waterway buffer widths from top of bank will also play a significant role in retaining bank stability.

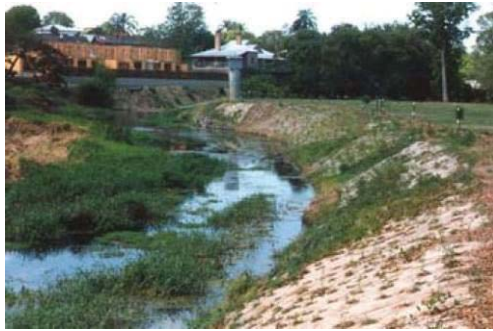
**Figure 22 Battering and revegetation**

The following provides a summary of the steps involved in battering and revegetation techniques:

- over-excavation to form stable batter e.g. 2H:1V maximum
- treatment of the dispersive soils (e.g. gypsum). This should be ripped into the newly formed stable batter
- placement of non-dispersive topsoil (200-300 mm minimum) over exposed dispersive soils
- vegetation installation and establishment.
