**GEOTECHNICAL REPORT**  
**CIVIL CONTRACTORS (AUST) PTY LTD**  
YARRABILBA PRECINCT 3B AND 3C  
SGSE/16/020N  
16 DECEMBER 2016

## DOCUMENT CONTROL SHEET

| | Title: | Geotechnical Report |
| | Synopsis: | Broadscale Geotechnical Investigation for proposed residential development. Information required for planning of earthworks. |

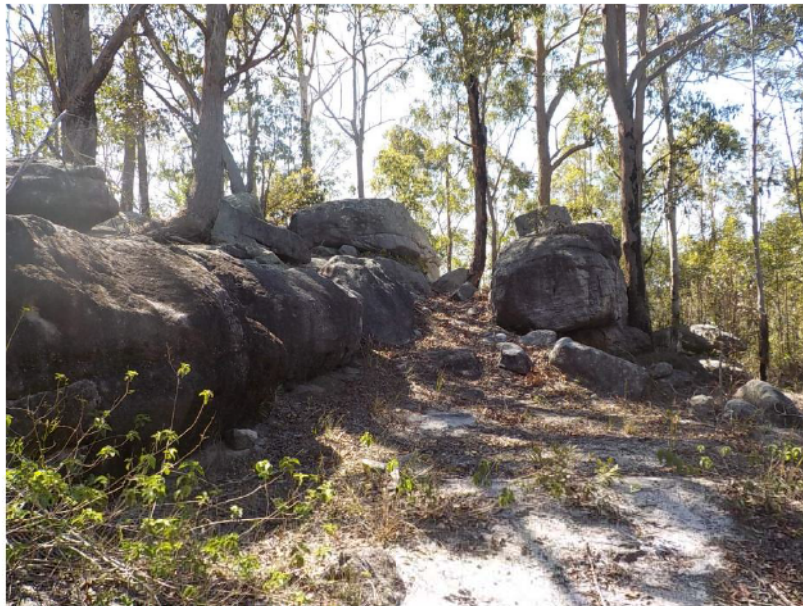
Figure 2 - Sandstone Outcrop at TP17

The topography of Precinct 3B is characterised a crest on the eastern boundary falling towards a watercourse along the western and northern boundaries. A sandstone outcrop was observed in the north eastern corner of the site at the location of TP17. Photographs of the exposed rock are provided below.

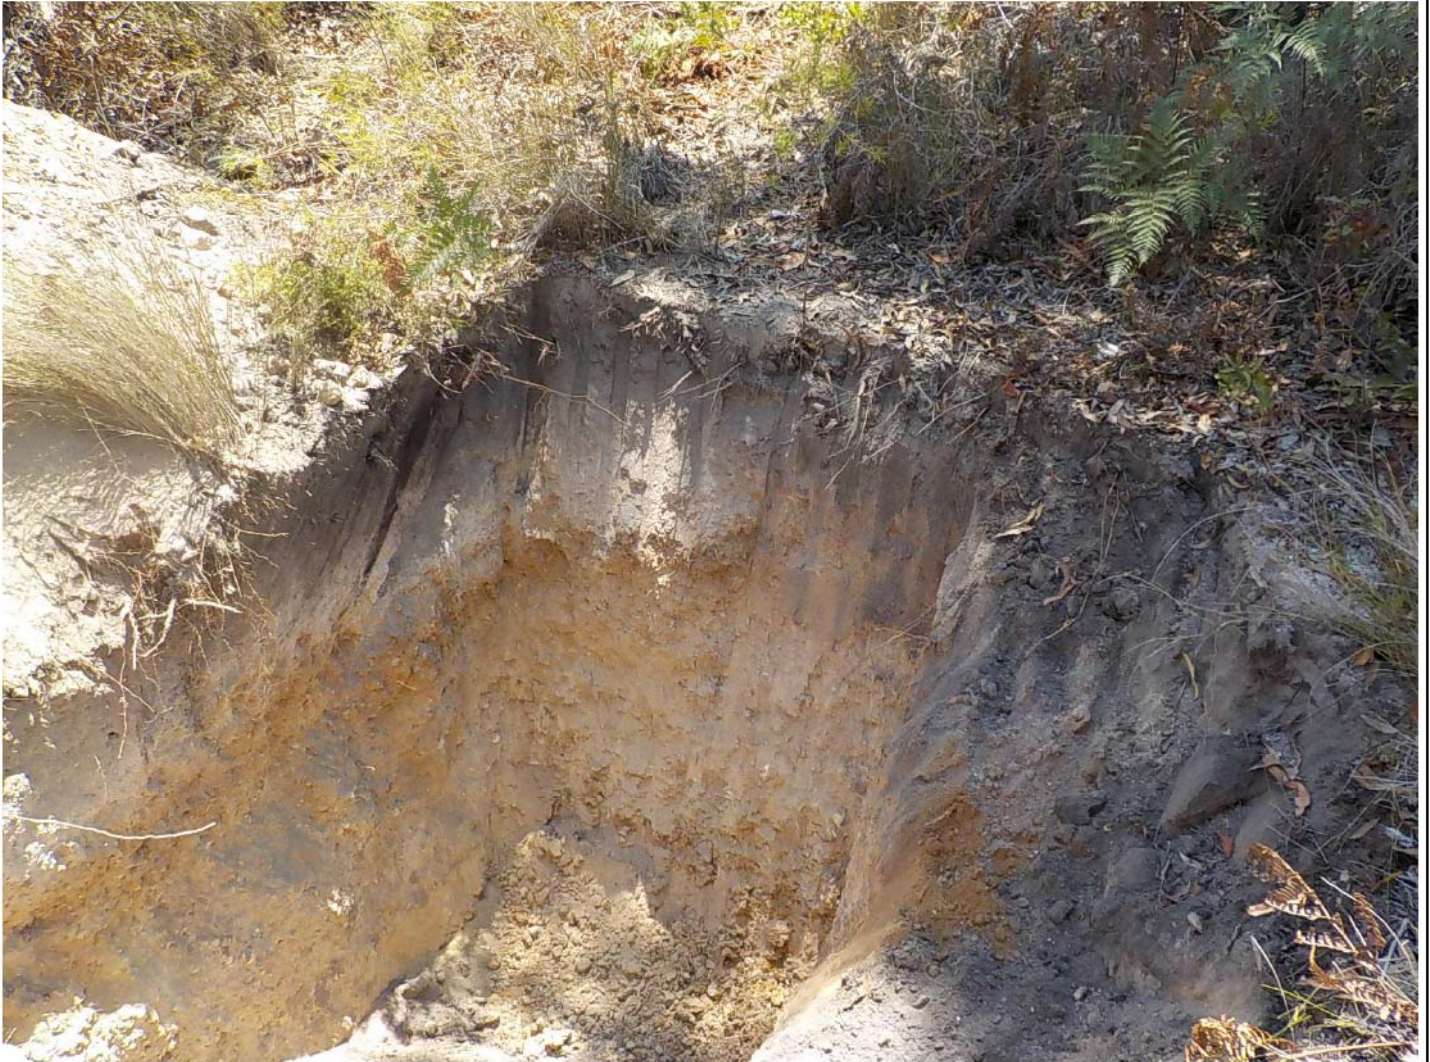
| <div><b>SGS Australia Pty Ltd</b><br/>ABN 44 000 964 278<br/>Unit 1/ 18 Leanne Crescent<br/>Lawnton, QLD 4501<br/>t +61 (7) 3481 9444<br/>www.sgs.com</div> | TITLE<br><b>TEST PIT 26</b> | | DRAWING NO.<br>SGSE.16.020N.1 | | |

Sandy gravel was observed to the test pit termination depths in test pits 26 and 27 positioned on the upper slopes of Precinct 3B.
