**PLANS AND DOCUMENTS  
referred to in the PDA  
DEVELOPMENT APPROVAL**

Precinct 1

**WATERWAY CORRIDOR RESTORATION STRATEGY  
(REVISION 3)**

**Address:** Dairy, Undullah & Wyatt Roads, Undullah

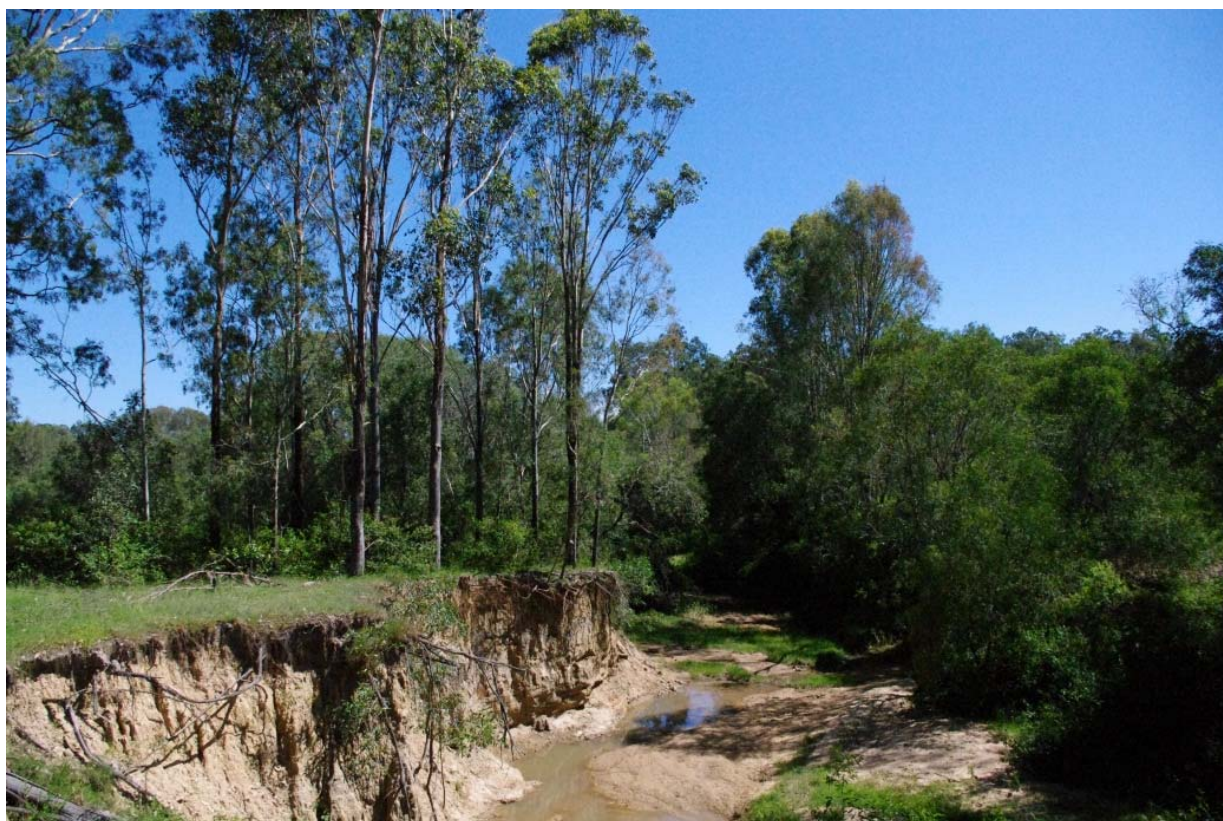
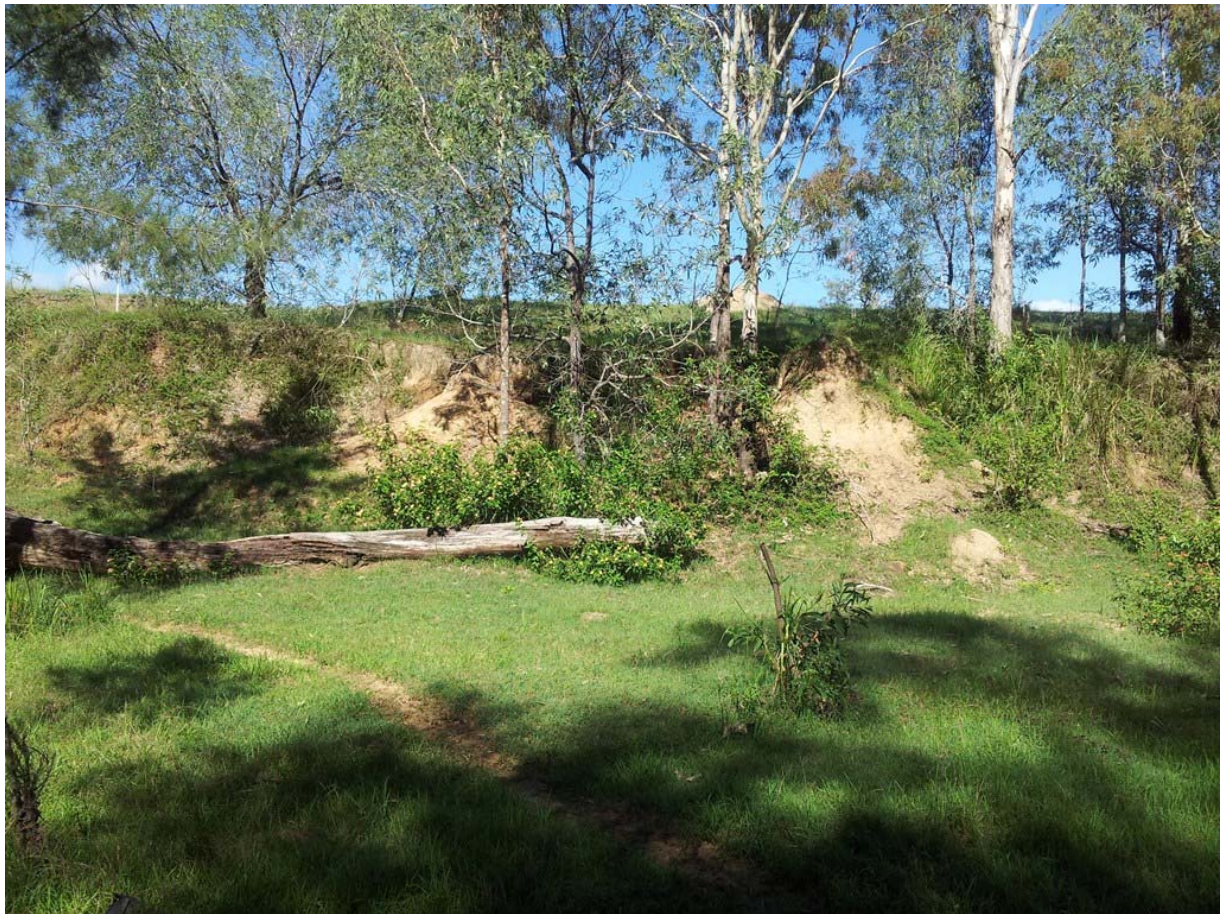
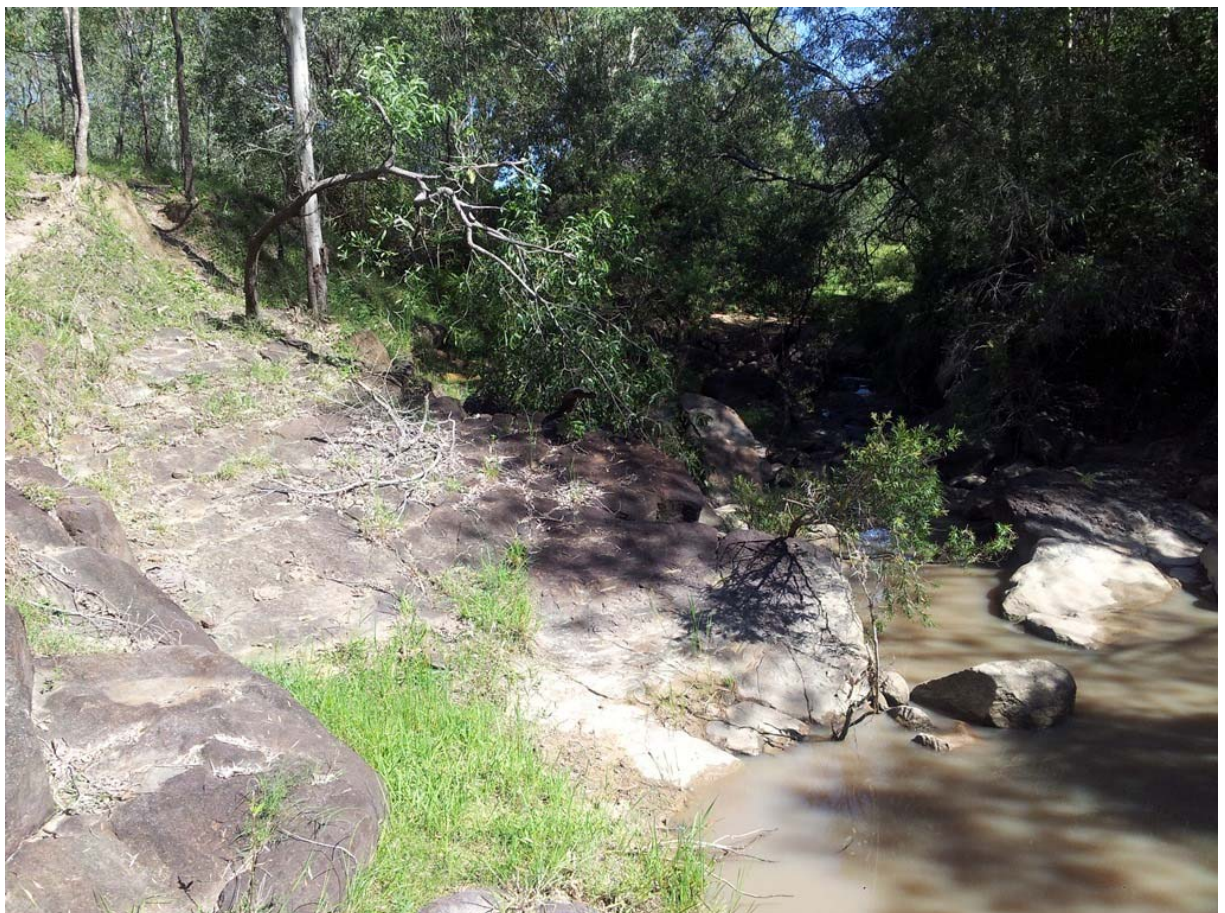
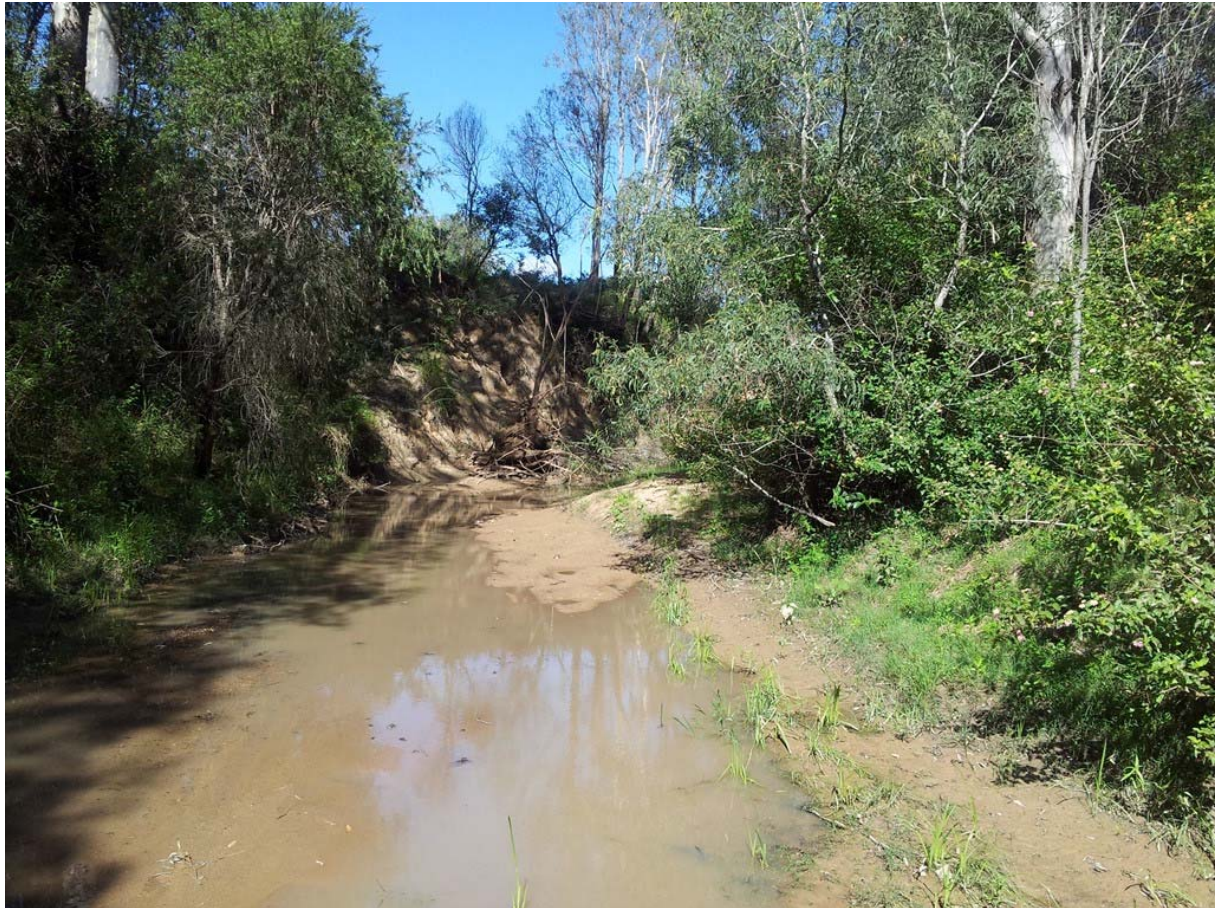
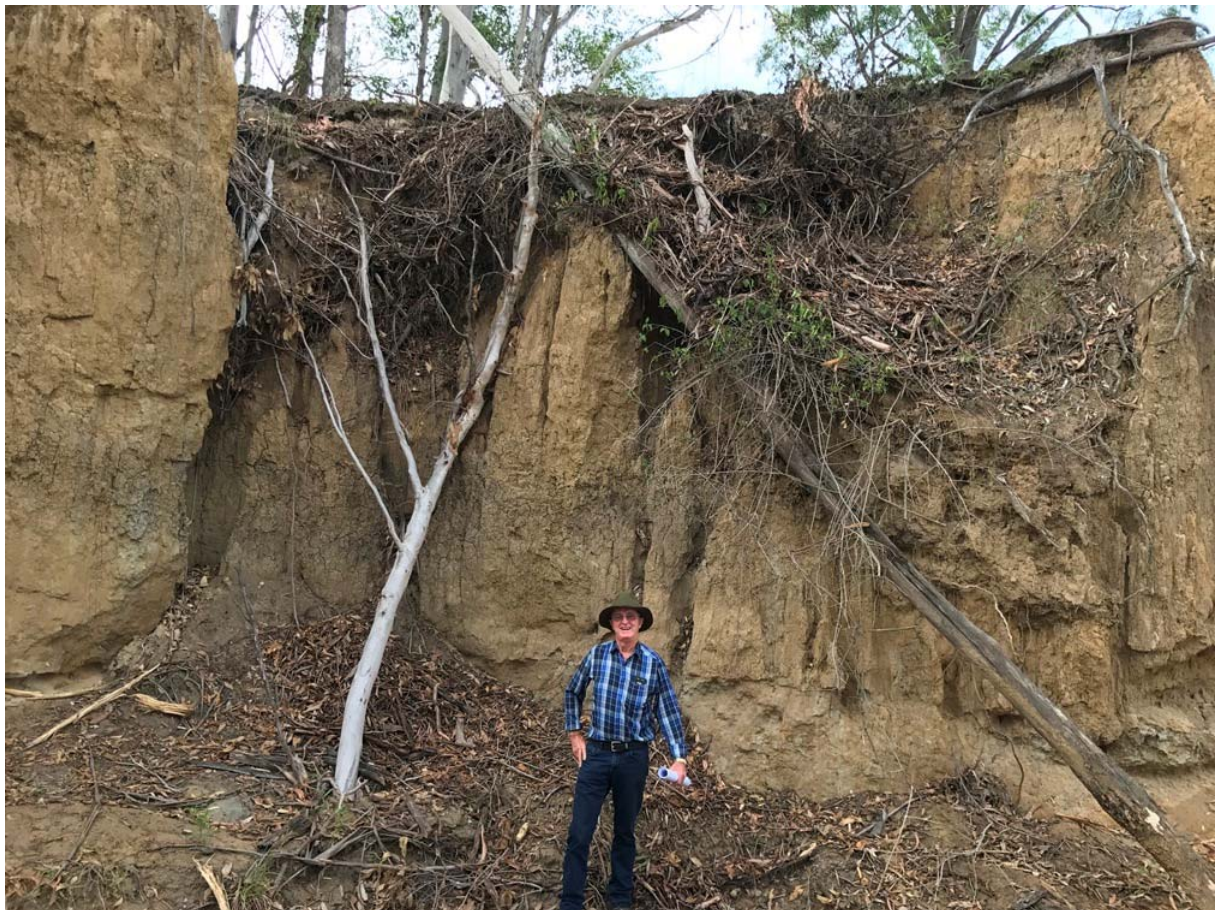
The two main waterways within the Flinders (Precinct 1) are currently heavily degraded. There is significant erosion along parts of these waterways for several reasons; but in particular, the soil types and lack of vegetation.

The next few pages contain photos taken of the onsite waterways showing the typical conditions.

Morrison Geotechnic observed several geomorphical processes occurring within the waterway banks with the most prominent being erosion. The *'predominant geomorphical process that is continually occurring along the assessment area is undercutting or incised meandering during significant rainfall events'*. This type of erosion presents itself through the vertical to near vertical banks observed on the outer bends of the creeks which is caused by high flow velocities within the waterways (refer **Section 3.2** above for indicative photos).

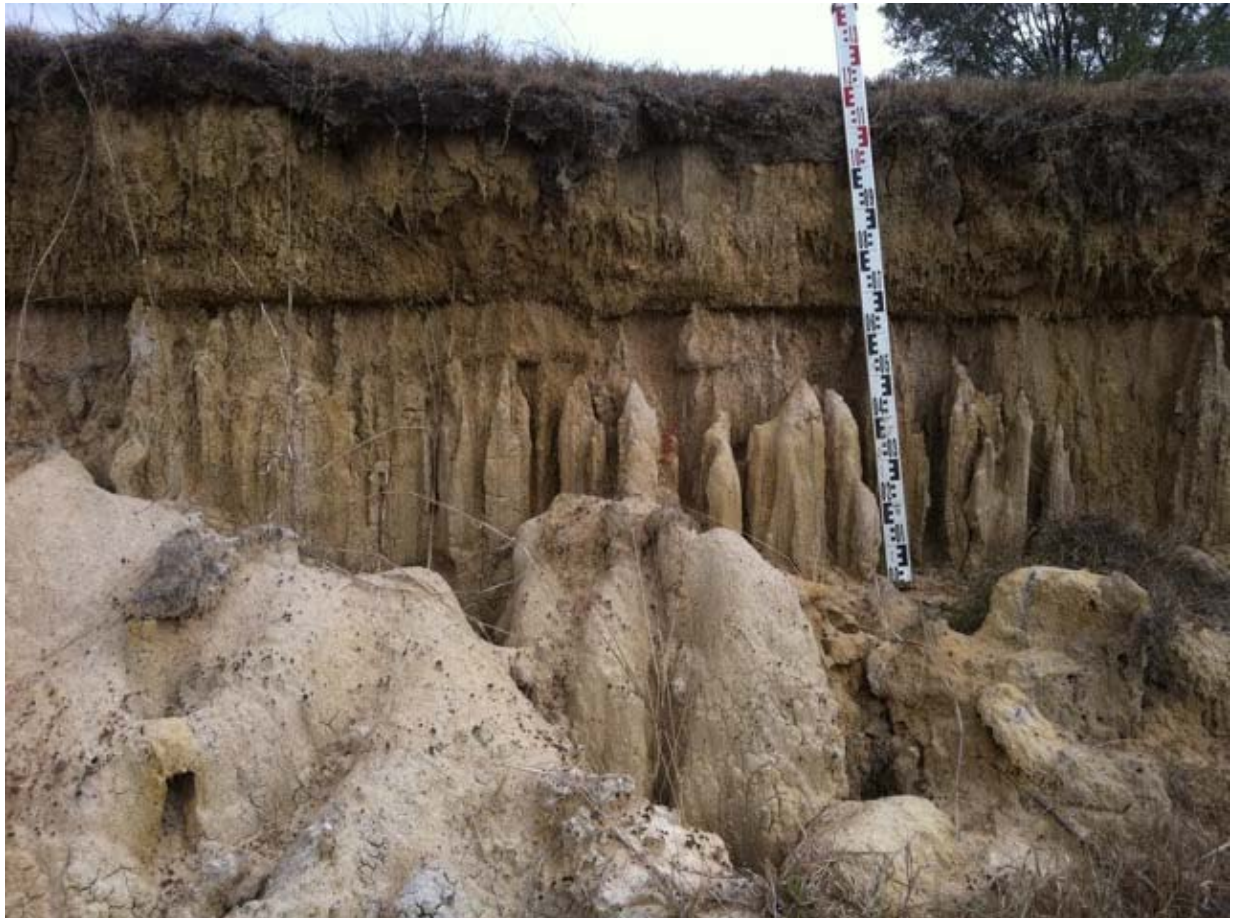
**Photo:** Example of soil profile in eroded waterway with stable sand layer overlying an abrupt change to a dispersive subsoil

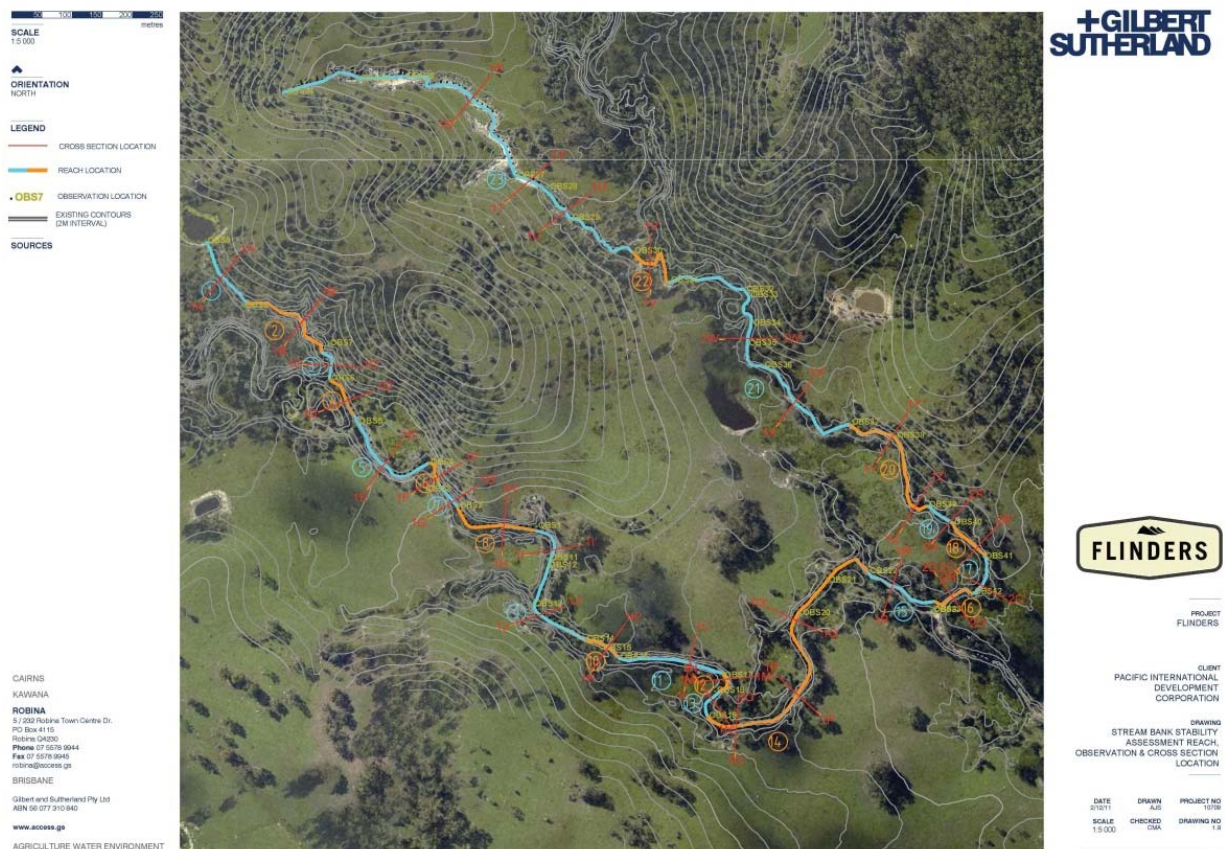
**Figure 3:** Excerpt from G&S Report – Reach Assessment & Observation Locations.

Gilbert & Sutherland (G&S) have prepared a document entitled, *Stream Bank and Bed Erosion Stability Assessment and Conceptual Management Plan* dated December 2011 (**Reference 3**) which addresses the quality of waterways in Neighbourhood 1 of Flinders (Precinct 1). Considerable instability was found during assessments of the beds and banks of the unnamed waterways bordering Neighbourhood 1 and this was found to result from the inherent characteristics of the sodic soils identified on the site. G&S advise that the historical removal of vegetation from these waterways and the disturbance of riparian vegetation and soils through grazing has further exacerbated the instability of these areas.

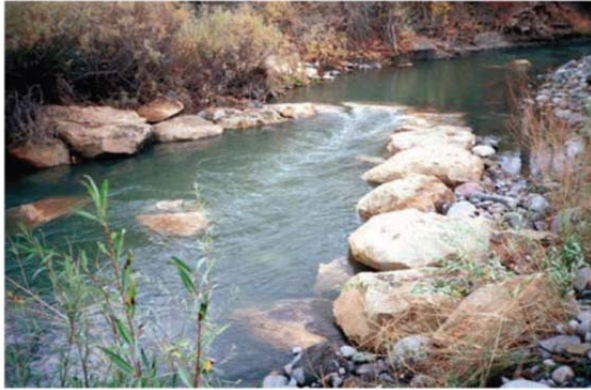
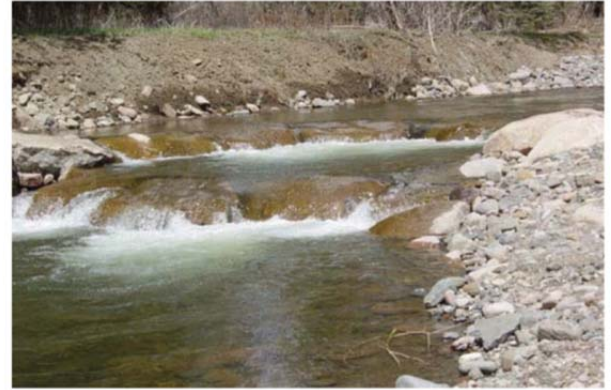
Natural Channel Design techniques aim to dissipate energy and divert the higher velocities away from the waterway banks. This is achieved via straightening the overall stream reach whilst maintaining meandering for the lower flows, strategically locating felled trees and rootballs along the banks, and the use of cross vanes and v-weirs to name a few of the common structures. When properly designed these structures increase habitat diversity along the waterways.

**Photos:** Cross-vane examples – United States Department of Agriculture, 2007

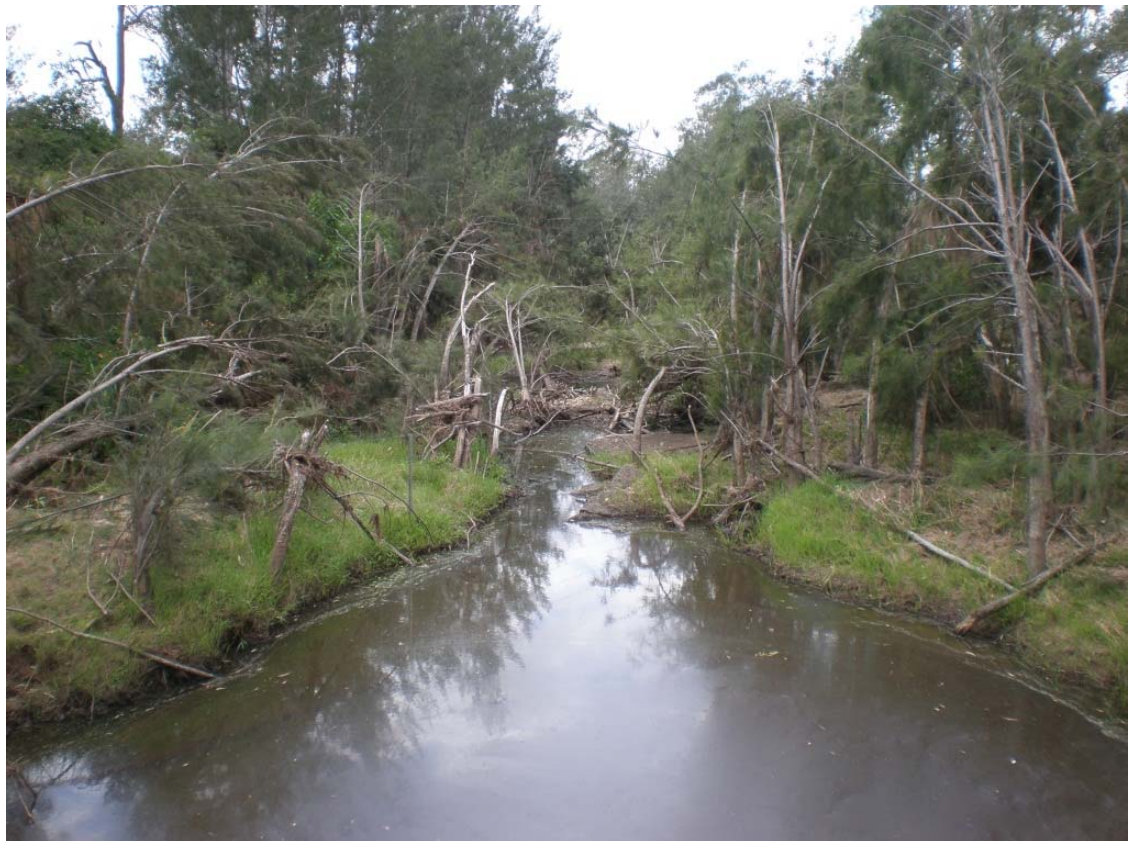
**Photo:** Eastern Catchment waterway a few days after heavy rainfall

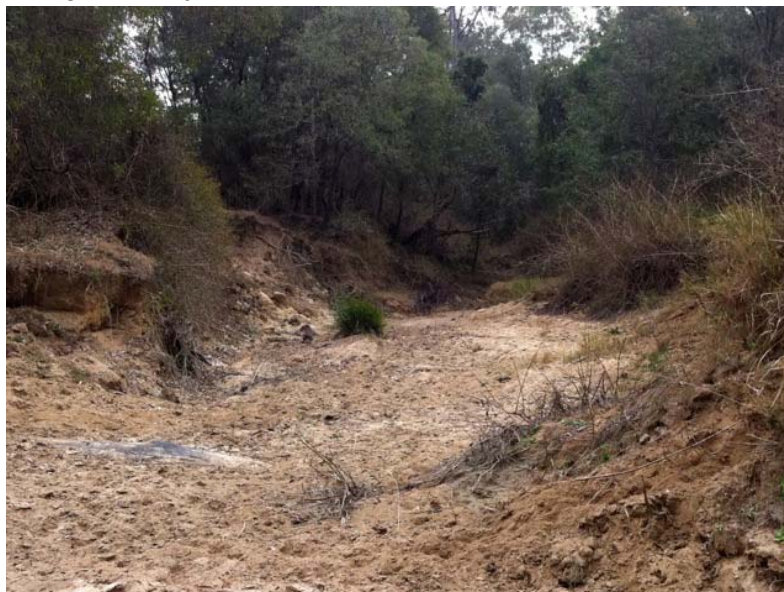
**Photo:** Existing waterway's sand bed load

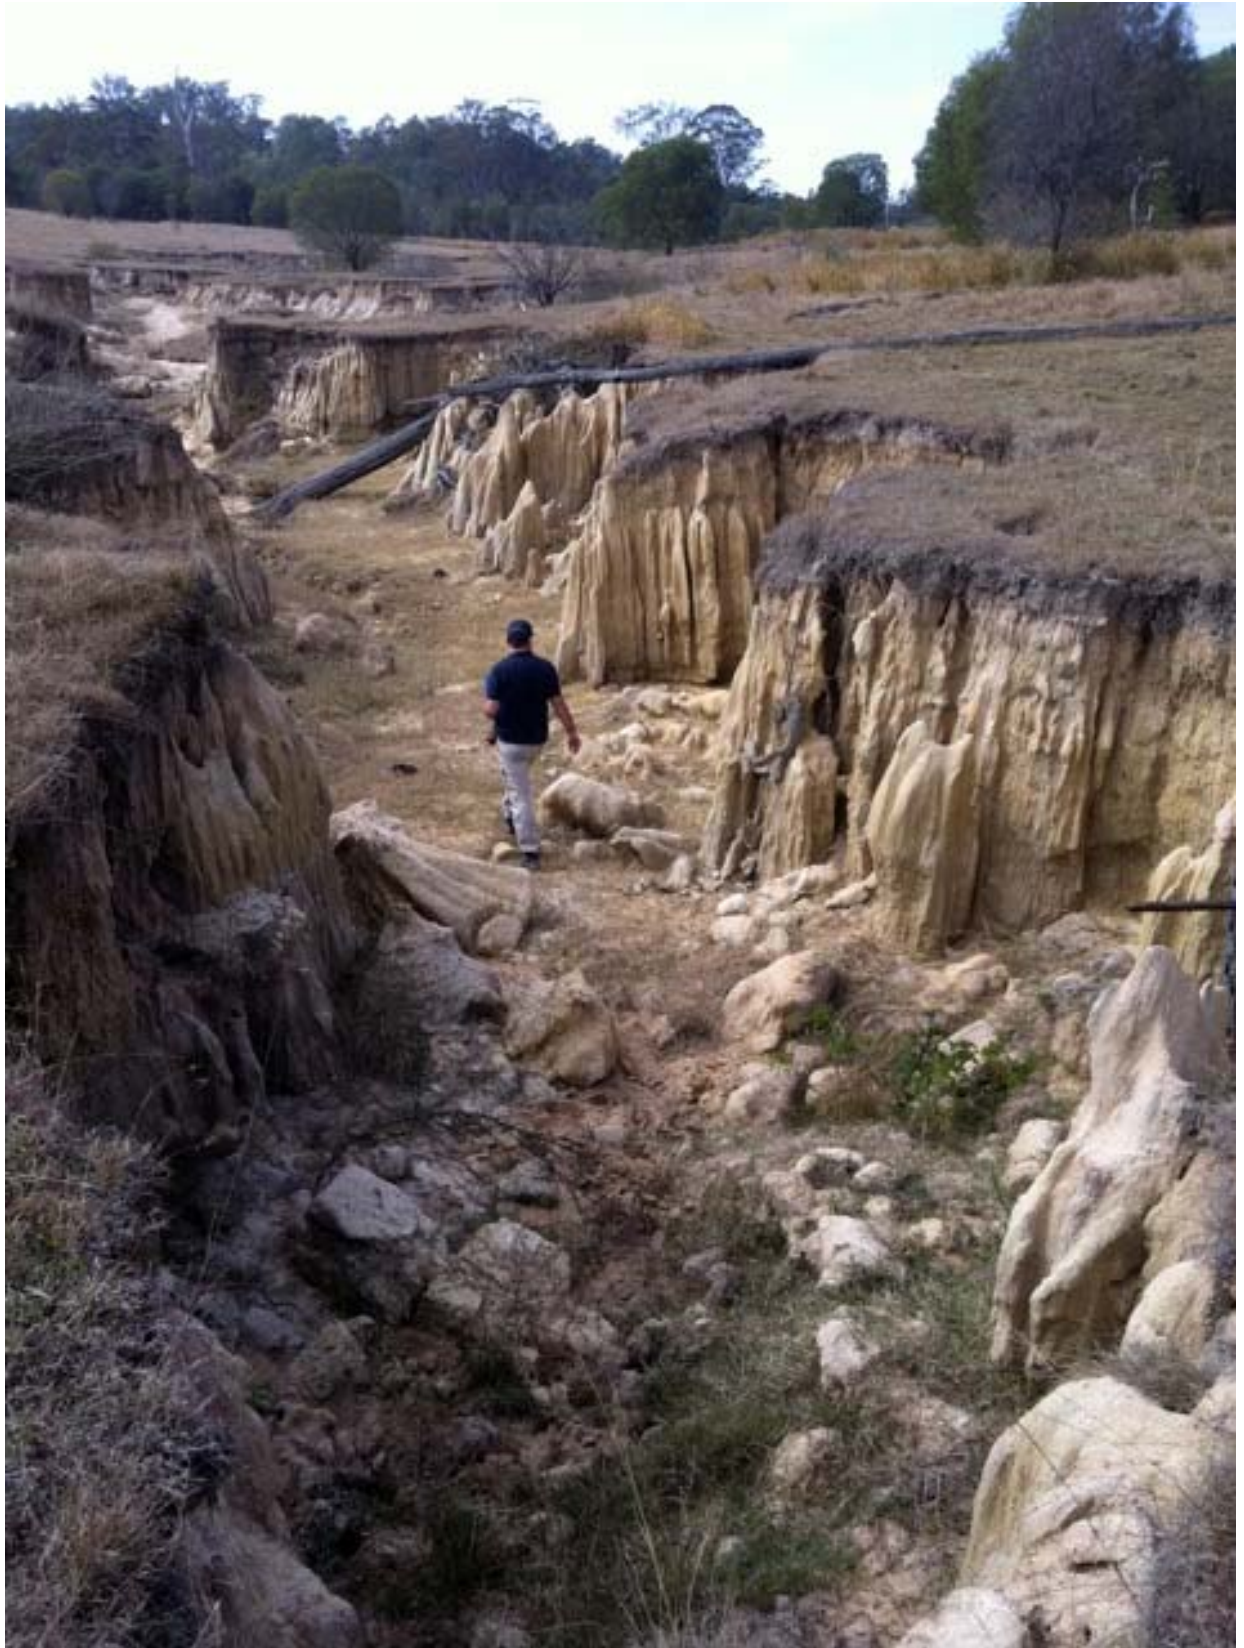
**Photo:** Existing waterway erosion to the east of NH4.

If the erosion in the photo above is left untreated, erosion within the waterway will continue as a result of the combination of dispersive soils and columnar structure.

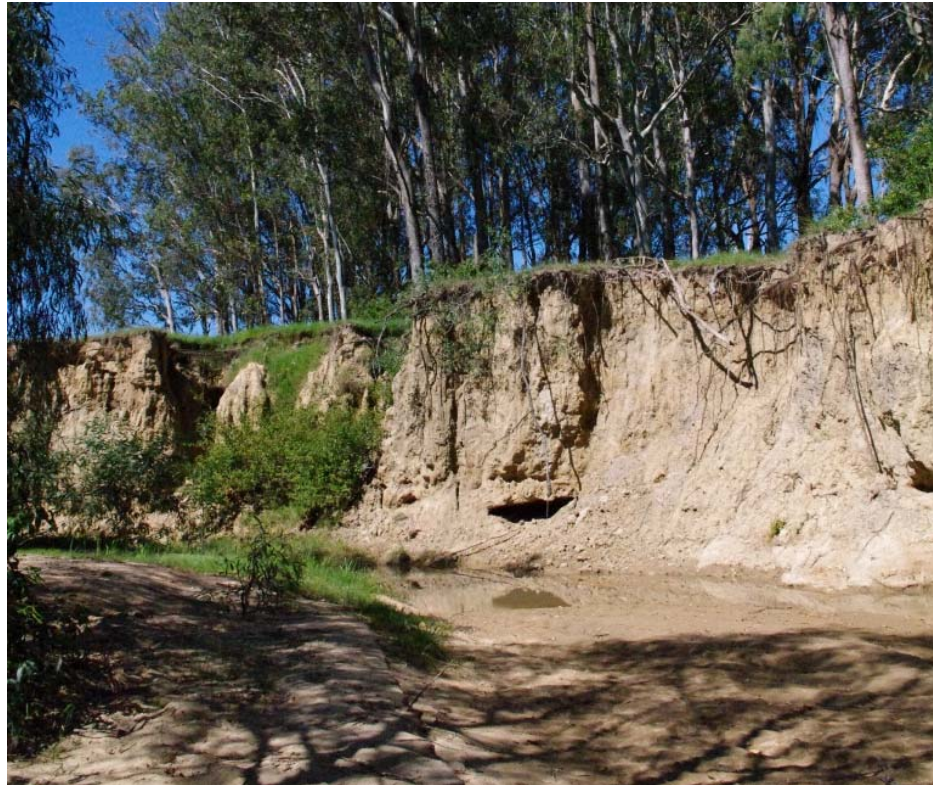
**Photo:** Existing waterway erosion typical around NH1.
