POD VOLUME 3:
ATTACHMENT D.7: THE
COMMISSARIAT STORE
AND MILLER PARK
CONSERVATION
MANAGEMENT PLAN

PREPARED BY: URBIS PTY LTD

QUEEN'S
WHARF
BRISBANE

DATE OF ISSUE: 24.11.2017

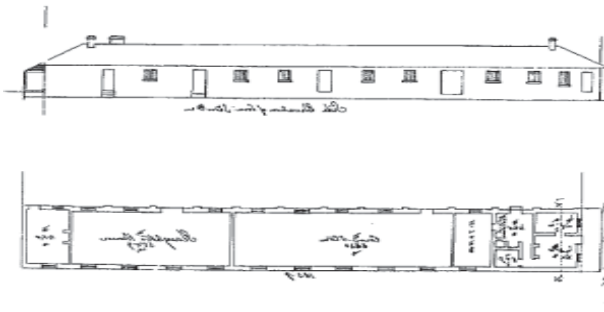
Figure 3 – Plan of First Commissariat Store

Miller was Captain in the 40th Regiment (Ireland). He brought an attachment of his regiment along with 30 convicts and established the first rudimentary buildings of the penal settlement. One such building was the first commissariat store; a slab constructed building (**Figure 3**) located in the vicinity of the present-day corner of Albert and Elizabeth Streets.

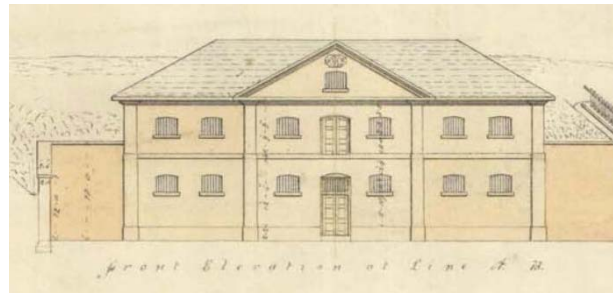
Figure 4 – Plan of southern elevation of the Commissariat Store, 1840

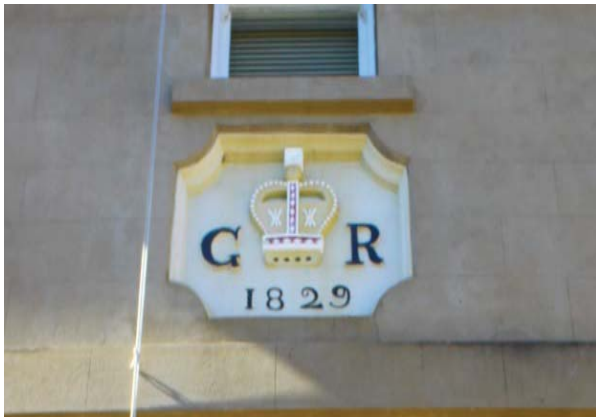
Figure 5 – Royal Cypher of King George IV

Construction on the Commissariat Store commenced in 1828. It was convict-built, using locally available stone known as Brisbane Tuff, from the quarry at Kangaroo Point; with building accents in sandstone quarried from Oxley Creek. The completed structure, with frontage to the river, was a two-storey building with a rectangular footprint, small hinged windows with security bars positioned high up on the wall of each level for security purposes, a hipped roof covered with shingles and featuring a centrally positioned gable to indicate the prominence of the building (**Figure 4**). To complete the construction, the royal cypher of King George IV, along with the date of completion, "1829", was added to the gable. This feature is still extant (**Figure 5**).

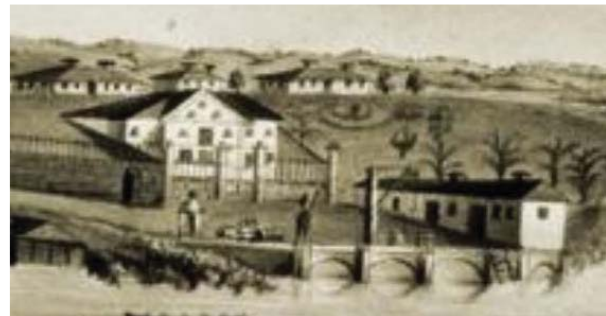
Figure 6 – Detail of watercolour painting of Moreton Bay Penal Settlement, 1835 (*H.B. Bowerman*), showing Commissariat Store, wharf and boatmen's facilities. Retaining wall to Miller Park at left.

Retaining walls were constructed around three sides of the building, and a fence to the present-day Queens Wharf Road. These features are still extant though the fence has been modified. These were constructed by convicts, and matched a retaining wall constructed along present day Queens Wharf Road at Miller Park c. 1831 (**Figure 6**).

Since its earliest days during the penal colony, the park has provided a means of access between William Street and Queens Wharf Road. During the time of the penal settlement, the site was cleared and a retaining wall constructed to Queens Wharf Road. It appears that an arched opening was created in the retaining wall (refer **Figure 6**) presumably leading to steps accessing the park (Allom Lovell Marquis-Kyle 1992).

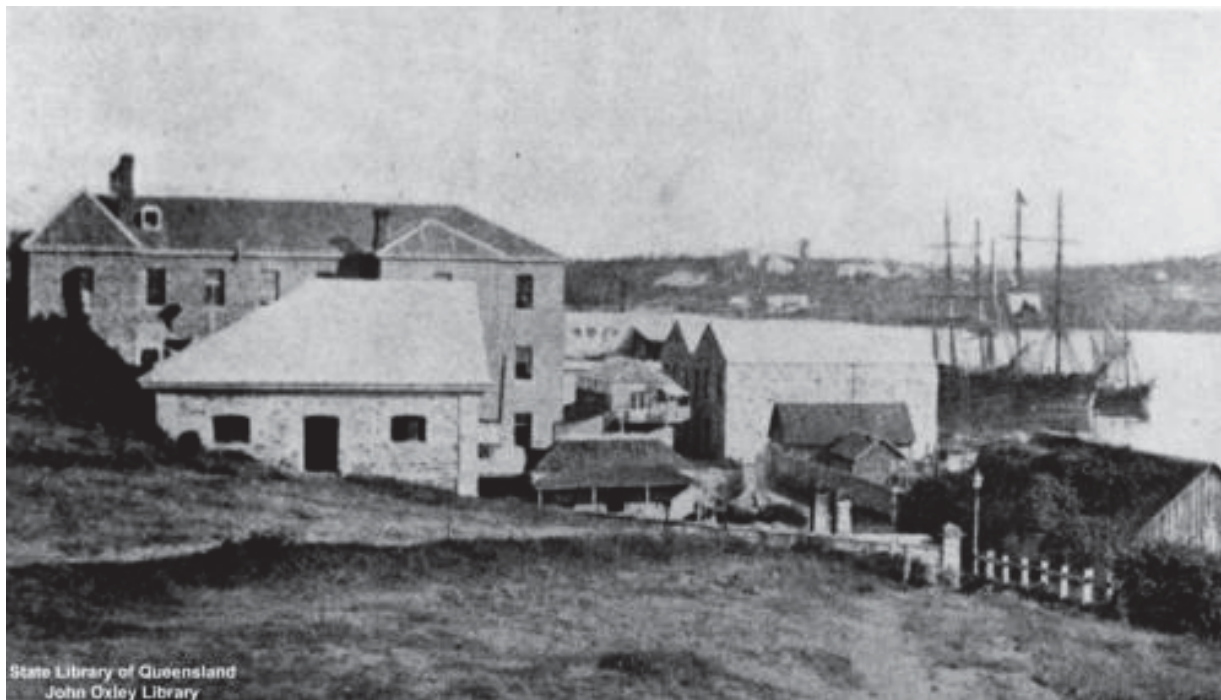
Figure 7 – View to Queen's Wharf, 1870. Commissariat Store mid-ground left, with side access door to Commissariat Store from Miller Park.

During the 1850s, a side entrance to the building's upper level was established, providing access for the resident immigrants from present-day Miller Park (**Figure 7**). This was established to avoid the need for the people to access the ground floor, which was still being used as a store (Kennedy and Pullar 1998).

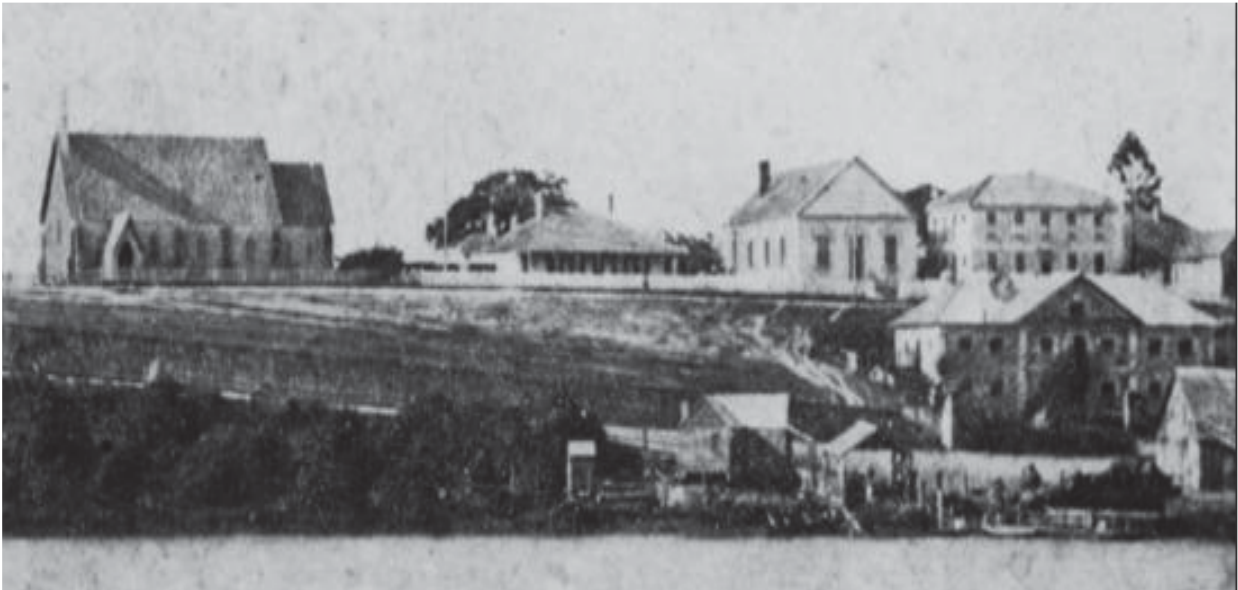
Figure 8 – Queens Wharf area, with Commissariat Store and Miller Park, 1865

In 1860, the building was renamed the Colonial Store, following the creation of the Colony of Queensland after separation from New South Wales in 1859. During this time, Miller Park was a simple grassed slope between William Street and Queens Wharf Road (**Figure 8**).

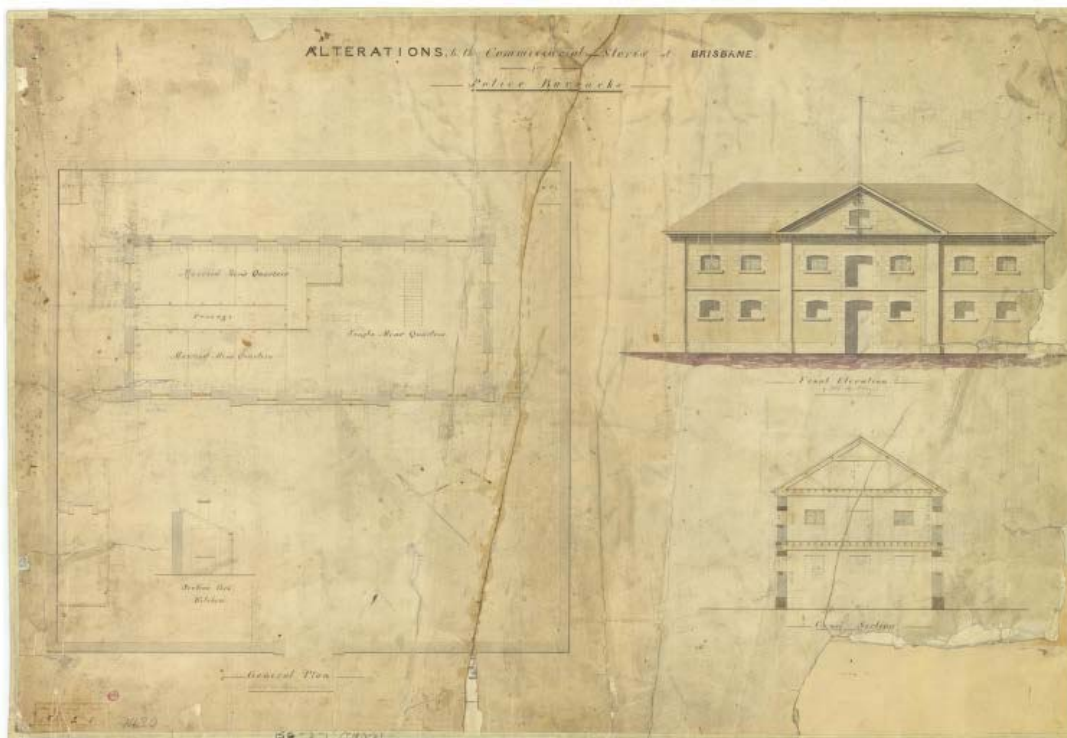
Figure 9 – Modifications to Store for use as Police Barracks, c.1860s

During 1860, the upper level of the building was refurbished for use as Police Barracks (**Figure 9**). Refurbishments included modified internal fitout and the installation of 18 new hardwood sash windows (Kennedy and Pullar 1998). It is likely that this use continued until c. 1870s, as during the 1870s and 1880s the Colony received a massive influx of new immigrants.

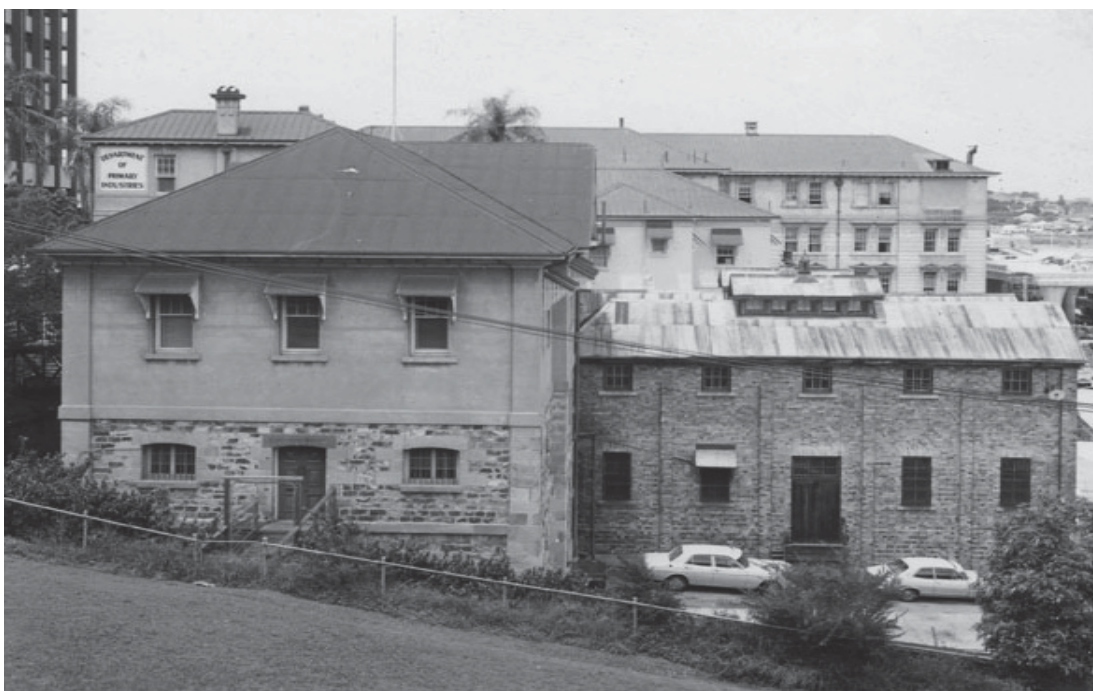
Figure 10 – Brick Annexe perpendicular to Commissariat Store, 1970s

The Federation movement was gaining momentum at the end of the nineteenth century, and in 1898 the building was renamed the Government Stores, in anticipation of Federation. Two years later a second storey was added to the brick annex (**Figure 10**), and one of the windows at the second storey of the Commissariat Store was converted to a door with a hoist added to facilitate lifting of goods. By 1909, two hand-operated goods lifts were constructed in the Store (Kennedy and Pullar 1998).

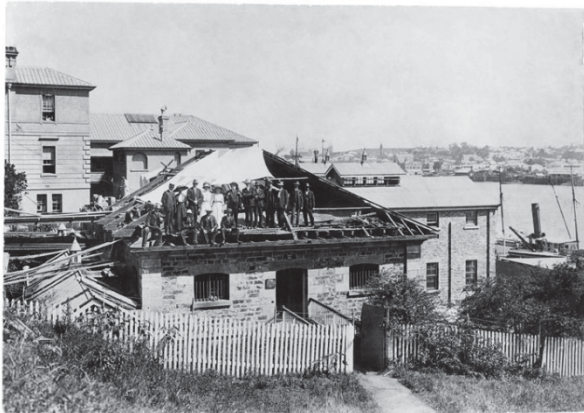
Figure 11 – Construction of third level, c.1912 also showing entrance to second storey via Miller Park

Externally, the iron roof was replaced with new material and a fleche and two dormer windows were added to the roof. A cast-iron gangway provided access between William Street and a new building entrance at the third floor.

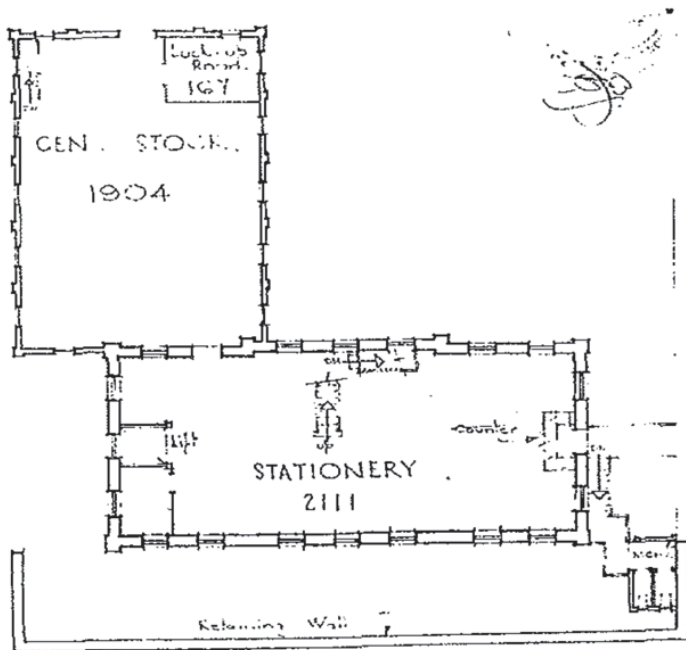
Figure 14 – First Floor, 1944 also showing use of Brick Annexe building

Plans dated to 1944 (Figures 13 to 15) show the internal arrangement of all three levels of the Commissariat Store at that time, and also depict a variety of ancillary buildings present in the Commissariat Store's grounds. These included sheds at the eastern elevation and north and south eastern walls of the building, a packing case shed in the western corner of the site, a store between the building and the William Street retaining wall, and a toilet block in the northern corner of the site.

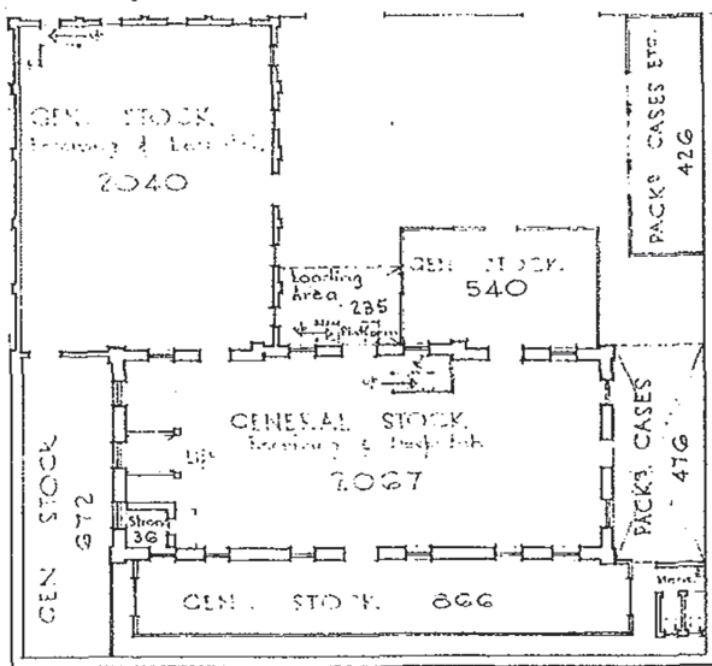
Figure 15 – Ground Floor, 1944 showing arrangement of buildings on site

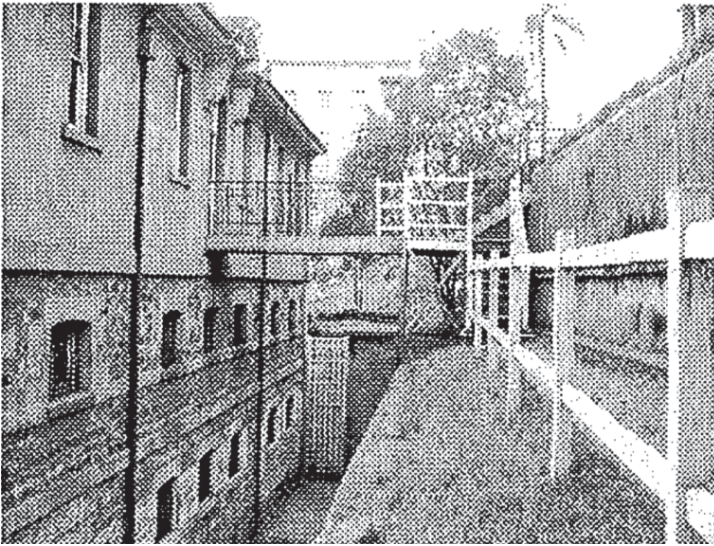
Figure 16 – Stairs and walkway constructed along William Street retaining wall during WWII

A stair and walkway were established at the top of the William Street retaining wall during World War II (**Figure 16**), to access an air raid shelter near to 95 William Street. It is rumoured that an air raid trench was constructed in Miller Park, and has since been infilled.

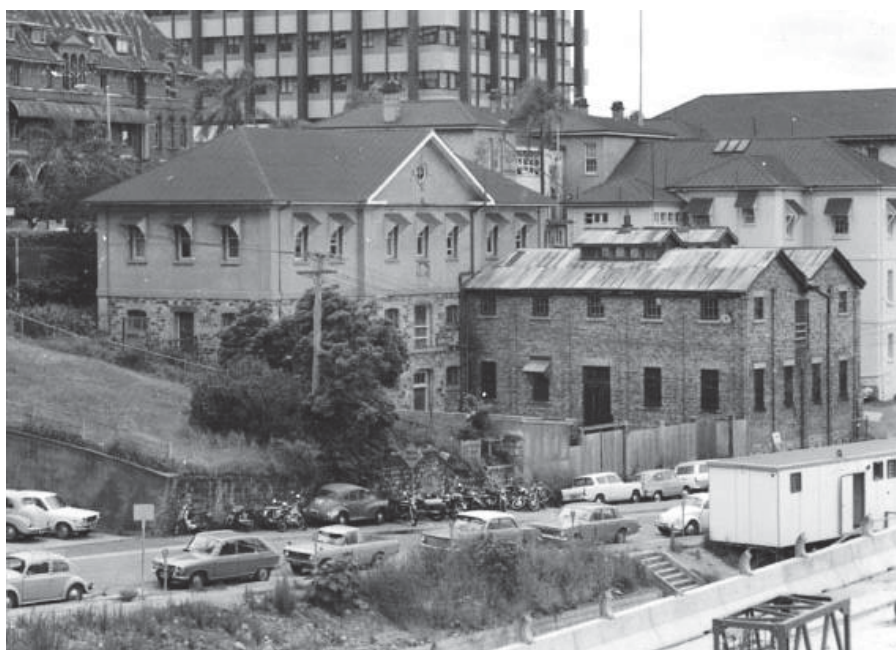
Figure 18 – Commissariat Store site, with Brick Annex prior to demolition, and Miller Park adjacent (1972)

In 1976, the brick annex (**Figure 18**) was demolished, and in 1977 the Royal Historical Society of Queensland (RHSQ) commenced use of the Commissariat Store as its headquarters, lecture room and library.

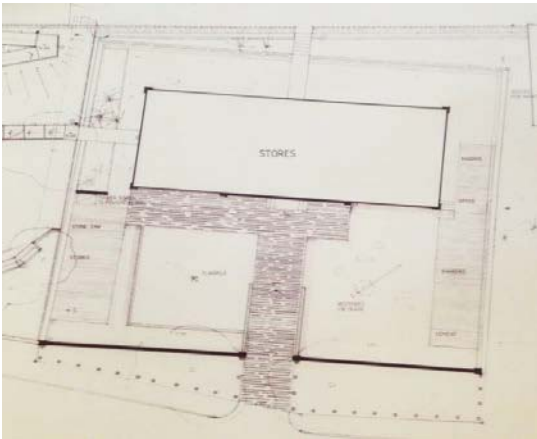
Figure 19 – Plans for modifications to Commissariat Store yard (1982)

In 1980, the Commissariat Store was officially opened as the headquarters of the RHSQ, and two years later a new stone wall and metal gates were completed at the Queens Wharf Road boundary with Miller Park and a paved driveway and grassed area were added to the yard (**Figure 19**).

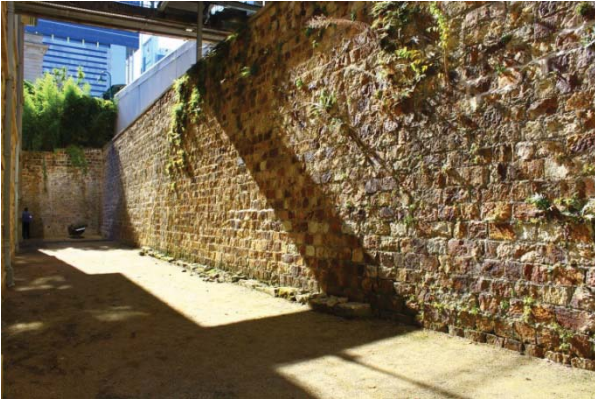
Figure 23 – William Street retaining wall

The building is flanked on three sides by retaining walls constructed of iron-stained Brisbane Tuff (**Figure 23**) which has been squared and roughly dressed.

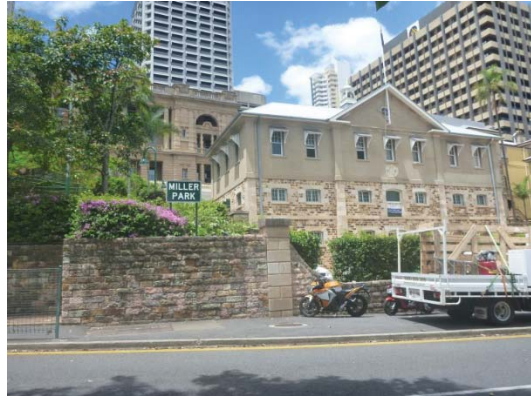
Figure 24 - Queens Wharf Road retaining wall, extending to Miller Park

A low stone wall (Brisbane Tuff) is along the property boundary at Queens Wharf Road. This wall extends north-west along the road and the Miller Park boundary, with a sandstone pillar denoting the boundary between the two places (**Figure 24**).

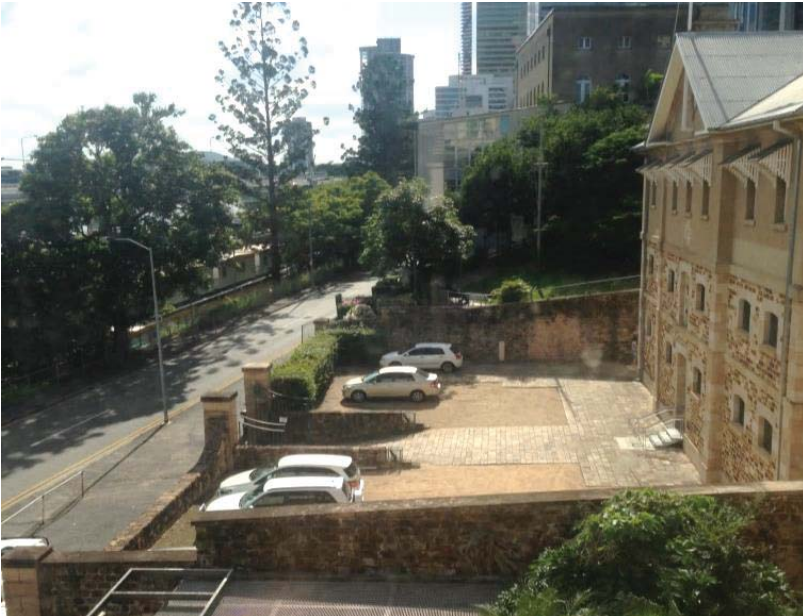
Figure 25 - Commissariat Store yard/carpark and Queens Wharf Road entrance

A set of iron gates along Queens Wharf Road accesses the property, opening to a yard that is generally used for car parking. The carpark is partially paved with Brisbane Tuff (c. 1979), and the balance of the site is surfaced with sandy gravel (**Figure 25**).

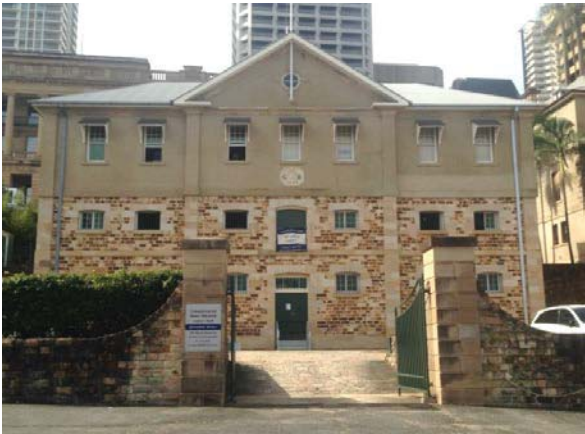
Figure 26 – Queens Wharf Road elevation
Source: Urbis 2016

The small windows of the original structure are small, multi-paned casements, with iron security bars. The centrally positioned double door at ground level is timber with fanlight over. A similarly styled timber double door is at the first level, historically used to receive goods into the building interior.

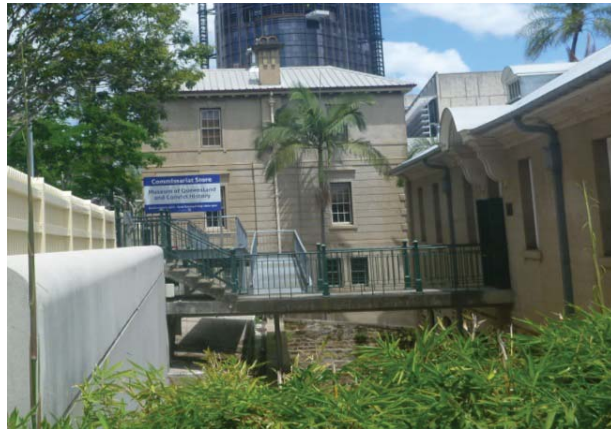
Figure 27 – Gangway and steel ramp
Source: Google Earth

A picket fence has been erected at the William Street site boundary, and access to the uppermost level of the structure is via a stepped concrete gangway (**Figure 27**) with green-painted aluminium handrail. A modern steel ramp adjacent to the gangway provides access for mobility restricted individuals.

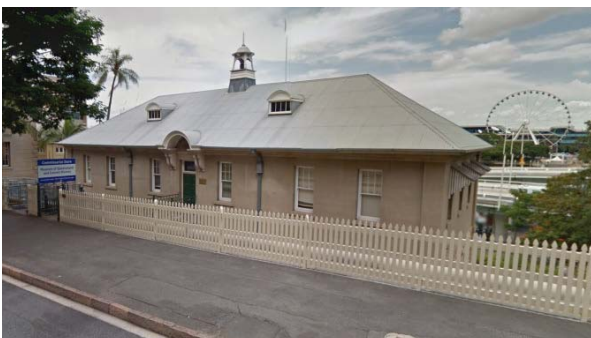
Figure 28 – William Street elevation
Source: Urbis 2016

Two arched dormers are positioned on the roof, as is a fleche, reconstructed as per 1912 detailing (**Figure 28**).

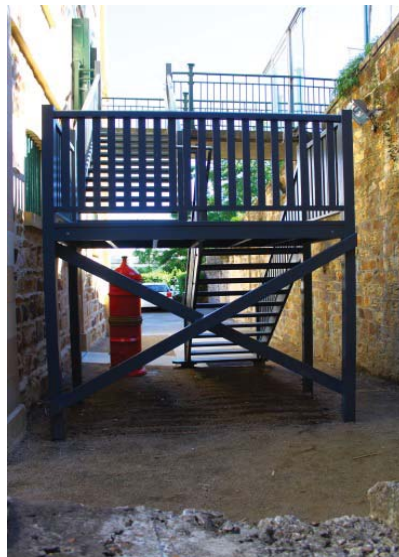
Figure 29 – Access to yard and Miller Park (Urbis 2016)

The side windows feature three windows at each storey, with the exception of the first floor at the north western elevation (facing Miller Park) which has a timber panelled double door that accesses both Miller Park and the yard of the Commissariat Store (**Figure 29**).

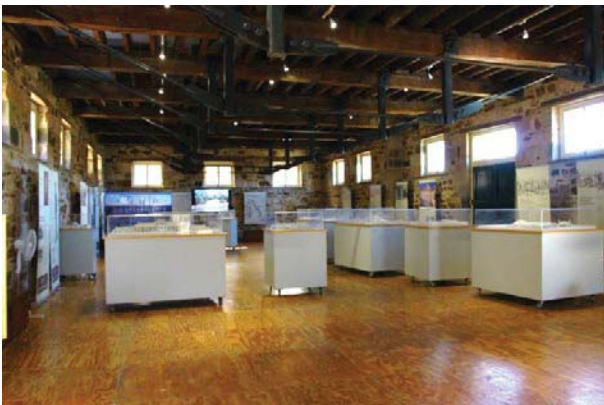
Figure 30 – Ground Floor, interior

At present, the ground floor of the building (**Figure 30**) is an open space used for interpretive museum display. The floor is squares of plywood but was originally Brisbane Tuff blocks laid over a significant drainage system. Walls are exposed Brisbane Tuff, and the ceiling is exposed beams which shows the underside of the timber floor above (**Figure 31**).

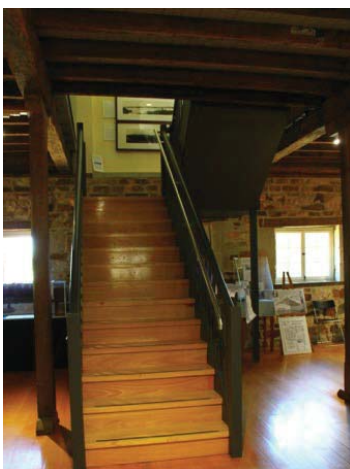
Figure 32 – Interior staircase

A timber staircase accesses the first floor (**Figure 32**) which has a timber floor, and a similar arrangement of exposed walls and beams. The space is also used for museum display purposes (**Figure 33**). The first floor is also accessed via a modern disability access lift, which features glass security panels with rounded aluminium handrail.

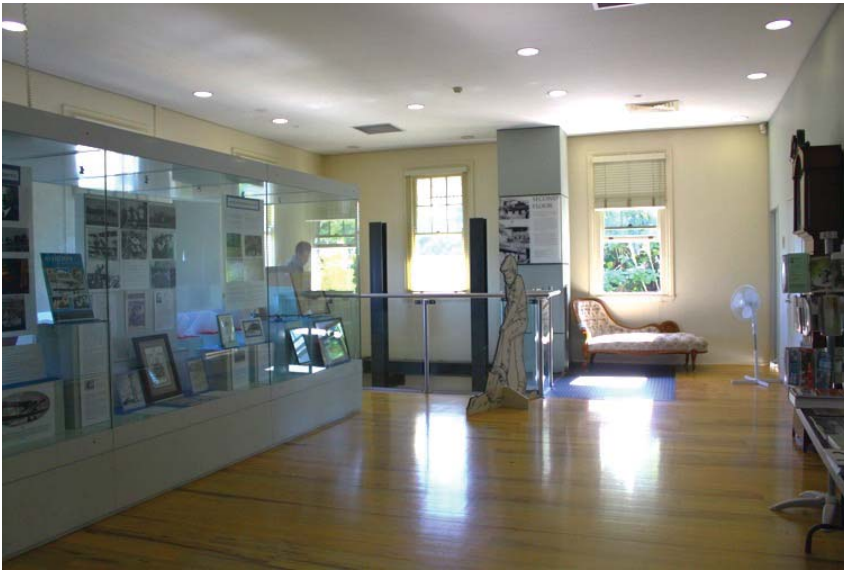
Figure 34 – Second Floor, interior

The second floor (**Figure 34**) is used as a display area and reception for the RHSQ. It has a timber floor, modern suspended ceiling with downlights, walls are lined with plasterboard, and modern partitions create office space.

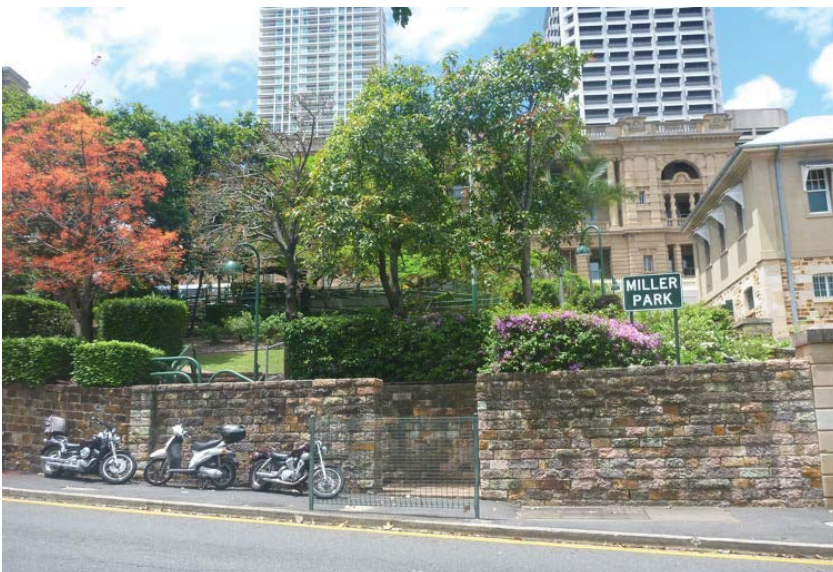
Figure 35 – View to Miller Park from Queens Wharf Road

Miller Park is a landscaped park sited directly to the north-west of the Commissariat Store (**Figure 35**). It has a modern chain-wire fence with hedge row behind, and a winding brick pathway that provides pedestrian access between William Street and Queens Wharf Road. The park features seating, rubbish bins, lighting and plantings.

The retaining wall to Queens Wharf Road is constructed of Brisbane Tuff. The north-west section of wall is original convict built construction, while the remainder of the wall, including stairs are part of the 1982 works to the site.

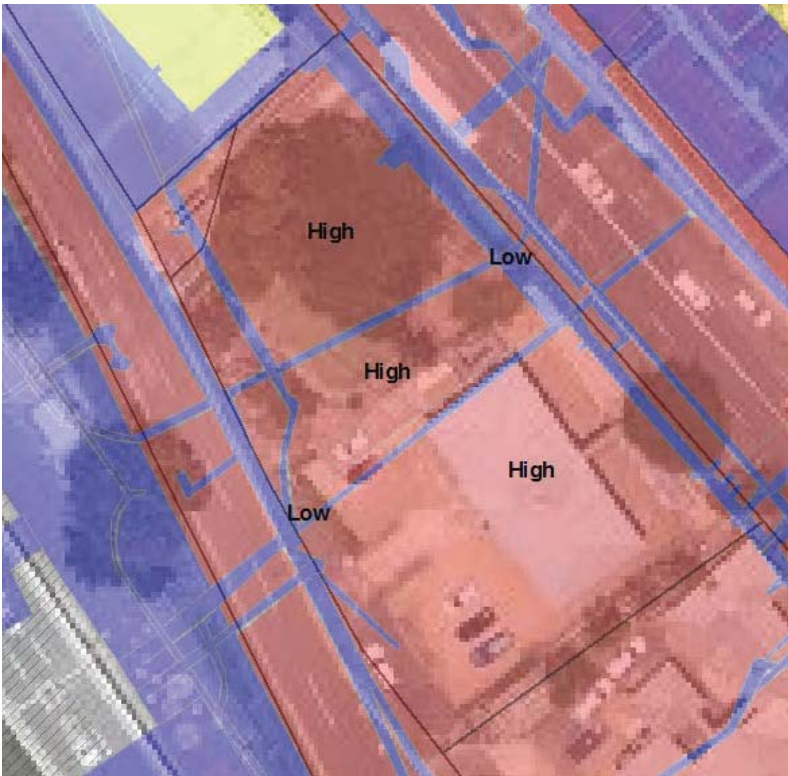
Figure 36 – Archaeological Potential, Commissariat Store and Miller Park

No archaeological potential: No archaeological remains possible due to prior substantial disturbance that has been recorded such as excavation.

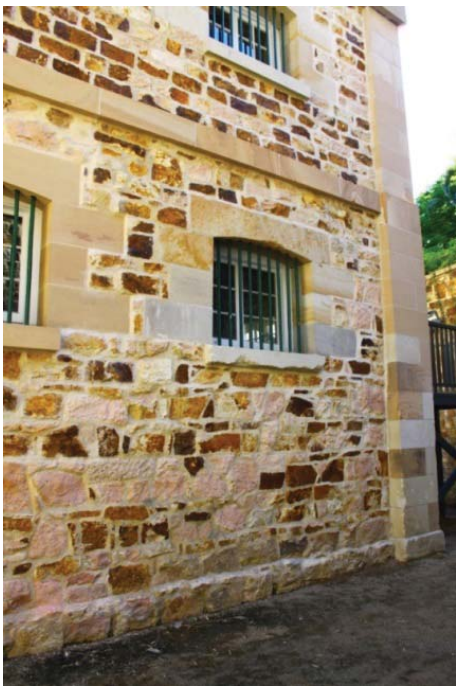
Exceptional
Original stone walls – the building and retaining walls	Exterior

Exceptional

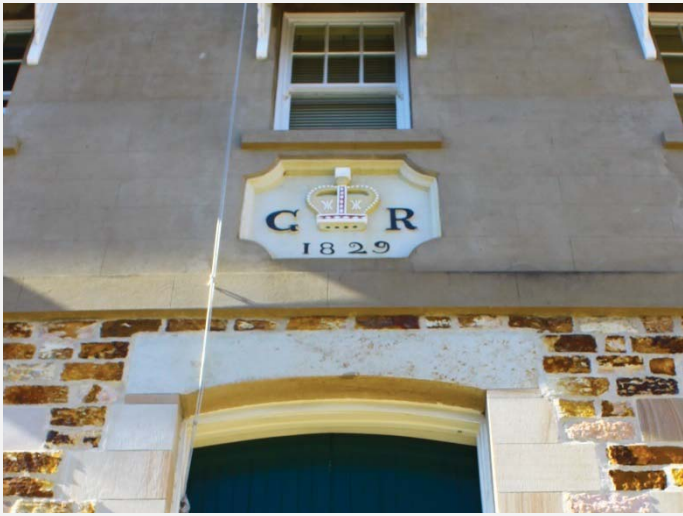
Structure, Space or Element	Location or Building	Photograph	Level
King George IV Royal Cypher	Queens Wharf Road facade

Exceptional
Bars on windows	Exterior

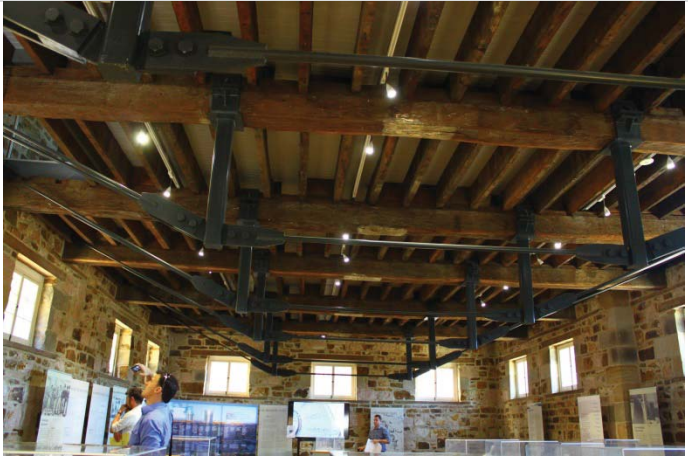
Structure, Space or Element	Location or Building	Photograph	Level
Original ceiling joists and bearers (pit sawn)	First and second floors

Exceptional
Interior beams and joinery – some reconstructed	Interior
