POD VOLUME 3:  
ATTACHMENT D.2:  
FORMER  
GOVERNMENT  
PRINTING OFFICE  
CONSERVATION  
MANAGEMENT PLAN

PREPARED BY: URBIS PTY LTD

QUEEN'S  
WHARF  
BRISBANE

DATE OF ISSUE: 24.11.2017

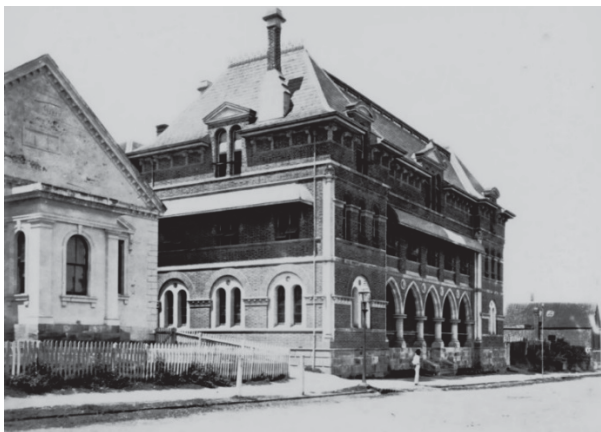
Figure 4 – William Street Wing-C, 1883

The William Street wing of the new building (**Figures 4 and 5**) stood on the site of the 1862 building, which had been demolished in late 1872. The new William Street building had an 'L' shape and extended onto the land previously occupied by the Commandant's residence, wrapping around the south-east side of the 1865 building. It had an arcade to the street frontage of the ground floor, and the roof was covered in Welsh slate to reduce the risk of fire. Narrow rear verandahs were located on the north-west side of the first and second floors of the rear wing.

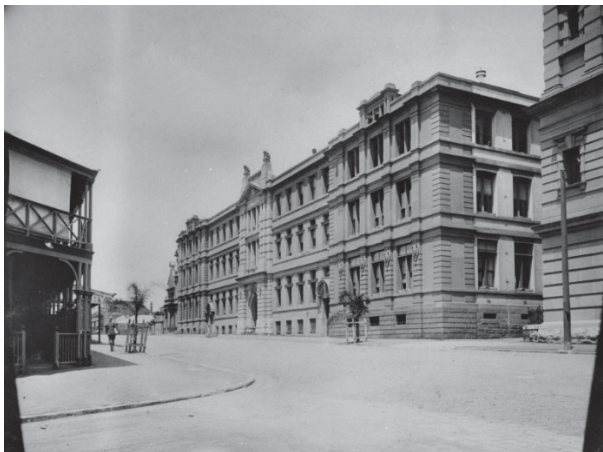
Figure 8 – View of George Street Printery, 1920

The George Street wing (**Figure 8**) was built by Thomas Hiron, while the Stephens Lane infill building was constructed by J Maskrey. The George Street wing was finished around mid-1912.

The George Street wing connected with both the 1887 Stephens Lane building and the 1887 Lithographic Office, forming a 'U' around the engine room. It was symmetrical, with the main entrance in the centre and secondary entrances and stair halls either side of the central section.

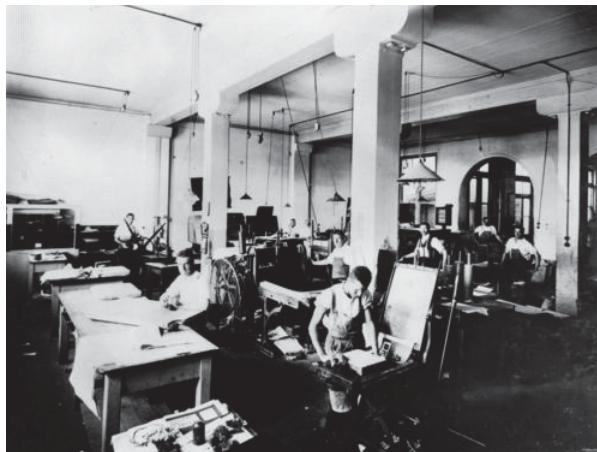
Figure 9 – Lithograph Press Department, with Hardwood Posts, 1921

There was an electric lift adjacent to each stair hall, and a basement. Whereas the roof of the Stephens Lane wing was supported on timber queen bolt trusses, the George Street wing used timber queen post trusses, and while cast iron columns had been used to support the main floor beams in the Stephens Lane wing, hardwood columns were used in the George Street wing (**Figure 9**).

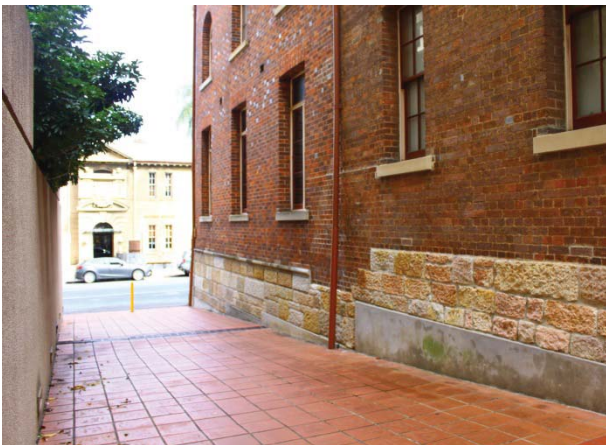
Figure 13 – Cart Lane

Stephens Lane runs along the north-western side of the site. A cart lane (**Figure 13**) runs alongside the south-eastern elevation of the Public Service Club. Both lanes provide access to the internal courtyard.

The former cart lane (**Figure 13** in **Section 3.1**) to the south eastern side of the building is paved with modern materials. A number of windows have been removed from this side elevation of the building and the spaces infilled with brickwork.

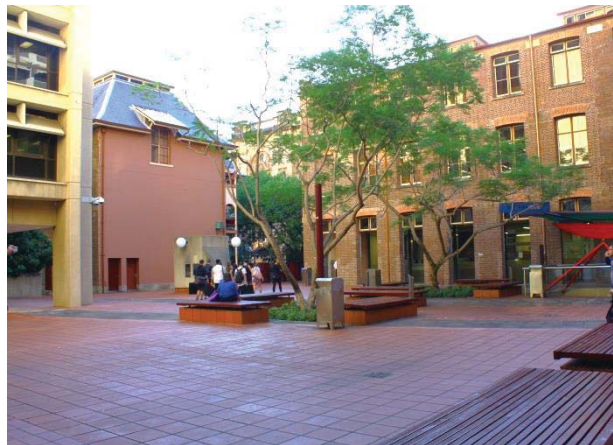
Figure 14 – Courtyard, Former Site of Commandant's Cottage

The paved courtyard (**Figure 14**) between the buildings was constructed in the 1980s as part of the refurbishment of these buildings and the wider site, and features modern materials. Within this courtyard the footprint of the former Commandant's cottage and detached kitchen is indicated in different coloured pavers.

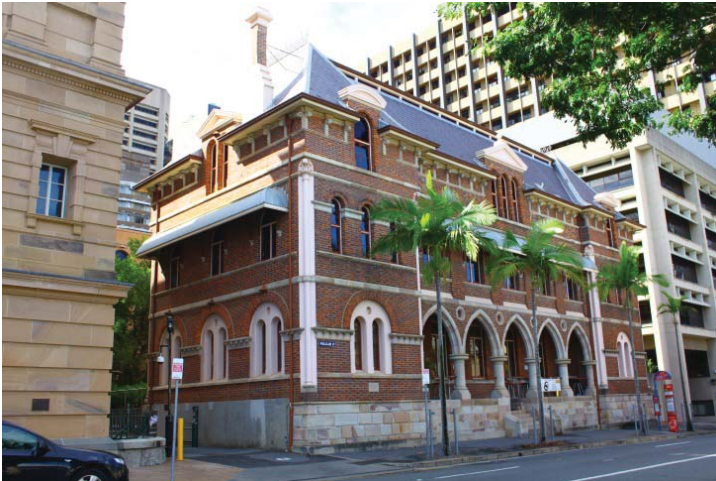
Figure 16 – William Street Façade

The external elevation of the building to William Street (**Figure 16**) demonstrates the influence of the Gothic Revival design of the late Victorian period, predominantly in the steeply pitched roof, arched colonnade and narrow windows.

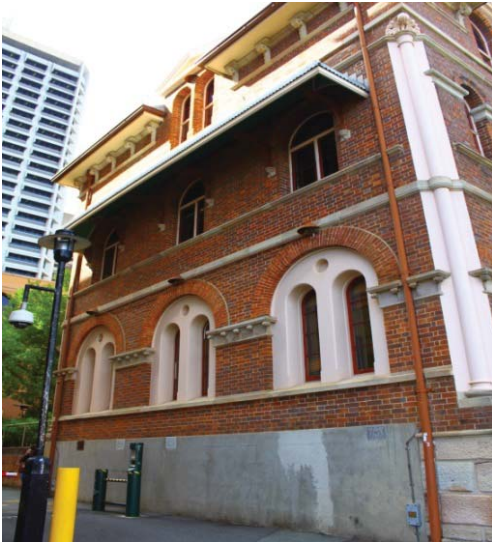
Figure 17 - Details of End Bay, Stephens Lane Elevation

The Stephens Lane elevation is similar in detail to the front elevation, with rendered arches containing multiple lancet-type windows at ground floor level and a concave corrugated iron awning over the first floor windows. The stone string courses of the front elevation continue around this elevation. These features are shown in **Figure 17**.

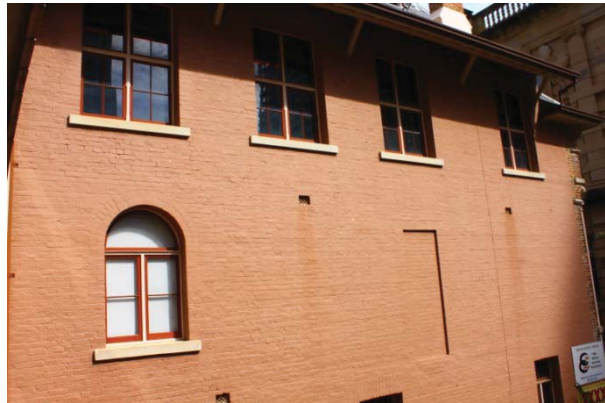
Figure 18 - Rear Elevation

The rear elevation of the William Street wing (**Figure 18**) is painted brick work and has a combination of arched and rectangular windows on all levels. Some former windows and doors at the rear of the building have been infilled with brickwork. A partially enclosed timber verandah is located on the north-west elevation of the return wing to the first and second floors.

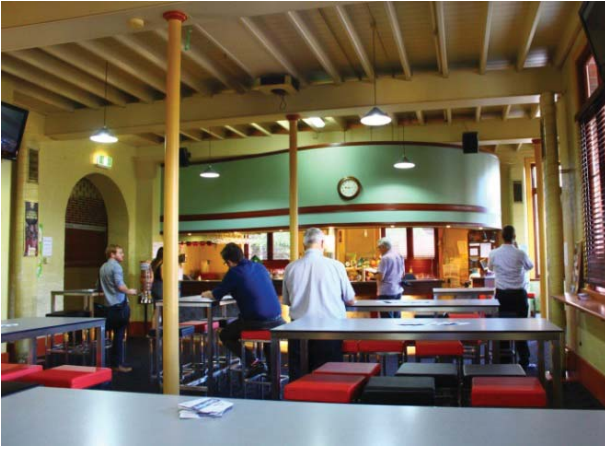
Figure 19 - Ground Floor Interior

Internally the William Street wing of the building is relatively intact. The ground floor (**Figure 19**) has a large single space which is used as bars and eating areas, with three smaller rooms to the Stephens Lane end. The bar fixtures and fittings are modern, and modern joinery lines some of the internal walls. Iron columns (original or reproductions) support the floors above (**Figure 19**) and are located centrally within the main space. An original timber column is extant in one of the end rooms. The main space on the ground floor is not ceiled (**Figure 19**) and the timber floor framing and boards of the floor above are visible. Doors exiting the building are generally framed tongue-and-groove sheeted.

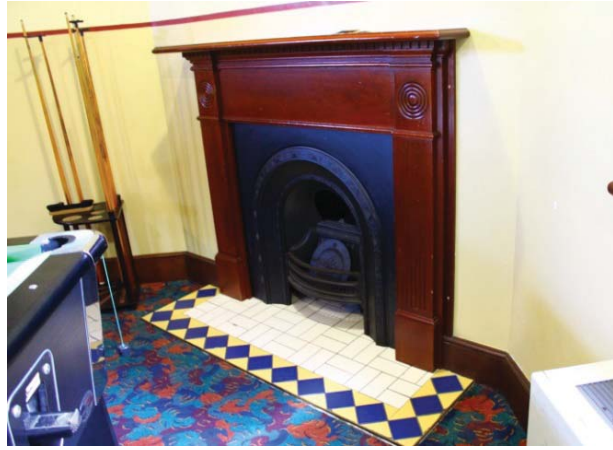
Figure 20 - Fireplace

The three rooms to the Stephens Lane end feature timber boarded ceilings. The three end rooms appear to be original and feature painted brick walls, four panelled timber doors, timber skirtings and architraves, and extant fireplaces with timber joinery (**Figure 20**).

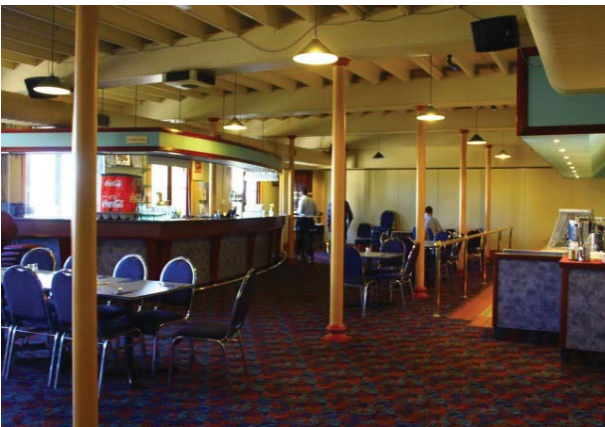
Figure 21 – First Floor

The first floor of the William Street wing is a large single space, but with a later partition to the Stephens Lane end. Modern glazed doors provide entry to the main space. The original arched opening between the two wings has been removed. There is no ceiling as such to the space and timber joists and beams are prominent, and are supported by two rows of iron columns located throughout the space. A modern servery and bar area are located at the back of the room. These features are shown in **Figure 21**.

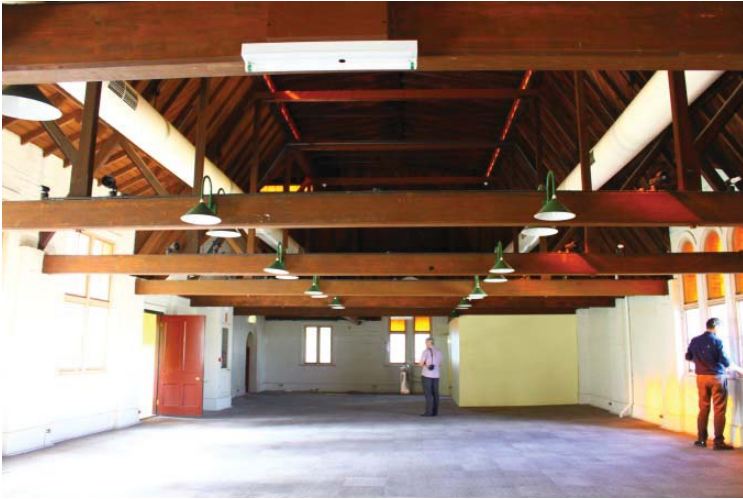
Figure 22 - Second floor

The underside of the roof is lined with timber beaded boards that are laid diagonally and raked to follow the mansard roof. The roof members and timber boards are stained dark brown. The amber-coloured glass in the clerestory is also used in the top of windows to William Street and Stephens Lane (**Figure 22**).

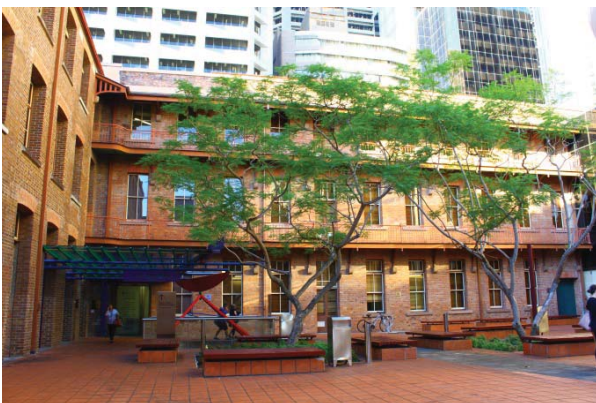
Figure 23 - George Street Building Viewed from Courtyard

The Printery is a three-storey, rendered masonry building set on a Brisbane Tuff base, with a partial basement to the George Street wing. The building forms an L-shape around the rear courtyard (**Figure 23**).

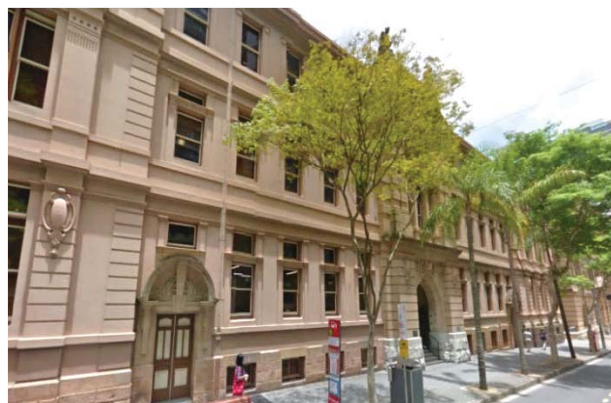
Figure 24 - George Street Elevation, looking towards the Central Entrance

Overall the George Street elevation (**Figure 24**) is symmetrically composed around a central, slightly projecting entrance bay with wings on both sides terminating in pavilions. The north-western bay of the George Street elevation corresponds with the 1880s Stephens Lane wing of the Printery.

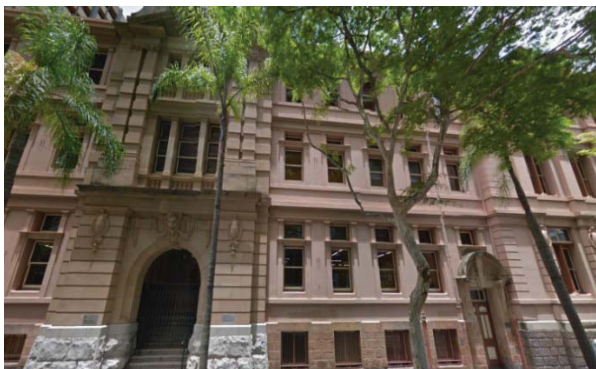
Figure 25 - George Street Elevation, Central Entry

The central entrance to the building is located on a granite base. An archway leads to an elevated porch and stone stairs from the street lead to timber entrance doors. These doors are timber with stained glass panels and side lights depicting various printing techniques. Original steel mesh doors are located at the street frontage and prevent access to the building from the street frontage. Above the stone archway are a series of stone carvings and decorative details including a devil's face, banners, the words "PRINTING OFFICE" and the date "1910". A large entablature separates the ground level from the upper two levels which have double pilasters rising through both levels on either side of the windows. These features are shown in **Figures 25 and 26**.

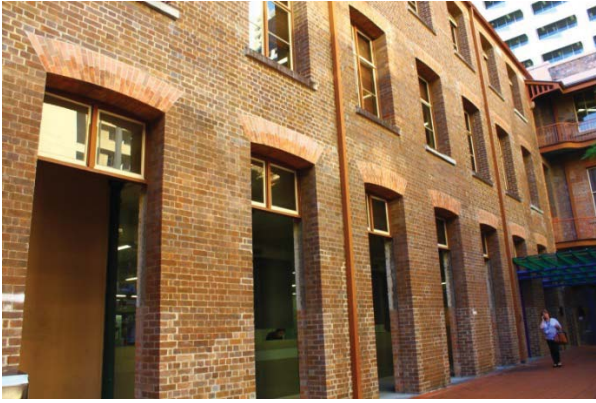
Figure 27 - Arcade, with Extant Fanlights

The ground floor to the Stephens Lane elevation of the Stephens Lane wing of the Printery features an arcade of flat-arched openings created by the removal of previous windows, sills and brickwork. Timber fanlights have been retained above. This has formed a covered walkway (**Figure 27**). A modern glazed wall sits inside this space constructed alongside one of the lines of iron columns internally, and forms the enclosure to the ground floor offices beyond.

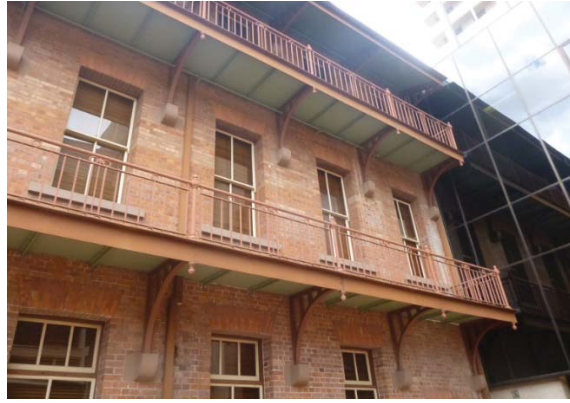
Figure 28 - Windows, Balconies and Brackets

The rear elevation of the George Street wing is of face brick with square headed timber sash windows with fanlights to each floor and stone sills. The first and second floors have cast iron balconies extending the length of the building. These balconies have cast iron handrails and decorative balustrading and are supported by cast iron brackets. Brackets of a similar style support the extended eaves to the second level. These features are shown in **Figure 28**.

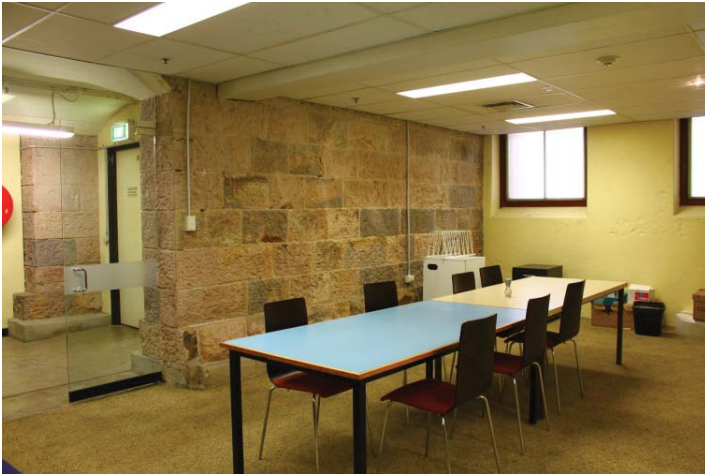
Figure 29 - Basement Showing Stone Wall

The basement level to the George Street wing contains some modern office spaces, showers and toilets etc., with predominantly modern partitions dating from the 1980s refurbishment. Suspended ceilings are common although some original herringbone struts are apparent in places. Some original stone foundation walls survive in-situ in the basement area (**Figure 29**) together with original heavy timber columns. An original strong room or safe survives in the basement, and is located directly below the entrance stairs.

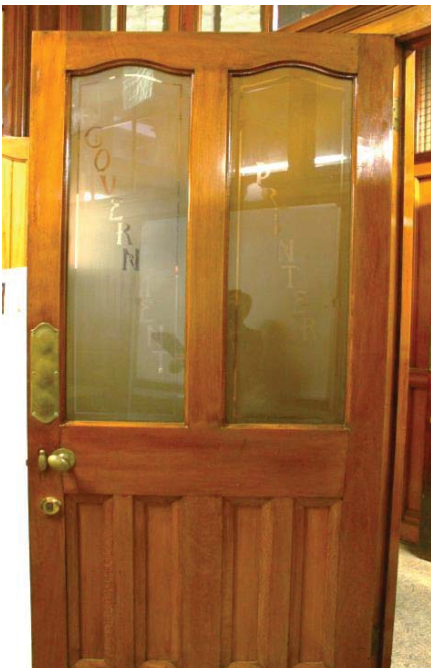
Figure 30 - ‘Government Printer’ Door

The ground floor of the George Street wing contains further office space and accommodation for Births, Deaths and Marriages. While modern glazed doors and partitions are present in places much of the original office layout on this floor survives, with original timber part height walls with glazed panels above. Original timber doors with stained and etched glass panels with original lettering also survive throughout this area (“Government Printer” and “Accountant”) (**Figure 30**).

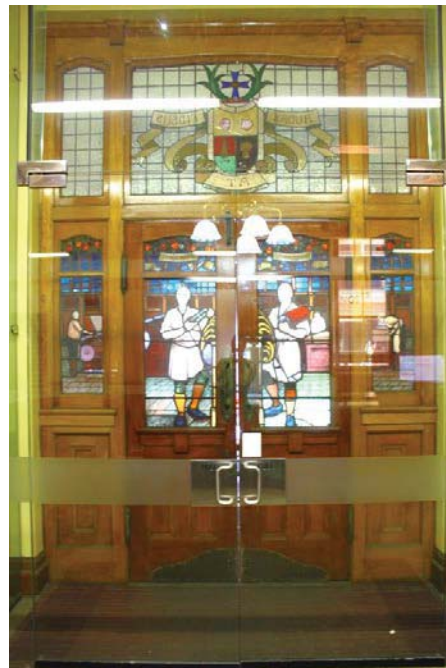
Figure 31 - Original Entry Door

The original entrance doors to the building off George Street survive but are not used (**Figure 31**). These are constructed of timber and feature stained glass panels with printing-type figures and motifs (“Typography” and “Lithography”). The original offices for the Government Printer and Accountant survive in this location and are accessed via an original transverse corridor. Pressed metal ceilings survive in many places and indicate the former office spaces and uses. Floors are carpeted throughout.

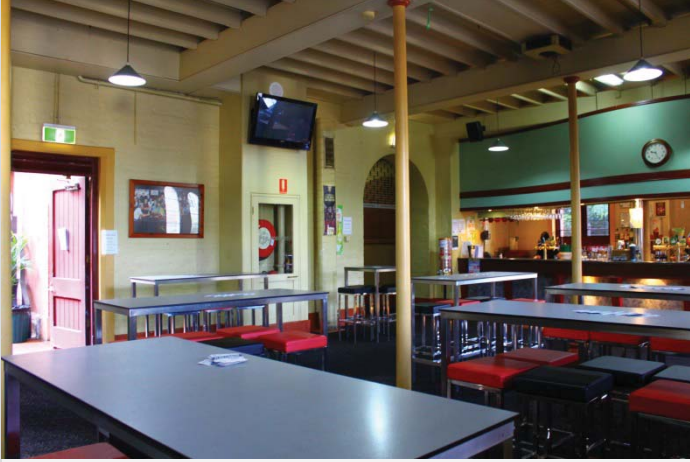
Structure, Space or Element	Location	Photograph	Level
Iron columns	Ground and first floors

<p>A photograph showing the interior of a bar or pub. Several tall, slender iron columns support the ceiling. The space is furnished with long tables and red-upholstered stools. A bar counter is visible in the background.</p>	High
Rooms and offices on ground floor	William Street wing

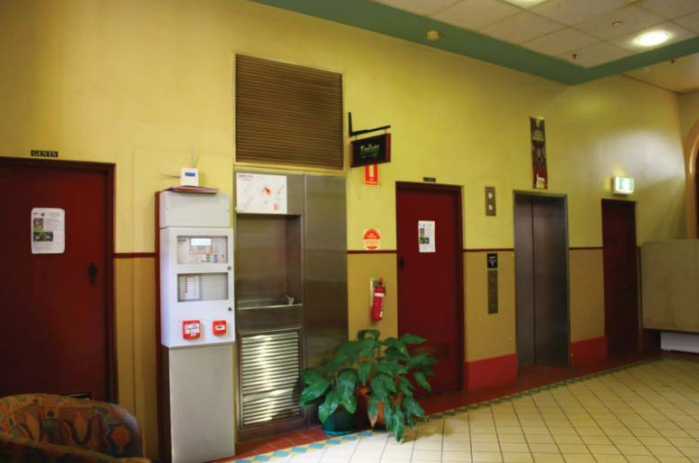
Intrusive
Lifts, fire escape stairs, toilets, plant, kitchens, suspended ceilings, etc.	Internally in return wing to all floors

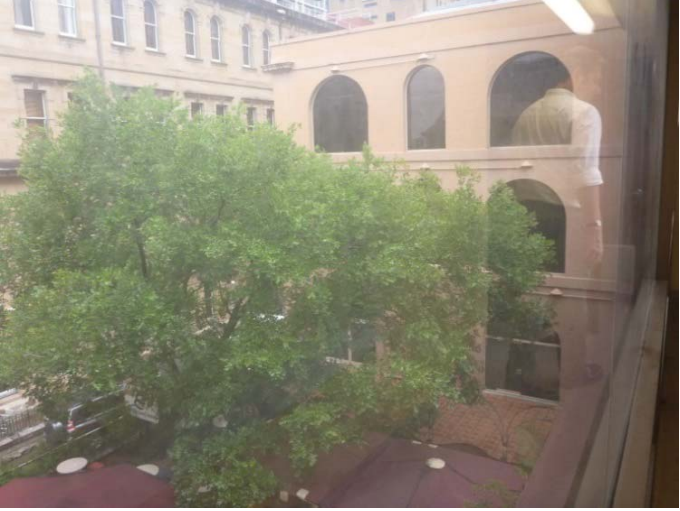
Structure, Space or Element	Location	Photograph	Level
<b>SETTING</b>			
Courtyard	Courtyard space between the two buildings

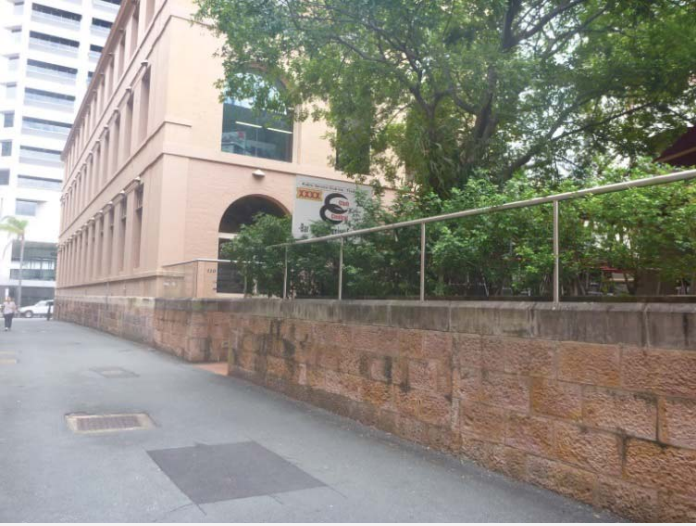
High
Stone wall to Stephens Lane	Stephens Lane

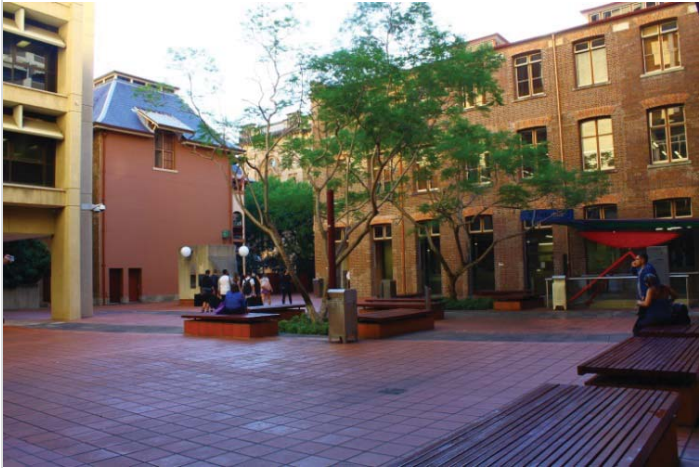
Structure, Space or Element	Location	Photograph	Level
Tiles and finishes to courtyard	Courtyard space between the two buildings

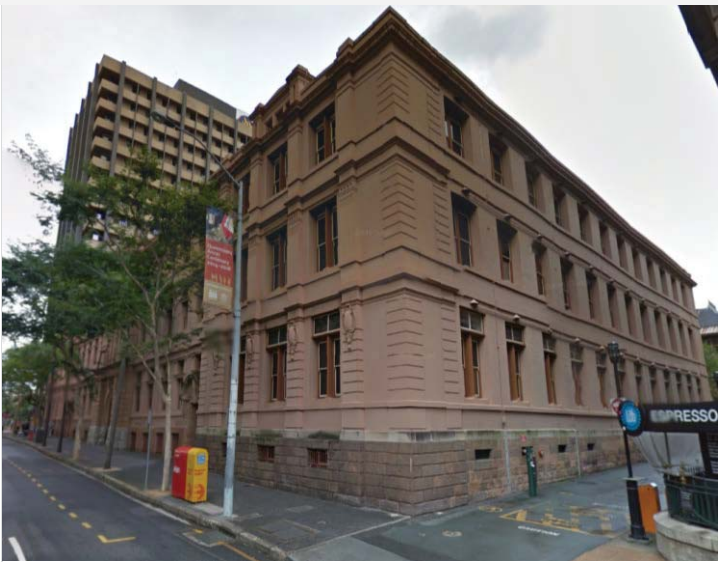
Neutral
<b>EXTERIOR</b>			
The external form and scale of the building generally, including the George Street, Stephens Lane and side elevations	Viewed from public areas including George Street and Stephens Lane

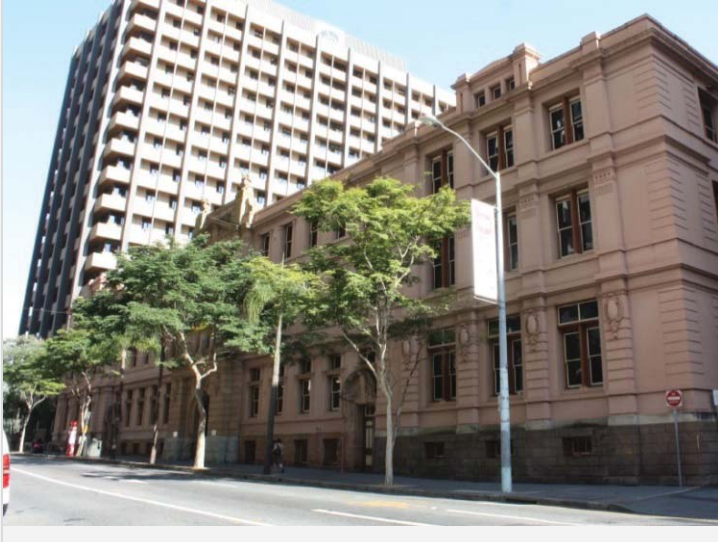
High
The George Street front elevation	Viewed from George Street

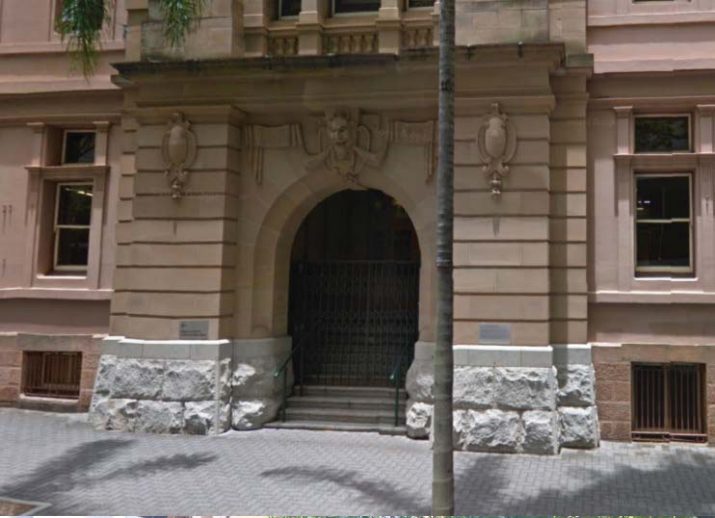
Structure, Space or Element	Location	Photograph	Level
Stone detailing, figures and gargoyles	George Street elevation

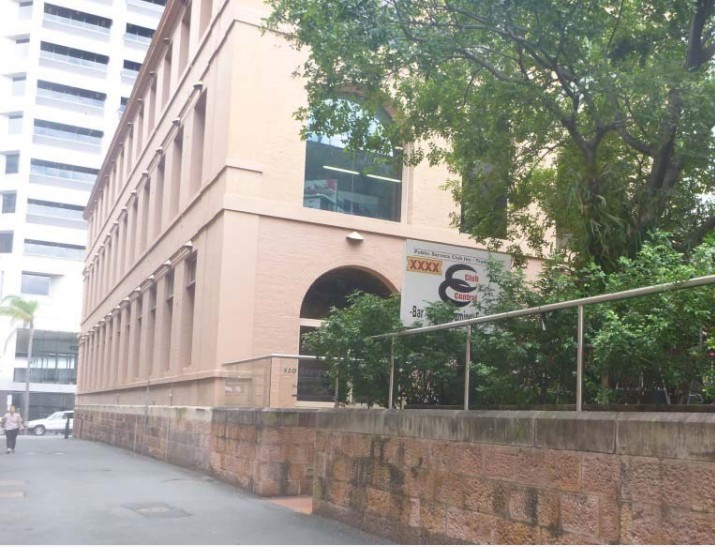
High
Stephens Lane side elevation	Viewed from Stephens Lane

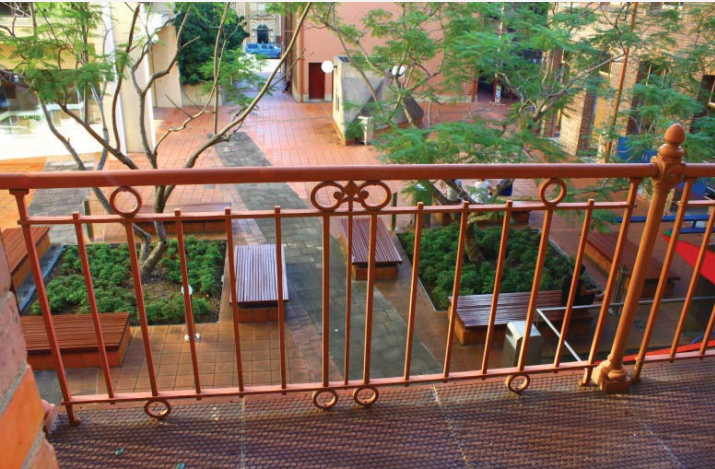
Structure, Space or Element	Location	Photograph	Level
Cast iron balconies and brackets	Rear elevation George Street wing

- Policy 19. The timber French doors to the rear elevation of the George Street wing of the Printery should be retained and conserved. If replacement doors are required, new doors should match the existing material, profile, finish and form. New door styles or materials (such as aluminium) should not be contemplated.*

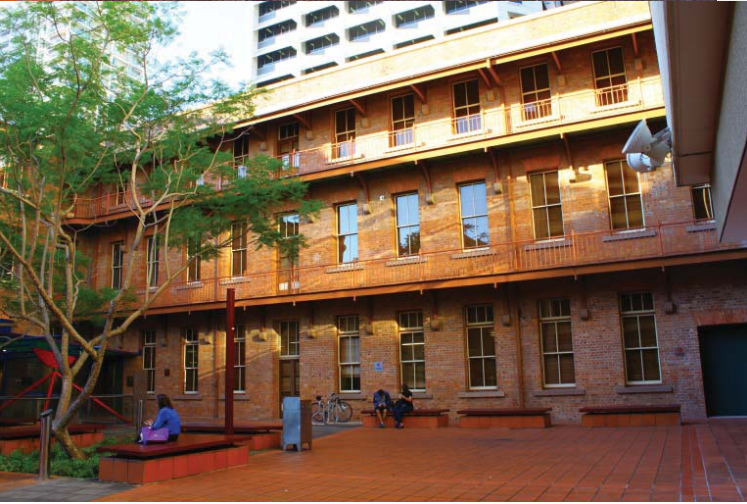
High
<p>openings</p> Windows to front side and rear elevations	George Street, Stephens Lane and courtyard

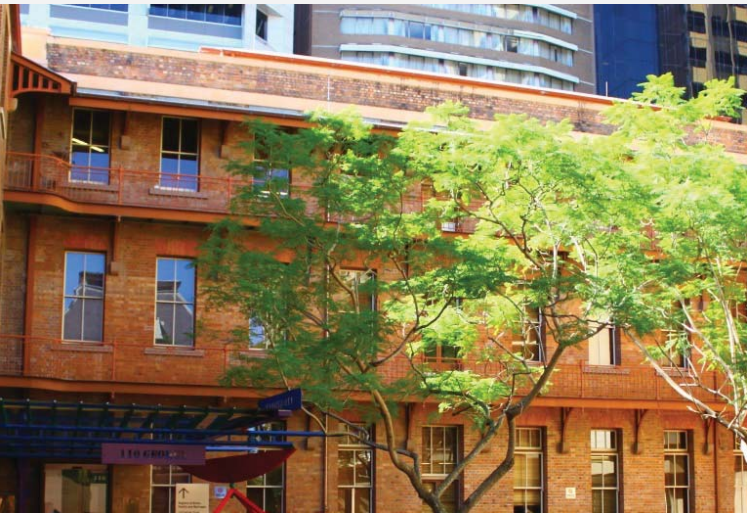
Moderate High
<p>Roof form = high</p> Roof sheeting	Roof

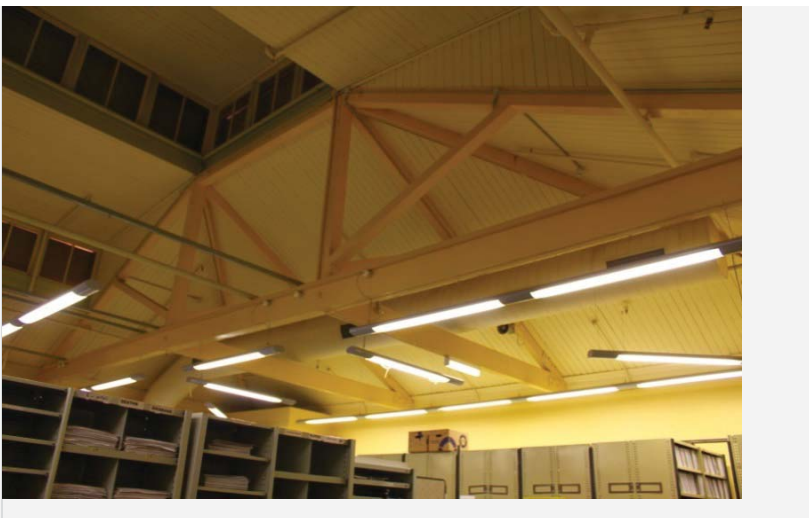
Structure, Space or Element	Location	Photograph	Level
<b>INTERIOR</b>			
Trusses	Second floor

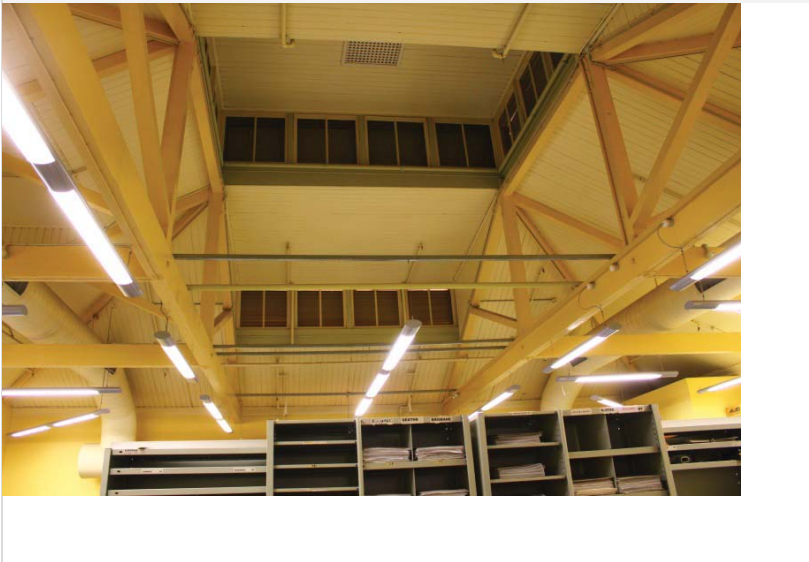
High
Timber linings to clerestory roof and general roof framing	Second floor

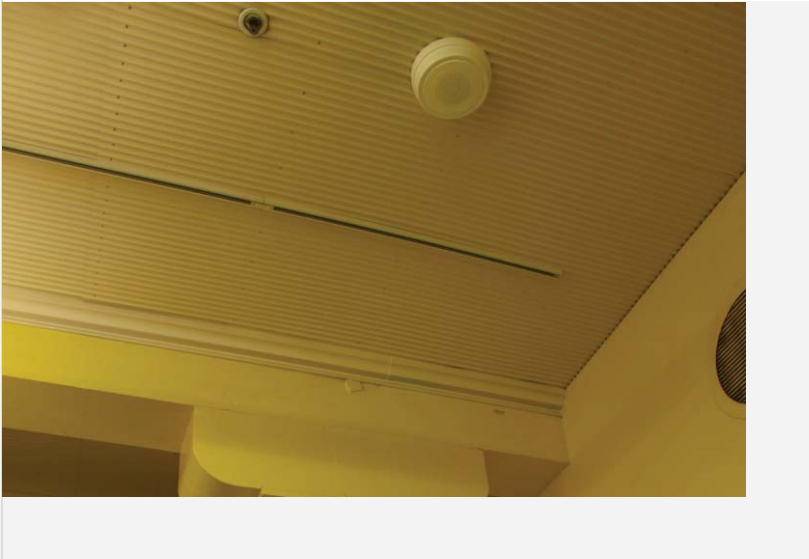
High
Ripple iron ceilings	Ground, first and second floors George Street wing

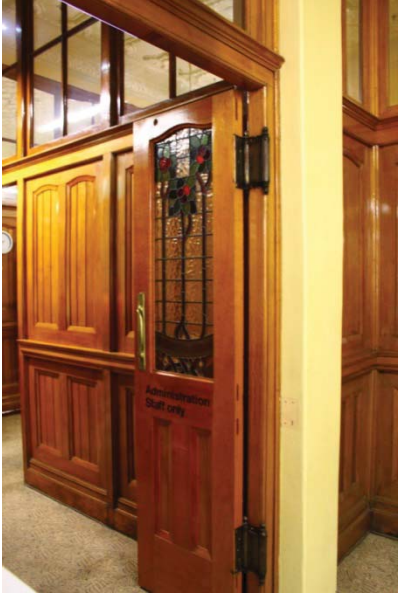
Structure, Space or Element	Location	Photograph	Level
Timber joinery, glazing, leadlight windows and doors	Ground floor George Street wing

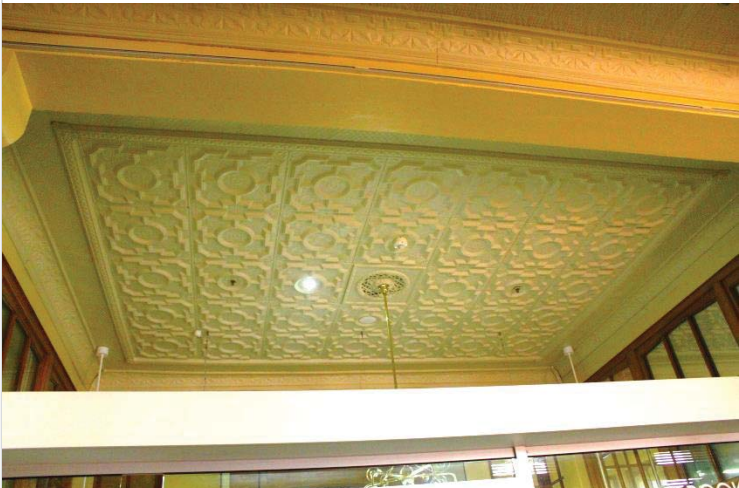
High
Pressed metal ceilings	Ground floor George Street wing

- Policy 25. The intact room layout of the ground floor of the George Street wing of the Printery should be retained. This includes timber joinery, doors, stained glass and other elements.*
- Policy 26. Pressed metal ceilings to the ground floor of the George Street wing of the Printery should be retained and remain visible. New partitions must not connect to the ceilings.*

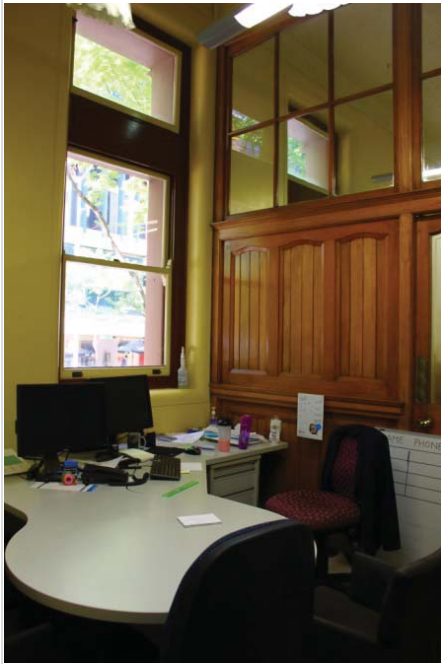
Structure, Space or Element	Location	Photograph	Level
Original room layout	Ground floor George Street wing

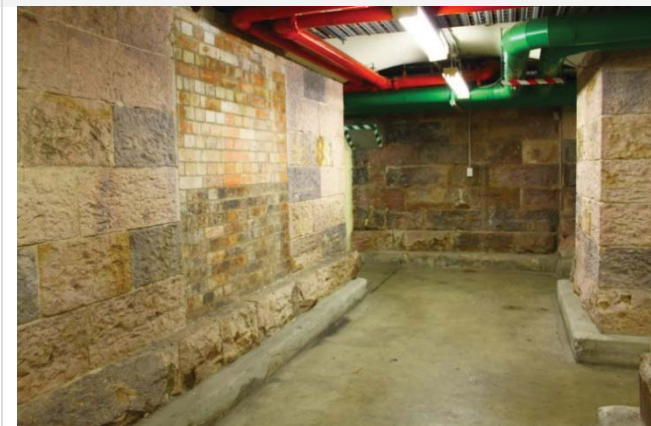
High
Remnant stone and bricks walls	Basement to George Street wing

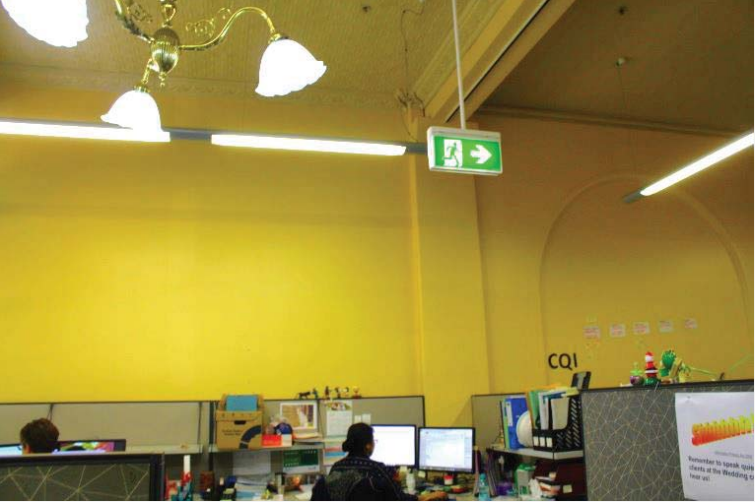
Structure, Space or Element	Location	Photograph	Level
Brick wall surfaces internally	Ground, first and second floors Stephens Lane wing

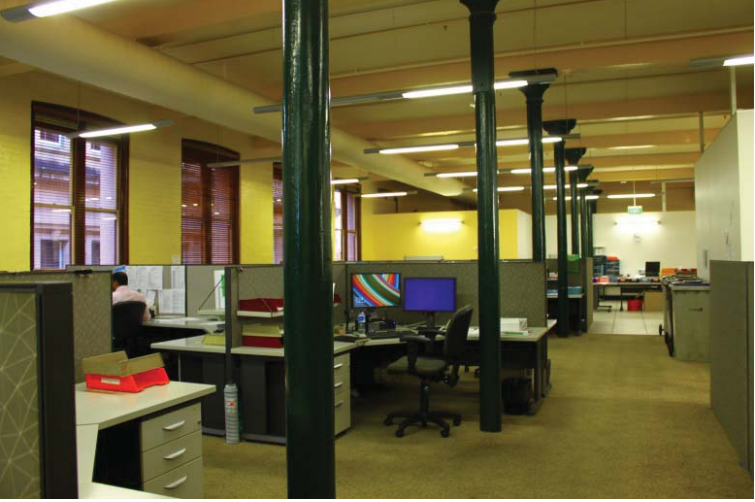
High
Iron columns	Ground, first and second floors Stephens Lane wing

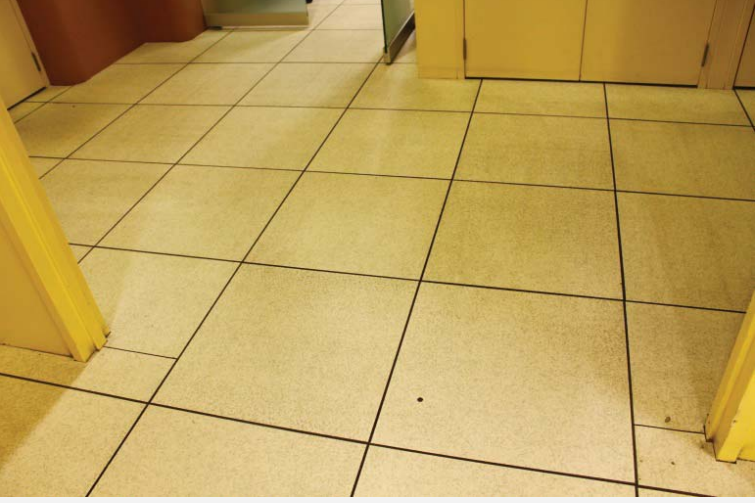
High
Timber floors generally (under later floor coverings)	Ground, first and second floors

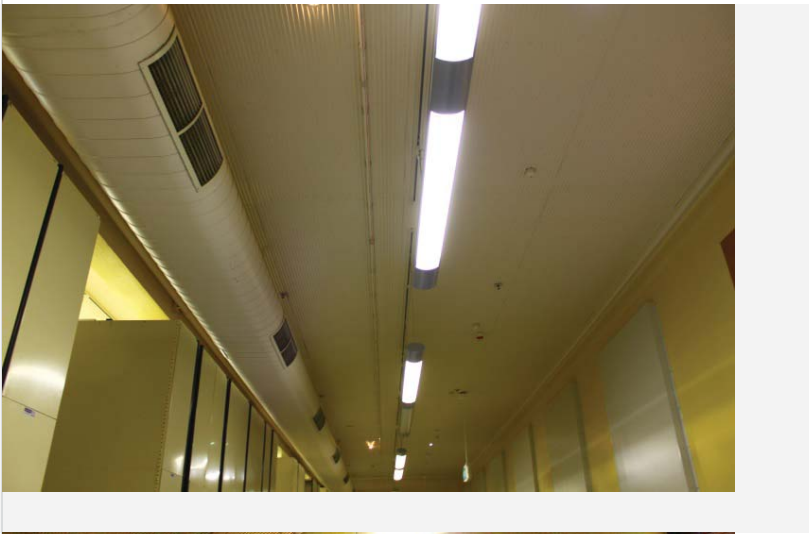
Moderate
Lighting generally	Ground, first and second floors George Street wing

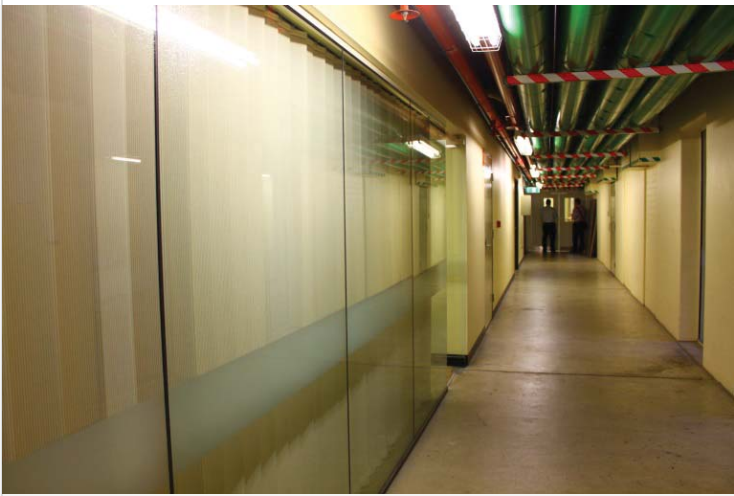
Structure, Space or Element	Location	Photograph	Level
Concrete walls	Basement to George Street wing

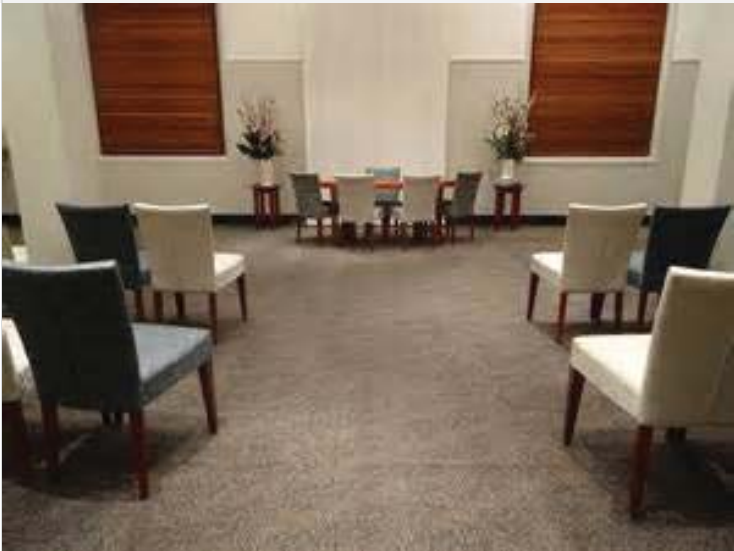
Intrusive
Chapel fitout	Ground floor George Street wing

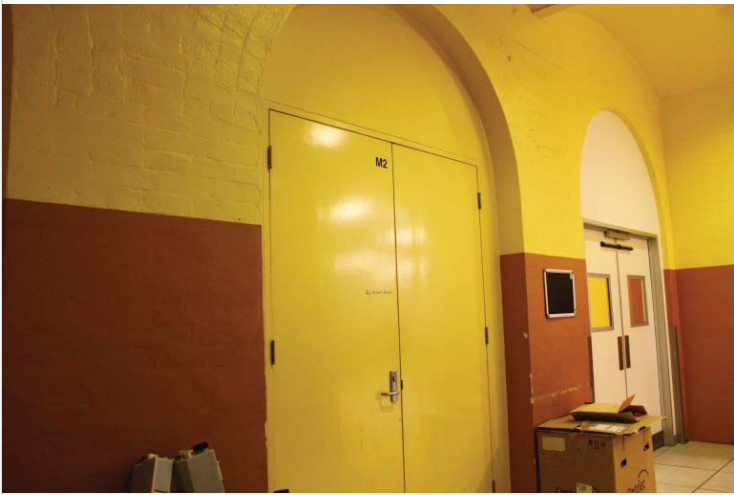
Neutral
Fire doors to stairwells	Ground, first and second floors George Street wing

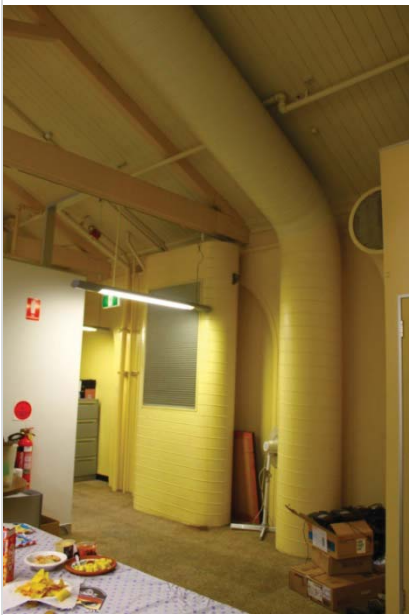
Structure, Space or Element	Location	Photograph	Level
Lifts, fire escape stairs, toilets, plant, kitchens, etc.	Ground, first and second floors

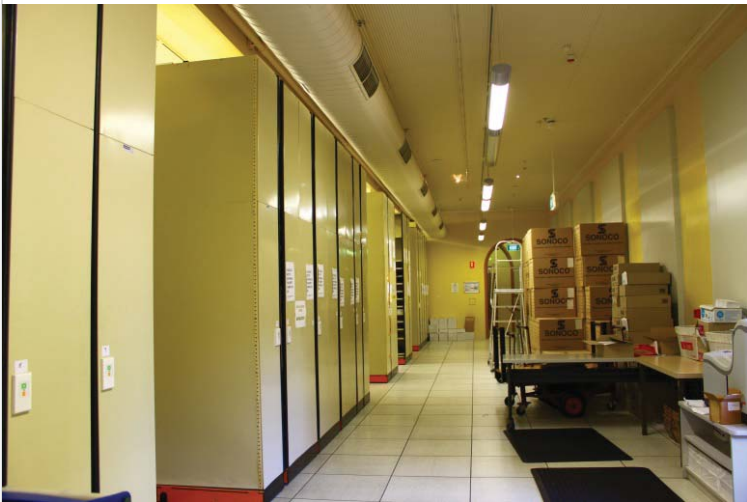
Intrusive
Raised floor and compactuses	First floor George Street wing

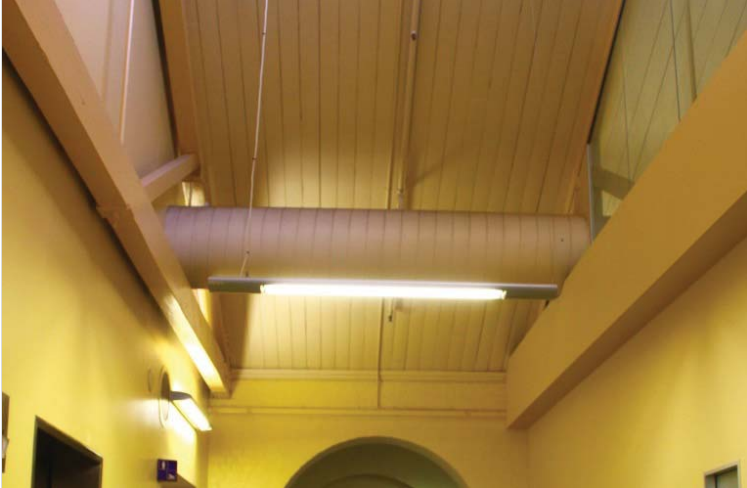
Intrusive
Air-conditioning plant	Second floor George Street end Stephens Lane wing

Policy 35. *The current air-conditioning plant to both buildings may be removed or rationalised. The provision of replacement air-conditioning needs to be carefully considered in terms of impacts to heritage fabric.*

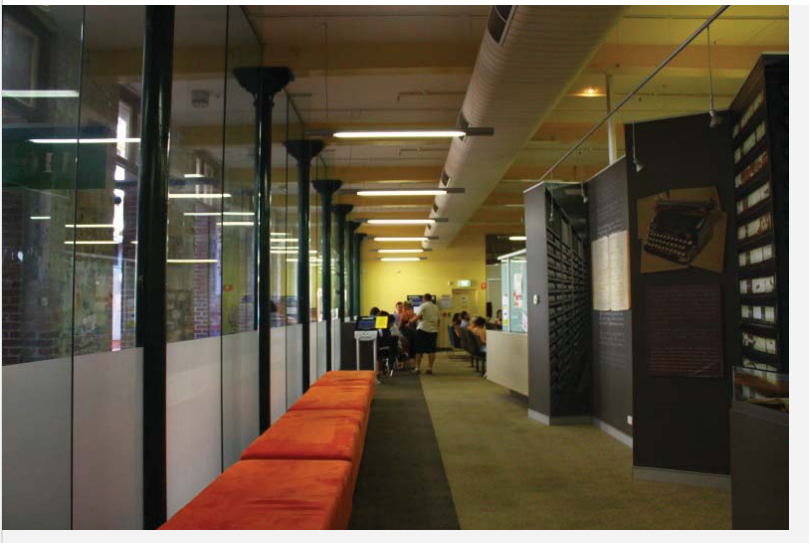
<b>Structure, Space or Element</b>	<b>Location</b>	<b>Photograph</b>	<b>Level</b>
Glazing to Births Deaths and Marriages offices	Ground floor Stephens Lane wing
