POD VOLUME 3:
ATTACHMENT D.1:
FORMER DPI BUILDING
CONSERVATION
MANAGEMENT PLAN
PREPARED BY: URBIS PTY LTD

QUEEN'S
WHARF
BRISBANE

DATE OF ISSUE: 24.11.2017

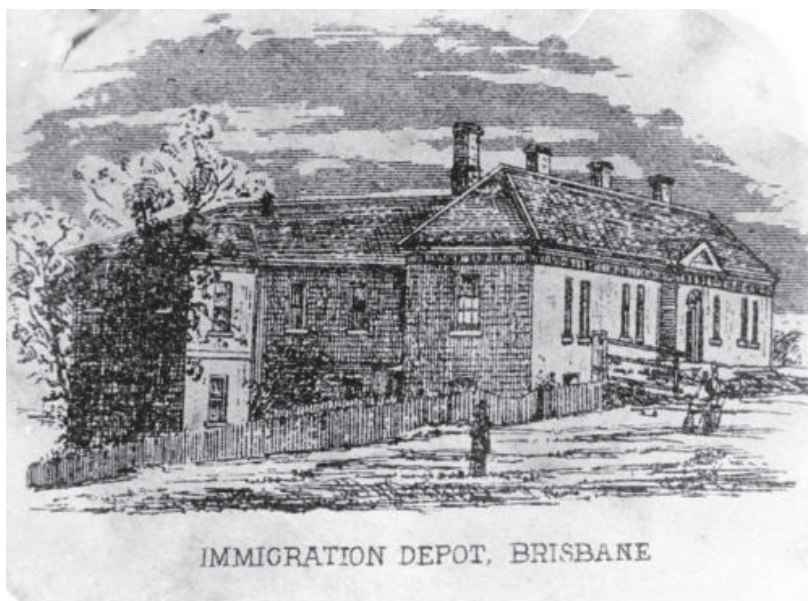
Figure 3 – Immigration Depot, c1868

Construction of the Immigration Depot commenced in 1865 and was completed by 1866. Designed in the office of Queensland's first Colonial Architect, Charles Tiffin, the building was originally single storey with a basement to William Street and a three-storey wing at the rear (**Figure 3**).

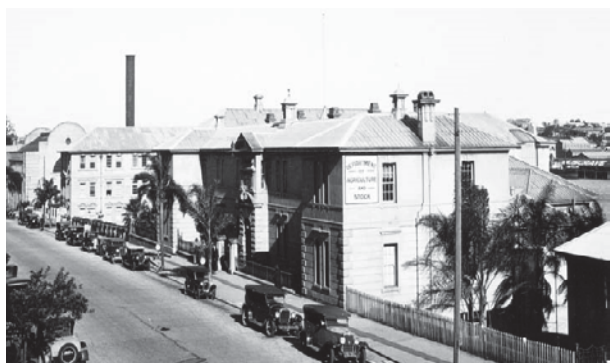
Figure 7 – William Street Elevation of Former DPI Building, 1936

Further extensions to the building were carried out in 1922, 1929, 1935 and 1936 and involved extending the building and construction of new buildings south-east of the original building along William Street (**Figures 7 and 8**).

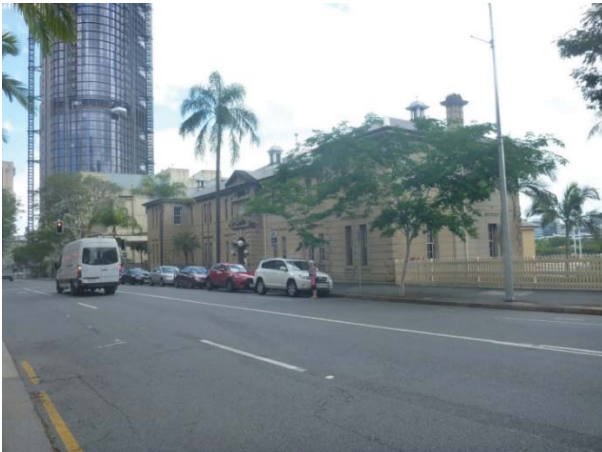
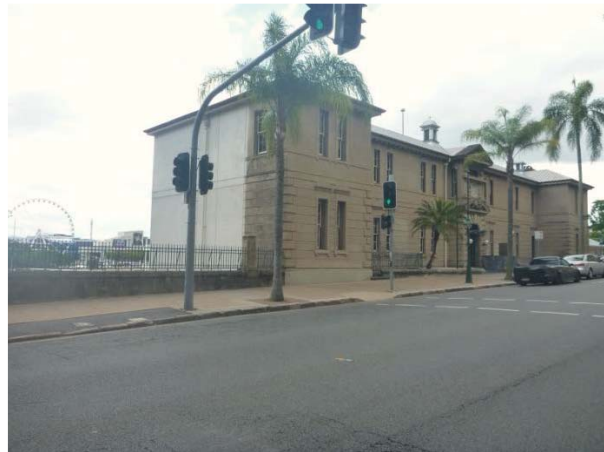
The building is of brick construction with rendered walls and a hipped rib and pan galvanised iron roof (**Figures 13 and 14**). The William Street section is two storeys with a basement and is rendered and unpainted (William Street wing). The three-storey wing at the rear is also of brick construction on a stone base (Queens Wharf Road wing). It extends from the ground floor of the William Street section, and is finished in painted brickwork.

Figure 13 – View of Building along William Street from the North

Figure 14 – View of Building along William Street from the South

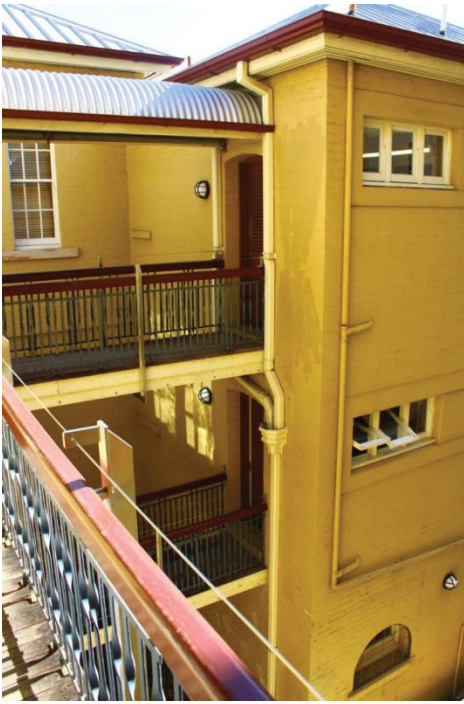
Figure 17 – 1924 Toilet Block to the Rear of the 1860s Building

The toilet block (**Figure 17**) is located to the rear of the William Street wing and is linked to the main structure via cantilevered walkways on the ground and basement levels. The toilet block has arched sash windows to the base, with high level hopper windows to the floors above, and curved iron brackets supporting a timber walkway with wrought iron balustrade. A new stainless steel top rail has been added to the balustrade in this location and along the rear location of the William Street wing.

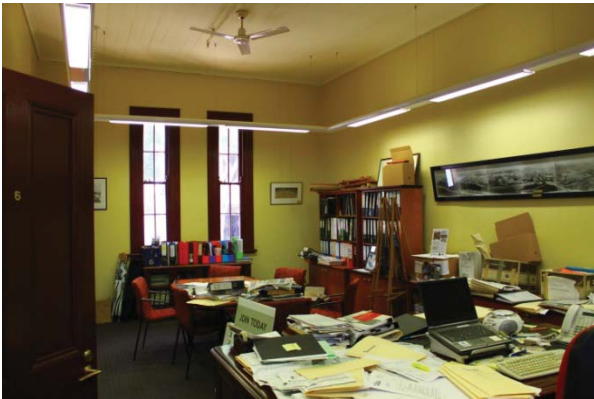
The William Street wing features office spaces on the ground and first floors (**Figures 18, 19 and 20**), and display space for the National Trust in the basement.

Figure 18 – Typical Ground Floor Office Fitout with Timber Ceiling, Carpeted Floors and New Services

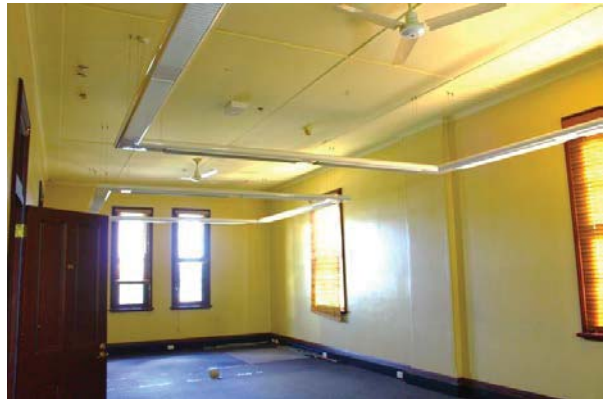
Figure 19 – Typical First Floor Office Fitout with Air Conditioning Unit

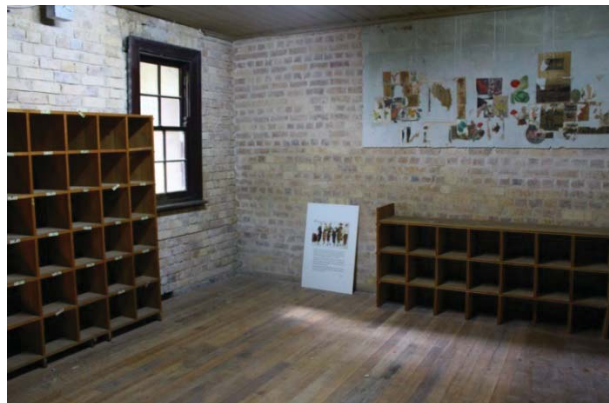
Figure 22 – Basement Room in William Street Wing

The basement level has exposed stone walls to the light well, and painted and unpainted brick walls in a number of rooms in the basement (**Figure 22**). A later lean-to bathroom is located on the south corner accessed via the verandah. Timber fireplace surrounds have been removed, but evidence of their form survives.

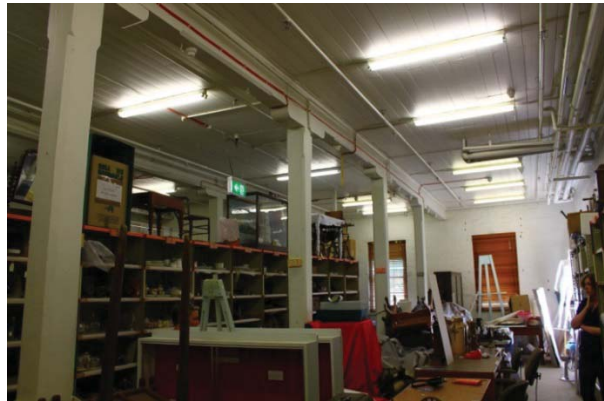
Figure 24 – Basement in Queens Wharf Road Wing

The basement level has a lower floor level than the William Street basement level, boarded timber ceilings (**Figure 24**), and a number of rooms with later partitions. The sub-basement level is similar, but more open plan (**Figures 25 and 26**).

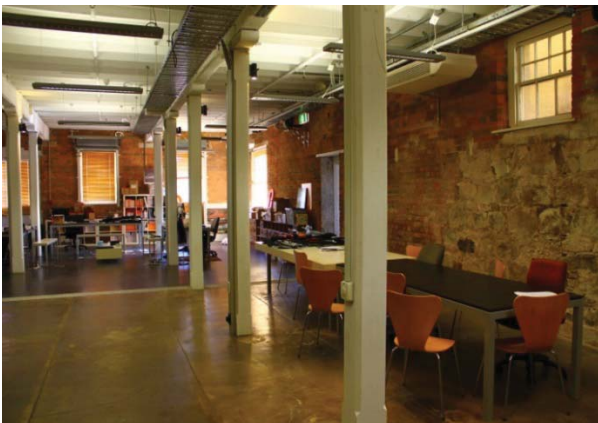
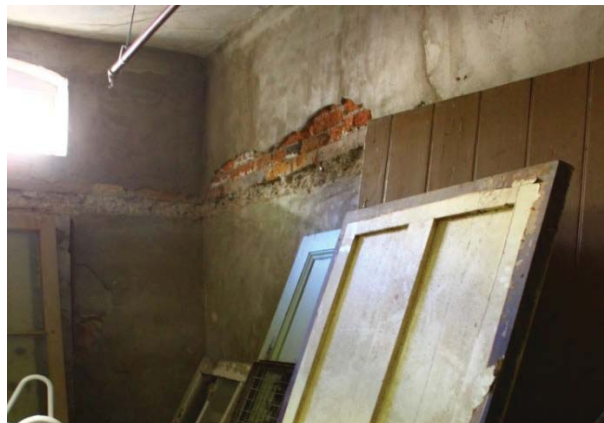
Figure 25 – Open Layout of Sub-Basement

Figure 26 – Storage Room on Southern side of Sub-Basement

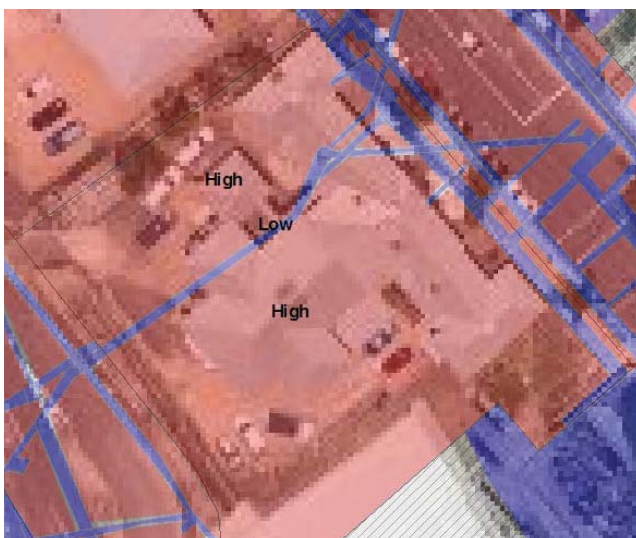
Figure 28 – Archaeological Potential of Former DPI Building

- **High (red)**

The remains of the 1916 addition are visible on the surface south of the building on William Street. There is also potential for additional subsurface structural remains of early wings and outbuildings including the carpenter's workshop and stables to be present, in addition to sub-floor deposits which may be associated with the early use of the building as an Immigration Depot.

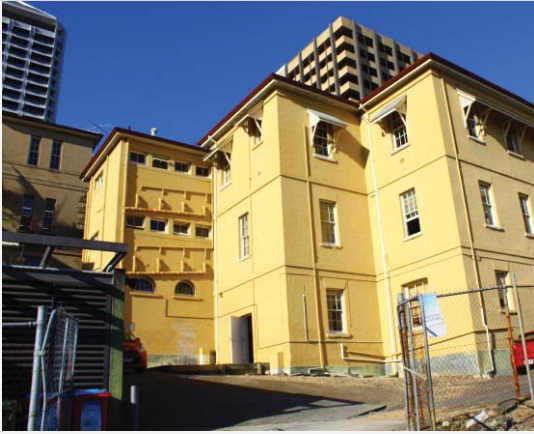
<p>High</p>
<p>The foundations and remnant structure of the various additions to William Street (now demolished)</p>	<p>Adjacent to south-eastern elevation</p>

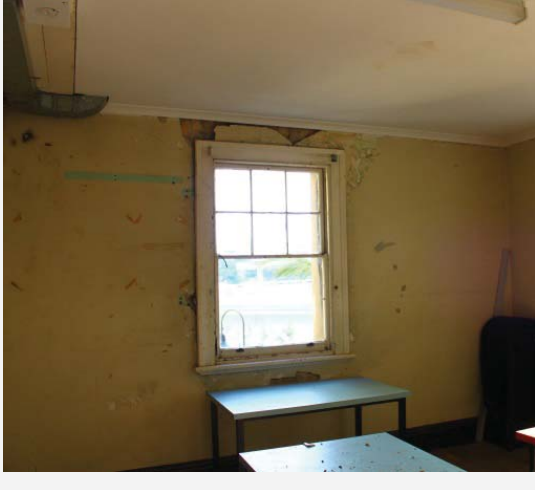
High
Exposed stone and brick walls internally.	Basement

Policy 18. Exposed brick walls must be retained. They should be carefully cleaned but remain unfinished. Paint may be removed from internal brick walls as long as this is carefully managed to not damage the brickwork.

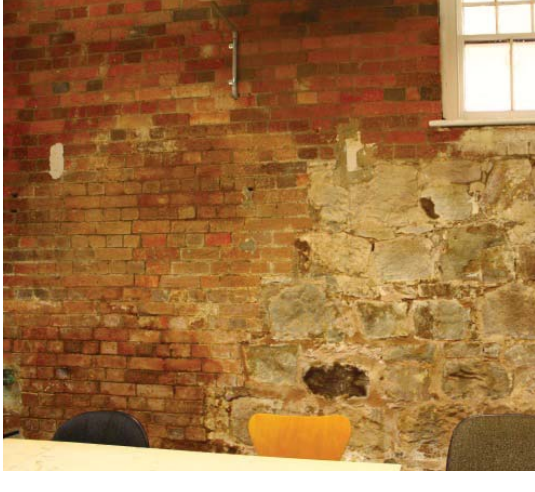
High
Pressed metal ceilings	Offices, ground floor, William Street wing

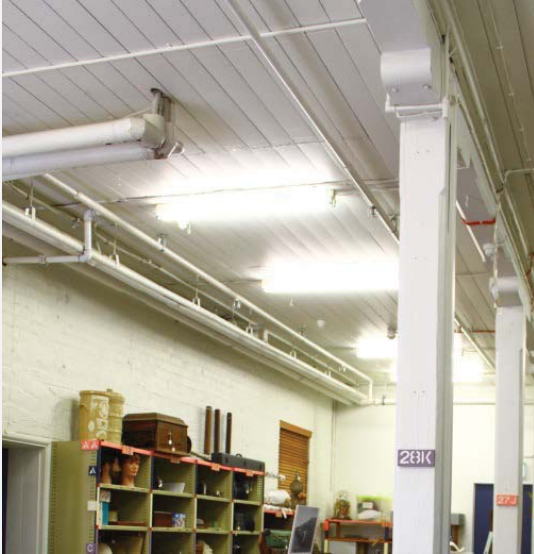
<p>High</p>
<p>Timber roof framing (beams and posts)</p>	<p>Basement level, Queens Wharf Road wing</p>
