# YARRABILBA PRECINCT 3

## WATERWAY STABILITY ASSESSMENT

DesignFlow & Hydrobiology  
Prepared for Lend Lease  
July 2016

| Report Title: | Yarrabilba Precinct 3 - Preliminary Waterway Stability Assessment |

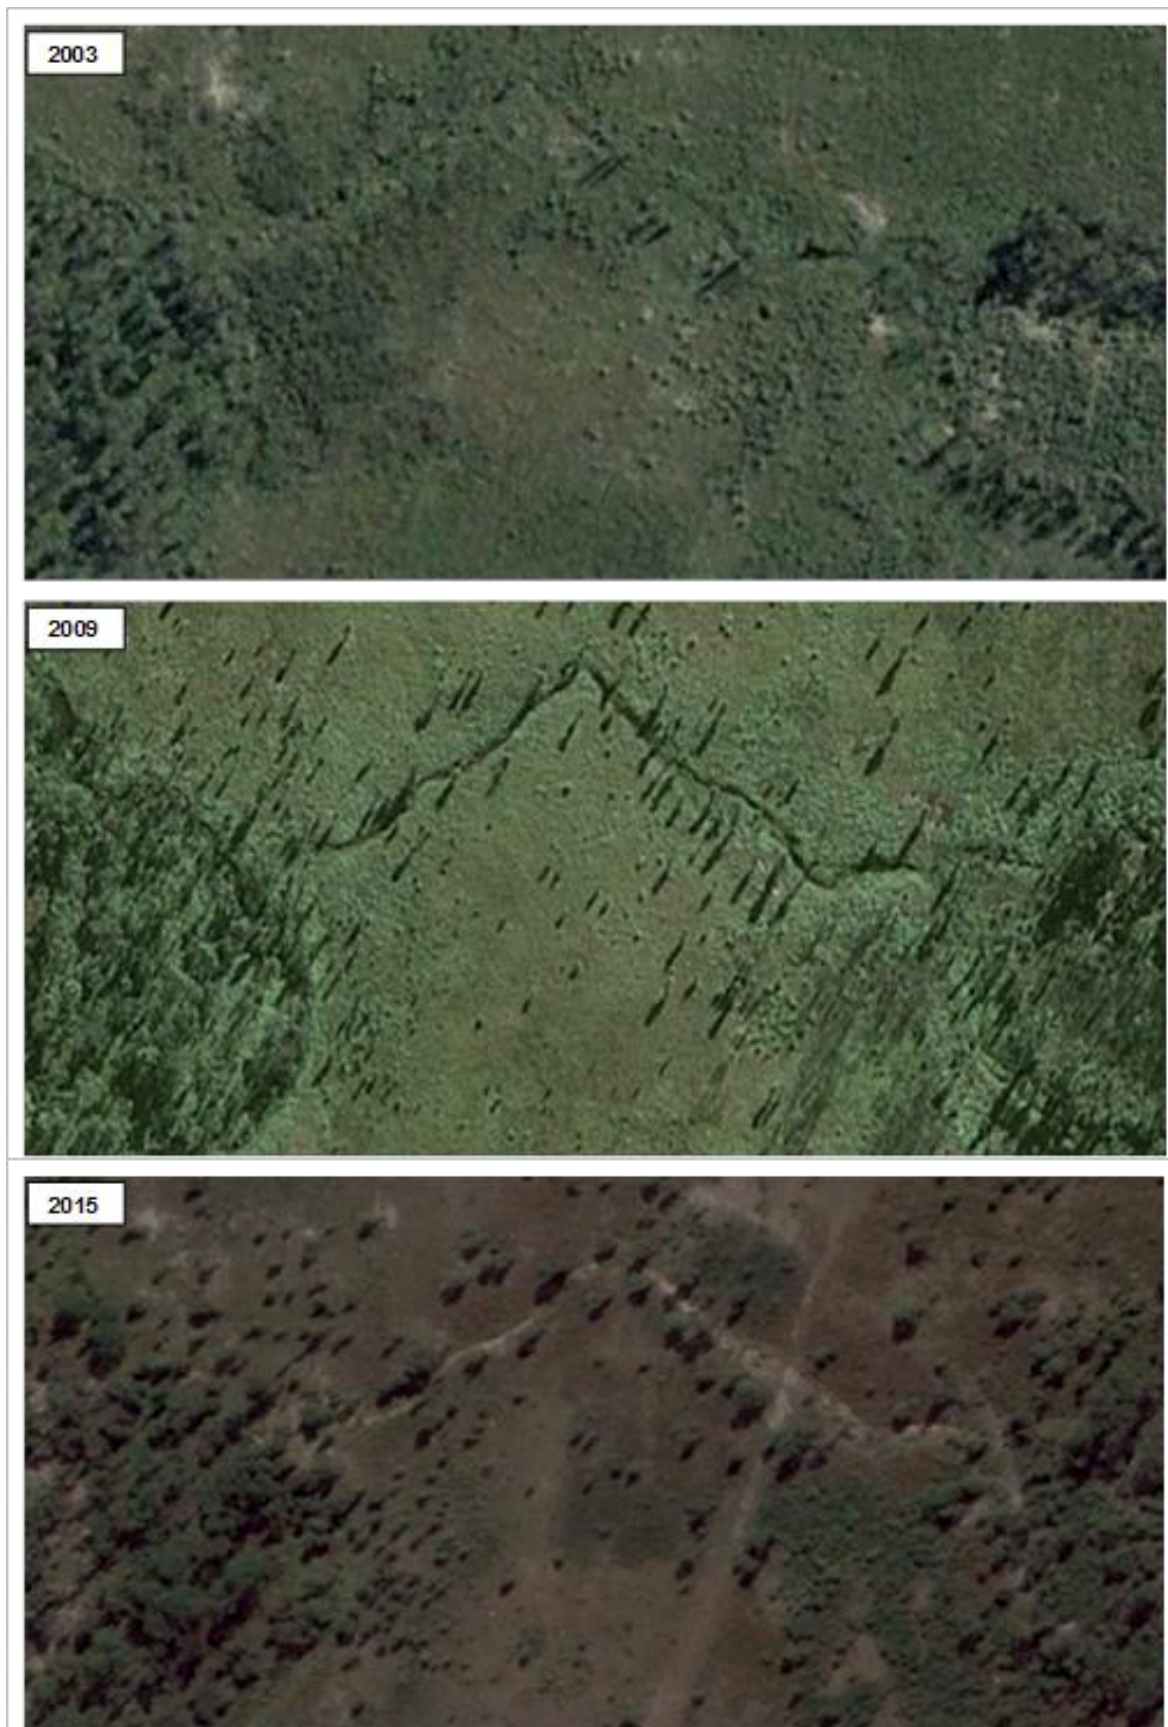
Any historical changes along the lengths of the waterways were masked by dense vegetation along the channel margins. As such, little could be deduced about their long-term stability. One section of Stream 5 downstream of its confluence with Stream 4 was visible in multiple images with different acquisition dates (2003, 2009, 2015). These are shown in Figure 11. They show a small meandering stream across an unconfined landscape. It is also evident from the sequence of photographs that the channel has been in a phase of degradation/deepening (2003-2009) and combined degradation/deepening and widening (2009-2015), suggesting that there has been upstream migration of incision, since 2003 at least. The channel appears to have incised into an 'outwash' zone at the base of the Stream 5 valley. Lidar analysis and field assessments support the incision theory, with multiple head cuts and over-steepened sections observed. These are discussed further in ensuing sections.

Figure 11 Historical aerial imagery Stream 5 (source: Google Earth)

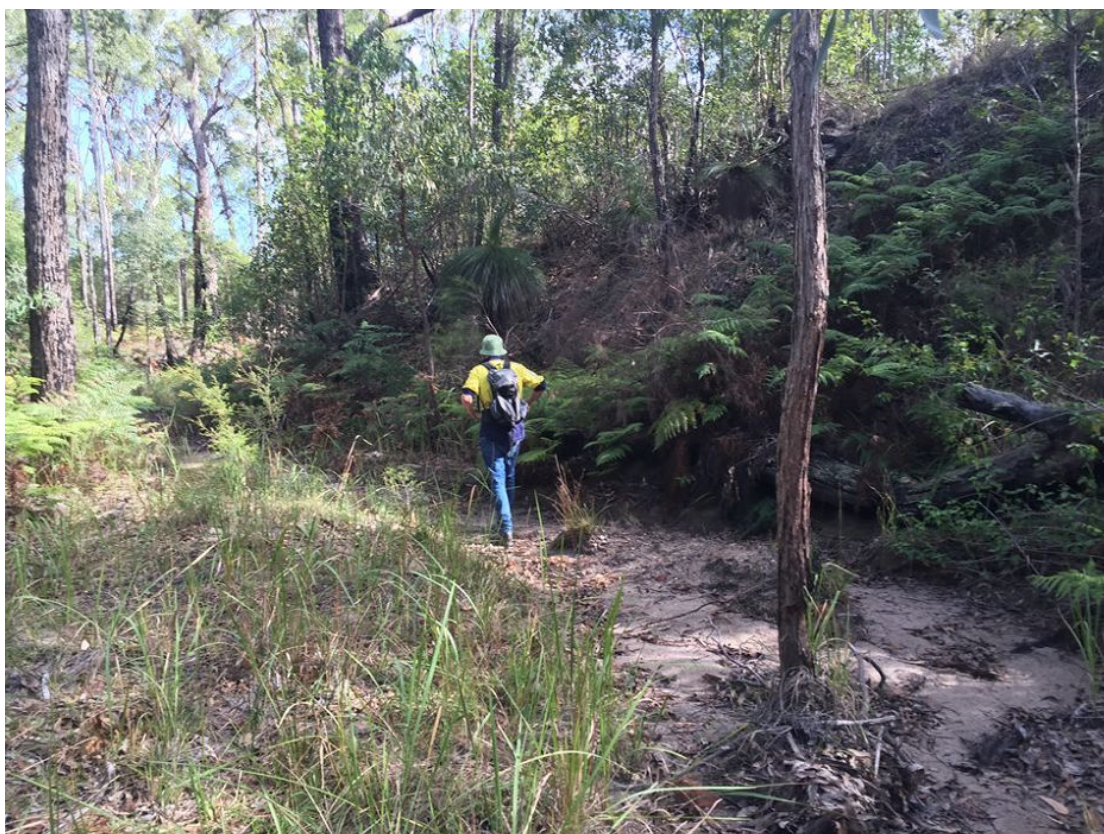
**Note:** Field observations indicated little evidence of bank undercutting along the length of streams within the study area. This indicates that future bank stability risks are most likely related to unmanaged overland flows, that subsequently erode dispersive soils, causing rilling and unstable banks. Management of overland flows will be critical to minimising future bank stability issues. Retention of minimum waterway buffer widths from top of bank will also play a significant role in retaining bank stability.

Figure 21 Example of low flow channel with stable adjacent bank along Precinct 3 streams

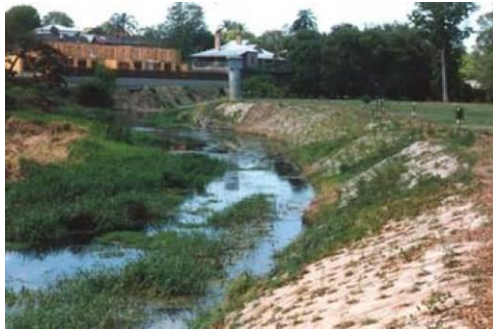
- over-excavation to form stable batter e.g. 2H:1V maximum
- treatment of the dispersive soils (e.g. gypsum). This should be ripped into the newly formed stable batter
- placement of non-dispersive topsoil (200-300 mm minimum) over exposed dispersive soils
- vegetation installation and establishment.

**Figure 22 Battering and revegetation**

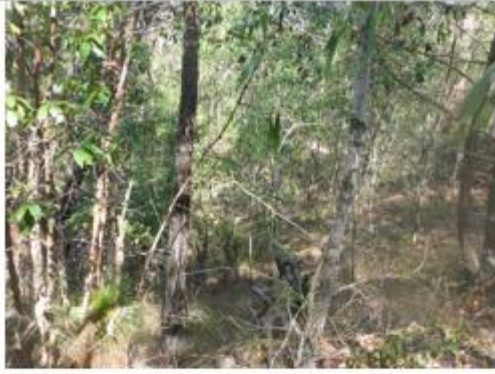
25. Stream 3, Zone 13 - ~1250m chainage

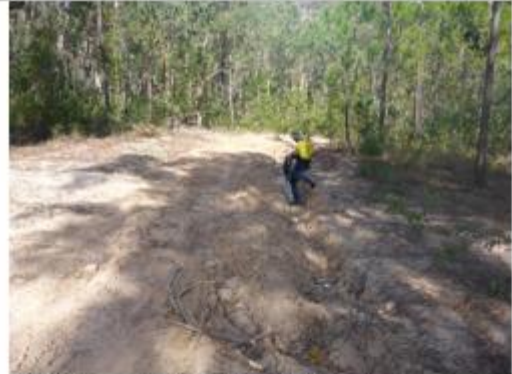
26. Stream 3, Zone 13 - ~1250m chainage

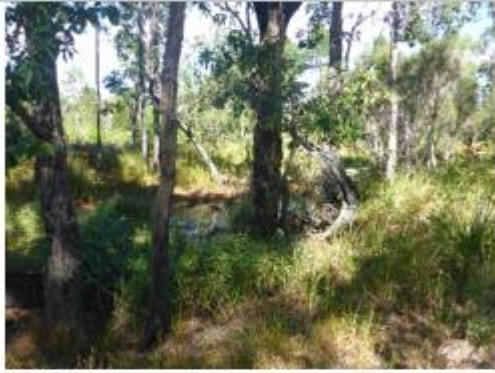
27. Quinzeh Creek (downstream of Stream 5)

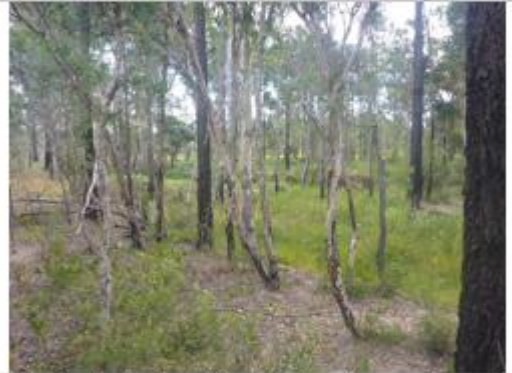
28. Quinzeh Creek floodplain upstream Stream 2

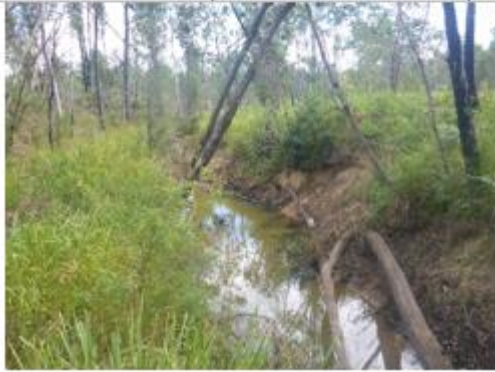
29. Quinzeh Creek channel Upstream Stream 2
