**ACID SULFATE SOIL ASSESSMENT  
HAMILTON HARBOUR DEVELOPMENT  
485-489 KINGSFORD SMITH DRIVE  
HAMILTON**

Prepared for **Devine Limited**  
Project No. **04298C**, November 2008

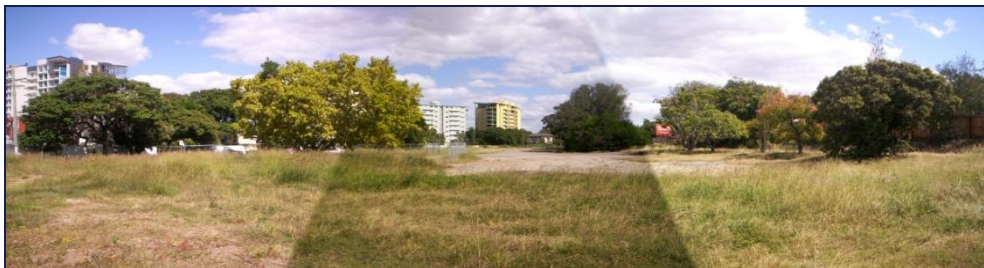
Photograph 1: Panoramic view of the site looking south-west from the eastern end of the site

At the time of assessment, the site had been cleared of previous development and was relatively level, except for an approximately 1.5m excavation located in the central western section of the site. The site appeared to be cut down below the level of Kingsford Smith Drive by approximately 1m in a local area between Bores 3 and 4. Other than the excavated area, ground surface levels varied between approximately RL 3.3m and RL 5.1m and appeared to generally increase in a north-westerly direction across the site. Isolated medium to tall trees were present over the site and the site ground surface comprised grass, paving and bare earth. Two general views of the site at the time of investigation are presented in Photographs 1 and 2.

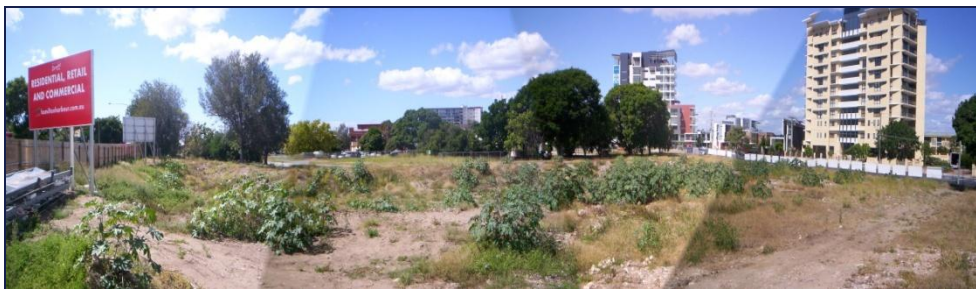
Photograph 2: Panoramic view of the site looking east from the western end of the site

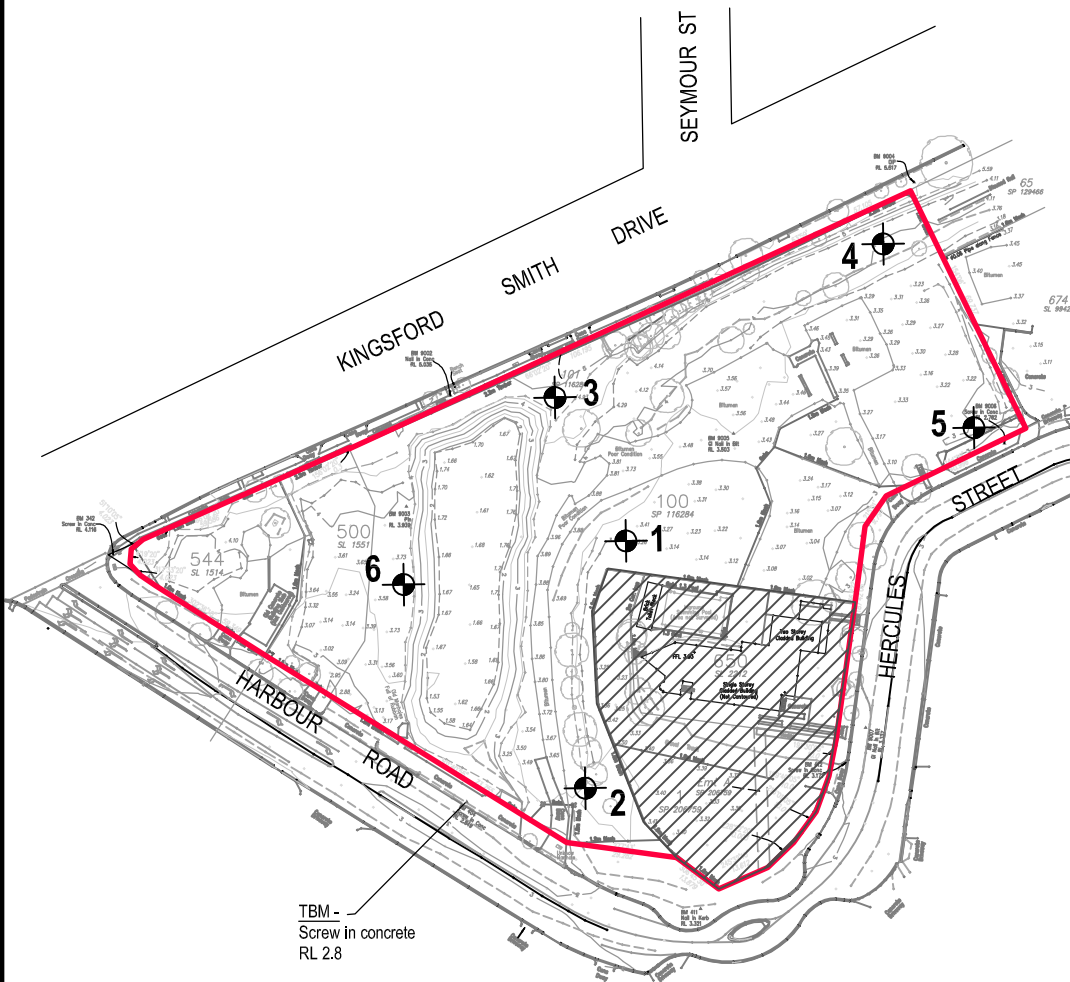
TBM -  
 Screw in concrete  
 RL 2.8

Bore locations were determined by direct measurement from existing site features and are indicated approximately on the attached Drawing No. 1.
