**ACID SULFATE SOIL INVESTIGATION**  
**PORTSIDE WHARF - STAGE 2**  
**BUILDINGS 2, 4 & 5**  
**HARBOUR ROAD**  
**HAMILTON**

**Prepared for**  
Multiplex Developments Pty Ltd

Project No. 03900  
13 March 2008

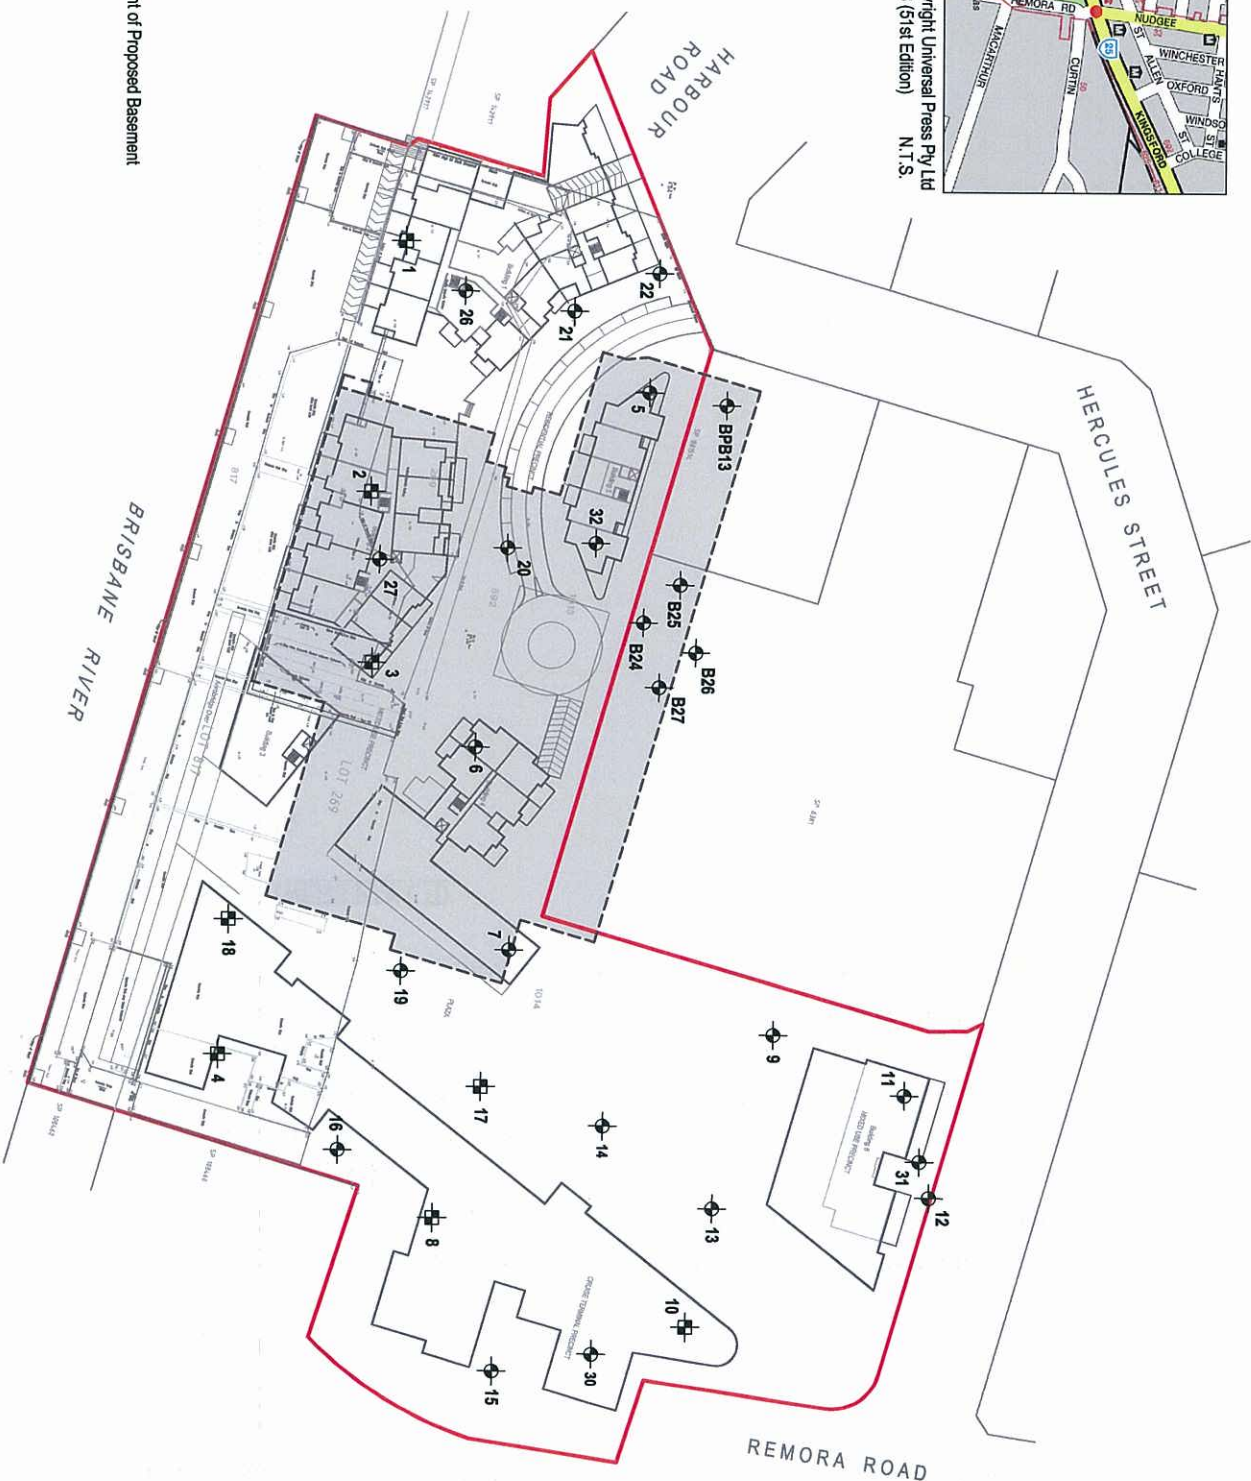
- LEGEND**
- 1 Test Pit
  - 5 Bore
  - Approximate Extent of Proposed Basement
  - Site Boundary

It is understood that Stage 2 of the Portside Wharf development is to include the construction of Buildings 2, 4 and 5, which comprises multi-level, mixed use residential and commercial towers, over a single level basement carpark. Bulk excavation will be required to approximately RL0.6m AHD, which will involve a maximum of approximately 2.5m of excavation below existing ground surface levels. The approximate location of the site and extent of the basement are shown on Drawing No. 1, attached.

Test locations were set out by hand-held GPS and/or reference to existing site features, and are indicated approximately on the attached Drawing No. 1. Approximate ground surface levels at each test location were interpolated from the 'Contour & Detail Survey' (Drawing Nos. 6121-04-01B,02B,03B,04B) prepared by Pike Mirls McKnulty, consulting surveyors.
