**PLANS AND DOCUMENTS**  
referred to in the ULDA  
**APPROVAL dated 20 / 7 / 11**

**Hamilton rock training wall – Condition 31**

This letter provides compliance with Condition 31 in the approval for site works in Macarthur Avenue, Eagle Farm, ULDA No. DEV000007\_09, which states:

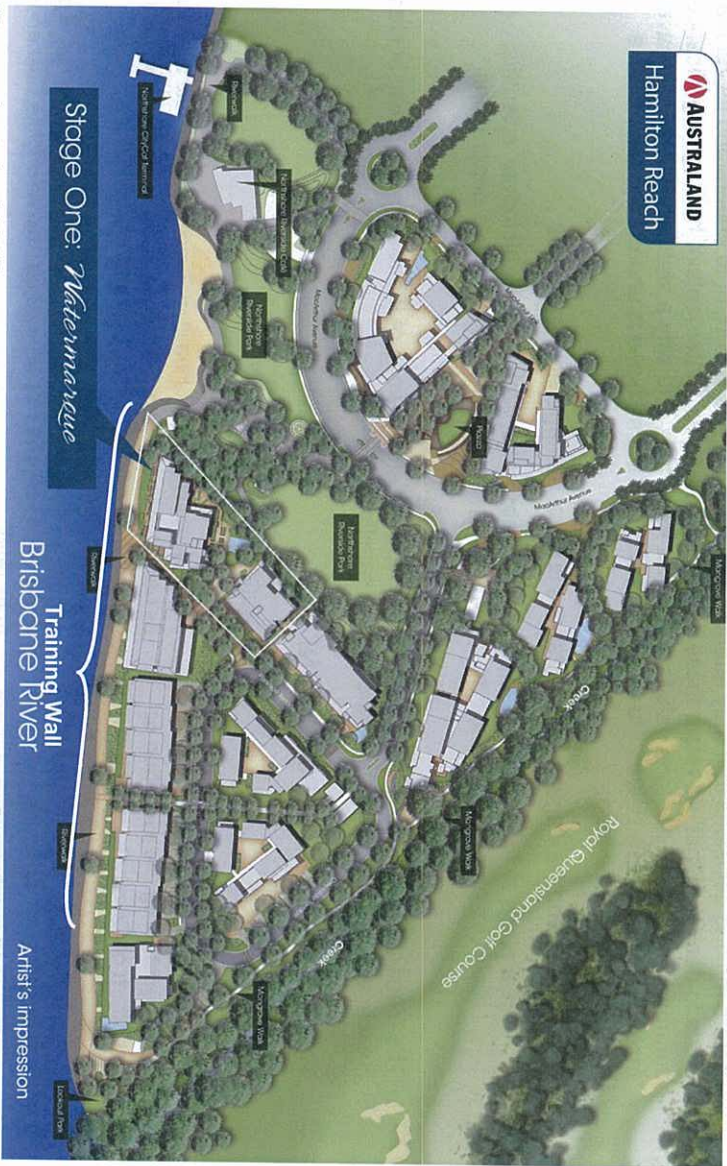
FIGURE 2 – PROPOSED DEVELOPMENT

Figure 2 shows the location of the rock training wall with respect to the subject development. A river-walk is proposed along the foreshore, next to the training wall, in addition to new stormwater outlets draining into the river which requires intrusions into the wall.

If new stormwater outlets are required along the length of the rock-wall, the intent should be for the rock wall to retain its aesthetic character by retaining a similar gradient and limiting projection from the wall. Where outlets are proposed, rocks should be carefully removed in that section only, stored on-site and reinstated in a similar loose pattern and to a similar gradient when infilling around the outlet. Any surplus rocks should be stored on-site and used for future maintenance of the wall.

The proposed river-walk should have a setback from the rock-wall, which should be determined through further engineering advice, to avoid cracking of the ground surface through natural movement of the rock wall.

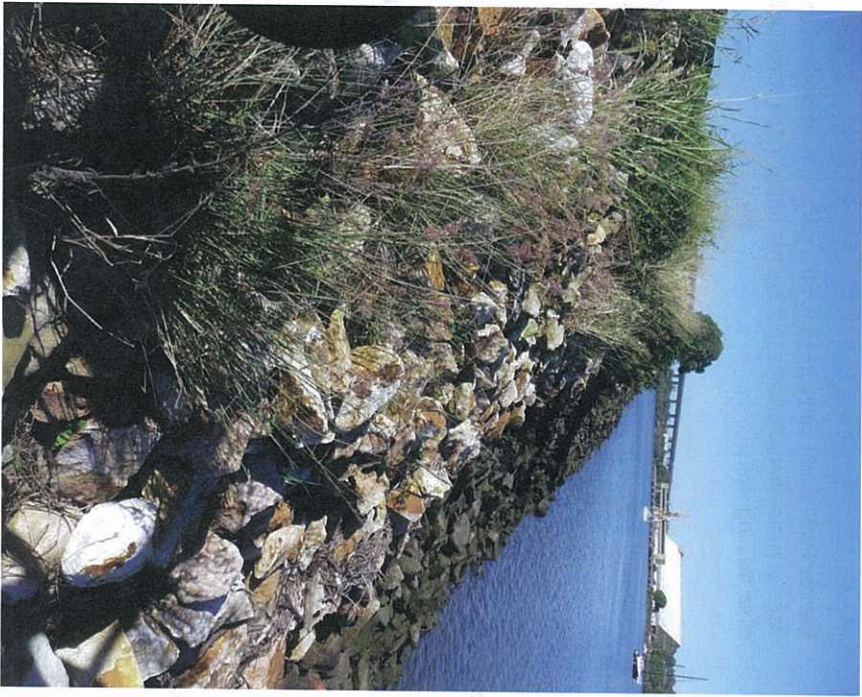
FIGURE 3 – PORTION OF RETAINING WALL

Figure 3 illustrates a portion of the rock retaining wall directly east of the sandy inlet.

To ensure the long-term conservation and structural stability of the rock retaining wall at Hamilton Reach, regular inspections (every 6 months) should be undertaken to identify any deterioration, displacement or settlement of the rocks. This occurs over time with tidal waters removing finer materials from the wall, which leads to movement and undermining of the rocks.

- removal of vegetation growing on or immediately adjacent to the river wall;
- removal of any damaged or deteriorated rocks; and
- addition of new rocks on the wall, as required to keep the same general form and dry wall effect.

Maintenance of the rock wall should not include fixing with mortar or grout. The rock wall should be maintained as a dry wall construction.

New rocks added to the wall should aim to be Brisbane Tuff or porph-free rock, and quarried to a similar size to existing rocks, so as to maintain the wall's aesthetic character.
