# Vegetation Clearing & Fauna Management Plan

Mountain Ridge Road upgrade,  
South Maclean

by Orchard (Pebble Creek) Developments  
Pty Ltd ATF The Flagstone Trust

# Vegetation Clearing and Fauna Management Plan

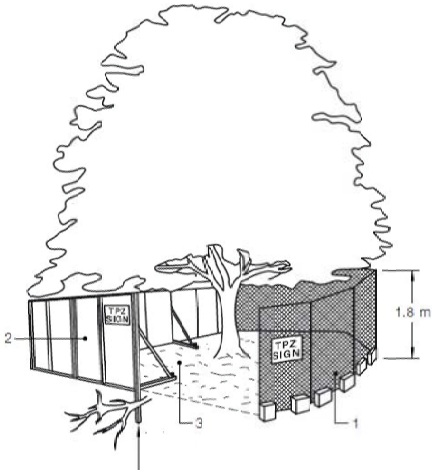
### AS 4970 Tree Protection Fencing Detail

- LEGEND
1. Chain wire mesh panels with shade cloth (if required) attached, held in place with concrete feet.
  2. Alternative plywood or wooden paling fence. This fencing option also prevents building materials or soil entering the TPZ.
  3. Mulch installation across surface of TPZ (at the discretion of the Project Arborist). No Excavation, construction activity, grade changes, surface treatment or storage of materials of any kind is permitted with the TPZ.
  4. Bracing is permissible within the TPZ. Installation of supports should avoid damaging roots.

PHASE 1 - Tree Protection Fencing to be installed prior to the commencement of any clearing works on the site. Tree protection fencing is to be located at or beyond 12 x diameter at breast height (DBH) unless approved by the appointed Arborist.

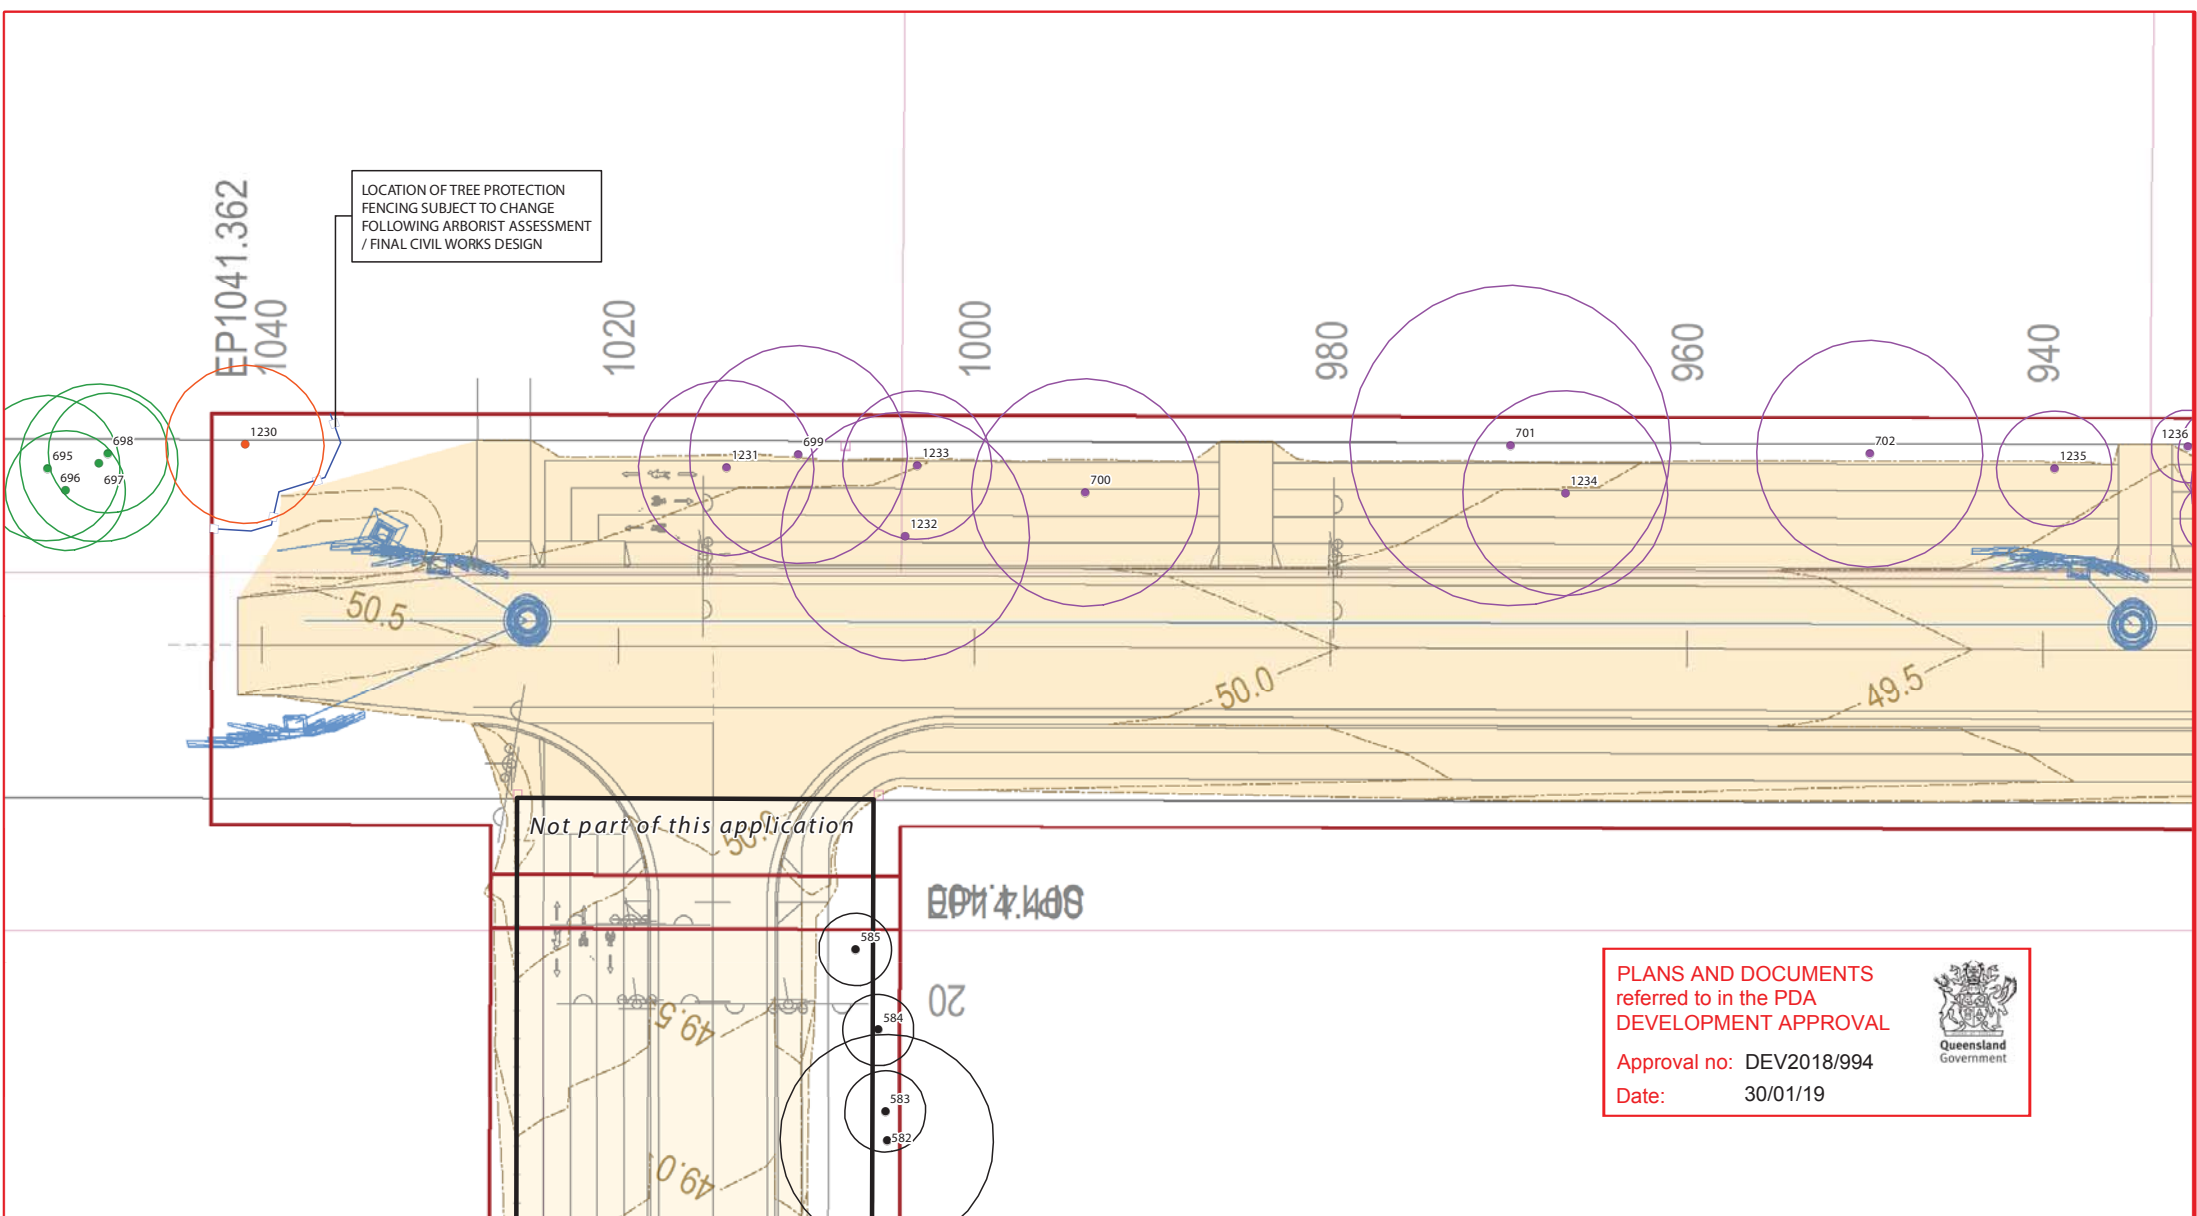
## Vegetation Clearing & Fauna Management Plan - Details sheet 4

- Tree to remove (w/TPZ)
- Status subject to arborist inspection (w/TPZ)
- Tree to retain (w/TPZ)
- Not part of this application
- ⊗ Non-native tree sp.
- QLD DCDB
- Development site boundary
- Works boundary
- Roads and pathways
- Earthworks and batters
- Stormwater services
- Sewer services
- Water services
- Electrical services
- Retaining wall
- Future lots
- Tree protection fencing - located around trees to retain adjacent to works
- Earthworks extent
- Earthworks extent not part of this application
- Stockpile location (indicative)

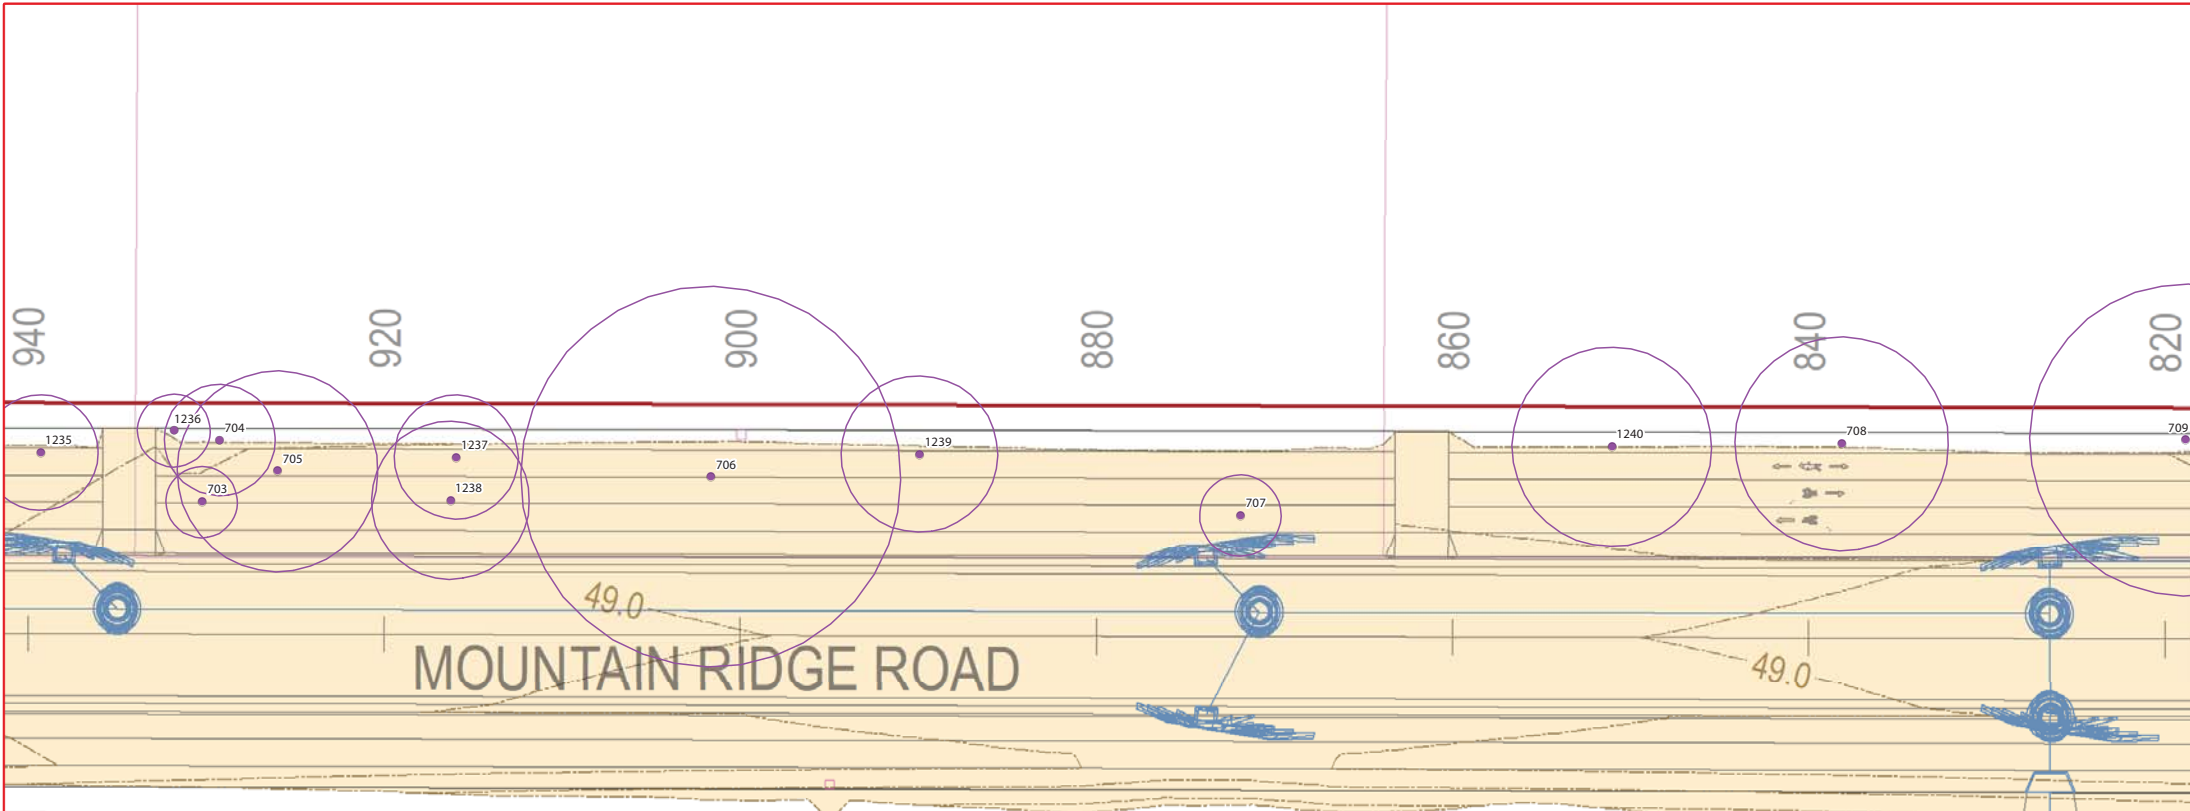
## Vegetation Clearing & Fauna Management Plan - Details sheet 5

PROJECT ARBORIST TO SUPERVISE  
AND DIRECT ANY WORKS WITHIN  
TPZ OF TREES TO BE RETAINED AND  
ADJOINING BUSHLAND.

- Tree to remove (w/TPZ)
- Status subject to arborist inspection (w/TPZ)
- Tree to retain (w/TPZ)
- Not part of this application
- ⊗ Non-native tree sp.
- QLD DCDB
- Development site boundary
- Works boundary
- Roads and pathways
- Earthworks and batters
- Stormwater services
- Sewer services
- Water services
- Electrical services
- Retaining wall
- Future lots
- Tree protection fencing - located around trees to retain adjacent to works
- Earthworks extent
- Earthworks extent not part of this application
- ⊗ Stockpile location (indicative)

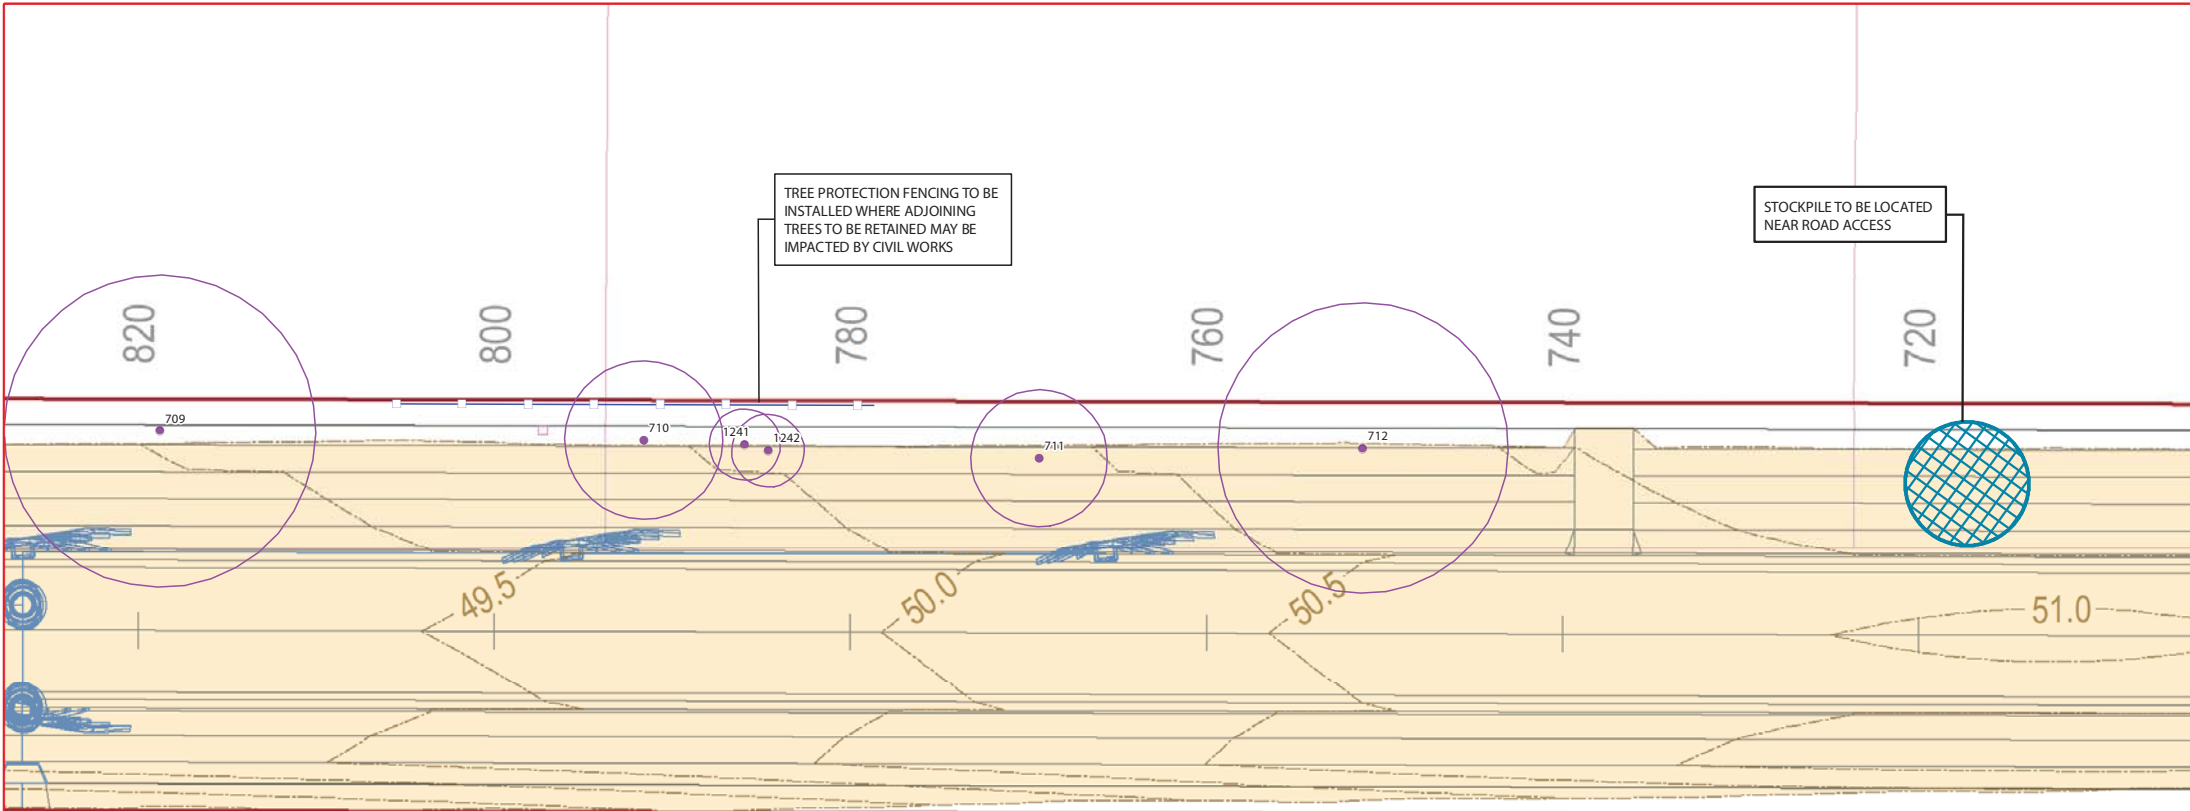
## Vegetation Clearing & Fauna Management Plan - Details sheet 6

| Tree to remove (w/TPZ) | Not part of this application | Development site boundary | Earthworks and batters | Water services | Future lots | Earthworks extent |
| Status subject to arborist inspection (w/TPZ) | Non-native tree sp. | Works boundary | Stormwater services | Electrical services | Tree protection fencing - located around trees to retain adjacent to works | Earthworks extent not part of this application |
| Tree to retain (w/TPZ) | QLD DCDB | Roads and pathways | Sewer services | Retaining wall | | Stockpile location (indicative) |

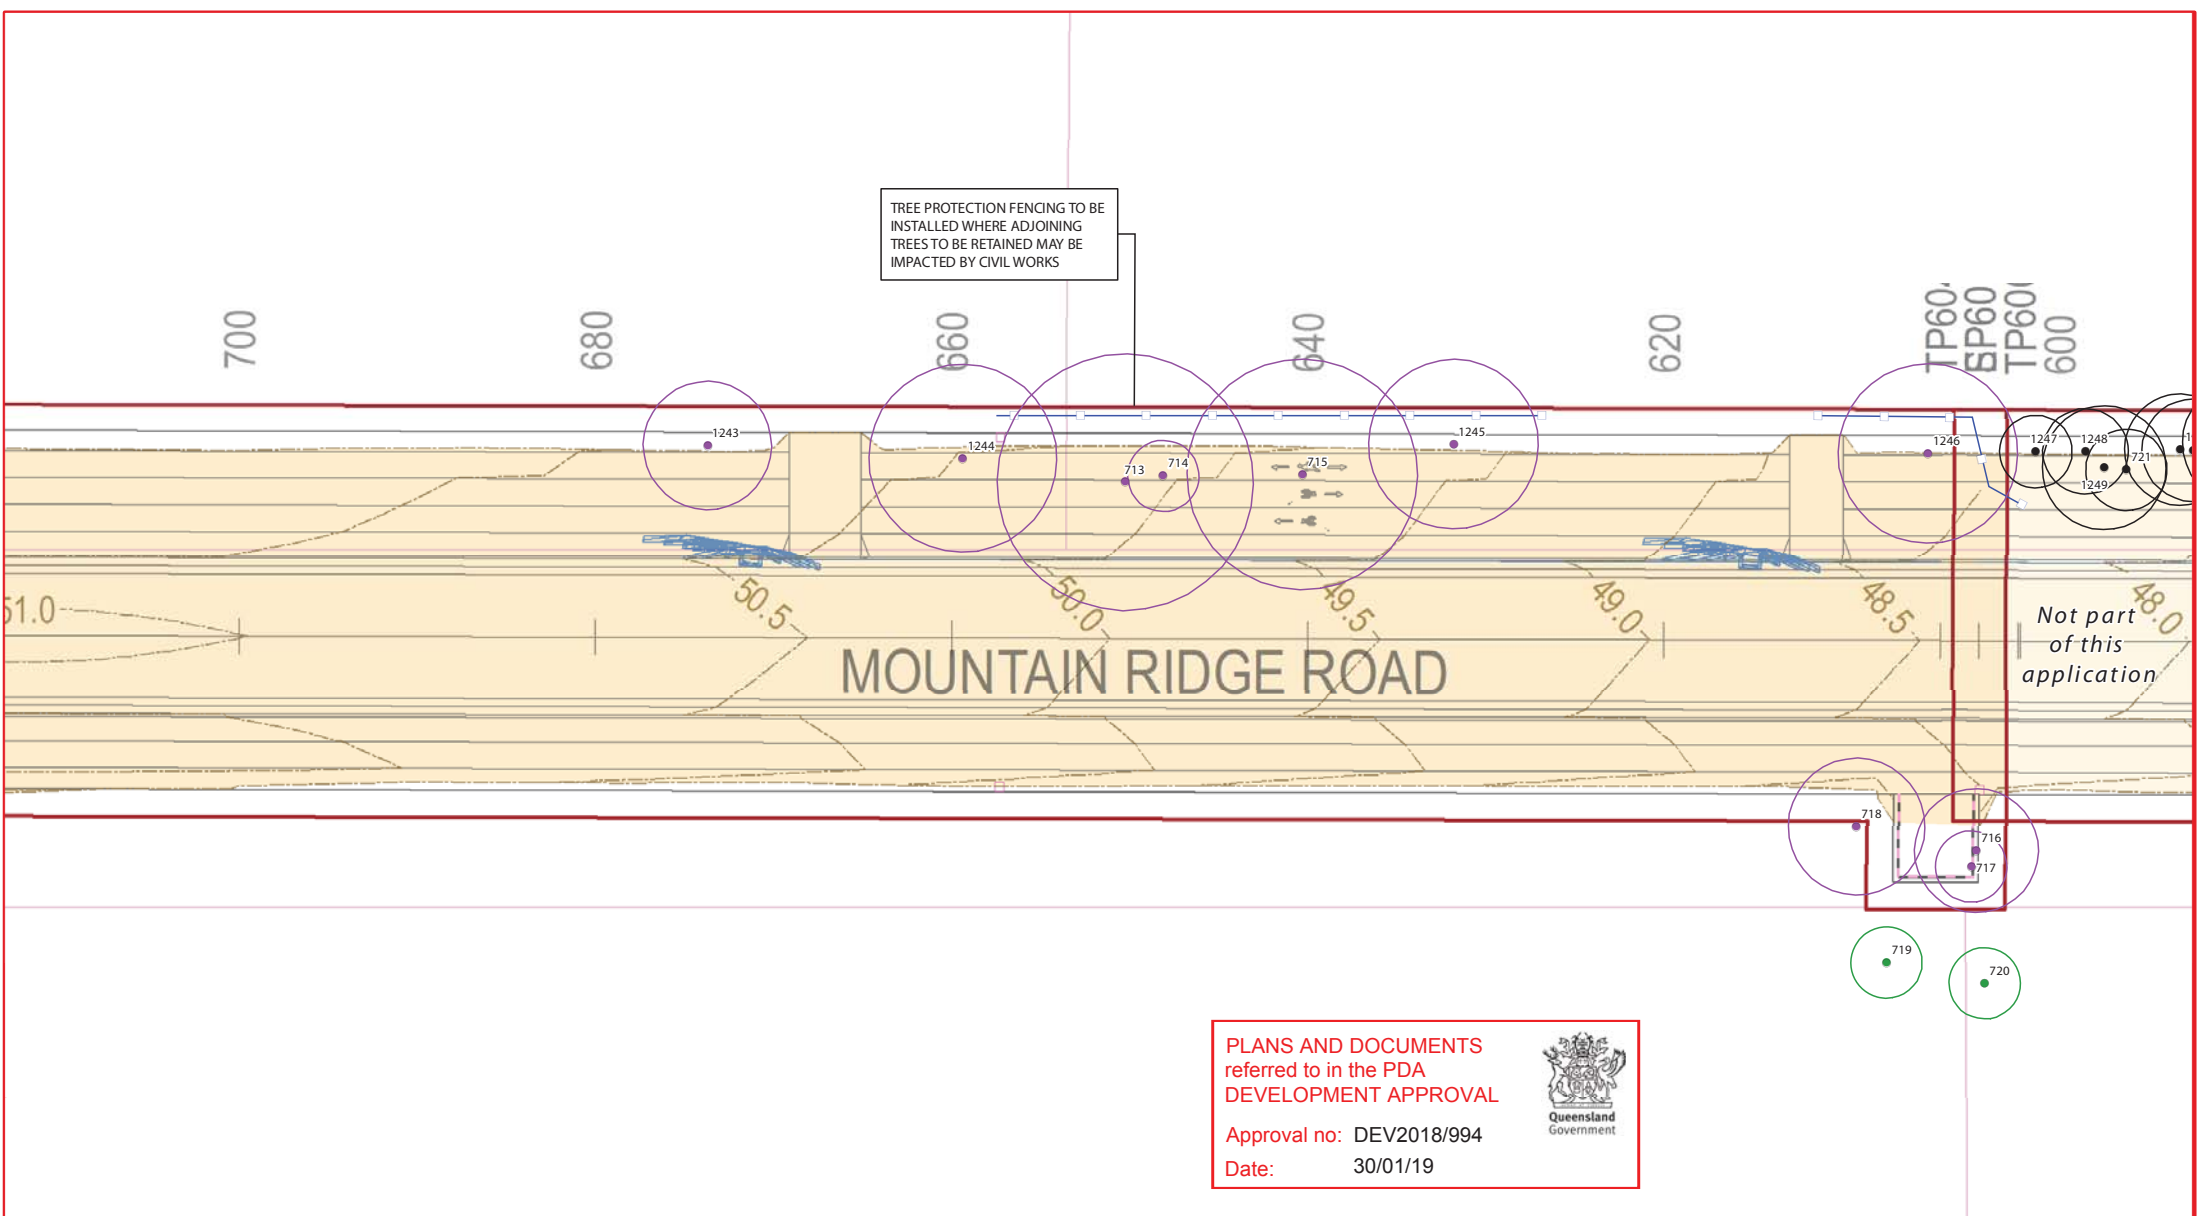
# Vegetation Clearing & Fauna Management Plan - Details sheet 7

| Tree to remove (w/TPZ) | Not part of this application | Development site boundary | Earthworks and batters | Water services | Future lots | Earthworks extent |
| Status subject to arborist inspection (w/TPZ) | Non-native tree sp. | Works boundary | Stormwater services | Electrical services | Tree protection fencing - located around trees to retain adjacent to works | Earthworks extent not part of this application |
| Tree to retain (w/TPZ) | QLD DCDB | Roads and pathways | Sewer services | Retaining wall | Stockpile location (indicative) | |

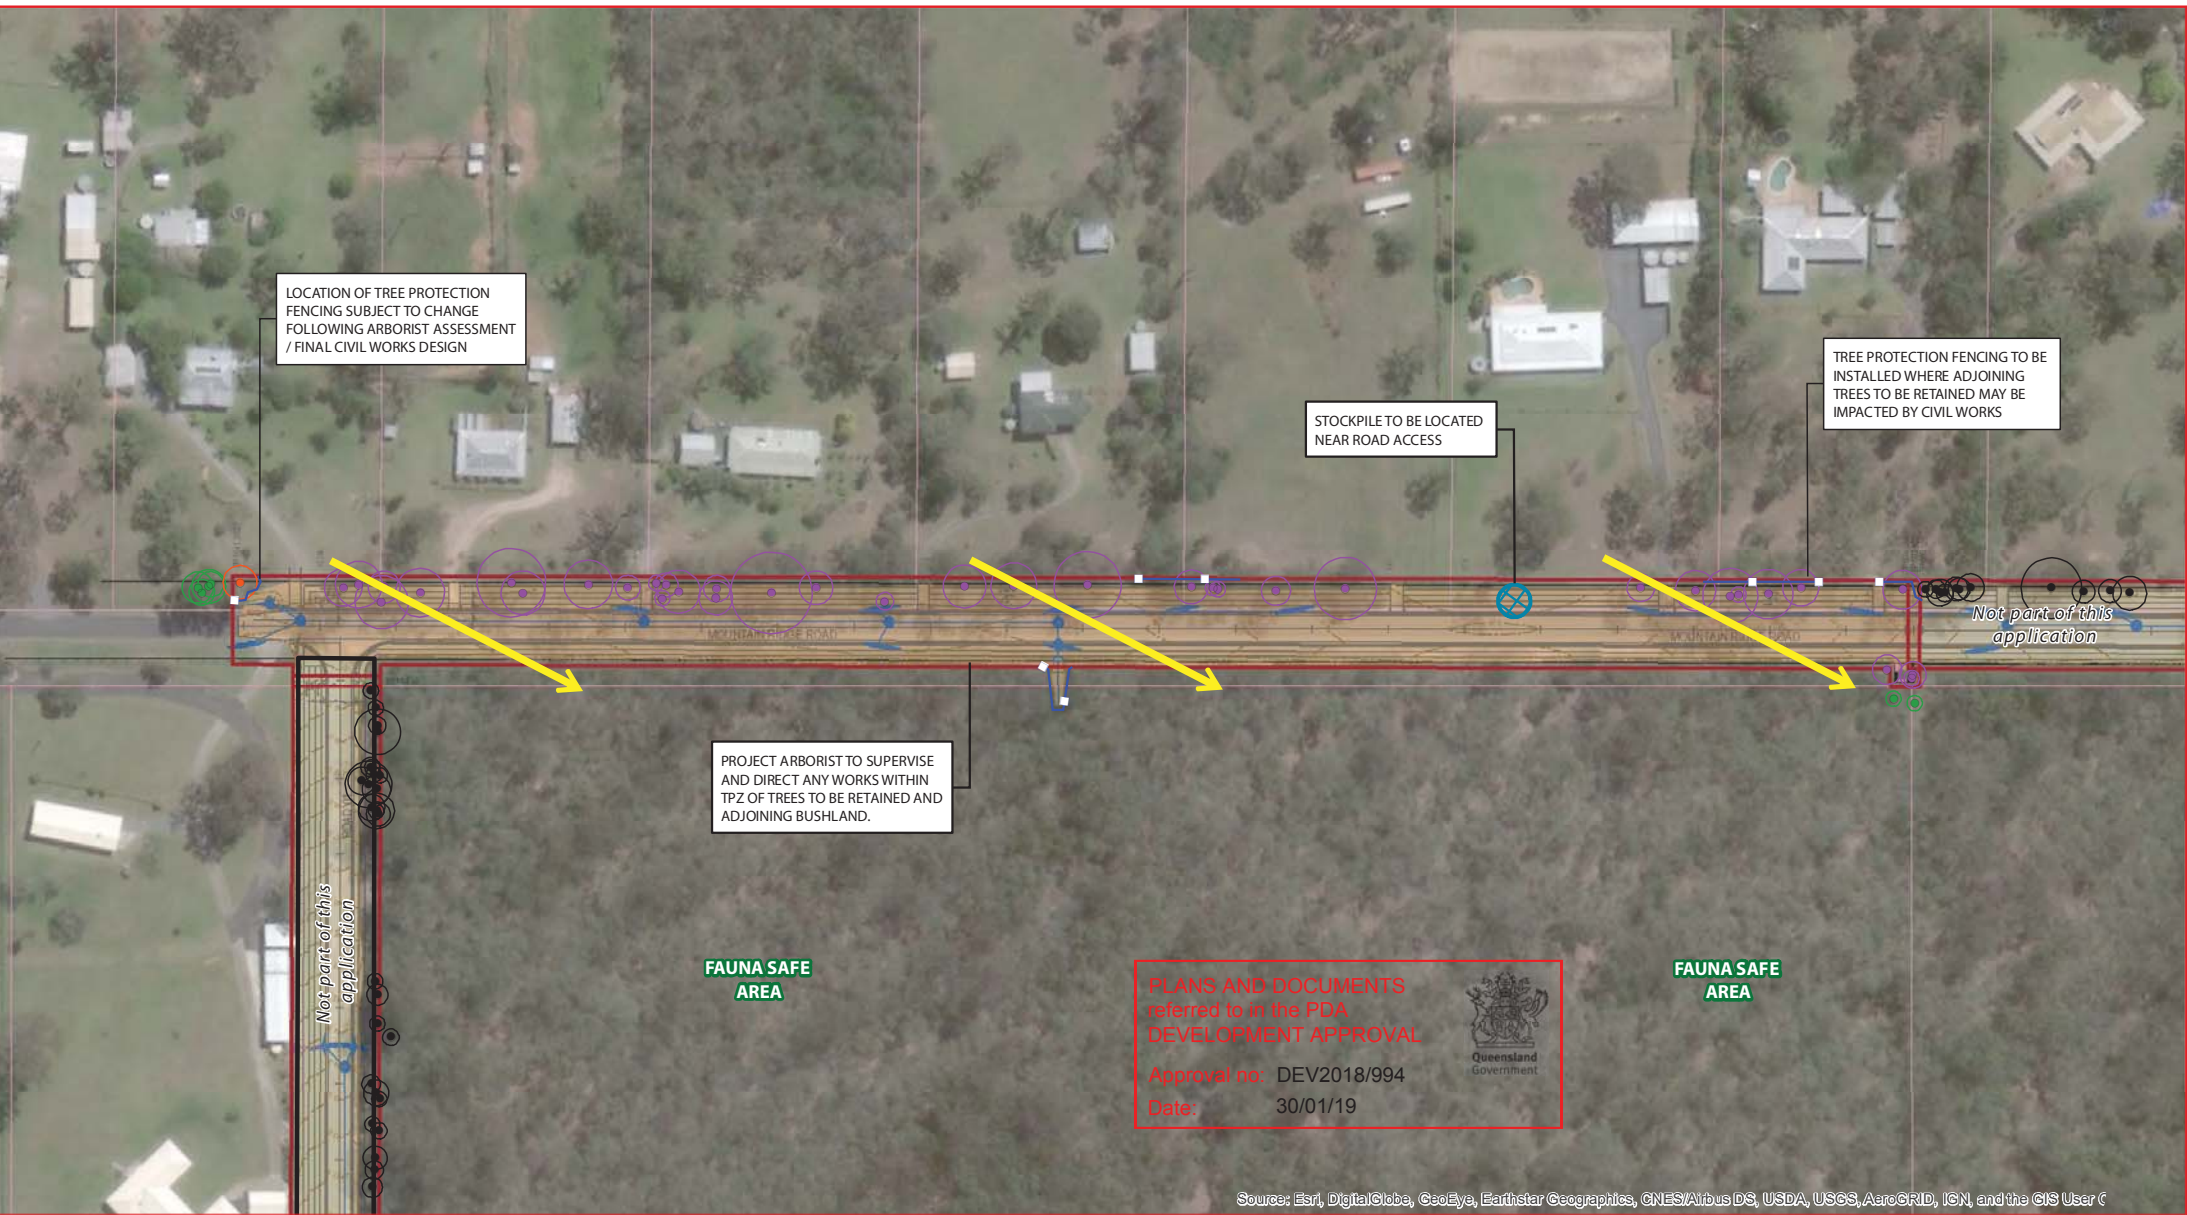
## Vegetation Clearing & Fauna Management Plan - Clearing Direction

- Tree to remove (w/TPZ)
- Status subject to arborist inspection (w/TPZ)
- Tree to retain (w/TPZ)
- Not part of this application
- Non-native tree sp.
- QLD DCDB
- Development site boundary
- Works boundary
- Roads and pathways
- Earthworks and batters
- Stormwater services
- Sewer services
- Water services
- Electrical services
- Retaining wall
- Future lots
- Tree protection fencing - located around trees to retain adjacent to works
- Earthworks extent
- Earthworks extent not part of this application
- Stockpile location (indicative)

PHASE 4 - Undertake Bulk Clearing  
Undertake wholesale removal of vegetation once approved for removal by qualified fauna spotter. Clearing will occur in the direction outlined in sheet 5 of this VCFMP and managed by the appointed fauna spotter to allow all fauna unimpeded movement towards bushland occurring south of Mountain Ridge Road.
