**APPENDIX L**

**LONG FORM INFORMATION RESPONSE  
AREA 1**

**RE: IR RESPONSE – DEV2010/084 – RIPLEY VALLEY AREA 1**

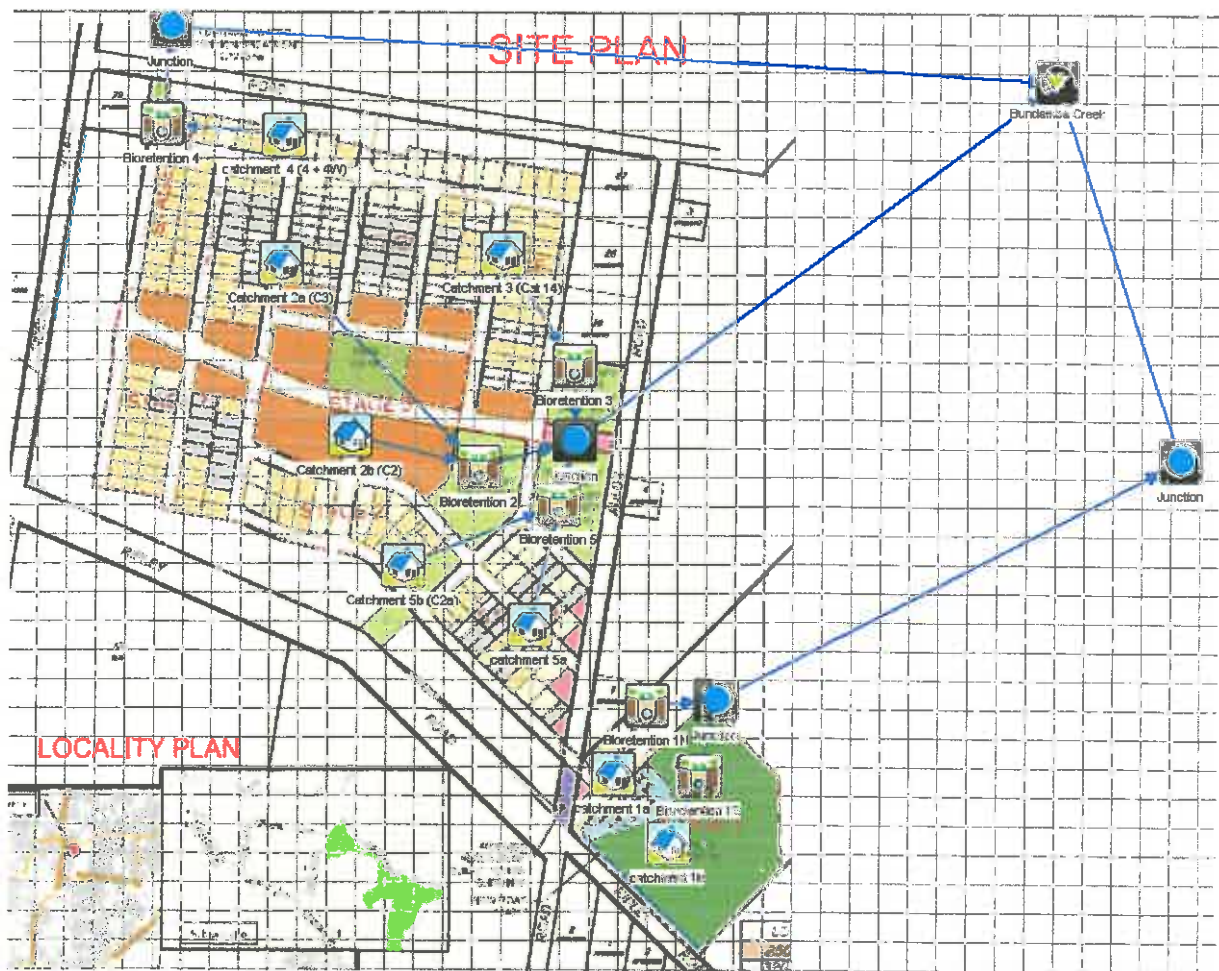
Refer to MPNs’ SMP section 7.5 (see Appendix I of the main report by Land Partners) and below modified Figure 7-1 that the Neighbourhood Park has been incorporated into the MUSIC model as a node and that the proposed treatment train achieves the pollution and nutrient removal targets set by Healthy Waterways.

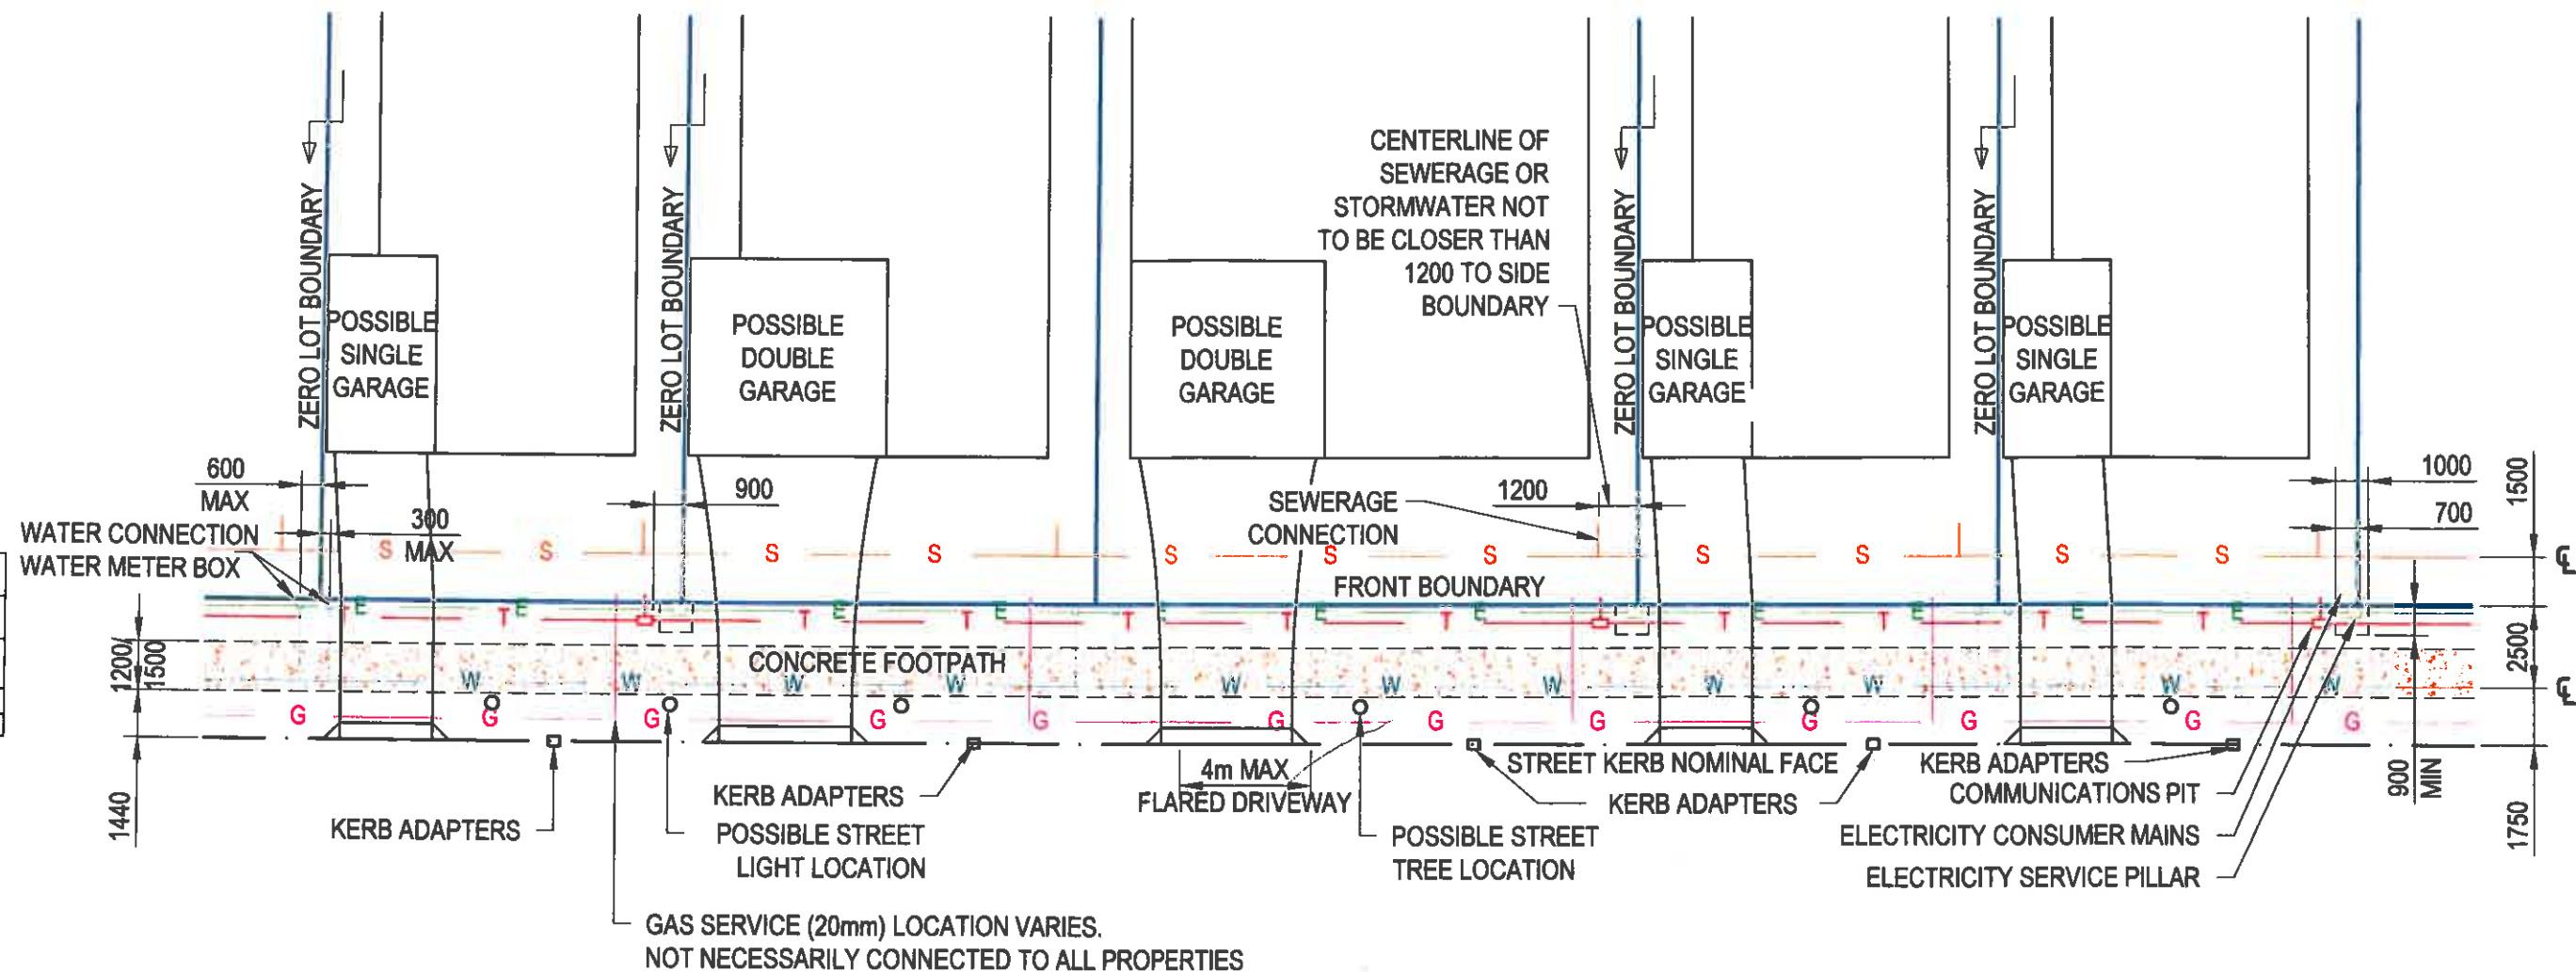
Refer to the attached MPN Drawing No 5874 - PSK70 (Attachment 1) which indicates the locations of Stormwater, Roofwater, Sewerage Reticulation, Water Supply, Gas, Concrete Footpaths etc in the vicinity of zero boundary setbacks.

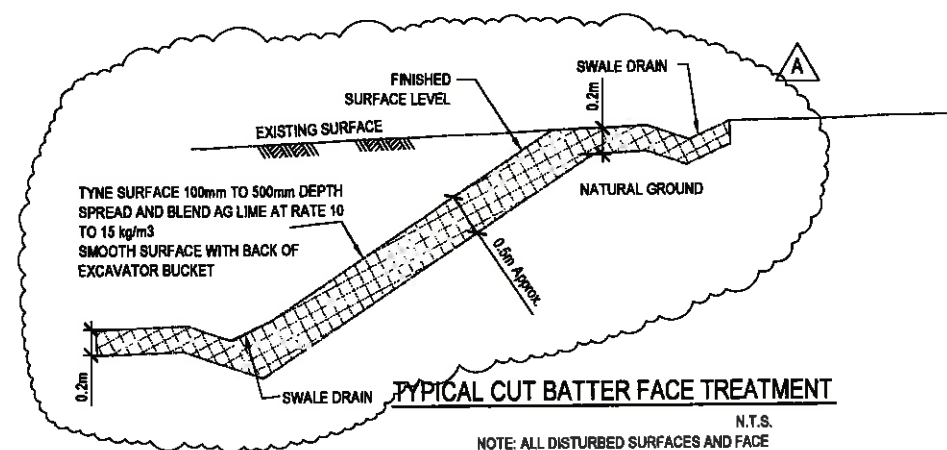
**TYPICAL CUT BATTER FACE TREATMENT**  
N.T.S.

5. A SOIL SCIENTIST FROM ESSA IS TO INSPECT THE SITE DURING AND AT THE COMPLETION OF WORKS AND TO CONFIRM IN WRITING THAT ALL BULK EARTHWORKS HAVE BEEN CARRIED OUT IN ACCORDANCE WITH ESSA RECOMMENDATIONS AND THAT THE SITE IS STABLE IN RESPECT OF EROSION

6. TOPSOIL MODIFIED IN ACCORDANCE WITH ESSA'S TREATMENT SCHEDULE TO BE SPREAD OVER THE ABOVE SURFACES BY OTHERS

- Area 1 site soils have been identified as “dispersive”, the treatment of the top 200mm of subsoils, top 500mm of cut batters and 2.0 m of fill batter soils is recommended in ESSA’s January 2011 soils investigate Table No 6. ESSA’s recommendations will be incorporated into the Operational Works documentation.

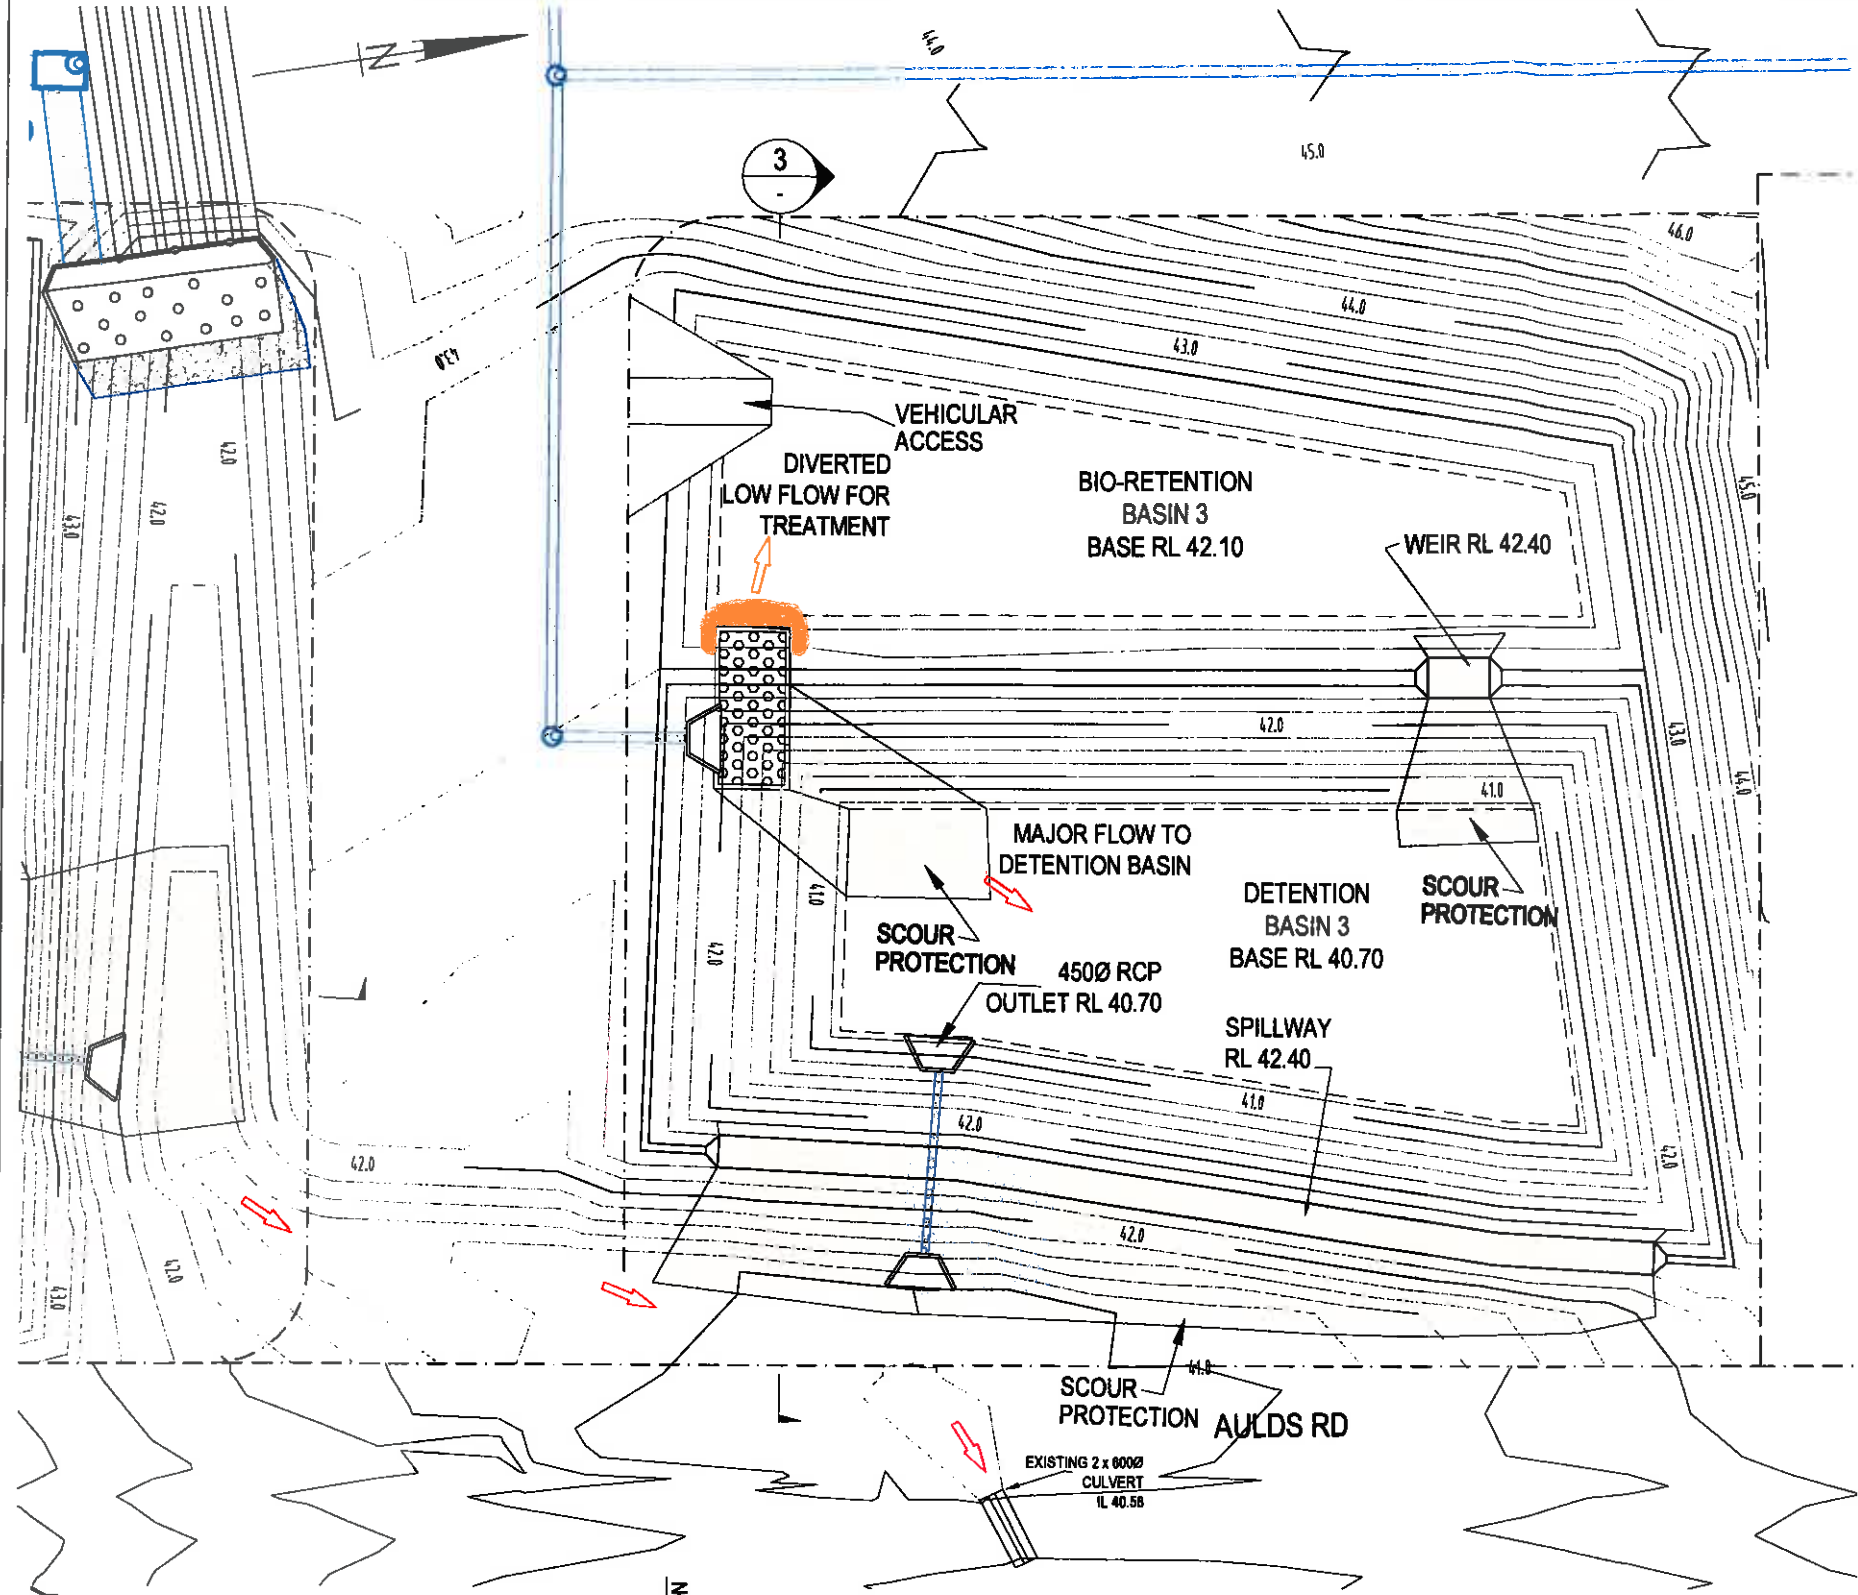
BIO-RETENTION BASIN 3 DETAILS

| AREA BASE (m²) | 683 |

| | LEVEL | AREA m2 | VOLUME m3 |
|---|---|---|---|
| WEIR LENGTH | 60m AT RL 42.40 | | |
| Q100 WATER LEVEL | RL 42.54 | | |

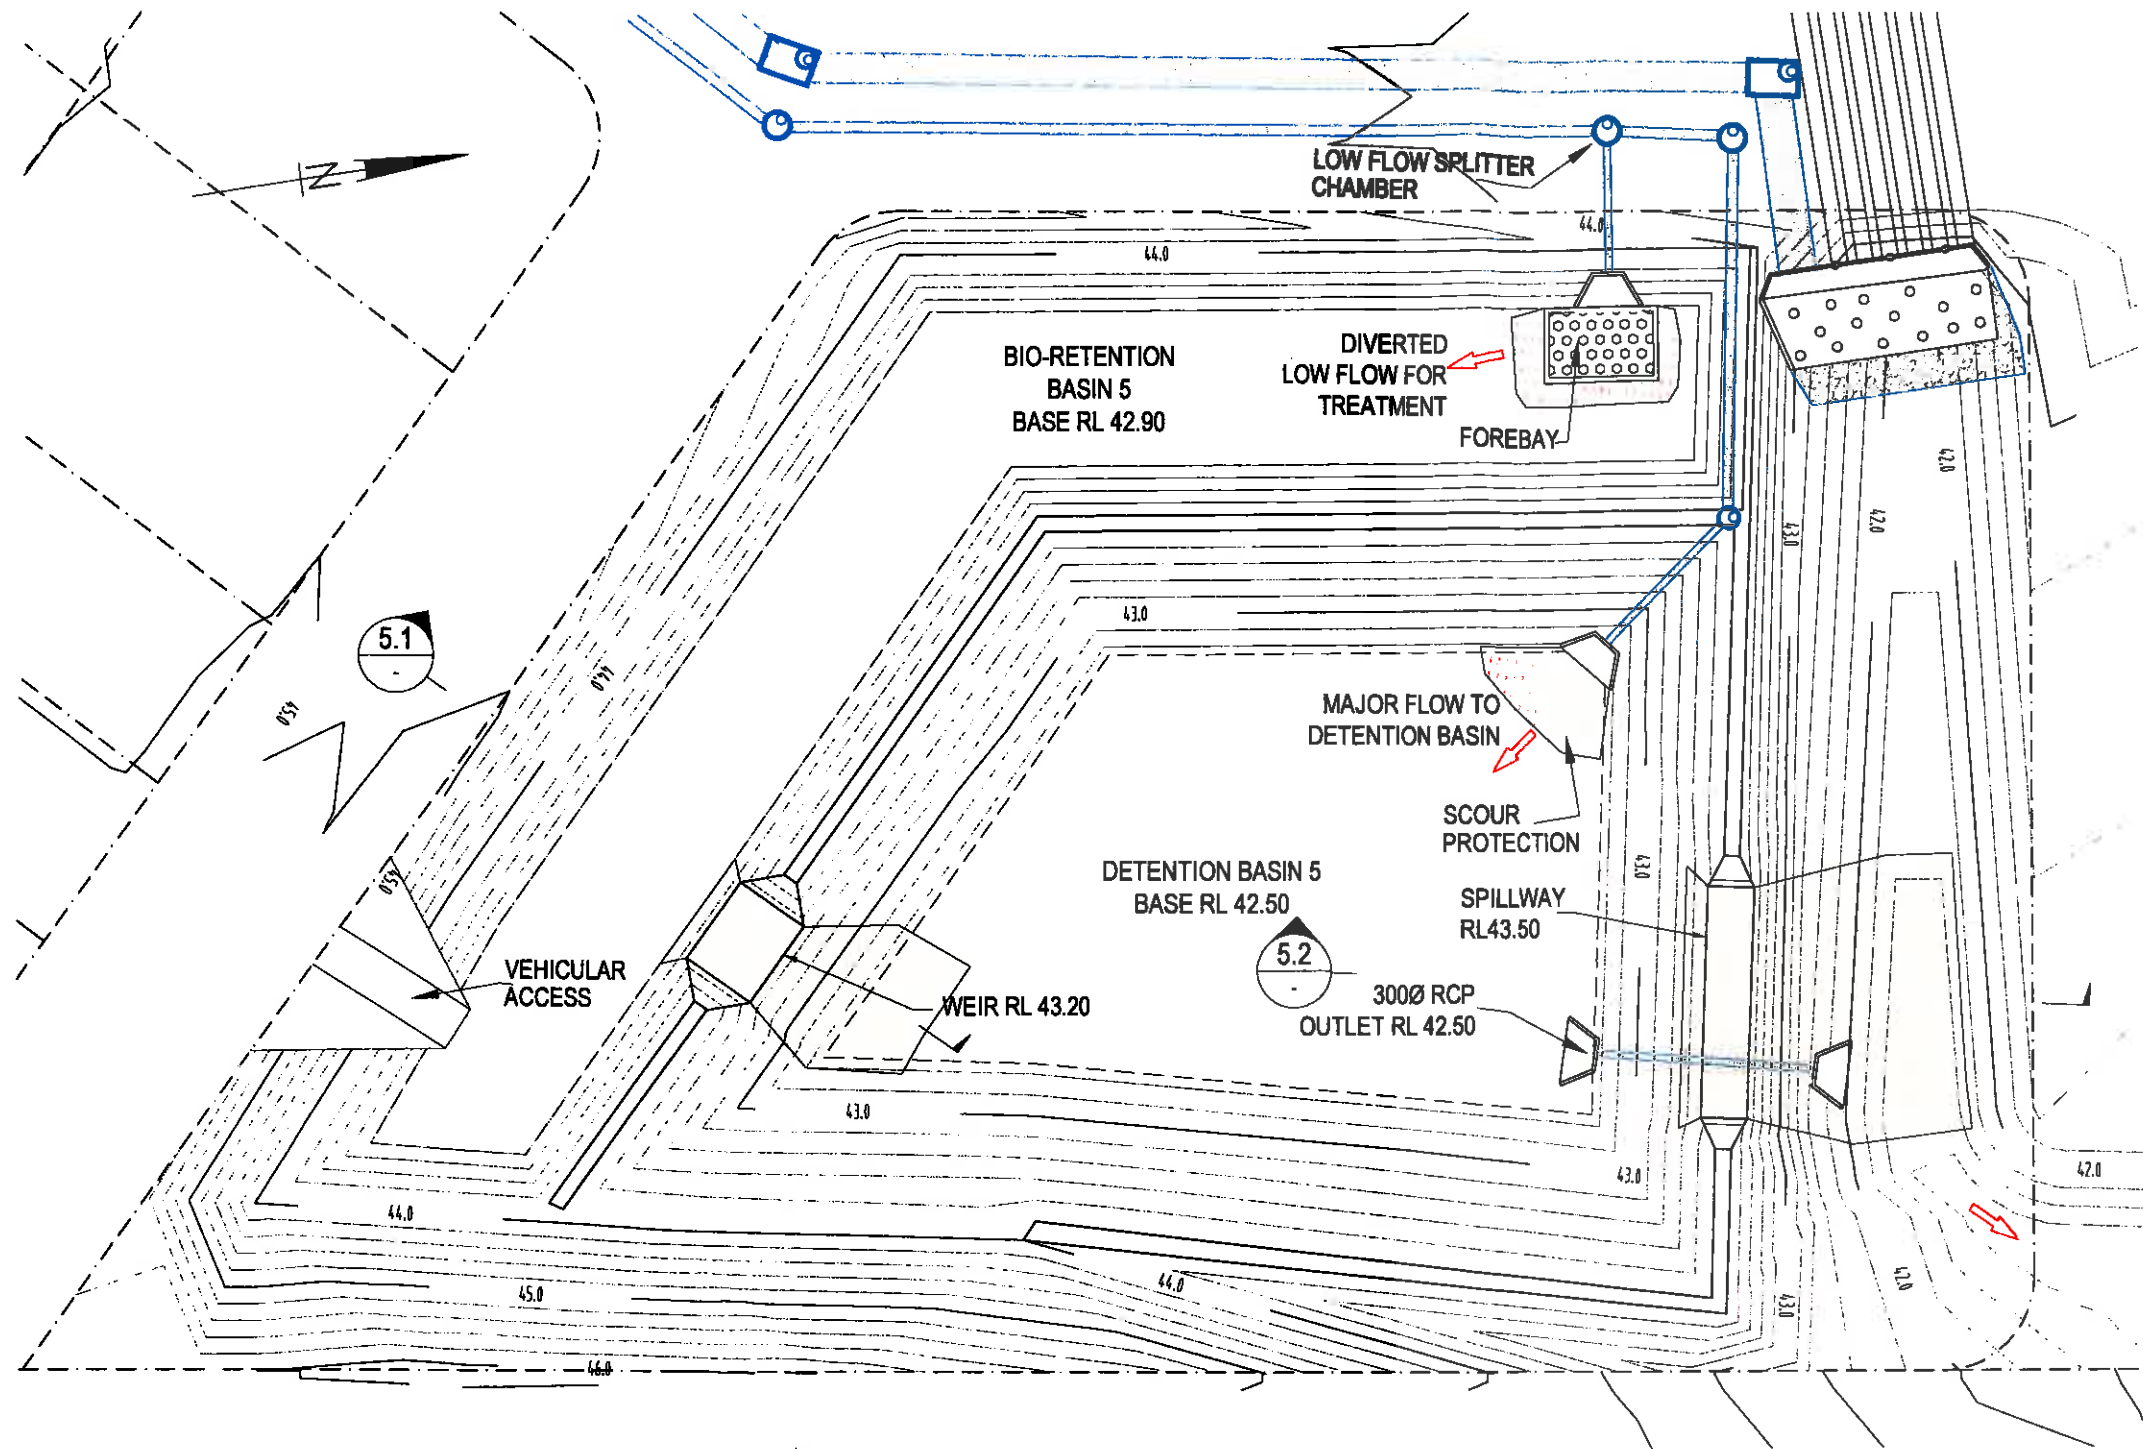
| BIO-RETENTION BASIN 5 DETAILS | |

| BIO-RETENTION BASIN 5 DETAILS | |
|---|---|
| AREA BASE (m²) | 1060 |

| DETENTION BASIN DETAILS | | | |
|---|---|---|---|
| WEIR LENGTH | 15m AT RL 43.50 | | |
| Q100 WATER LEVEL | RL 43.82 | | |

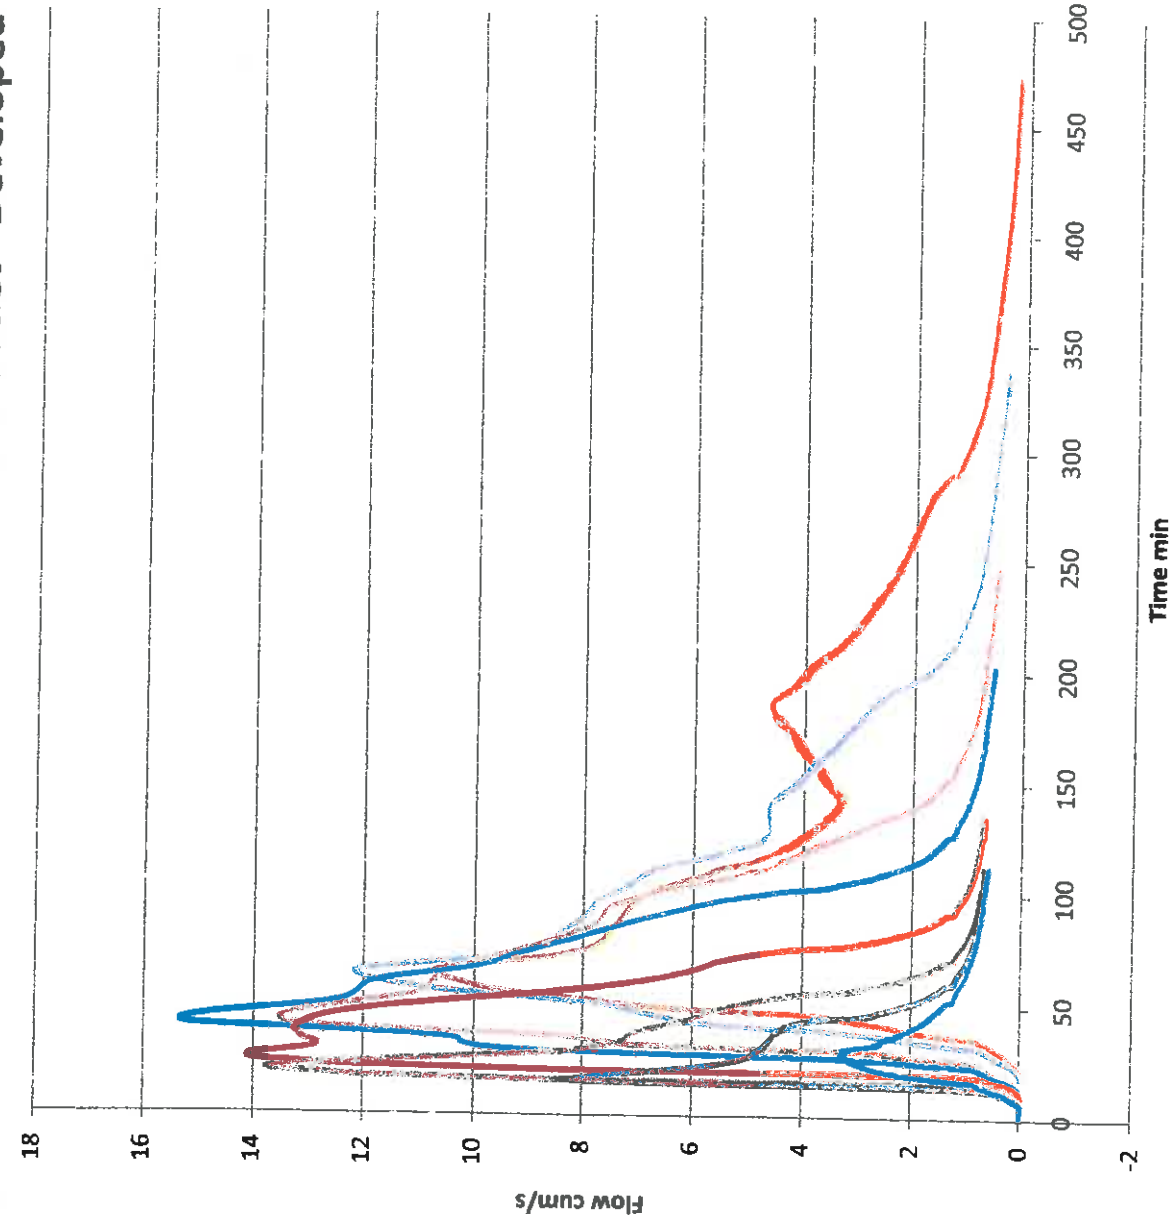
## Aulds Road Outlet - Developed Q100

- Hydrograph - AR&R 100 year, 4.5 hours storm, average 38.4 mm/h, Zone 3
- Hydrograph - AR&R 100 year, 3 hours storm, average 52 mm/h, Zone 3
- Hydrograph - AR&R 100 year, 2 hours storm, average 69 mm/h, Zone 3
- Hydrograph - AR&R 100 year, 1.5 hours storm, average 86 mm/h, Zone 3
- Hydrograph - AR&R 100 year, 45 minutes storm, average 132 mm/h, Zone 3
- Hydrograph - AR&R 100 year, 20 minutes storm, average 194 mm/h, Zone 3
- Hydrograph - AR&R 100 year, 10 minutes storm, average 259 mm/h, Zone 3
- Hydrograph - AR&R 100 year, 5 minutes storm, average 328 mm/h, Zone 3

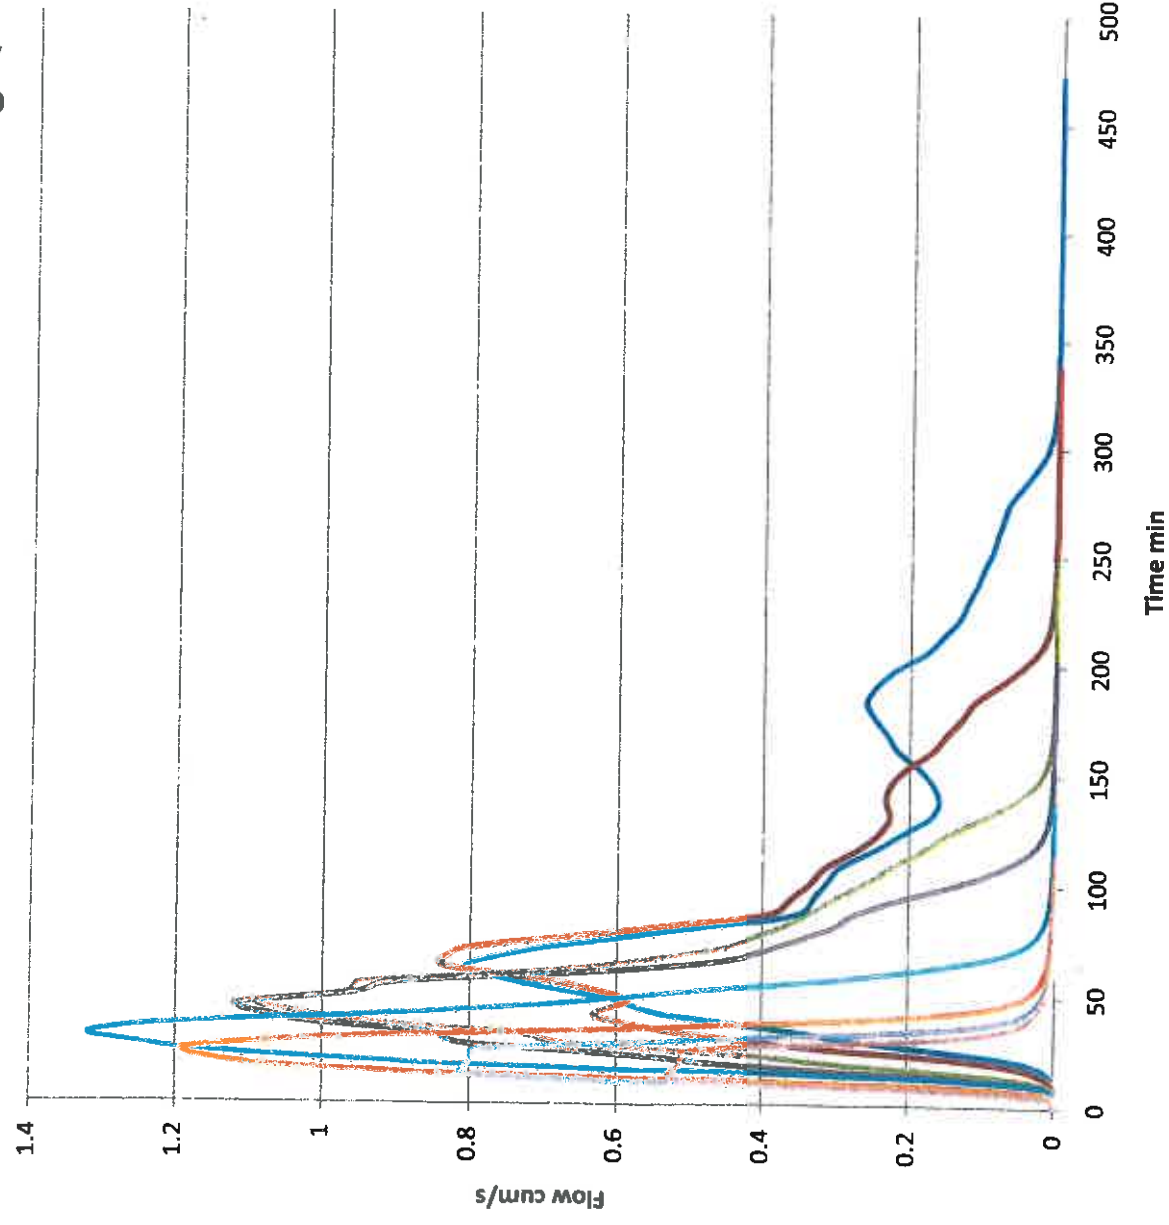
## Sales Outlet - Existing Q20

- Hydrograph - AR&R 20 year, 4.5 hours storm, average 28.1 mm/h, Zone 3
- Hydrograph - AR&R 20 year, 3 hours storm, average 37.8 mm/h, Zone 3
- Hydrograph - AR&R 20 year, 2 hours storm, average 51 mm/h, Zone 3
- Hydrograph - AR&R 20 year, 1.5 hours storm, average 62 mm/h, Zone 3
- Hydrograph - AR&R 20 year, 45 minutes storm, average 97 mm/h, Zone 3
- Hydrograph - AR&R 20 year, 20 minutes storm, average 144 mm/h, Zone 3
- Hydrograph - AR&R 20 year, 10 minutes storm, average 193 mm/h, Zone 3
- Hydrograph - AR&R 20 year, 5 minutes storm, average 247 mm/h, Zone 3

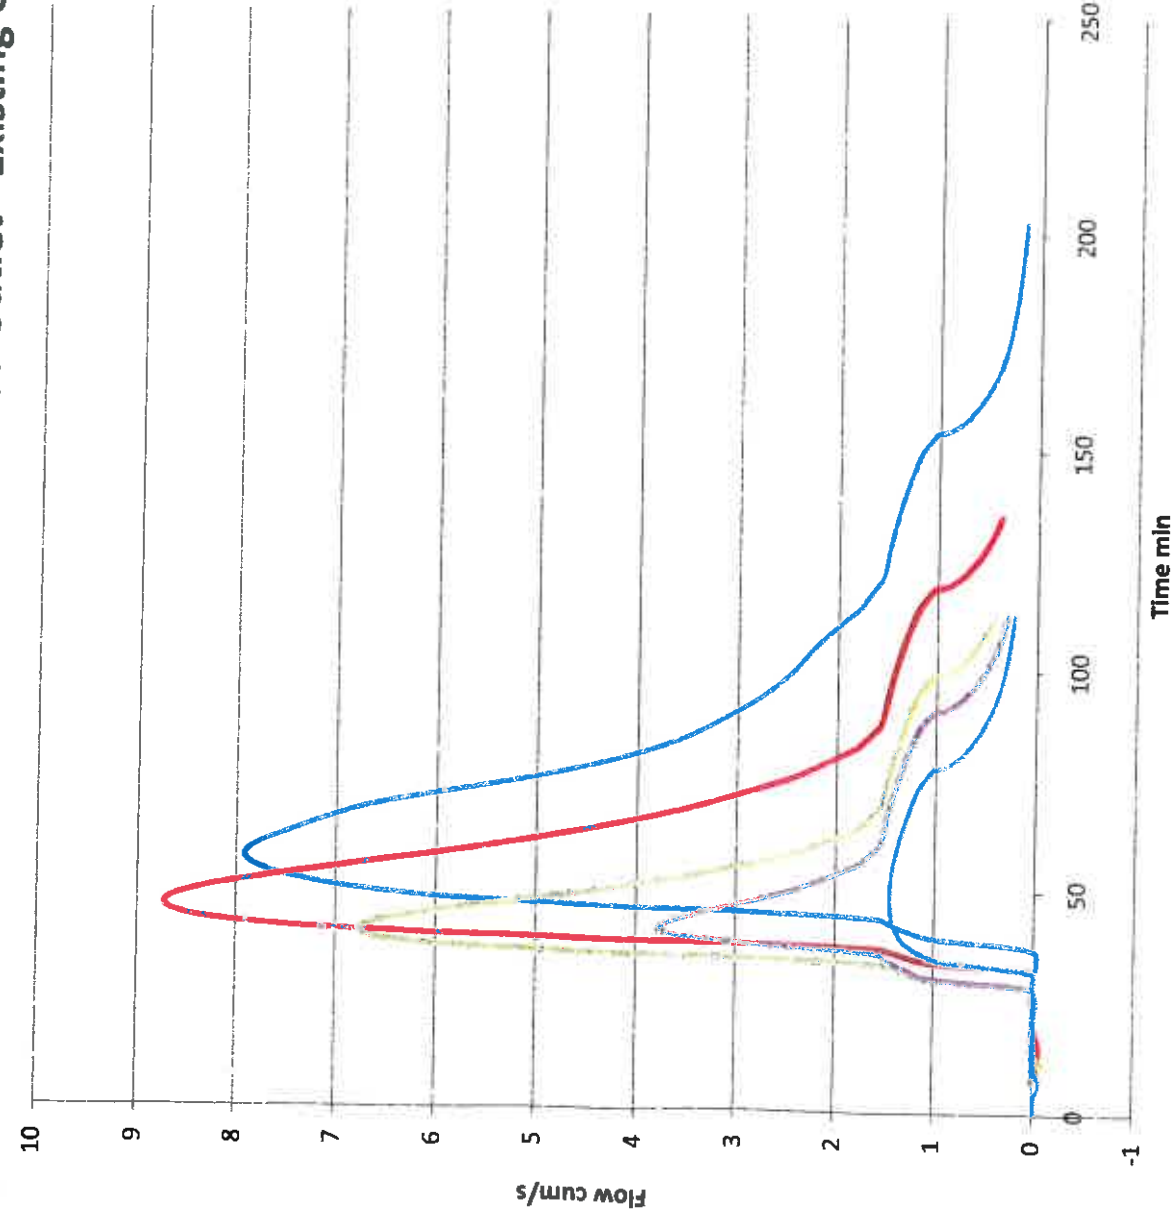
## Aulds Road Outlet - Existing Q10

— Hydrograph - AR&R 10 year, 1.5 hours storm, average 53 mm/h, Zone 3

— Hydrograph - AR&R 10 year, 45 minutes storm, average 82 mm/h, Zone 3

— Hydrograph - AR&R 10 year, 5 minutes storm, average 213 mm/h, Zone 3

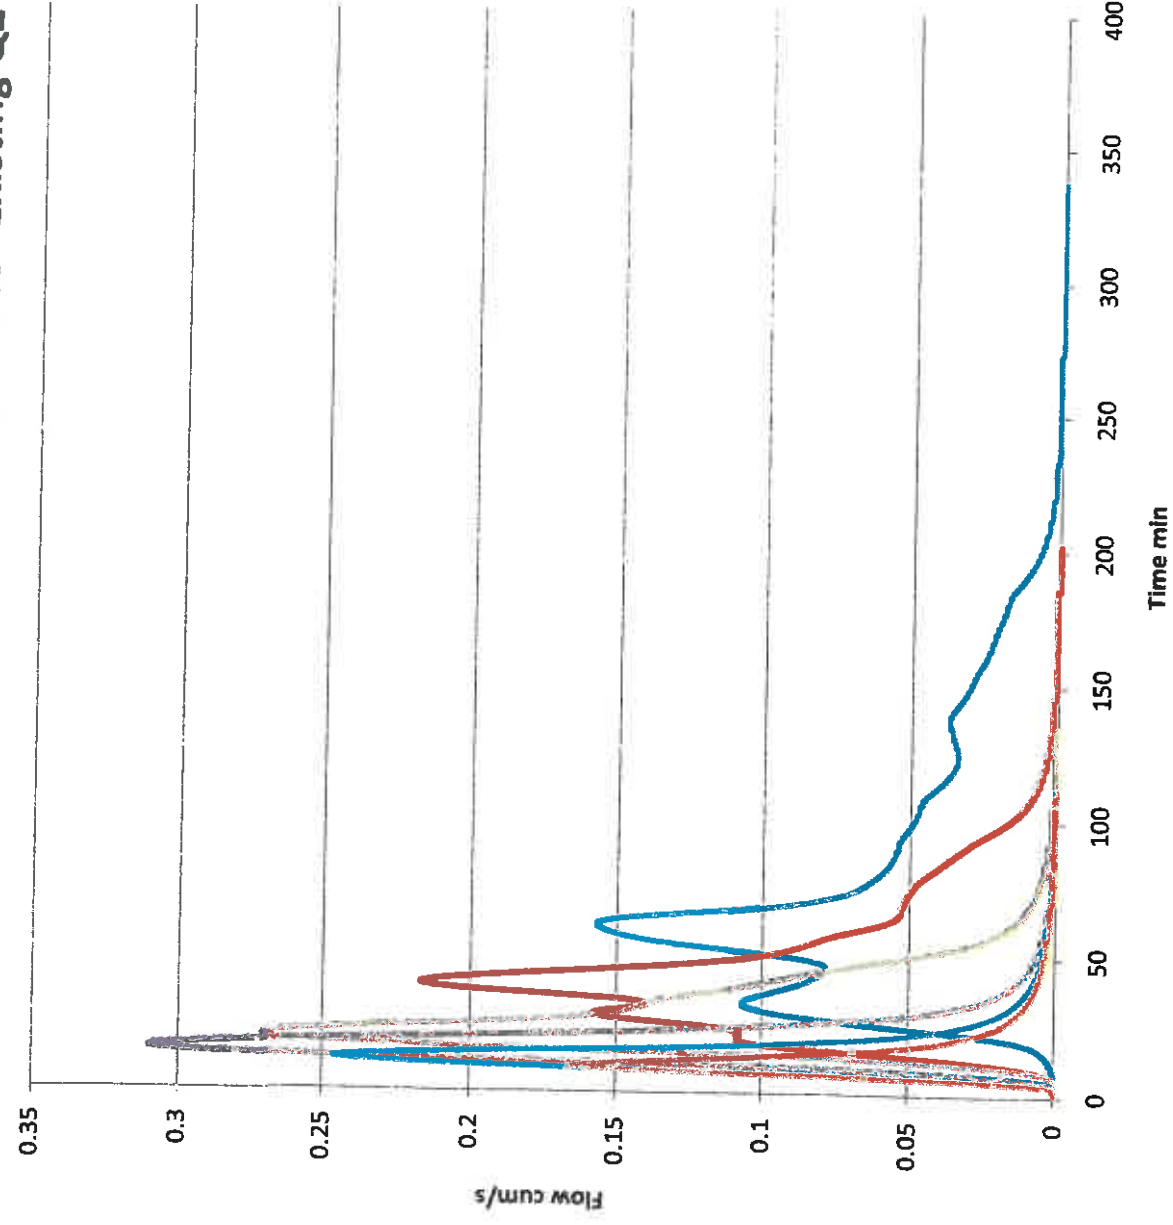
## Sales Outlet - Existing Q2

- Hydrograph - AR&R 2 year, 3 hours storm, average 20.9 mm/h, Zone 3
- Hydrograph - AR&R 2 year, 1.5 hours storm, average 34.3 mm/h, Zone 3
- Hydrograph - AR&R 2 year, 45 minutes storm, average 53 mm/h, Zone 3
- Hydrograph - AR&R 2 year, 20 minutes storm, average 82 mm/h, Zone 3
- Hydrograph - AR&R 2 year, 10 minutes storm, average 112 mm/h, Zone 3
- Hydrograph - AR&R 2 year, 5 minutes storm, average 145 mm/h, Zone 3
