# Oonoonba Site

## Geotechnical Assessment of Land Suitability for Residential Development

16 July 2010

60158509

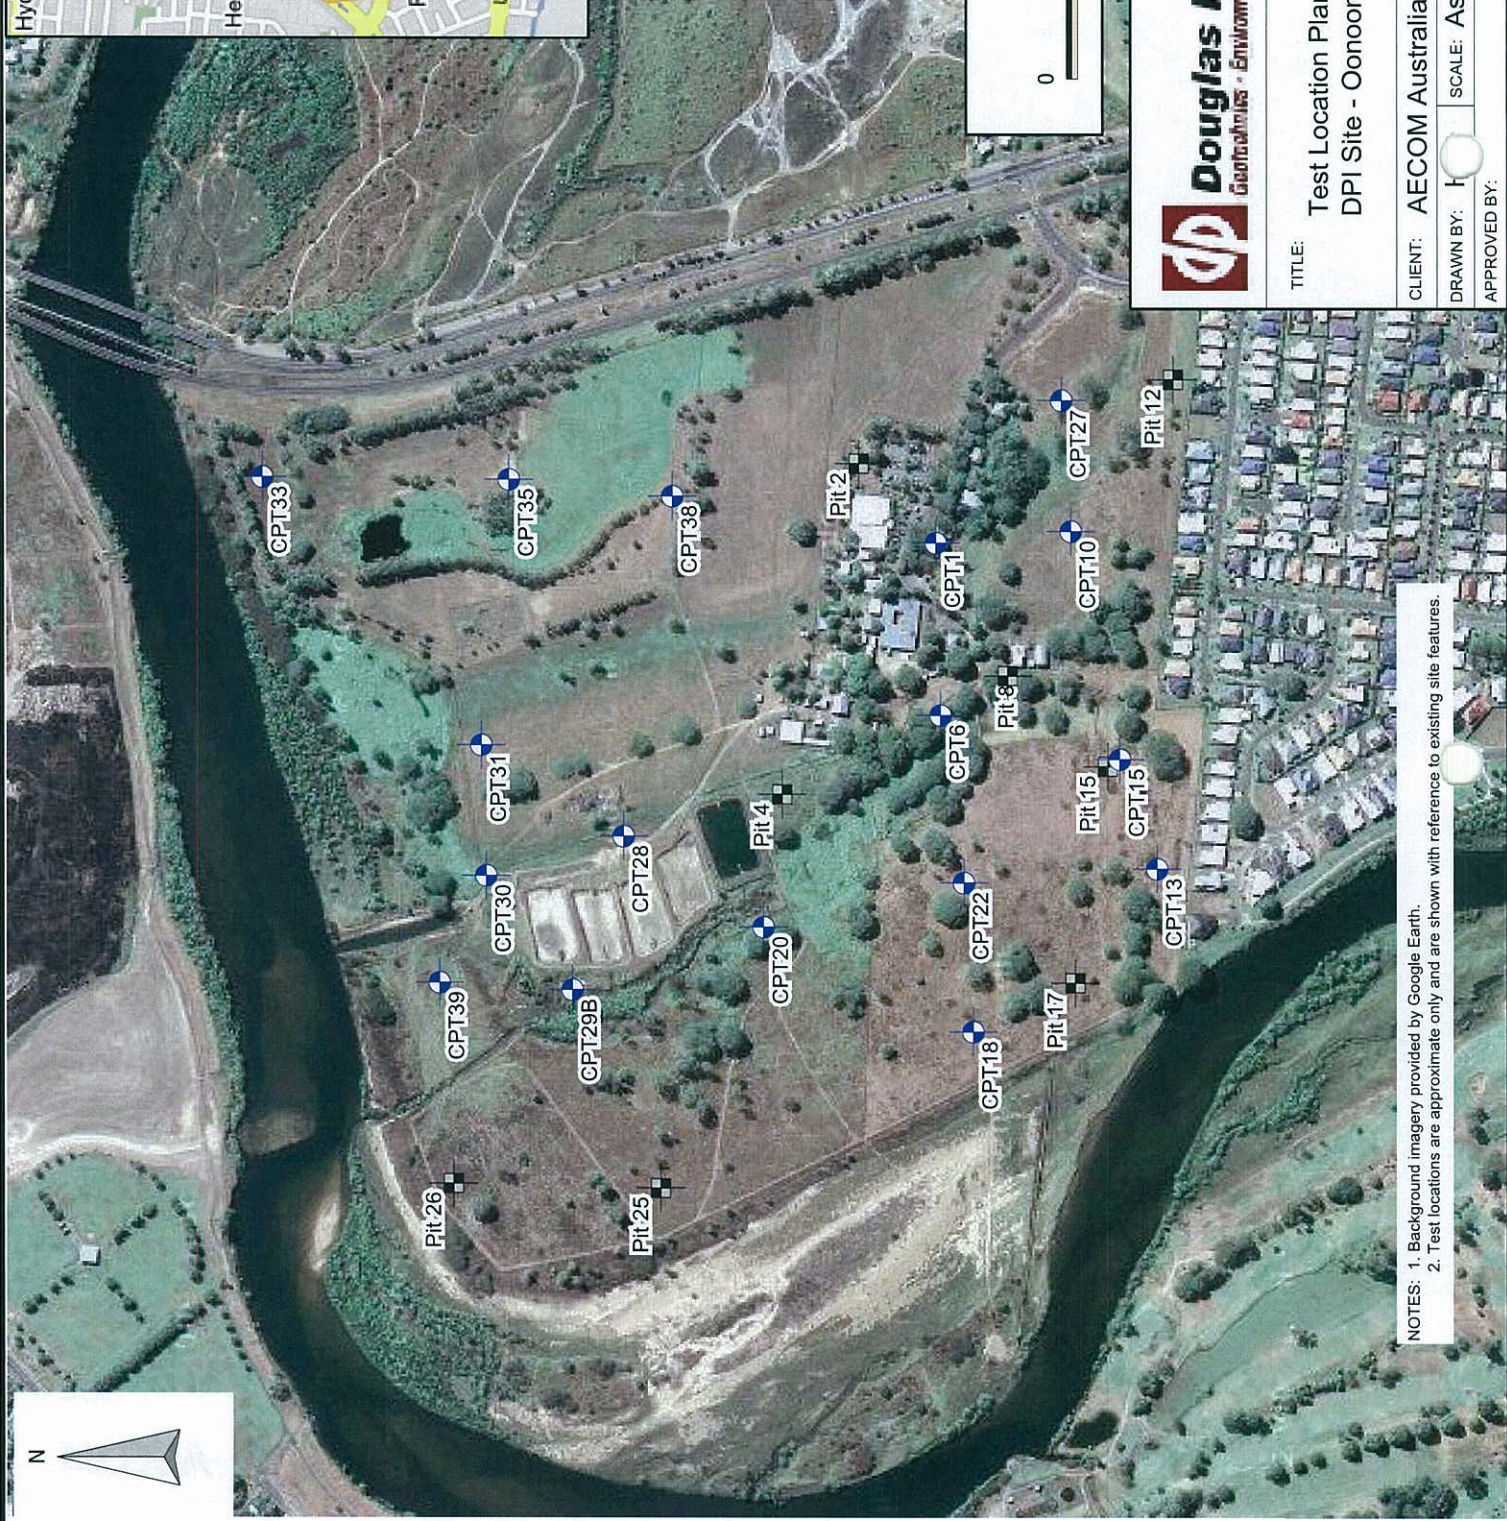
DRAWING NO: 1

NOTES: 1. Background imagery provided by Google Earth.  
2. Test locations are approximate only and are shown with reference to existing site features.
