**Groundwater Assessment**  
**Oxley PDA - Stage 1A**  
**Blackheath Road, Oxley**

Prepared for  
**Economic Development Queensland**

**Project No.: 018-118D**  
15 September 2020

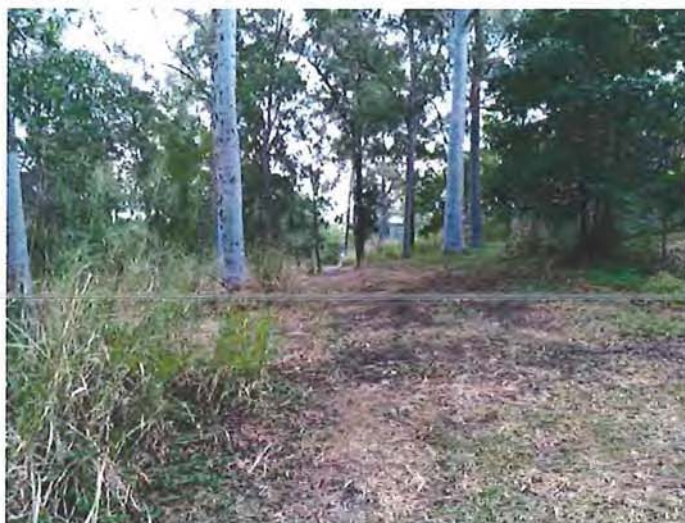
Photograph 3: View of the site looking north-east from Bore 102
