## Preparatory Environmental Recovery Works Ross River Site RM2S1 [Oonoonba PDA] – DRFA Stage 1 Site #2

### Introduction - Terrace Extension and Bank Stabilisation

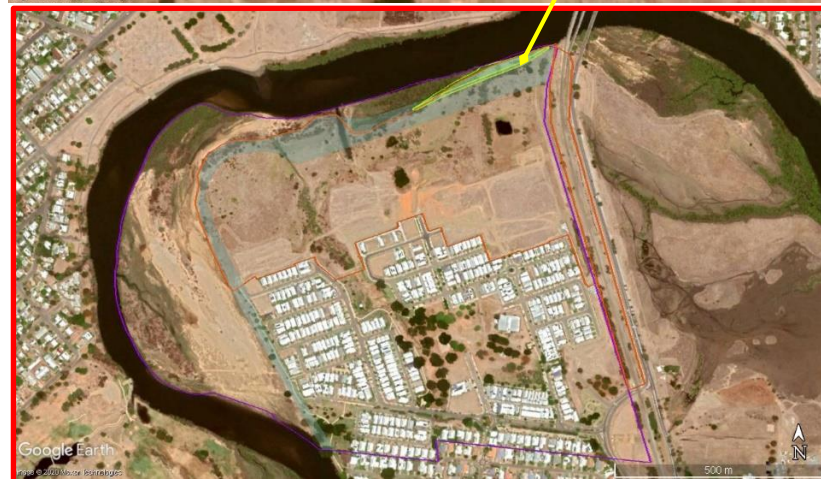
**Figure 1 Main Bank Stabilisation Works (All Within Open Space Zone)**

Main figure - the terrace extension area is shaded green and the 'new' and re-profiled bank location is shaded brown. The bank batter will be 1:3 to 1:4 batter to facilitate revegetation works to further stabilise the bank over the long term. The riparian revegetation zone is shaded dark green.

The inset shows the proposed works in relation to the larger PDA area and the Open space zone [light blue shading].

Works will be undertaken conjointly on both banks of the river upstream of the North Coast Rail line, as part of a unified design and flood resilience approach for the Ross River and Townsville floodplain. The proposed works on the south bank (see Figure 1) will consist of:

Prior to undertaking the proposed DRFA funded environmental recovery program (ERP) Ross River bank stabilisation and flood resilience works [see Figure 1] the vegetation will need to be removed from the areas to be excavated. The preparatory vegetation management works required are:

The secondary area also includes the northern end of the terrace extension and bank re-profiling works area [see Figure 1] where native trees will be retained. The fine scale design of the bank stabilisation works for the eastern end will be undertaken on-ground to ensure the best possible integration of the works with the remaining in situ, 'stable' elements of the terrace and bank.

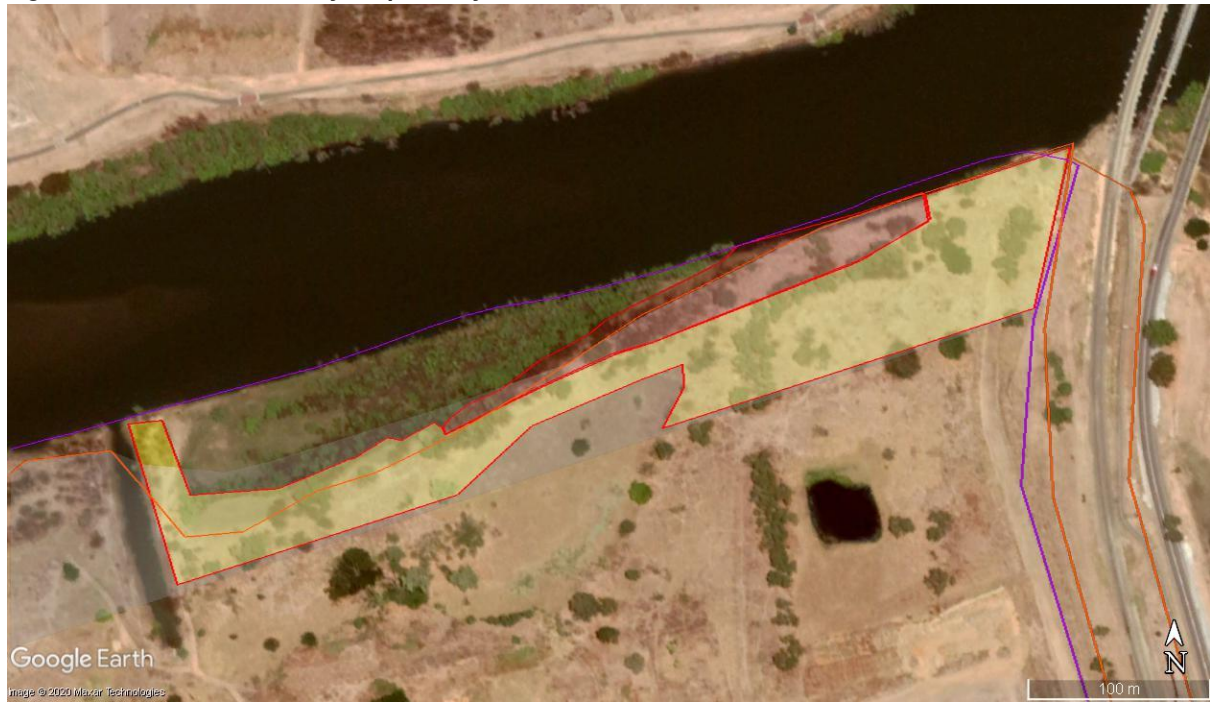
**Figure 2 Main and Secondary Preparatory Work Areas**

Notes: Main preparatory work area is red and the secondary area is yellow .

The secondary area for preparatory vegetation management works is approximately 23,000m<sup>2</sup> and adjoins the main preparatory works area, as shown in Figure 2. The secondary area consists of the higher ground in the Open Space zone [Ooononba PDA Development Scheme] where:

Permission to access the Ooononba PDA Open space zone is requested to implement the preparatory works above. Approval of set down and processing pads in the secondary preparatory work area [see Figure 2] is also requested for the duration of the project. This will enable the removed vegetation to be treated with beneficial microbes and stored while it is being transformed into a humus [carbon] rich organic soil for later use to enhance revegetation areas.
