Third Draft
**Additional Geotechnical Investigation
Herston Quarter Redevelopment –
Northern Car Park**
Research Road, Herston

Prepared for
Herston Development Co Pty Ltd
Project No. 017-141C

29 October 2018

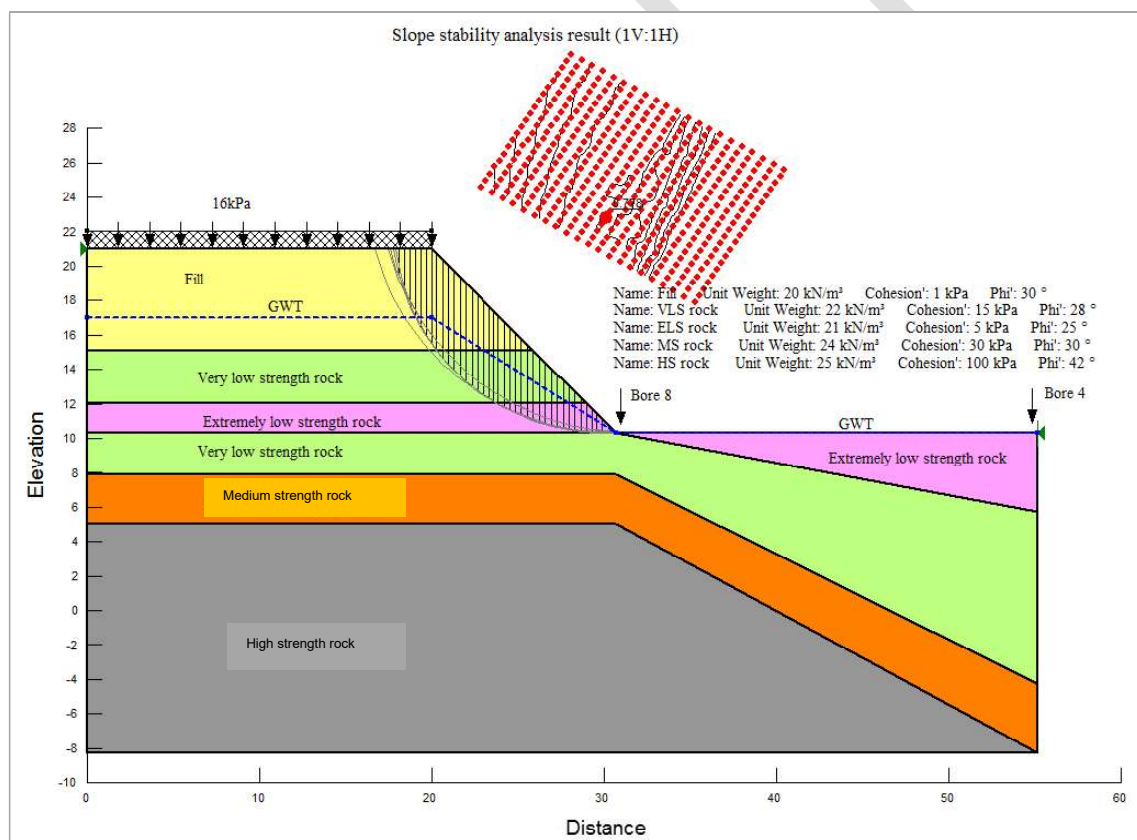
Figure 1: 'Long term' analysis for an excavated (cut) batter slope of 1V:1H at the location of Bore 8

For the analysis conducted, an automated search of potential circular failure surfaces was carried out to assess the failure surface with the lowest calculated FOS. The results of the preliminary analysis considering excavated (cut) batter slopes of 1V:1H and 1V:2H is presented graphically in Figure 1 and Figure 2 respectively (showing the failure surface with the lowest calculated FOS) and is also summarised in Table 9.

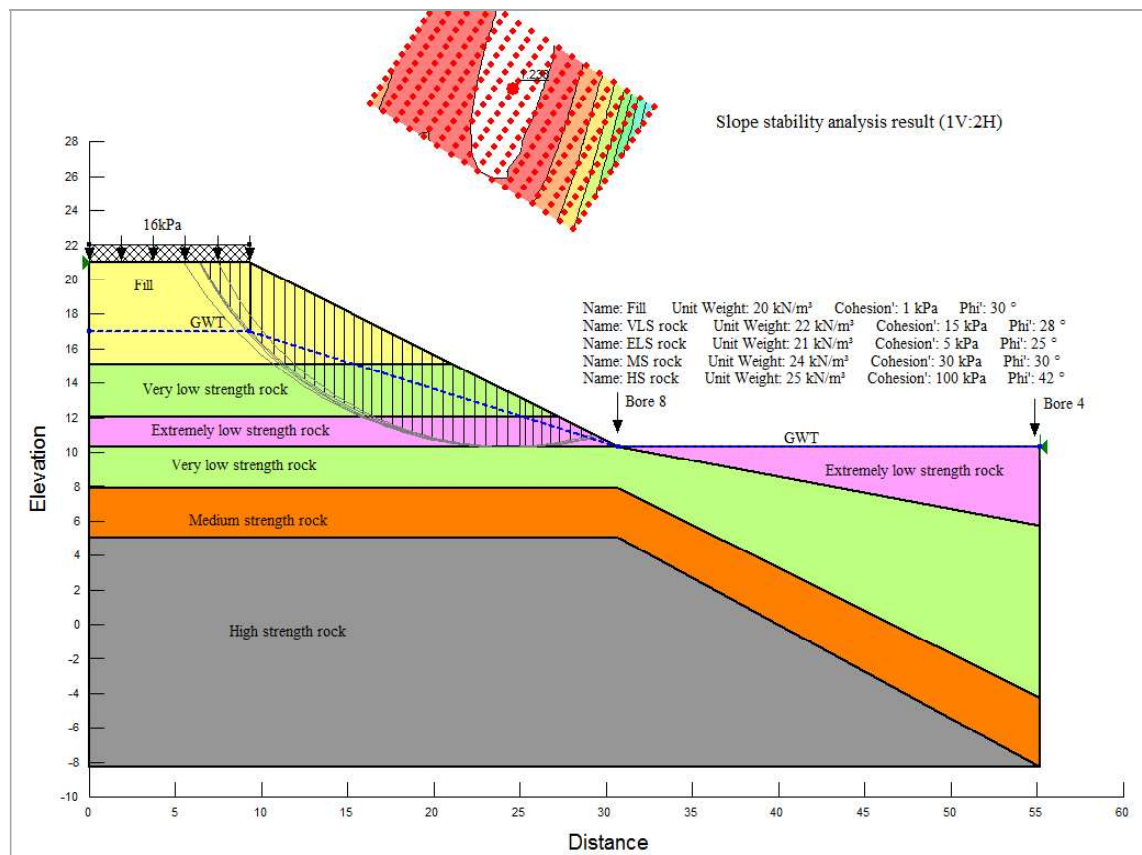
Figure 2: 'Long term' analysis for an excavated (cut) batter slope of 1V:2H at the location of Bore 8

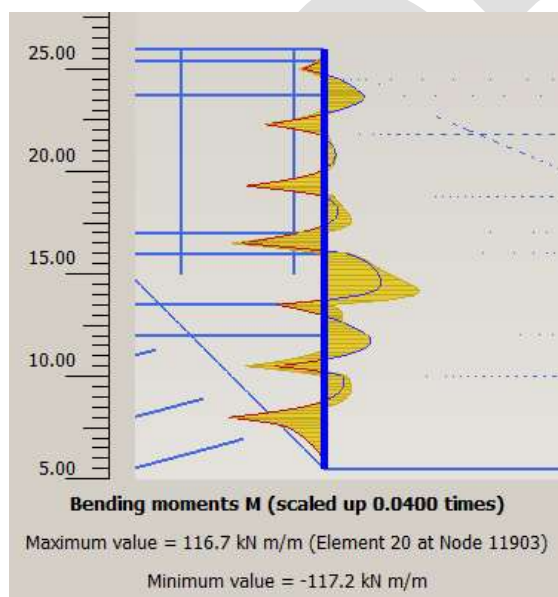
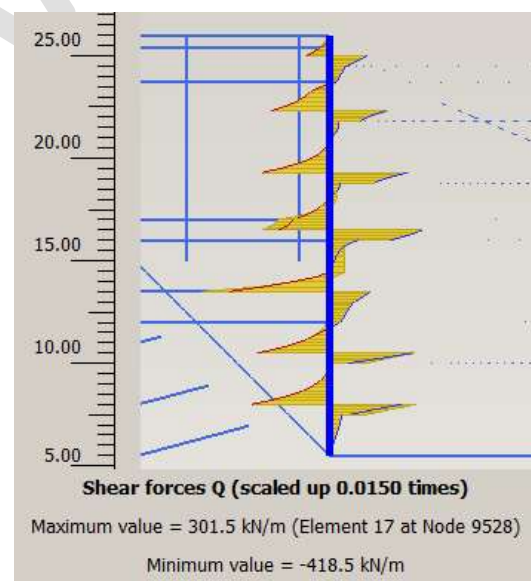
(a) Bending Moment Envelope

(b) Shear Force Envelope

Figure 5: Calculated wall bending moment and shear force plots (Condition 1)

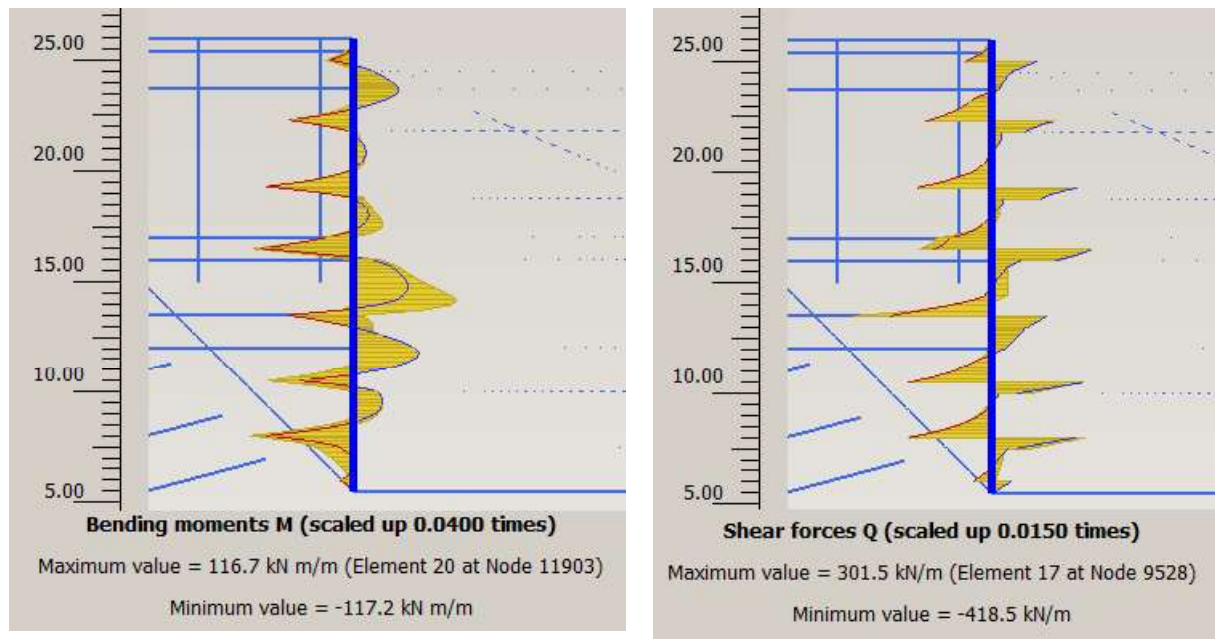
(a) Bending Moment Envelope

Figure 6: Calculated wall bending moment and shear force plots (Condition 2 with 'short' piles)

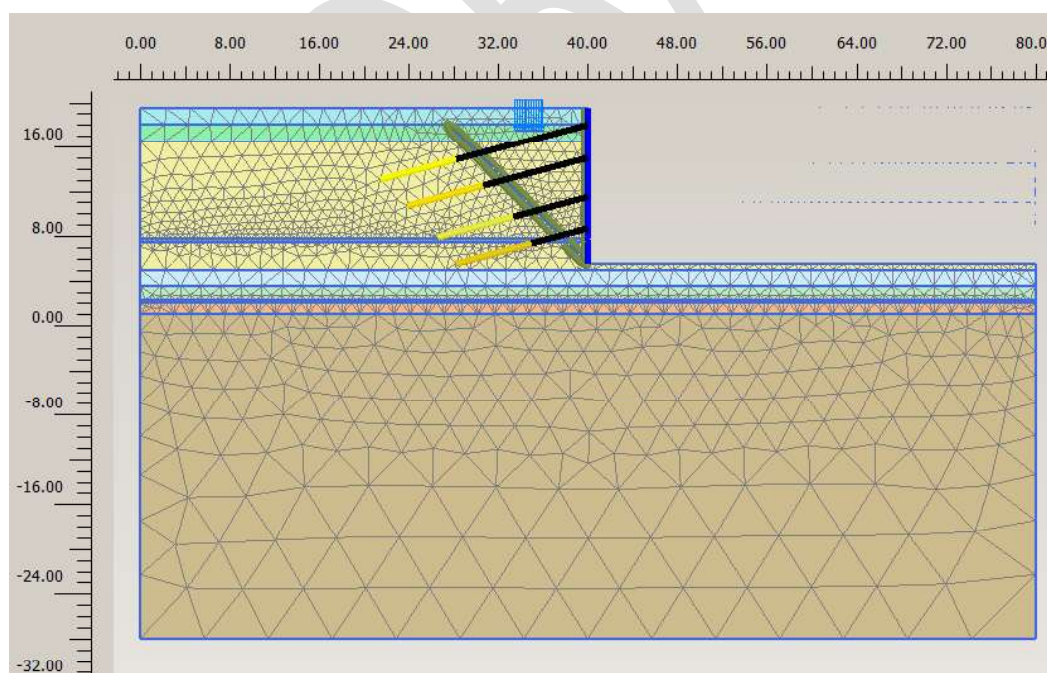
Figure 8: PLAXIS Model Analysed with HADS footing pressure applied

Figure 8 shows an overview of the PLAXIS model with HADS footing pressure applied.

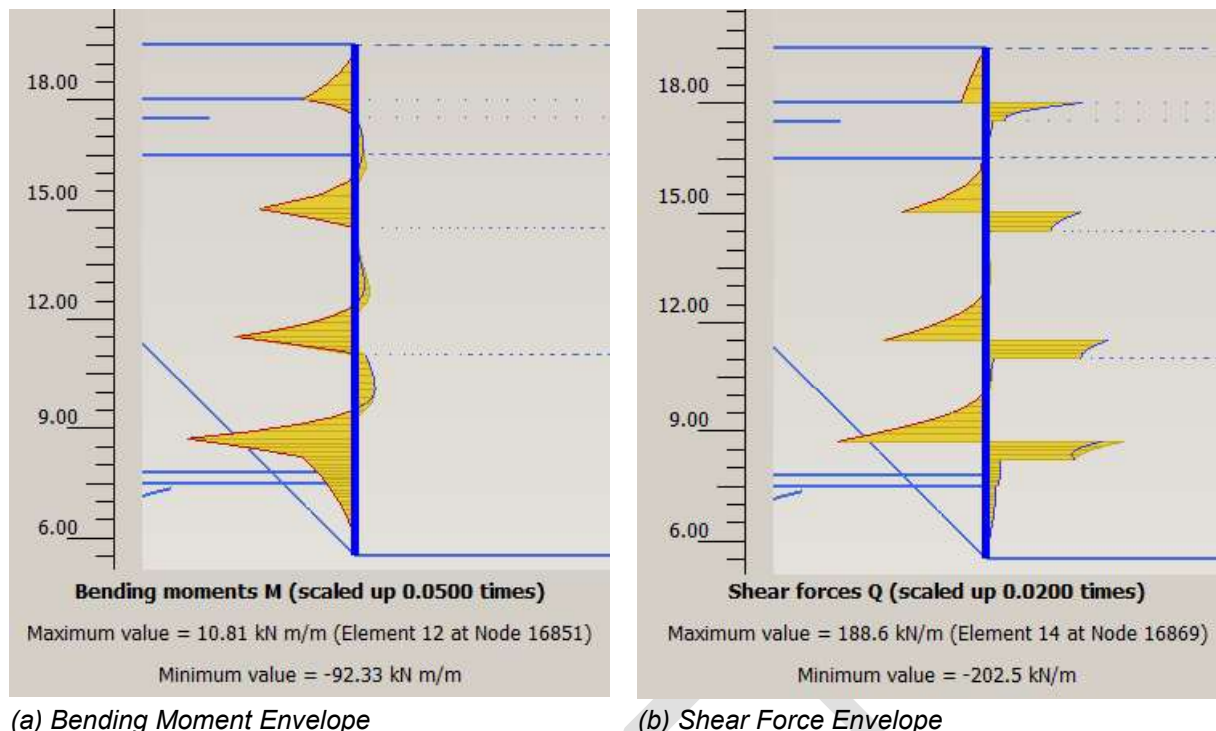
Figure 9: Calculated wall bending moment and shear force plots (vertical coordinate is RLm)

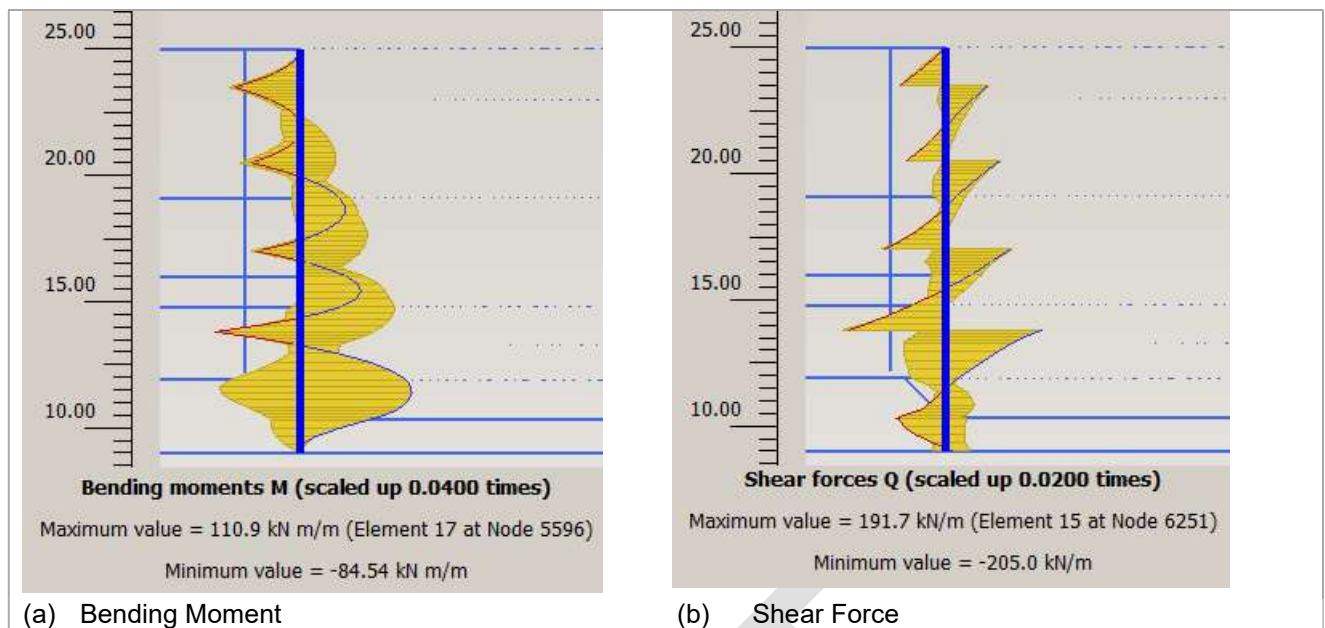
Figure 11: Calculated envelopes of wall bending moment and shear force (vertical coordinate is RLm)

The distribution of wall bending moment and shear force are shown in Figure 11.

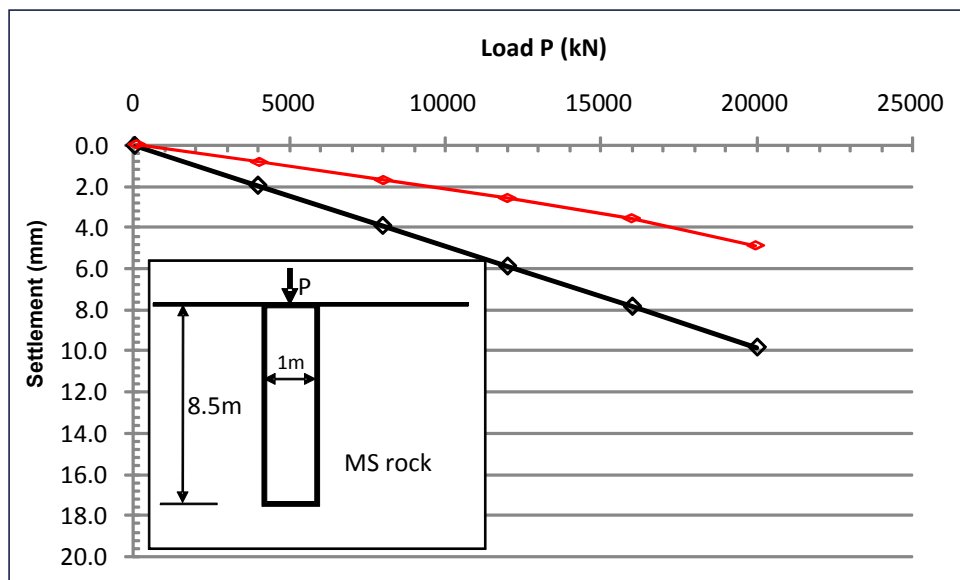
Figure 12: Estimated Range of Load Settlement Response – 1.0m diameter pile (8.5m socket)

In each case the estimates have been done for the lower and upper range of settlement modulus values given in Table 41 and the results are plotted in Figure 12 to Figure 14. The estimated load/settlement curves provided do not include any load/strength factors and represent the anticipated range of actual settlements under unfactored working loads for medium strength rock.

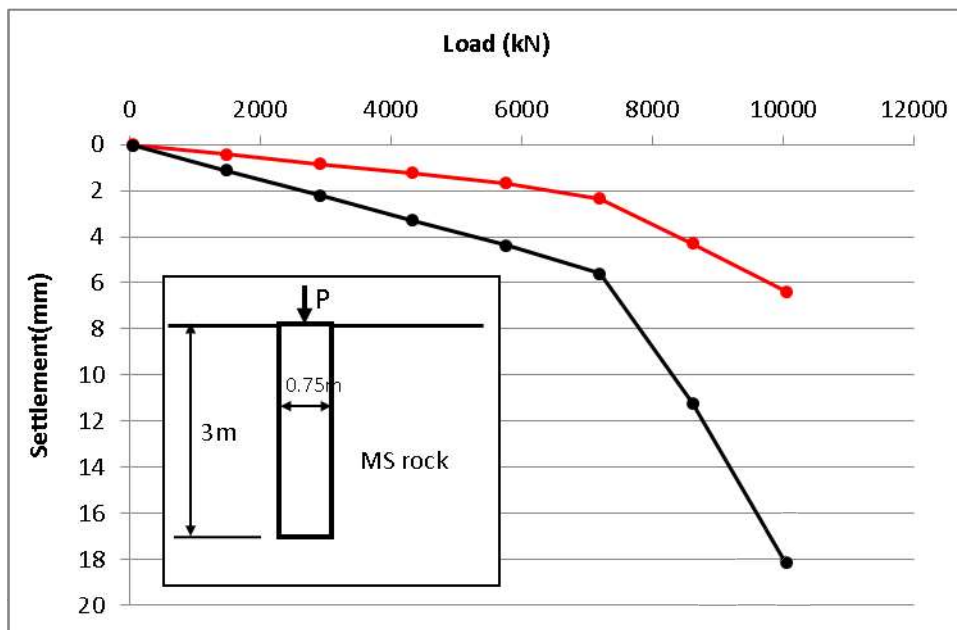
Figure 14: Estimated Range of Load Settlement Response – 0.75m diameter pile (3m socket)
