**Groundwater Assessment  
Oxley PDA - Stage 1A  
Blackheath Road, Oxley**

**Prepared for  
Economic Development Queensland**

**Project No.: 018-118D  
15 September 2020**

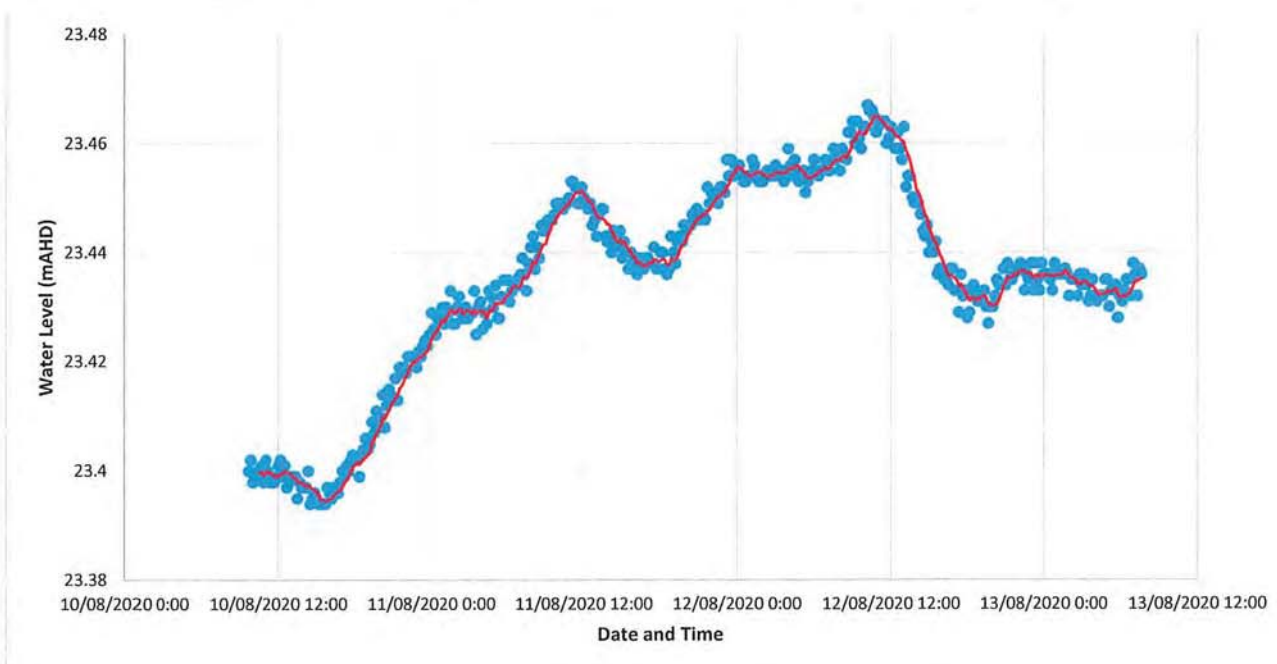
Figure 9: Hydrograph of continuous groundwater monitoring in Well 102 (10 to 13 August 2020)

The groundwater level in the sloping areas of the site is considered to be mainly determined by the rainfall infiltration recharge. There was some notable rainfall on Friday, 7 August 2020 comprising 14.6mm for twenty-four hours to 9am 8 August 2020. In order to assess the magnitude of rainfall recharge on groundwater level, a data logger was installed in three monitoring wells (Well 25, 28 and 102) on Monday morning, 10 August 2020, and the groundwater level was continuously recorded at ten minute intervals for three days.

It is possible that the rise in water level was caused by rainfall infiltration recharge, but the magnitude of change is very small, approximately the same magnitude as the previously recorded daily tidal influence.

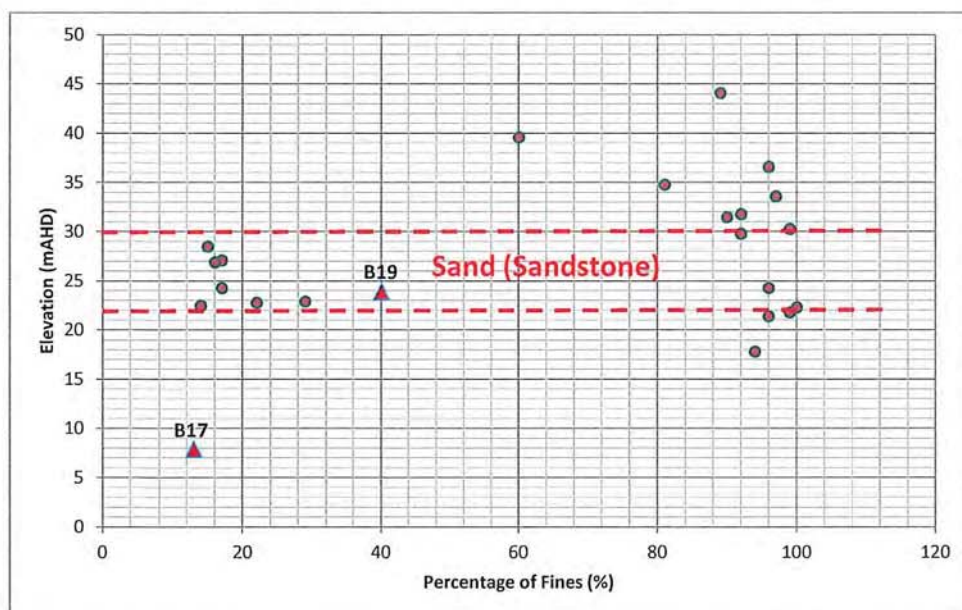
Figure 11: Results of the particle size distribution analysis

Two soil samples, one each from Bores 17 and 19, from previous preliminary geotechnical investigations were previously tested for particle size distribution and their results are included in Table 8 and Figure 11, indicate a sand zone between RL22mAHD and RL30mAHD, which is considered likely to consist of weakly cemented Tertiary sandstone of the Darra Formation; Bores 17 and 19 are located on the east slope of the overall site. It is noted that the result for the sample from Bore 19 at elevation RL23.9mAHD indicates it is within the sand zone, consistent with the results from the Stage 1A bores. The sample from Bore 17 at RL7.9mAHD, could indicate another sandstone (or the conglomerate), strata of the Darra Formation.

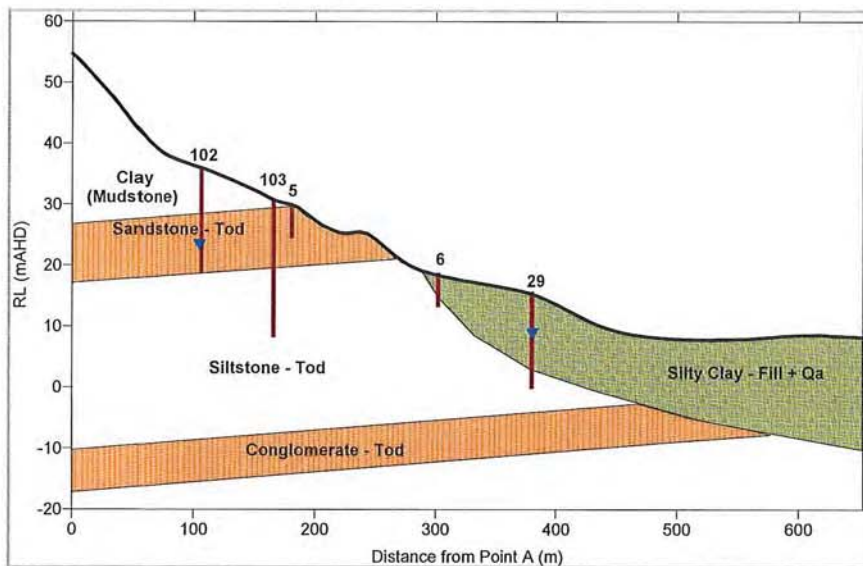
Figure 13: Geological cross-section along Line A-A'

According to the structures on the detailed surface geology presented on the Queensland Globe, the interface of the Tertiary units dips approximately 10° to the south-east. This dip direction and angle are consistent with the descriptions presented on the geotechnical Bore Report sheets for Bores 102 and 103, as depicted in Figure 13. However, for the groundwater modelling, it was assumed that the interfaces were horizontal.

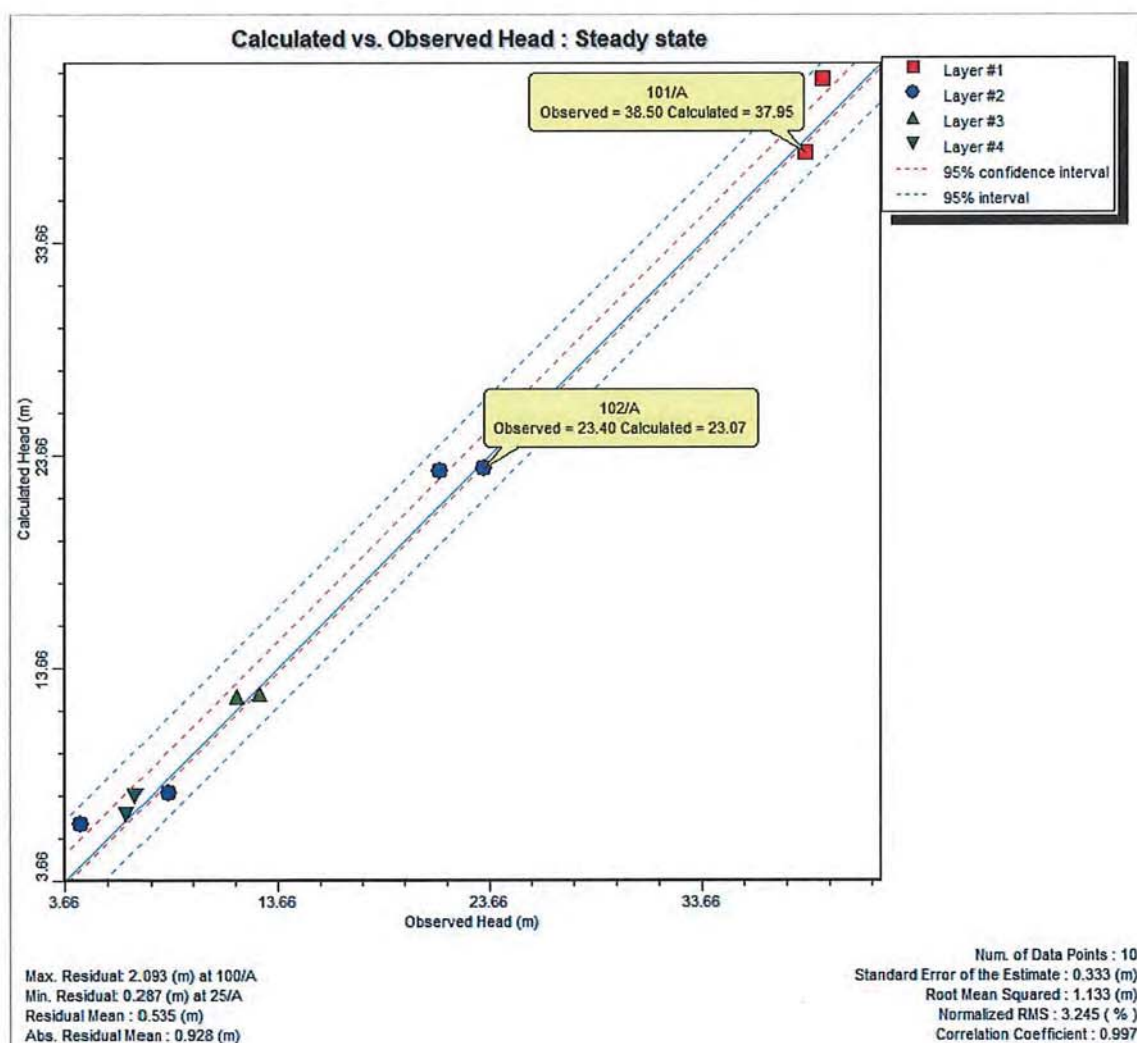
Figure 16: Comparison of modelled and observed groundwater levels

Comparisons of the modelled and the observed water levels are summarised in Table 10 and a cross-plot of the two is shown in Figure 16. The normalized RMS (root mean squared of the differences) is 3.2% which is acceptable for a basic model, especially considering the heterogeneity of the actual aquifer and significant differences in water levels over a small area in the model domain.

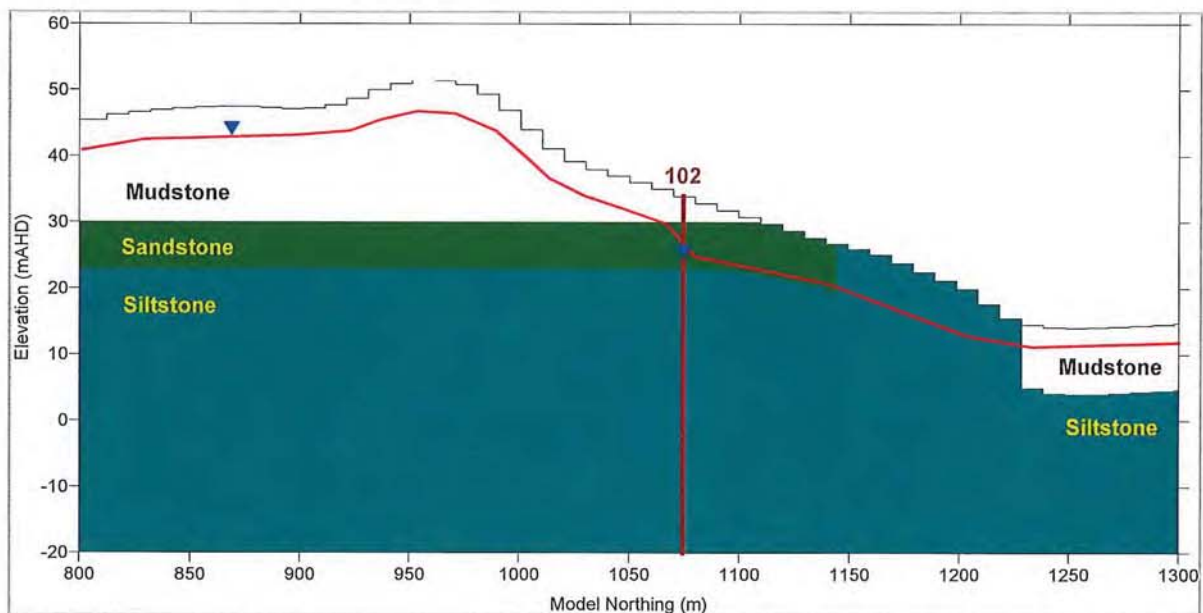
Figure 18: Cross-section view of modelled water table (in red) across Well 102 (Section B-B')

Modelled contours of the groundwater table elevation are shown in Figure 17, and two cross-sectional views of the modelled results are shown in Figure 18 and Figure 19.

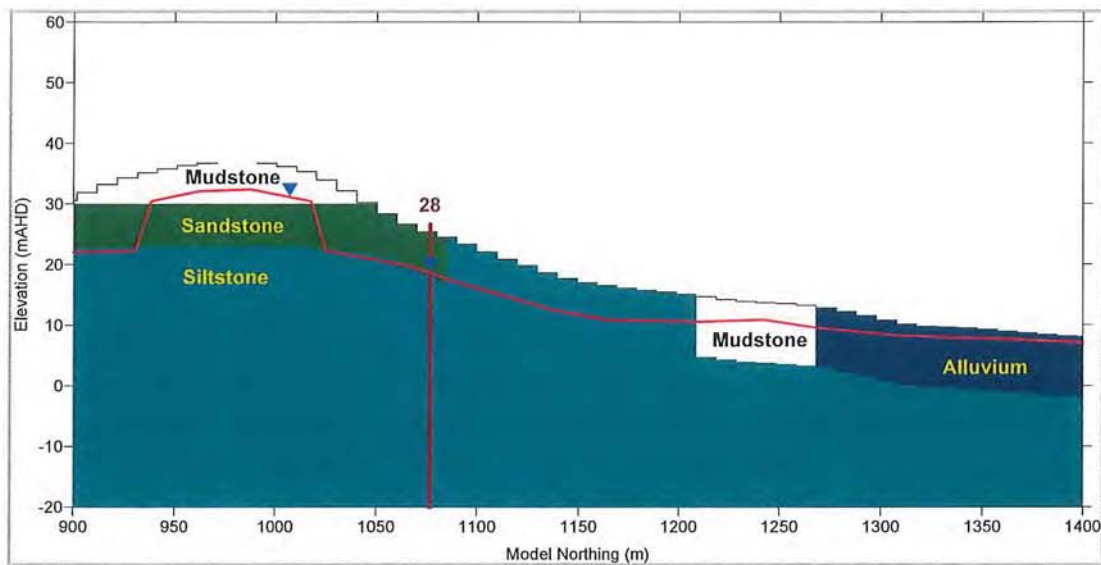
Figure 19: Cross-section view of modelled water table (in red) across Well 28 (Section C-C')

As indicated in Figure 19 and Figure 20, the minimum depth of the groundwater table level calculated from the model is approximately 5m; as noted above, the materials immediately beneath the indicated water table level are not saturated.
