Arboricultural Impact Assessment

Prepared For: Economic Development
Queensland

53 Seventeen Miles Rocks Road
Oxley 4075

IAS7460

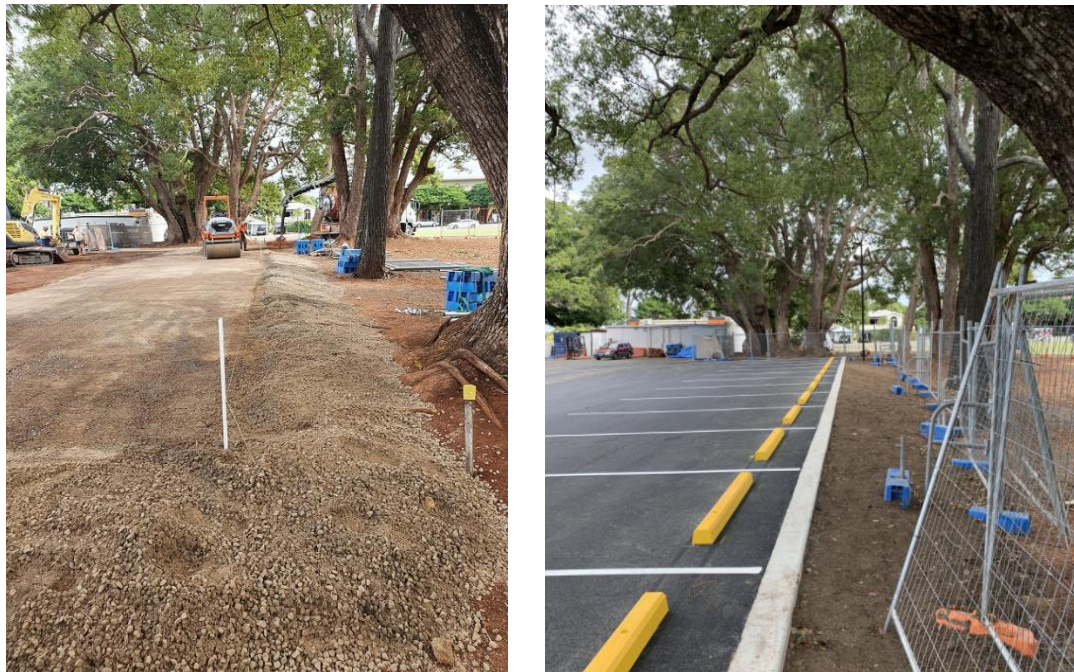
Example of the use of Structural Soil

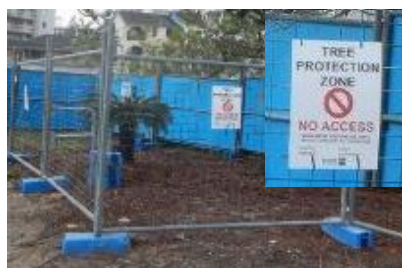
Figure 9

Example of Fauna Friendly Rigid Style Temporary Fencing
