Report on  
Geotechnical Investigation

Yeronga Priority Development Area  
Park Road, Yeronga

Prepared for  
Economic Development Queensland

Project 200443.01  
February 2022

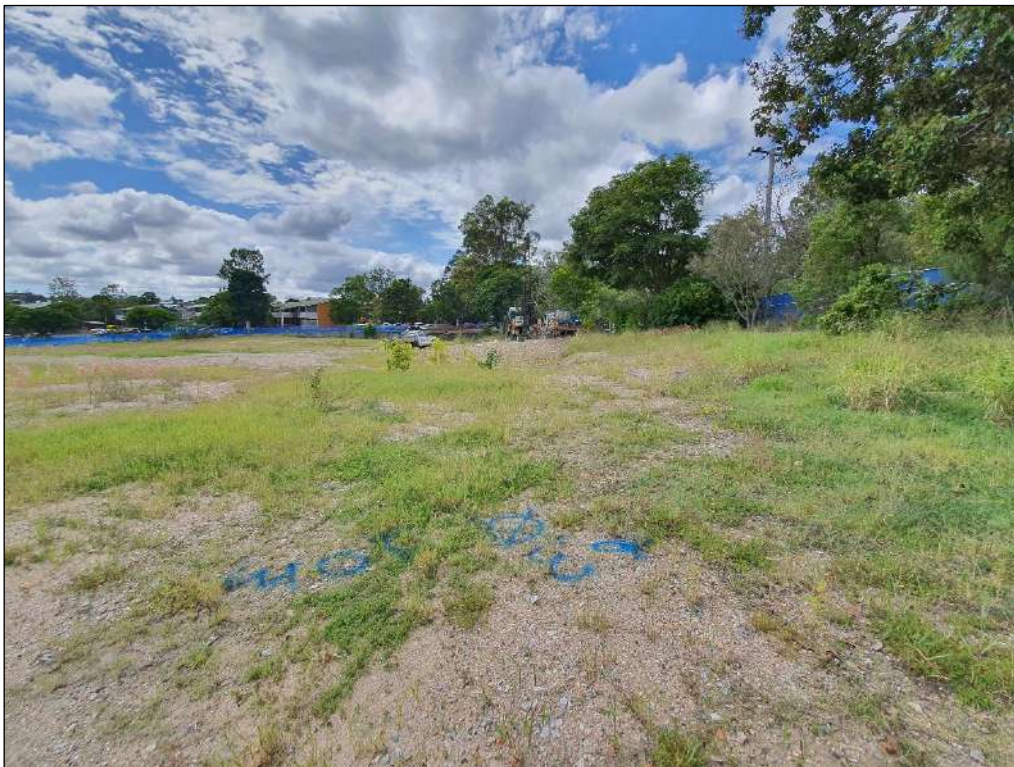
**Figure 1: Looking east towards the rig set up on Bore 2.**

The ground surface at the site was sparsely covered by poorly-maintained grass with the remaining areas exposed fill subgrade and small to large sized trees were observed scattered along the northern, western and eastern boundaries. Furthermore, localised rock outcrops were also observed in various areas of the site. The topography within the majority of the site was relatively flat, however, generally sloped gently down from the southern and south-western boundary towards the north, north-eastern boundary. With reference to recorded bore levels and Brisbane City Council Interactive Mapping, the site levels are approximately RL 20 mAHD near the southern boundary, and approximately between RL10 mAHD and RL7 mAHD near the northern boundary of the site. Photographs of the site are indicated in Figures 1 to 3.

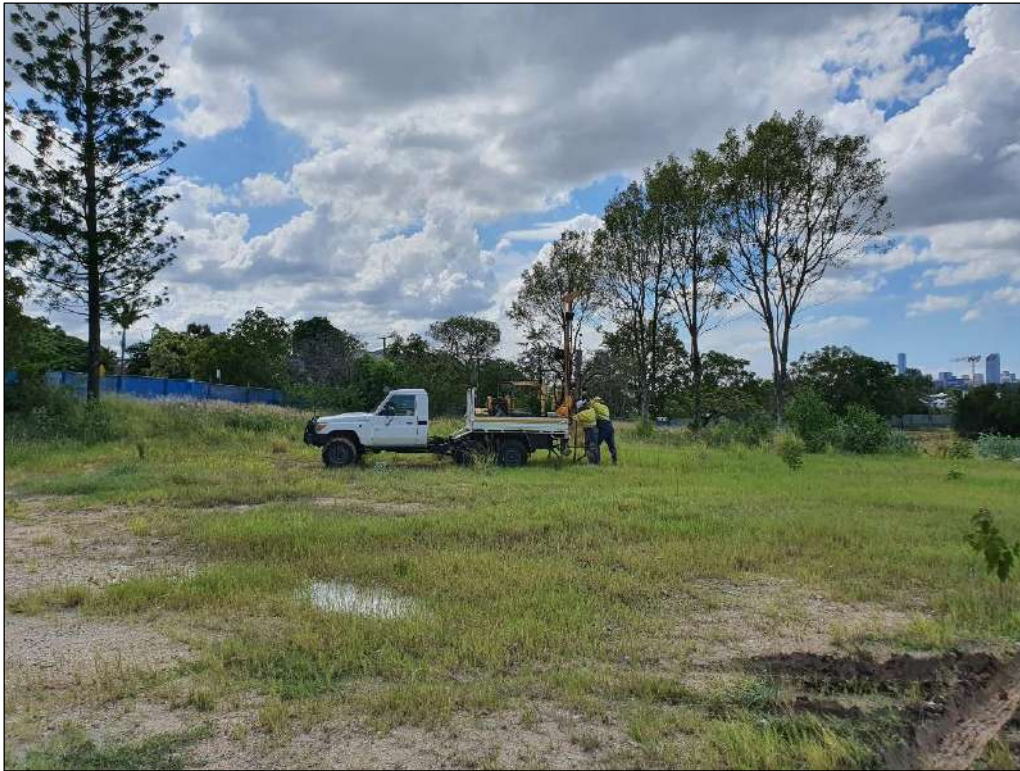
**Figure 2: Looking north-west towards the rig set up on Bore 2.**

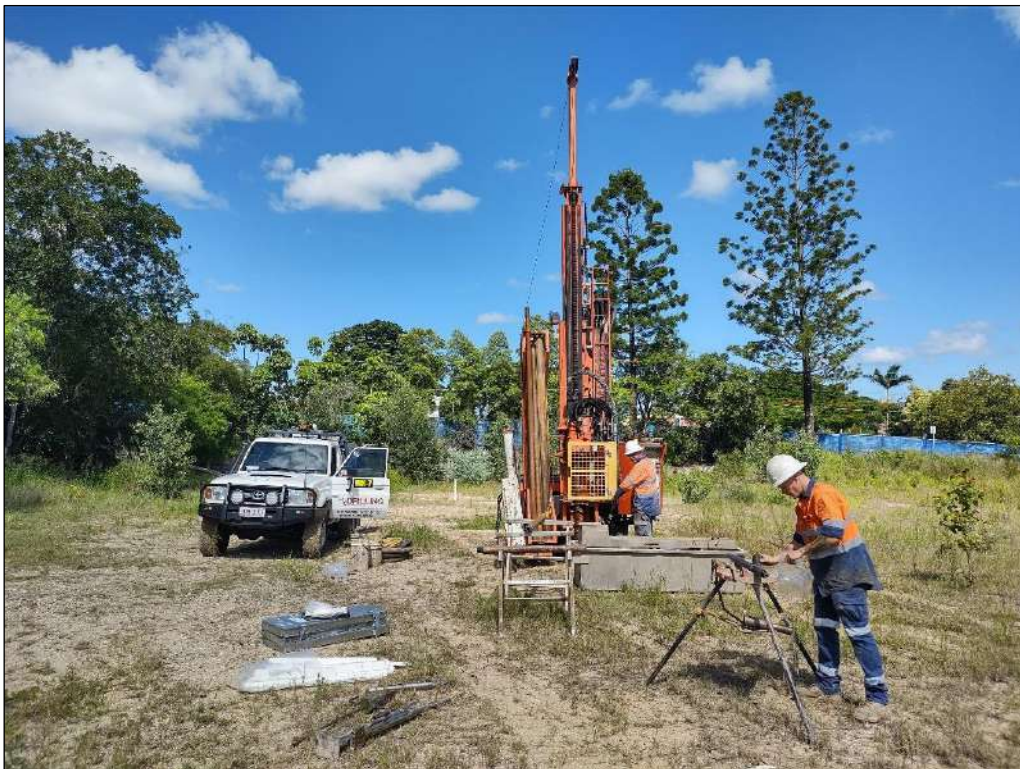
**Figure 3: Looking west towards the rig set up on Bore 24.**

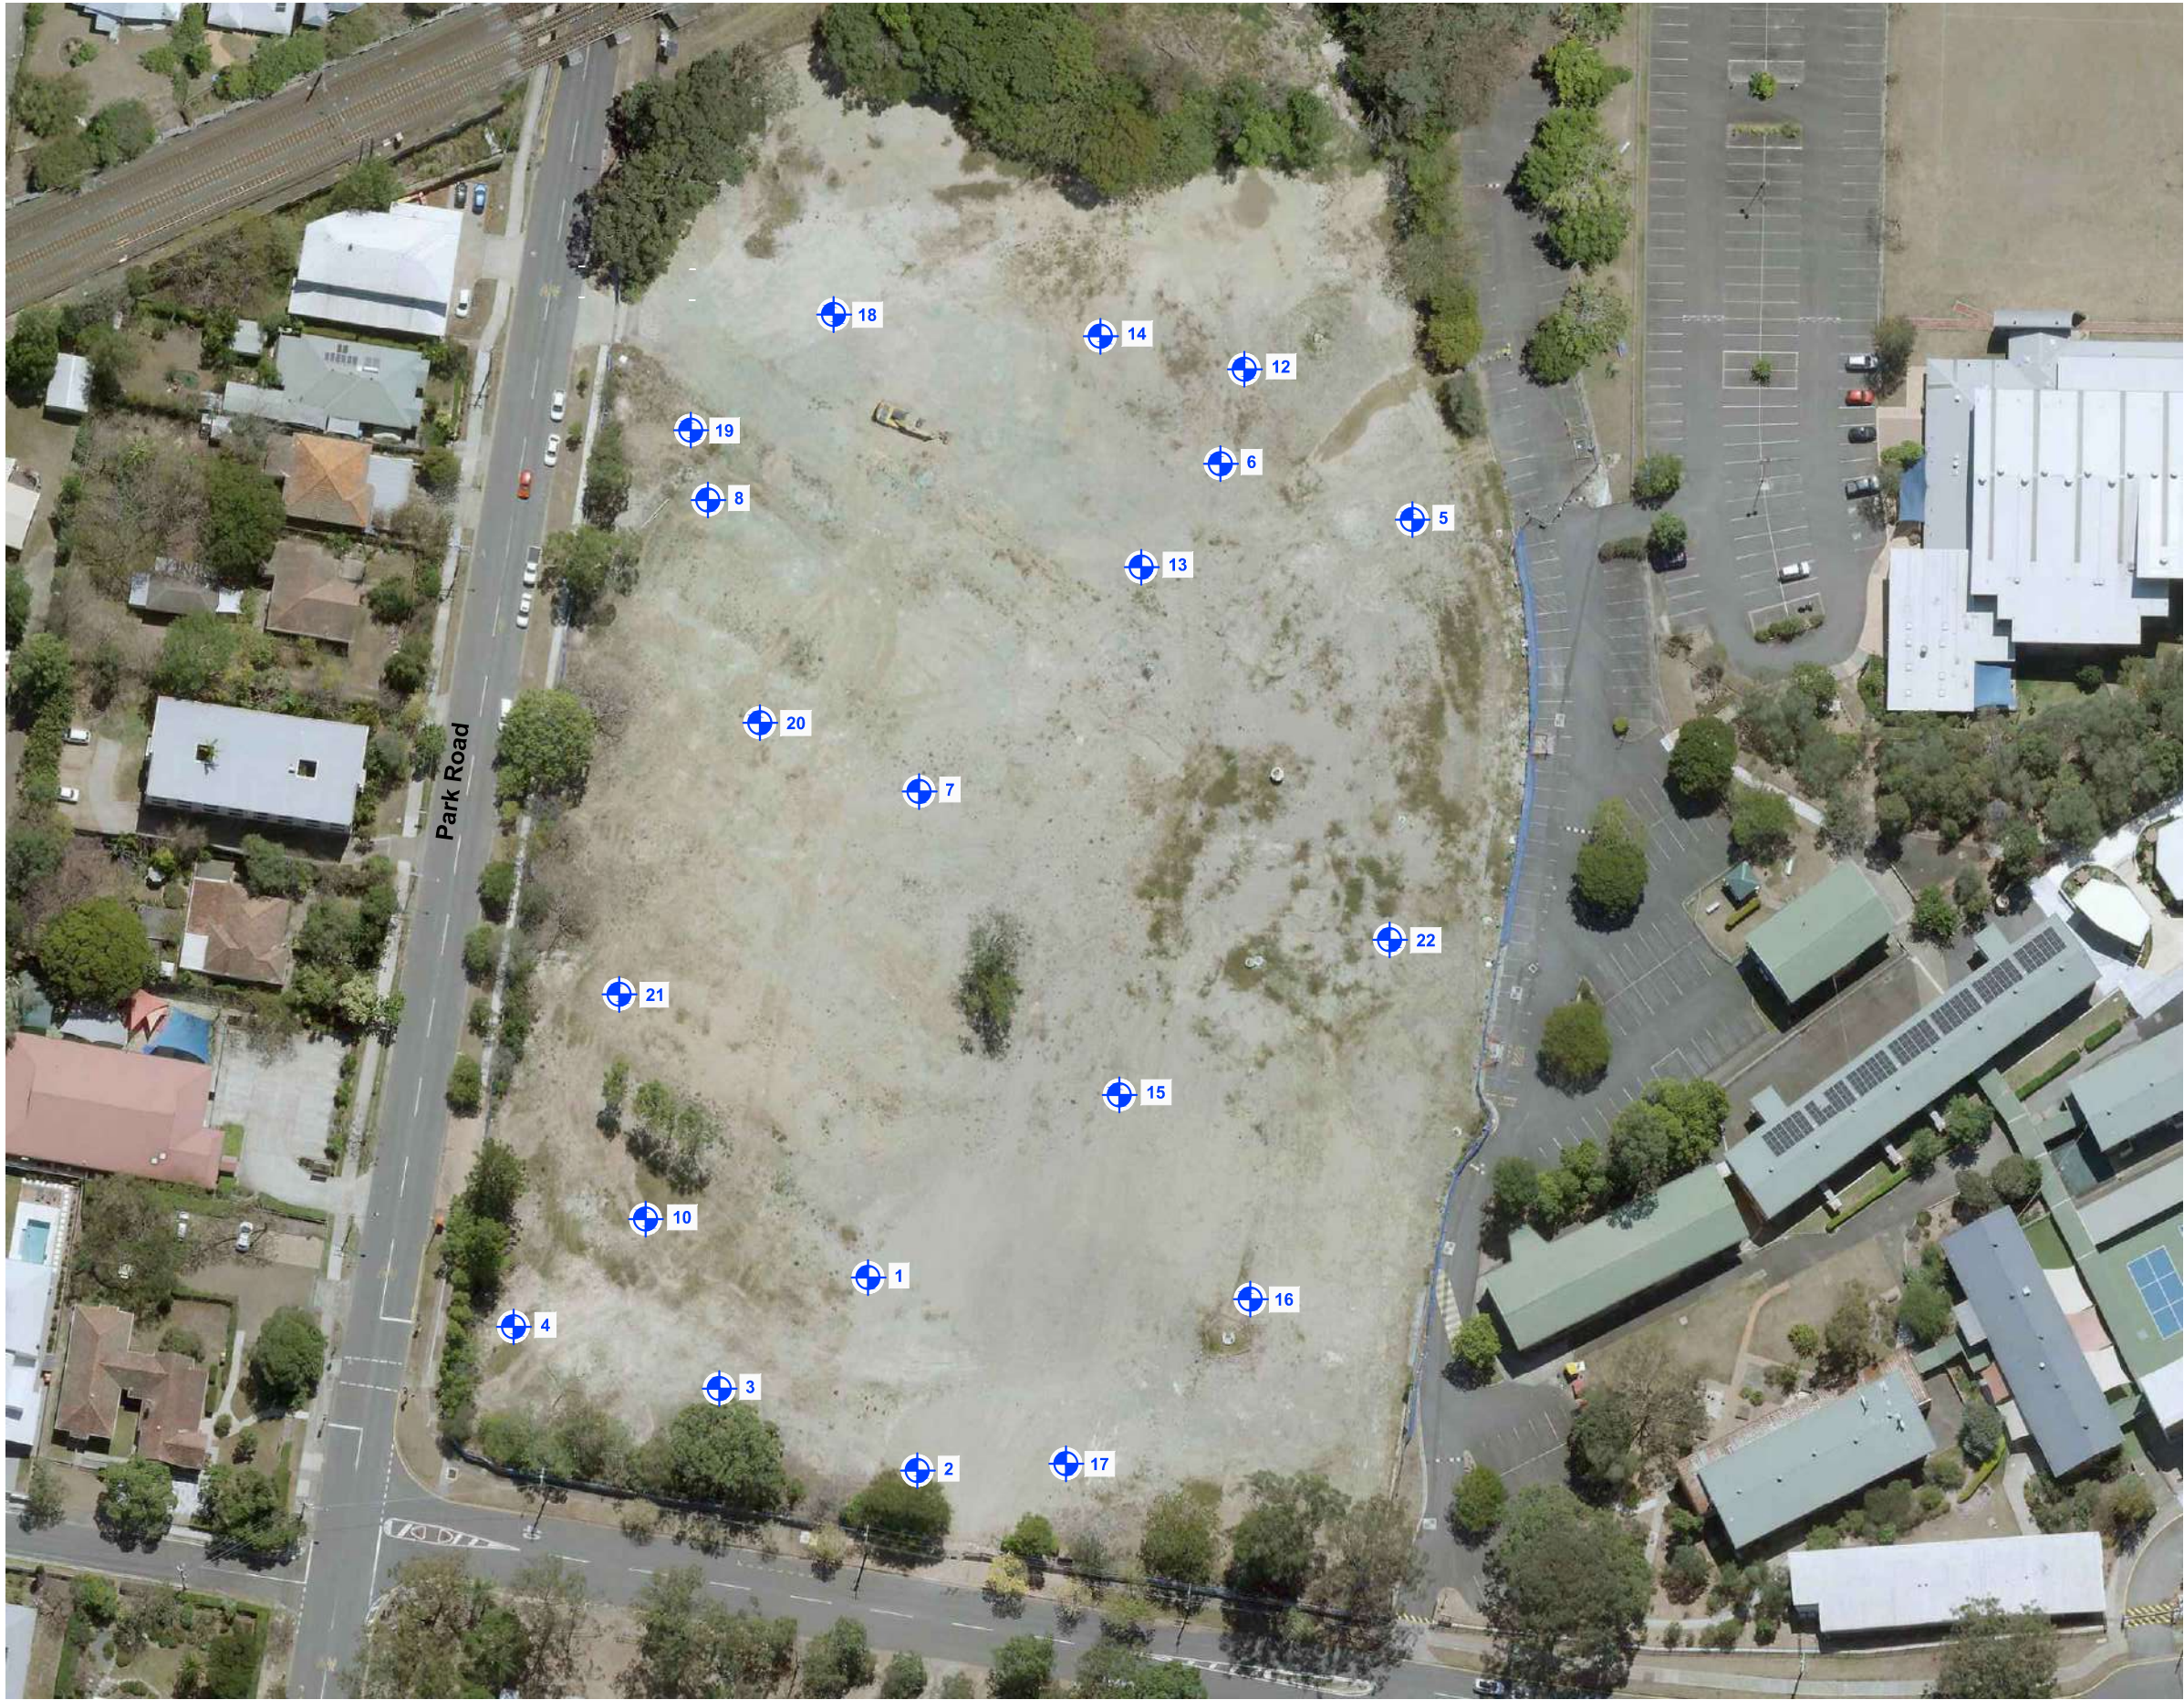
Drawing 1 - Site and Test Location Plan

1. Test locations are approximate only and are shown with reference to existing site features.
2. Image obtained from Metromap. Date of imagery 27-09-2020.

The site is located on the eastern side of Park Road, Yeronga (refer to Drawing 1 in Appendix B), and is bounded by Park Road to the west, Villa Street to the south, the Ferny Grove and Beenleigh railway lines to the north and Yeronga State High School to the east. At the time of the investigation, the site was vacant with all previous buildings/developments having been demolished.

The test locations were set out by a geotechnical engineer and the UTM coordinates and ground surface levels at the test locations were recorded using a differential GPS accurate to approximately up to 5 m and are presented on Drawing 1 in Appendix B. Bores 1 to 6 were completed by an experienced engineer who logged the bores, collected samples for laboratory testing. The remaining bores were then completed by a geotechnician who prepared field logs of the subsurface conditions, collected samples for visual and tactile assessment, and laboratory testing. Upon receipt of the samples at DP's laboratory, the samples and field logs were checked by a geotechnical engineer.
