Project No.: 018-150C

26 August 2021

**RE: BROADSCALE CONTAMINATION ASSESSMENT  
NORTHSHORE HAMILTON – WATERFRONT PRECINCT  
MACARTHUR AVENUE, HAMILTON**

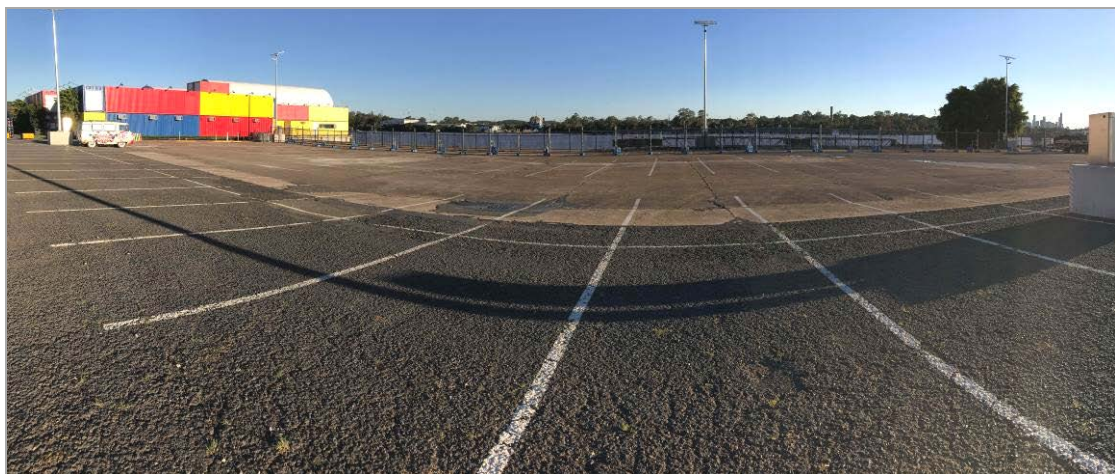
Photograph 1: Panoramic view of part of the site looking south towards Blockyard Spaces with Eat Street Northshore visible in the top left of the photograph

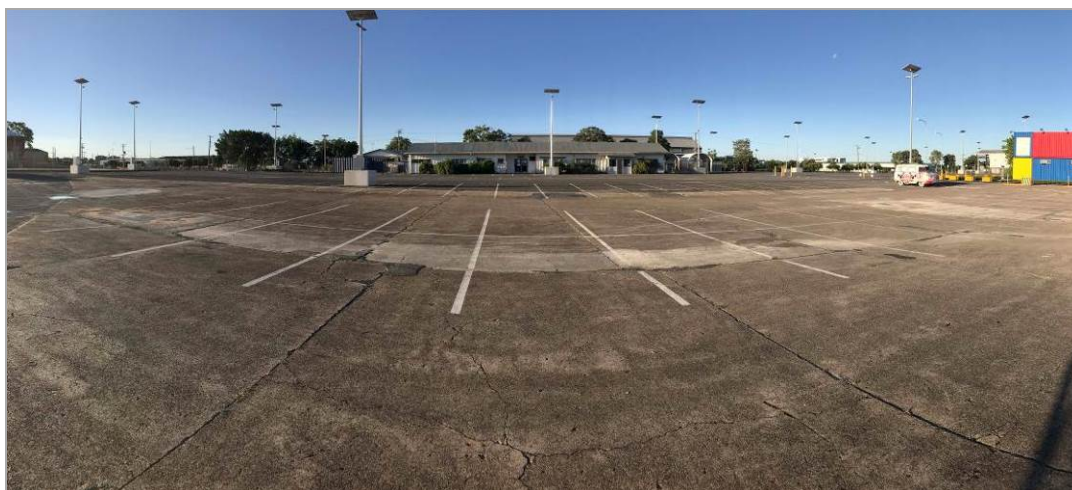
*Photograph 2: Panoramic view of part of the site looking north from near Blockyard Spaces towards Blockyard Workshops with Eat Street Northshore visible in the right hand side of the photograph*

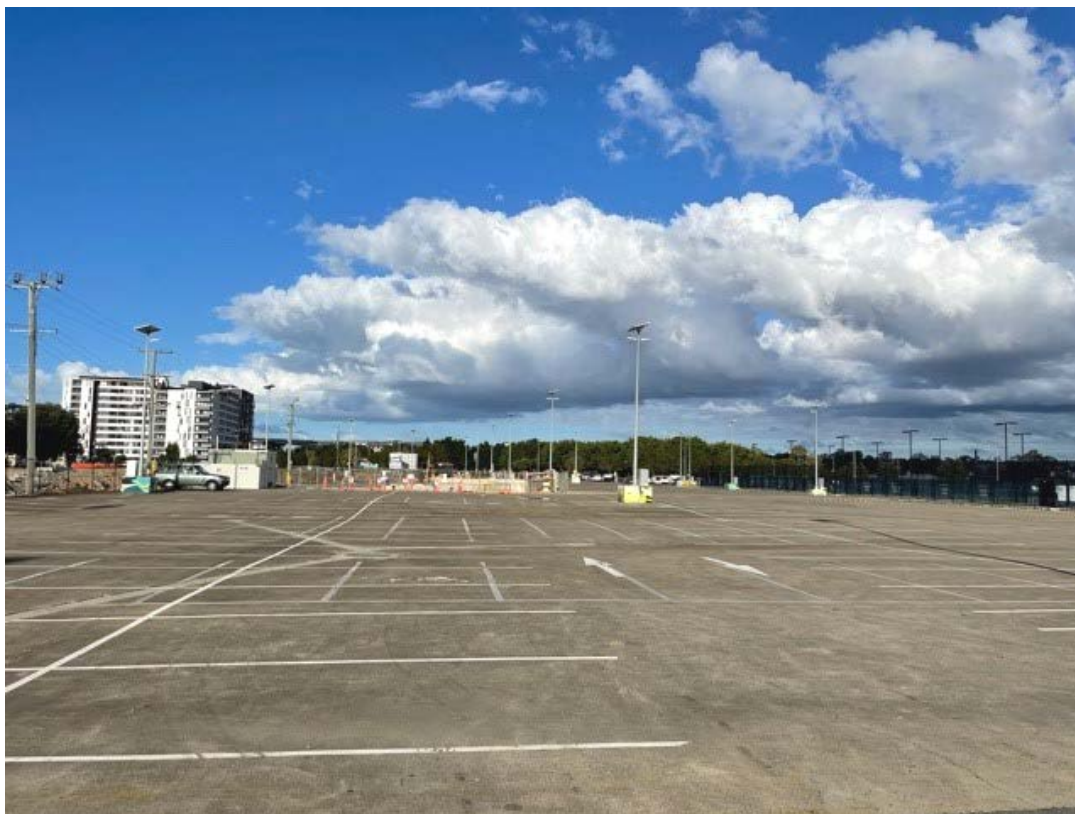
*Photograph 3: Looking east across the eastern car park area from The Shed*

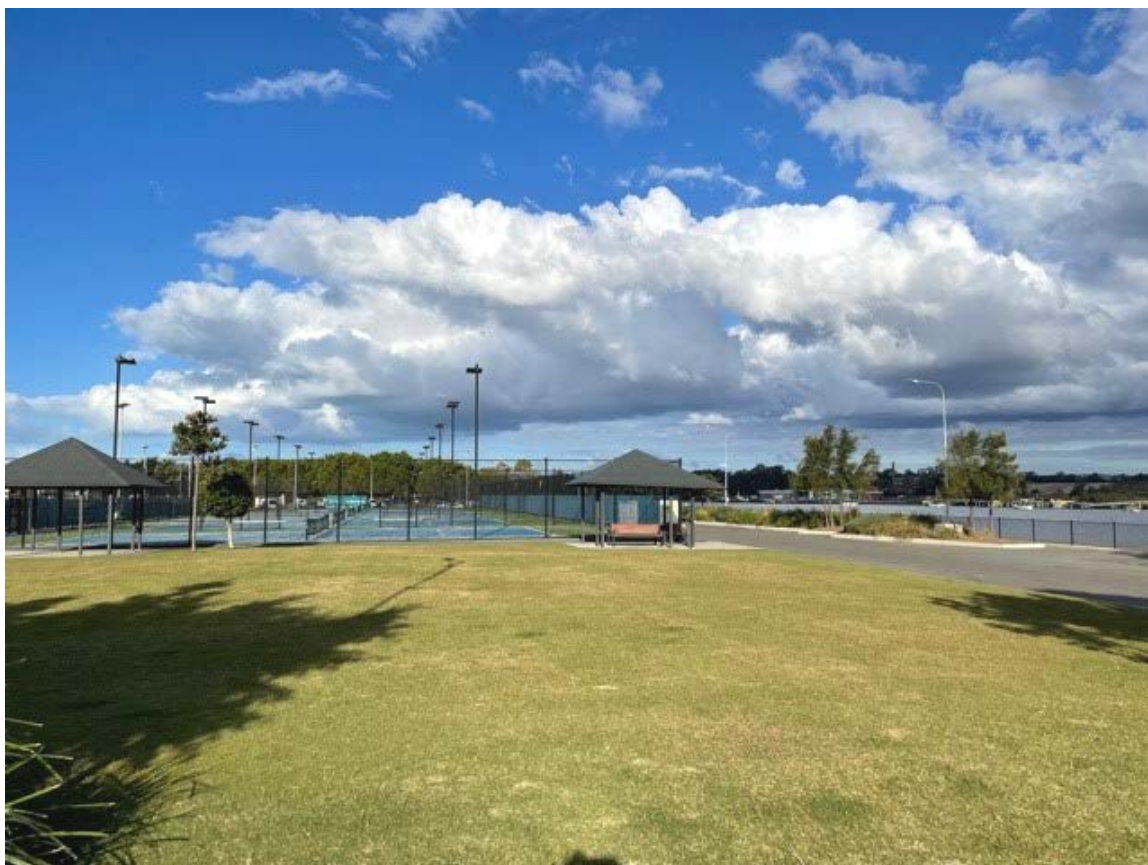
*Photograph 4: View east across the tennis courts from the landscaped area*

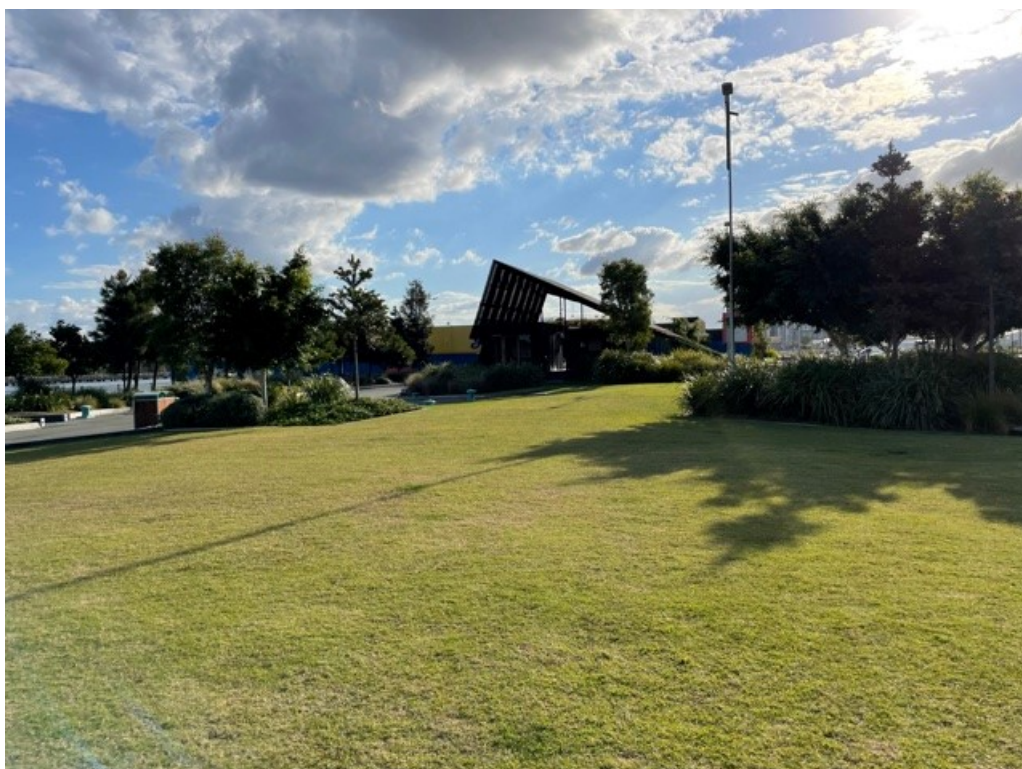
*Photograph 5: The Deck with landscaped area*

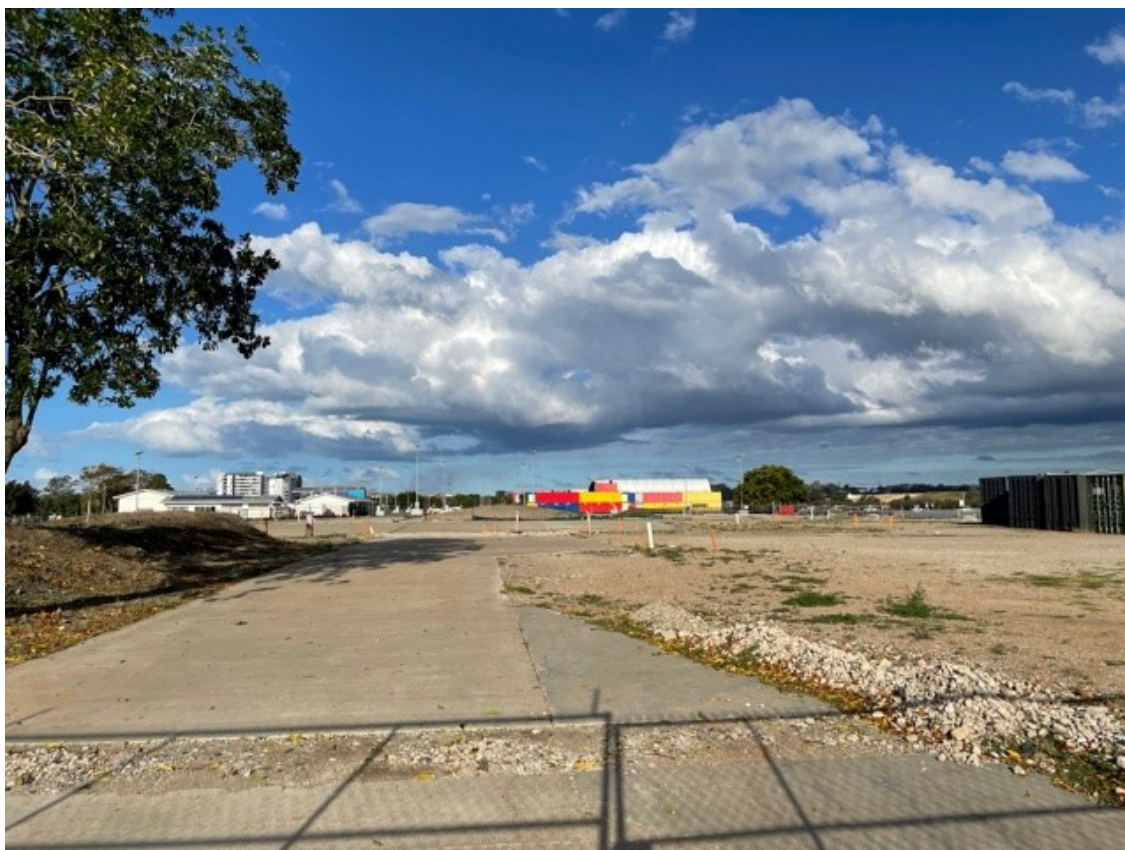
*Photograph 6: Looking east across the Maritime Pop Up Park*

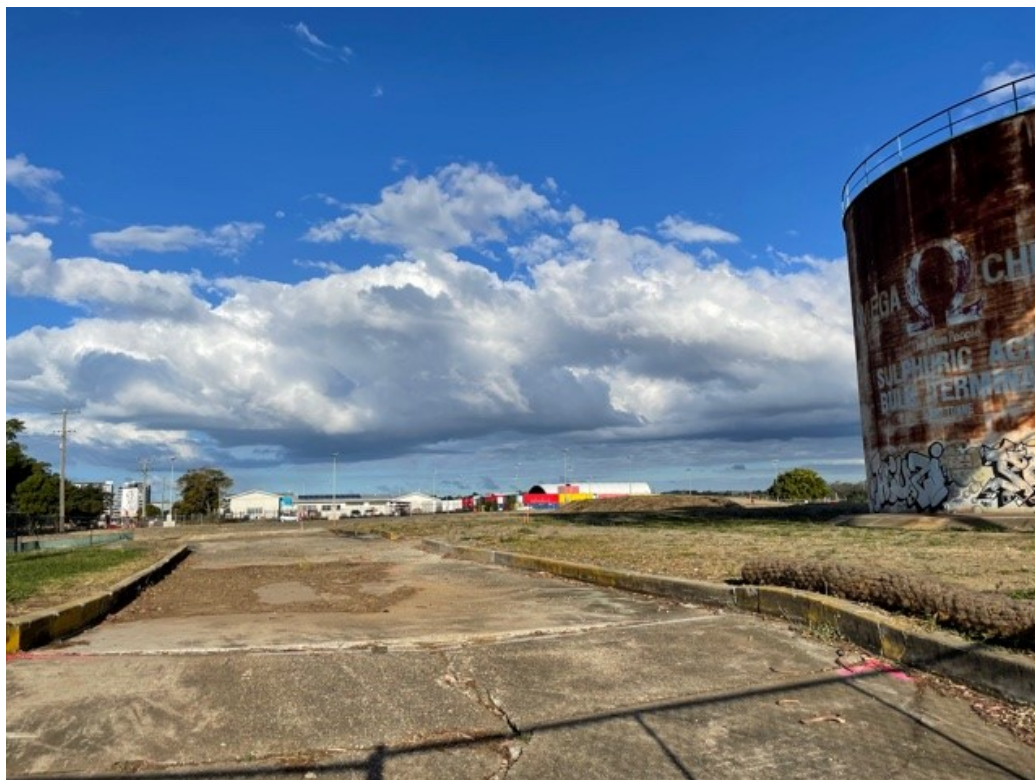
*Photograph 7: Looking east across the tank site to the future Flipside Circus site*

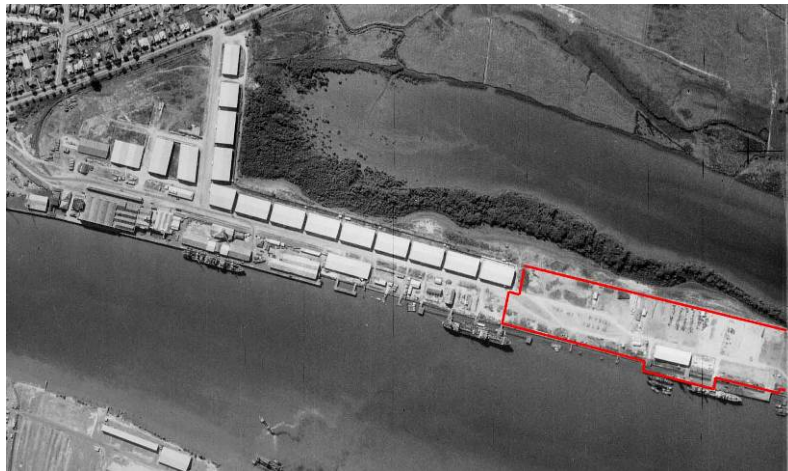
1946: In general the site appears largely vacant. Roads or paths are observed to pass through the site. There are wharves present along the southern boundary of the site and some equipment storage and small sheds appear scattered across the site area. A single large warehouse is visible in the central portion adjacent to the southern boundary. Warehouses can be seen west of the site, likely used to store goods unloaded from ships. An estuary is observed north of the site. An extract of the 1946 aerial photograph is presented as Photograph 8, with the approximate site boundary marked in red.

*Photograph 8: Extract from the 1946 aerial photograph (Source: BCC, Image Date: 1946)*

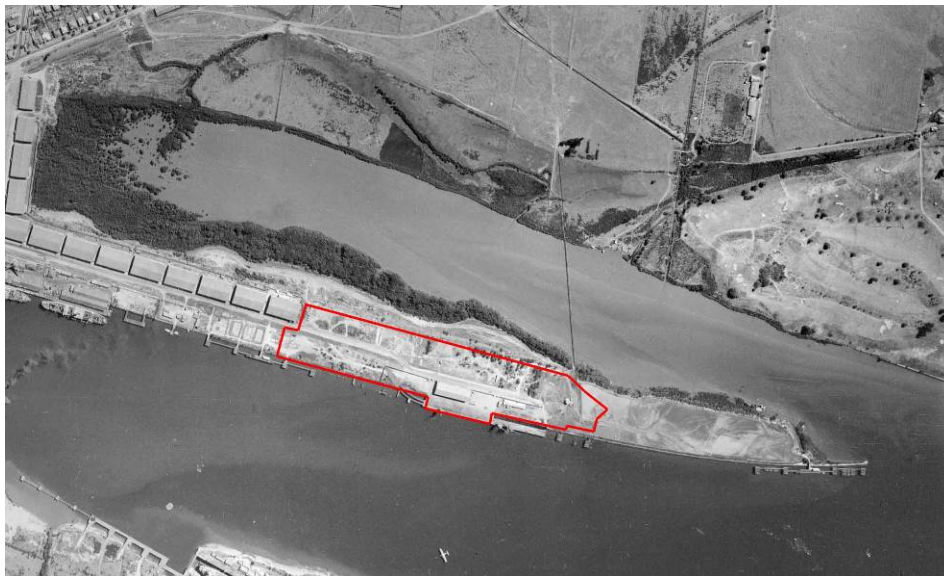
1951: The site and surrounding area appears to be similar to the 1946 aerial photograph. A rail track appears to have been constructed through the site connecting the wharf area to the south-east with the land. An extract of the 1951 aerial photograph is presented as Photograph 9.

*Photograph 9: Extract from the 1951 aerial photograph*

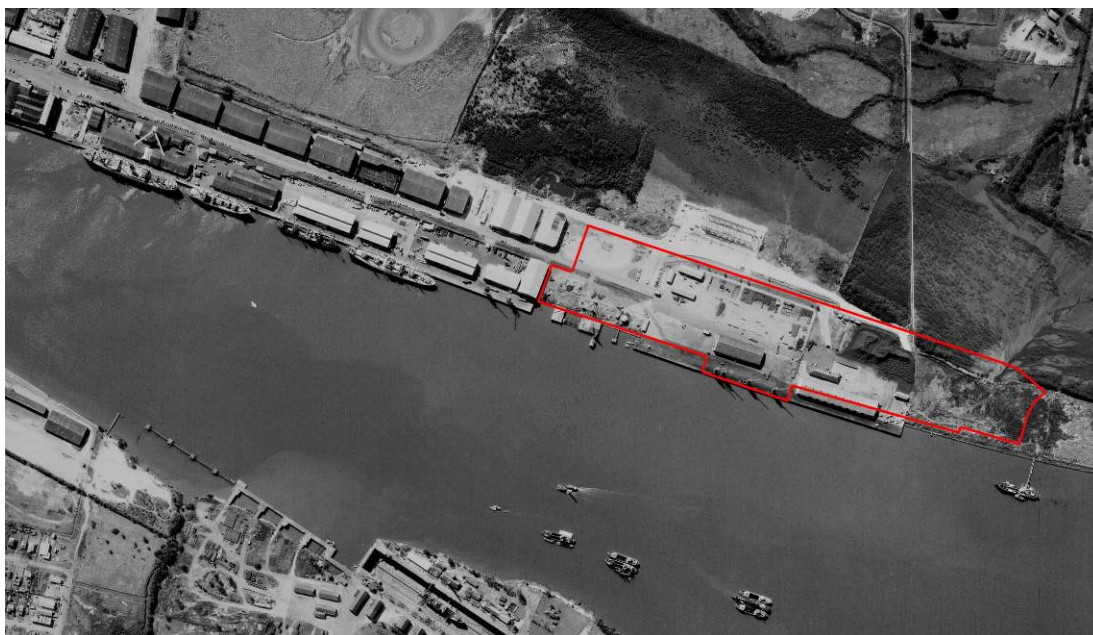
1964: The site appears to be largely paved with hardstand except for the eastern end. The wharf structure adjacent to the southern site boundary is more substantial than in the 1951 photograph, but the rail track leading from the wharf is still visible. North of the site, the estuary observed in the 1946 aerial photograph has been filled. Additional warehouses can be observed west of the site. Overall, the site and surrounding area appear to be more heavily utilised than in the 1951 photograph. An extract of the 1964 aerial photograph is presented as Photograph 10.

*Photograph 10: Extract from the 1964 aerial photograph*

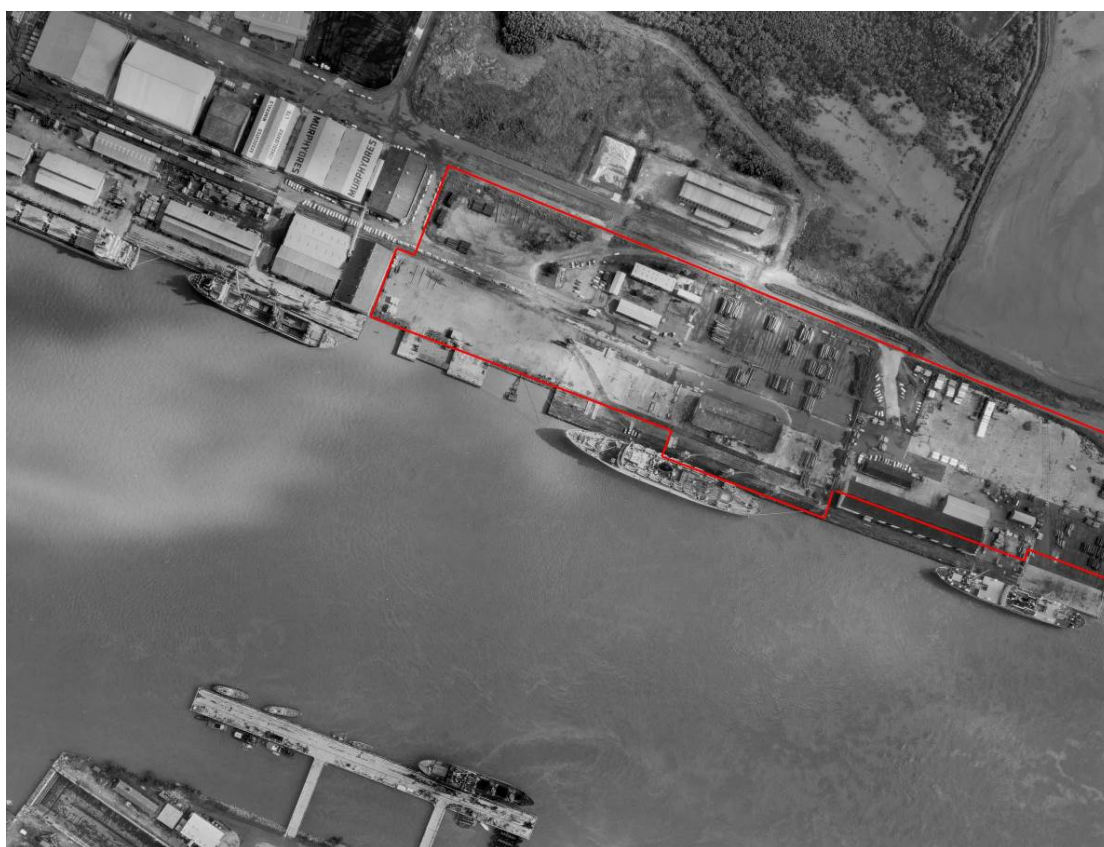
1974: The site and surrounding area appear similar to the 1964 aerial photograph with some additional structures and storage observable. An extract of the 1974 aerial photograph is presented in Photograph 11.

*Photograph 11: Extract from the 1974 aerial photograph*

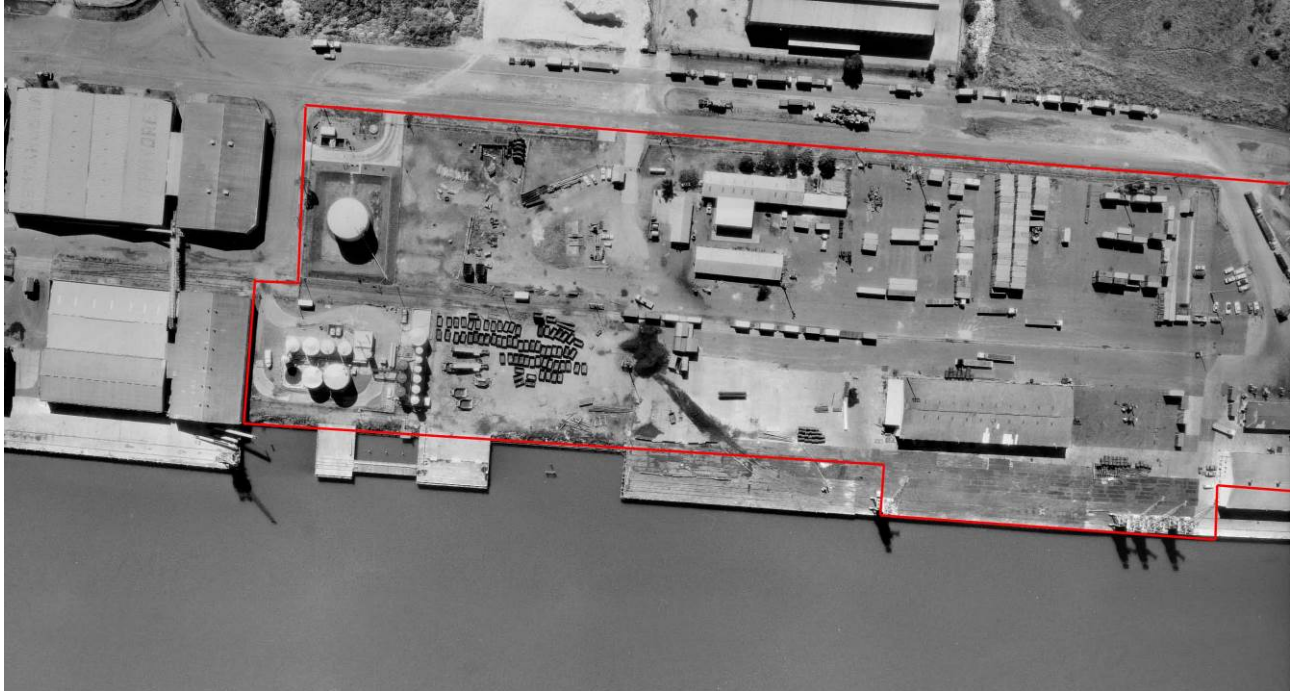
1985: The surrounding area appears similar to the 1978 aerial photograph. Multiple storage tanks have been erected in the western portion of the site and new structures can be observed across the entire site area. An extract of the 1985 aerial photograph is presented in Photograph 12.

*Photograph 12: Extract from the 1985 aerial photograph*

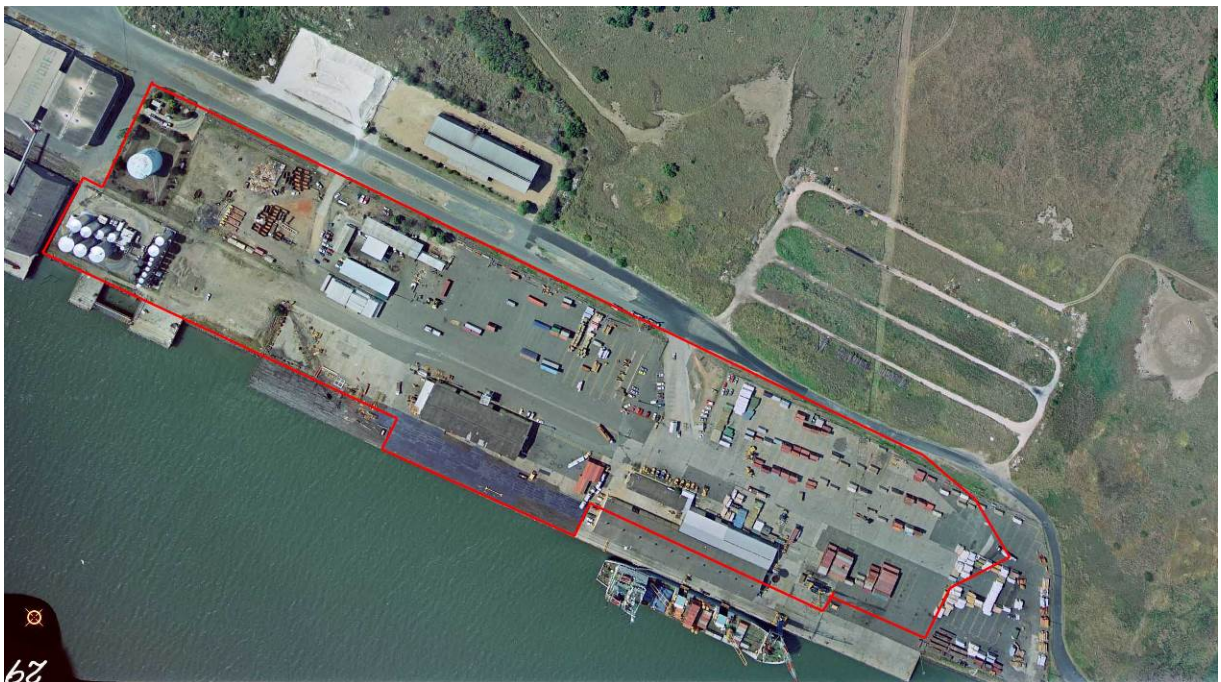
1991: The site and the surrounding area appear generally similar to the 1985 aerial photograph. An extract of the 1991 aerial photograph is presented in Photograph 13.

*Photograph 13: Extract from the 1991 aerial photograph*

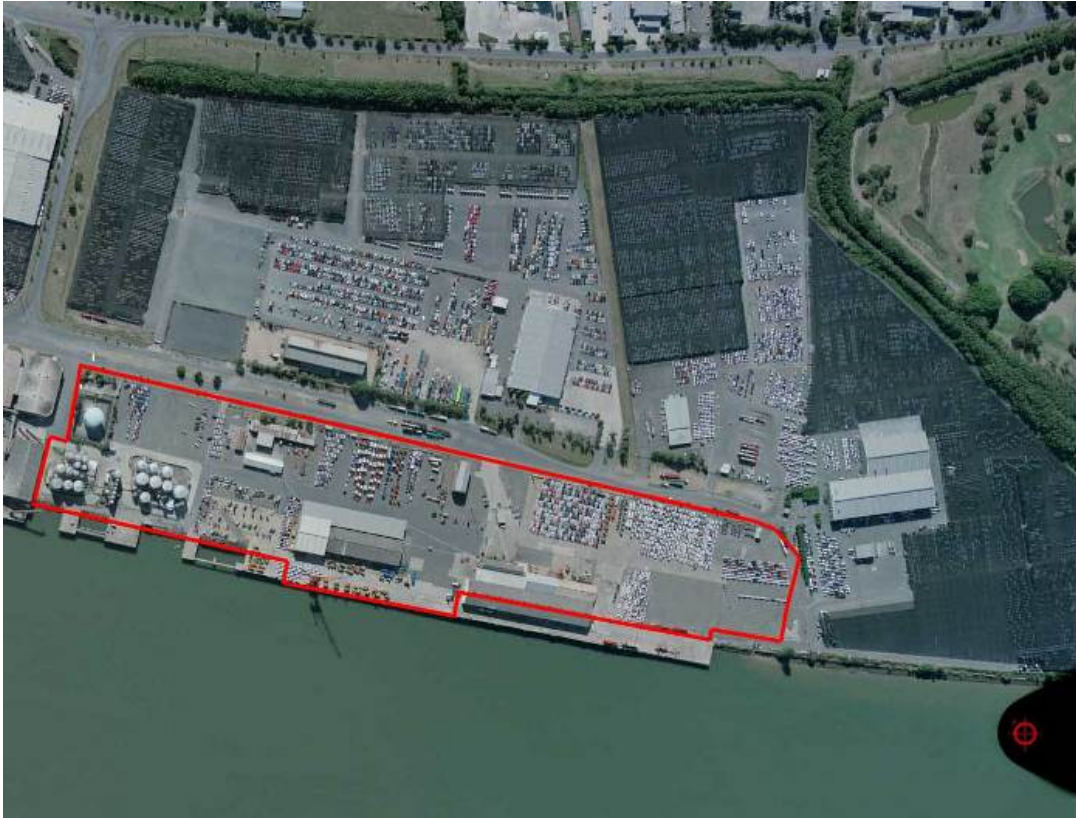
2004: The site appears generally similar to the 1991 aerial photograph although more heavily utilised and additional tanks are present in the western portion of the site. The surrounding land to the north and east is being utilised for car storage. An extract of the 2004 aerial photograph is presented in Photograph 14.

*Photograph 14: Extract from the 2004 aerial photograph.*
