PLANS AND DOCUMENTS
referred to in the PDA
DEVELOPMENT APPROVAL

Approval no: DEV2022/1329

RE: FAUNA FLORA MANAGEMENT PLAN FOR STAGE V (INCLUDING PHASE 2 SWALE DRAIN) AND PHASE 1 SWALE DRAIN OF THE CARSELDINE VILLAGE RENEWAL MASTERPLAN

CARSELDINE VILLAGE STAGE V FUNCTIONAL LAYOUTS

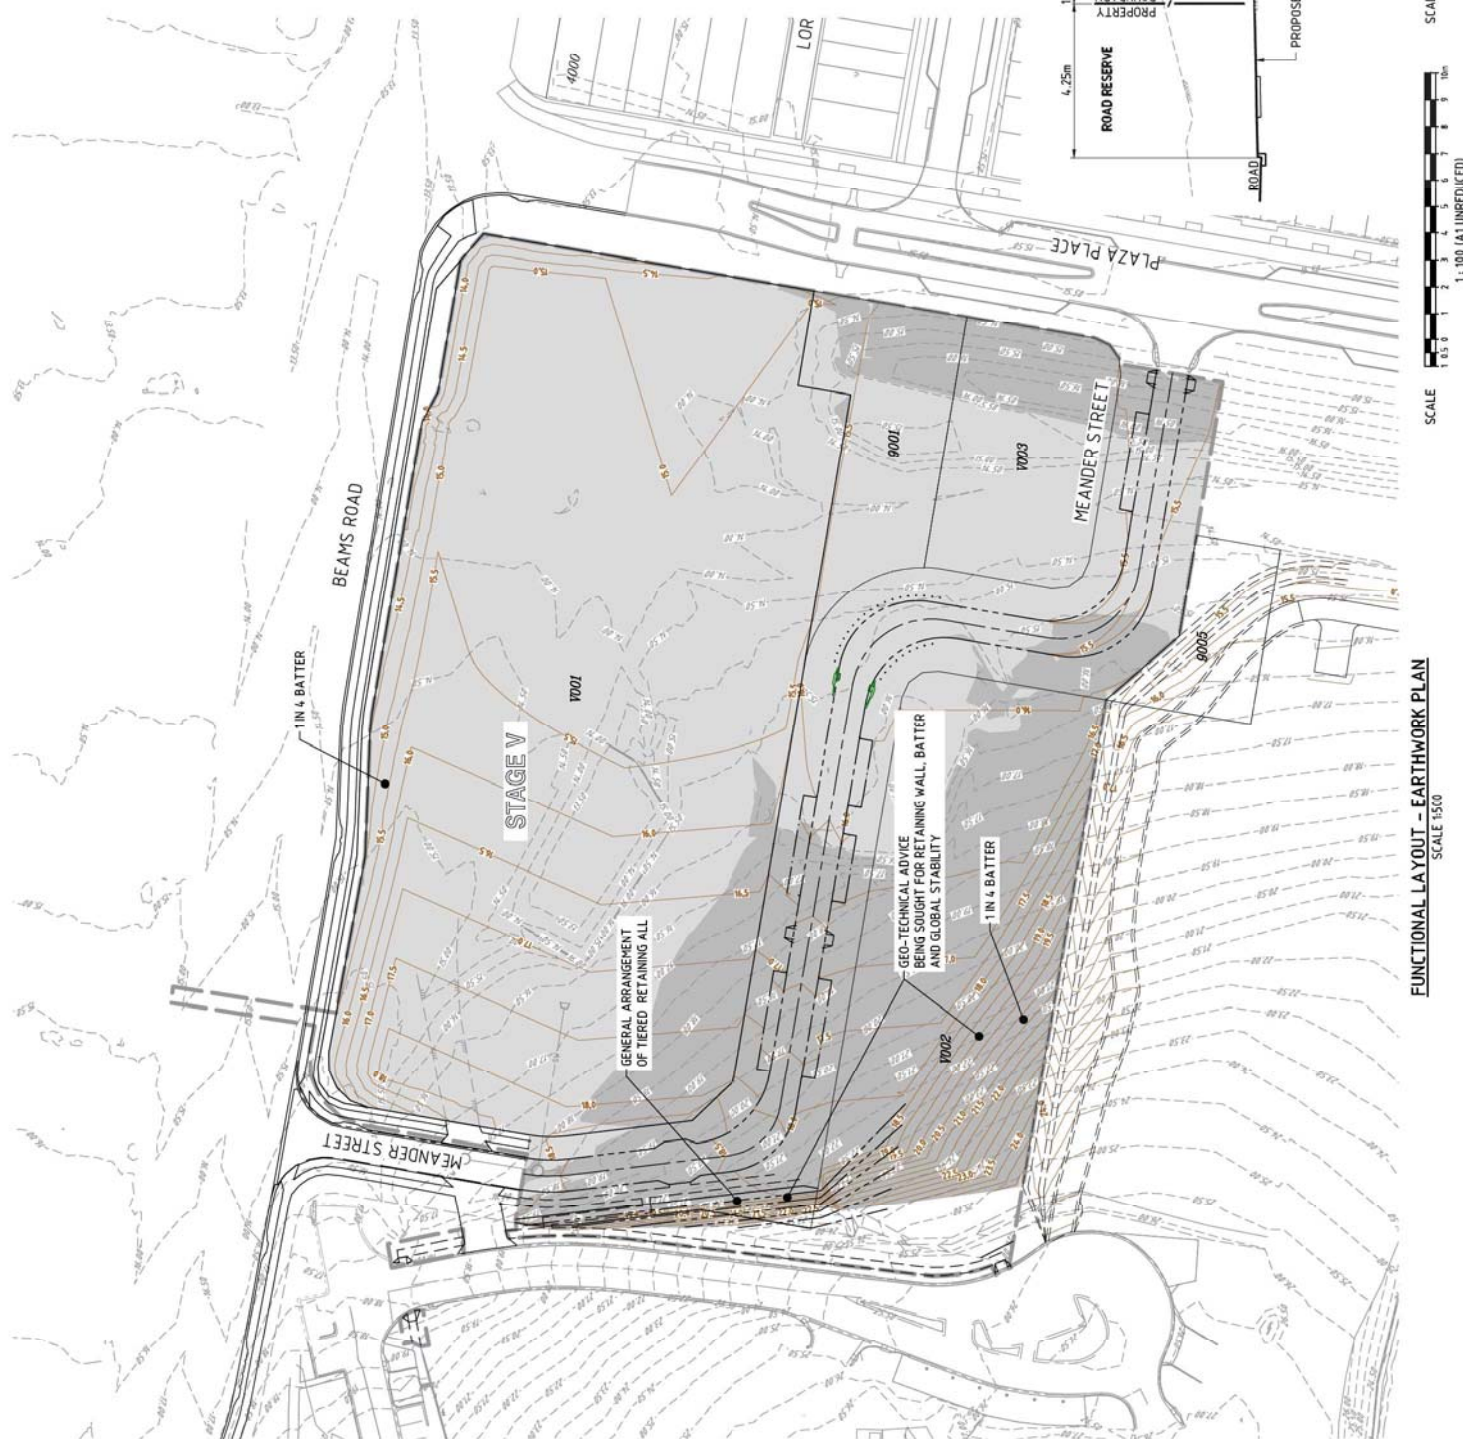
FUNCTIONAL LAYOUT - EARTHWORK PLAN
SCALE 1:500

- WORKS BOUNDARY
- ROAD CENTRELINE
- KERB AND CHANNEL - TYPE E
- KERB ONLY - TYPE E
- INVERT CHANNEL
- FINISHED SURFACE CONTOURS
- EXISTING SURFACE CONTOURS
- BATTER LINE
- EXTENT OF CUT
- EXTENT OF FILL

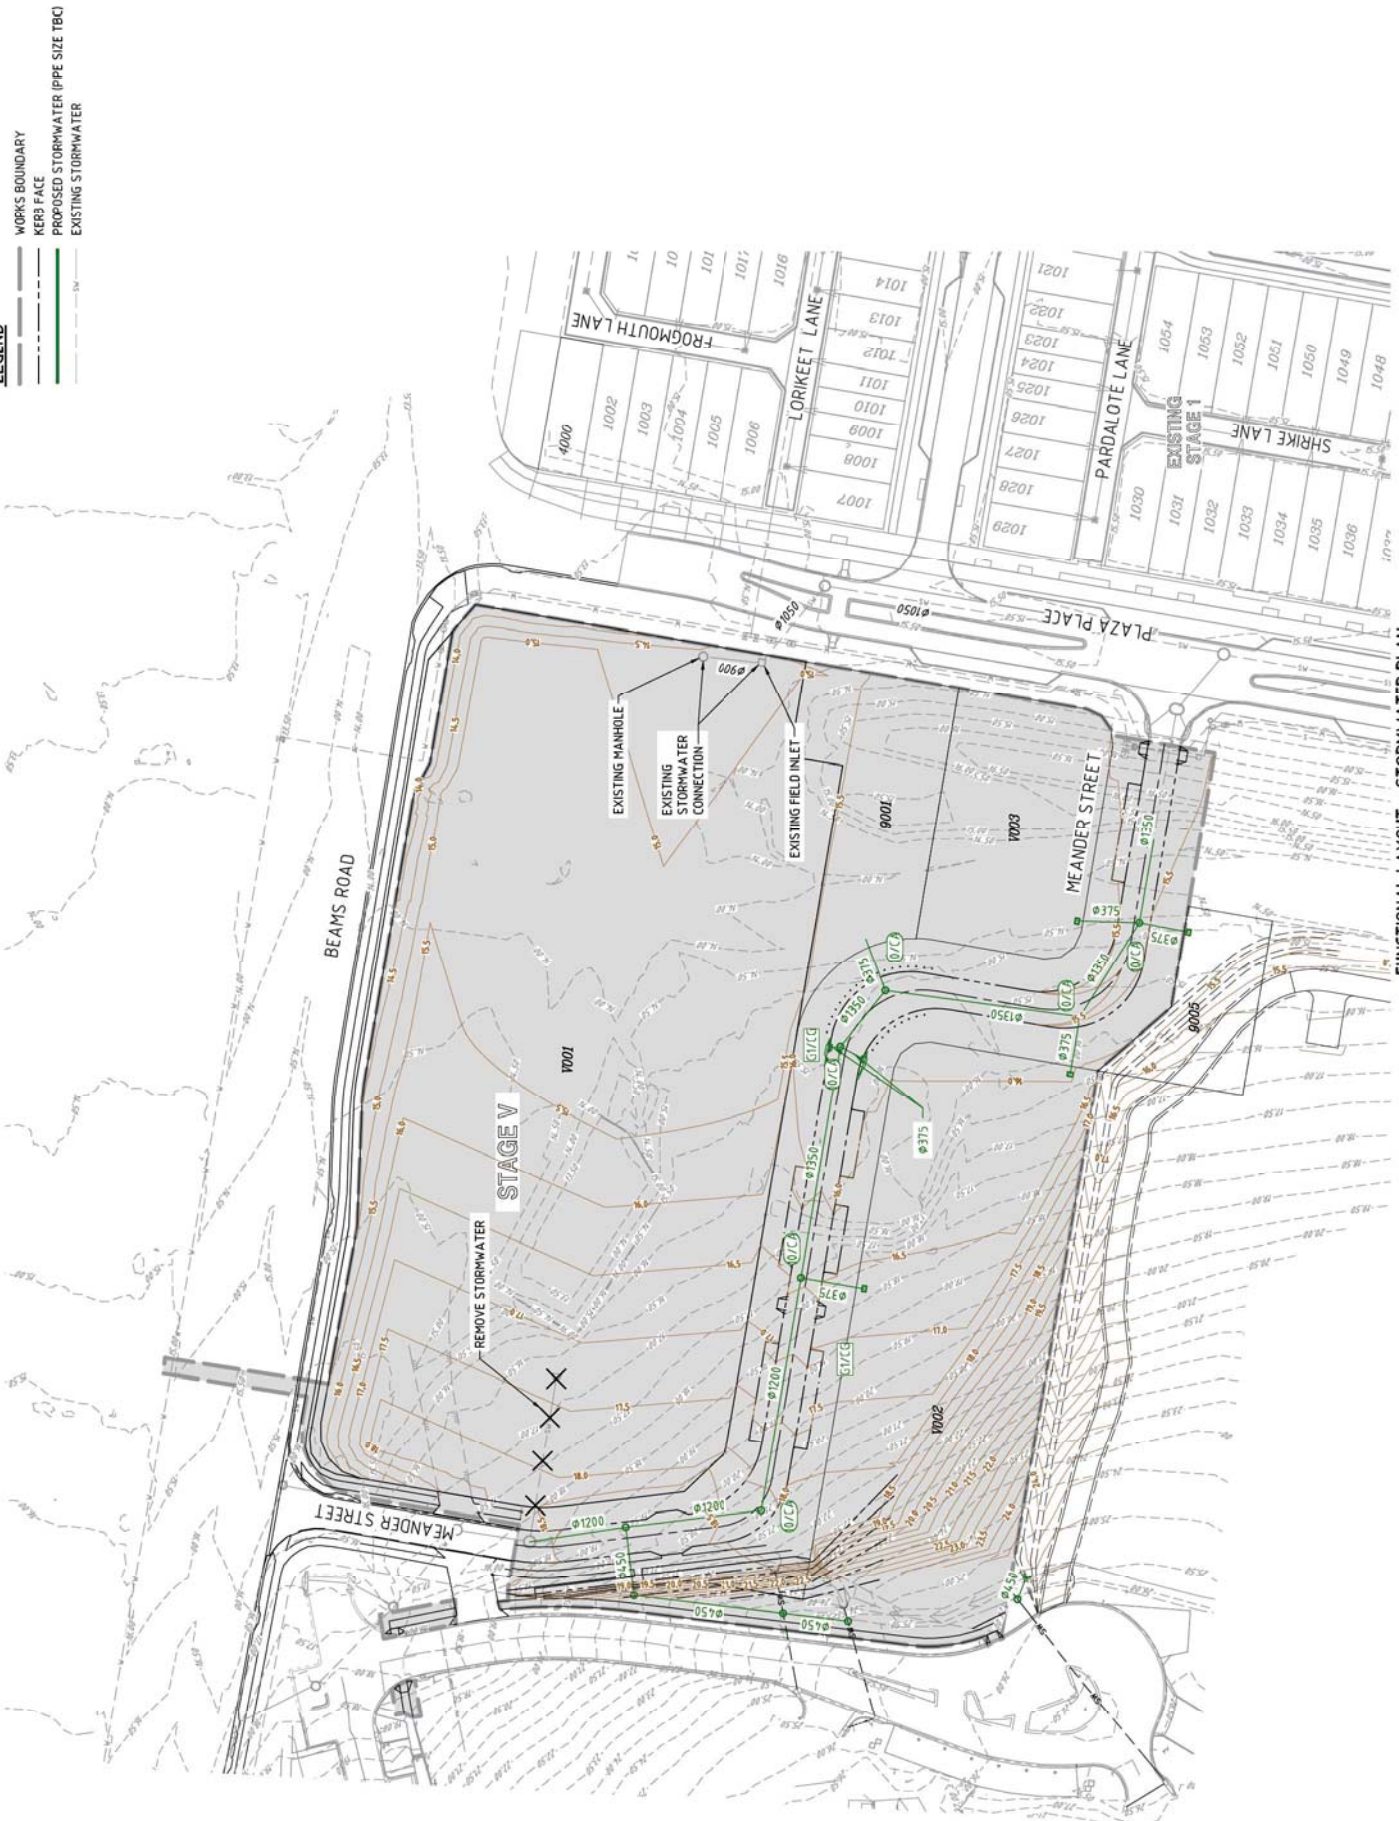
FUNCTIONAL LAYOUT - STORMWATER PLAN
SCALE 1:500

- WORKS BOUNDARY
- KERB FACE
- PROPOSED STORMWATER (PIPE SIZE TBC)
- EXISTING STORMWATER

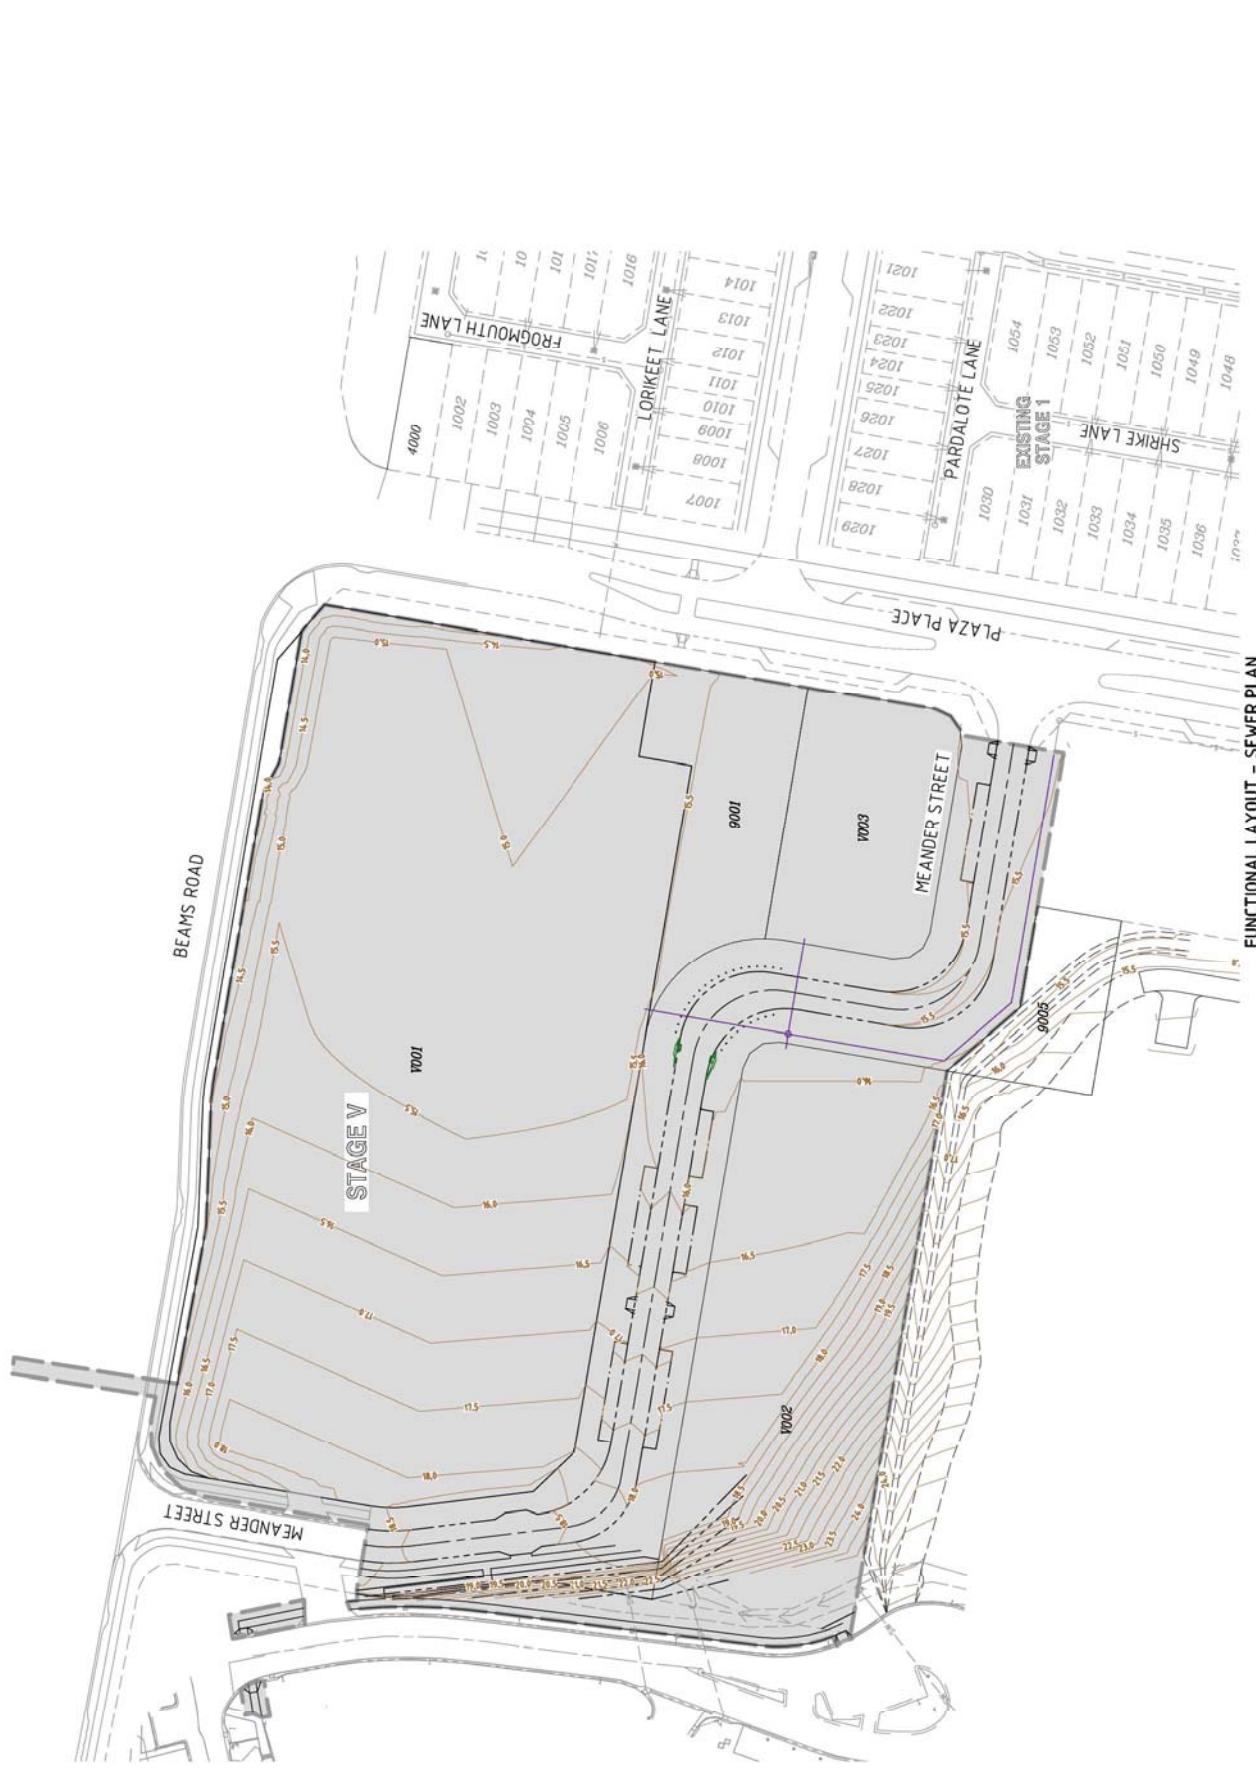
FUNCTIONAL LAYOUT - SEWER PLAN

- LEGEND**
- WORKS BOUNDARY
 - KERB FACE
 - PROPOSED SEWER RETICULATION
 - EXISTING Ø150 SEWER RETICULATION

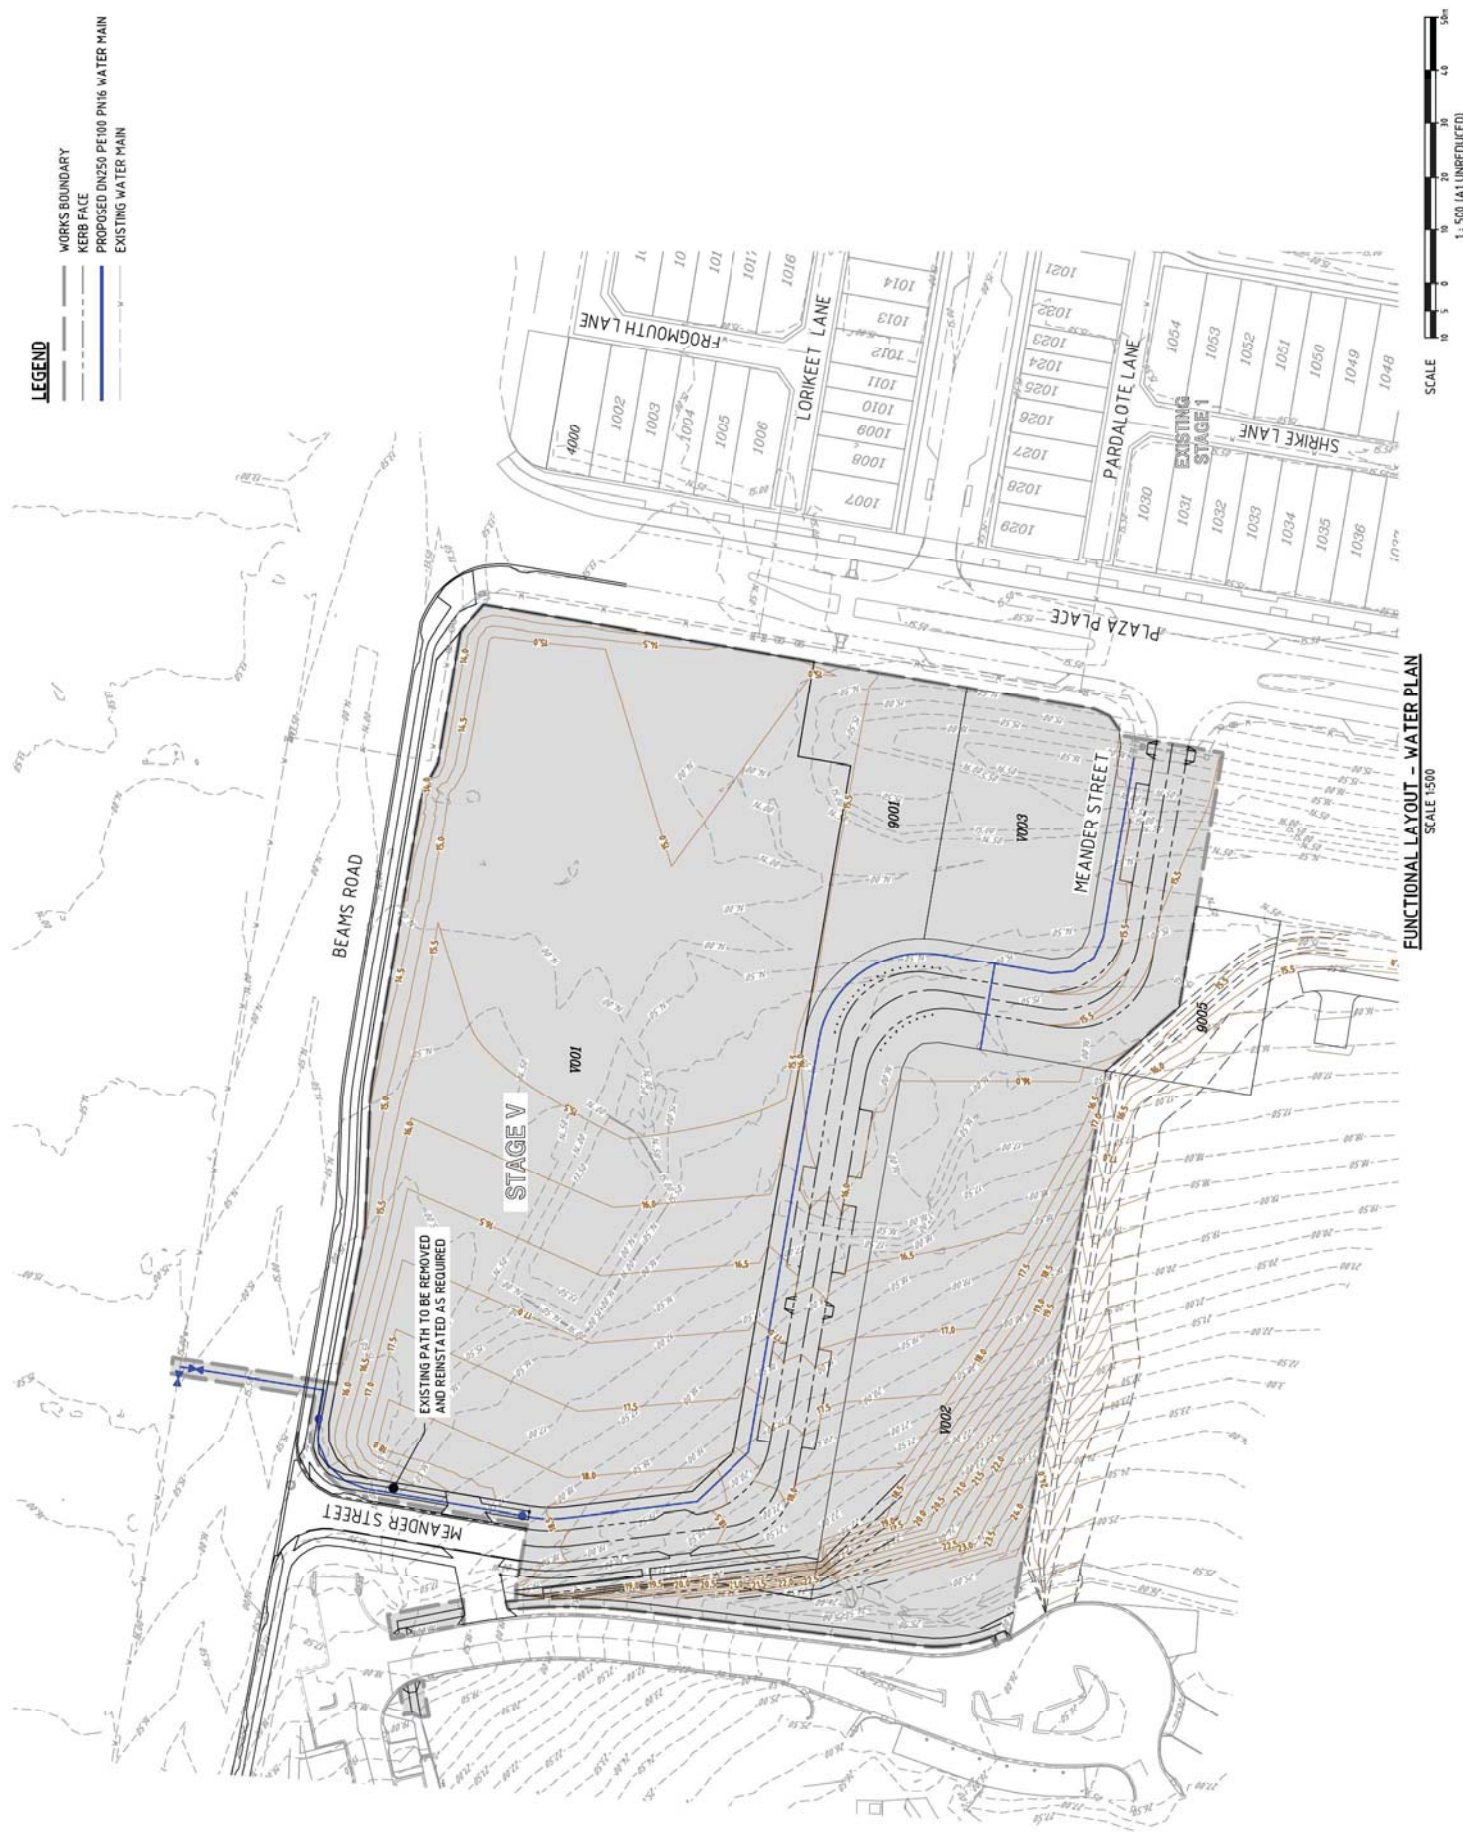
FUNCTIONAL LAYOUT - WATER PLAN
SCALE 1:500

- WORKS BOUNDARY
- KERB FACE
- PROPOSED DN250 PE100 PN16 WATER MAIN
- EXISTING WATER MAIN

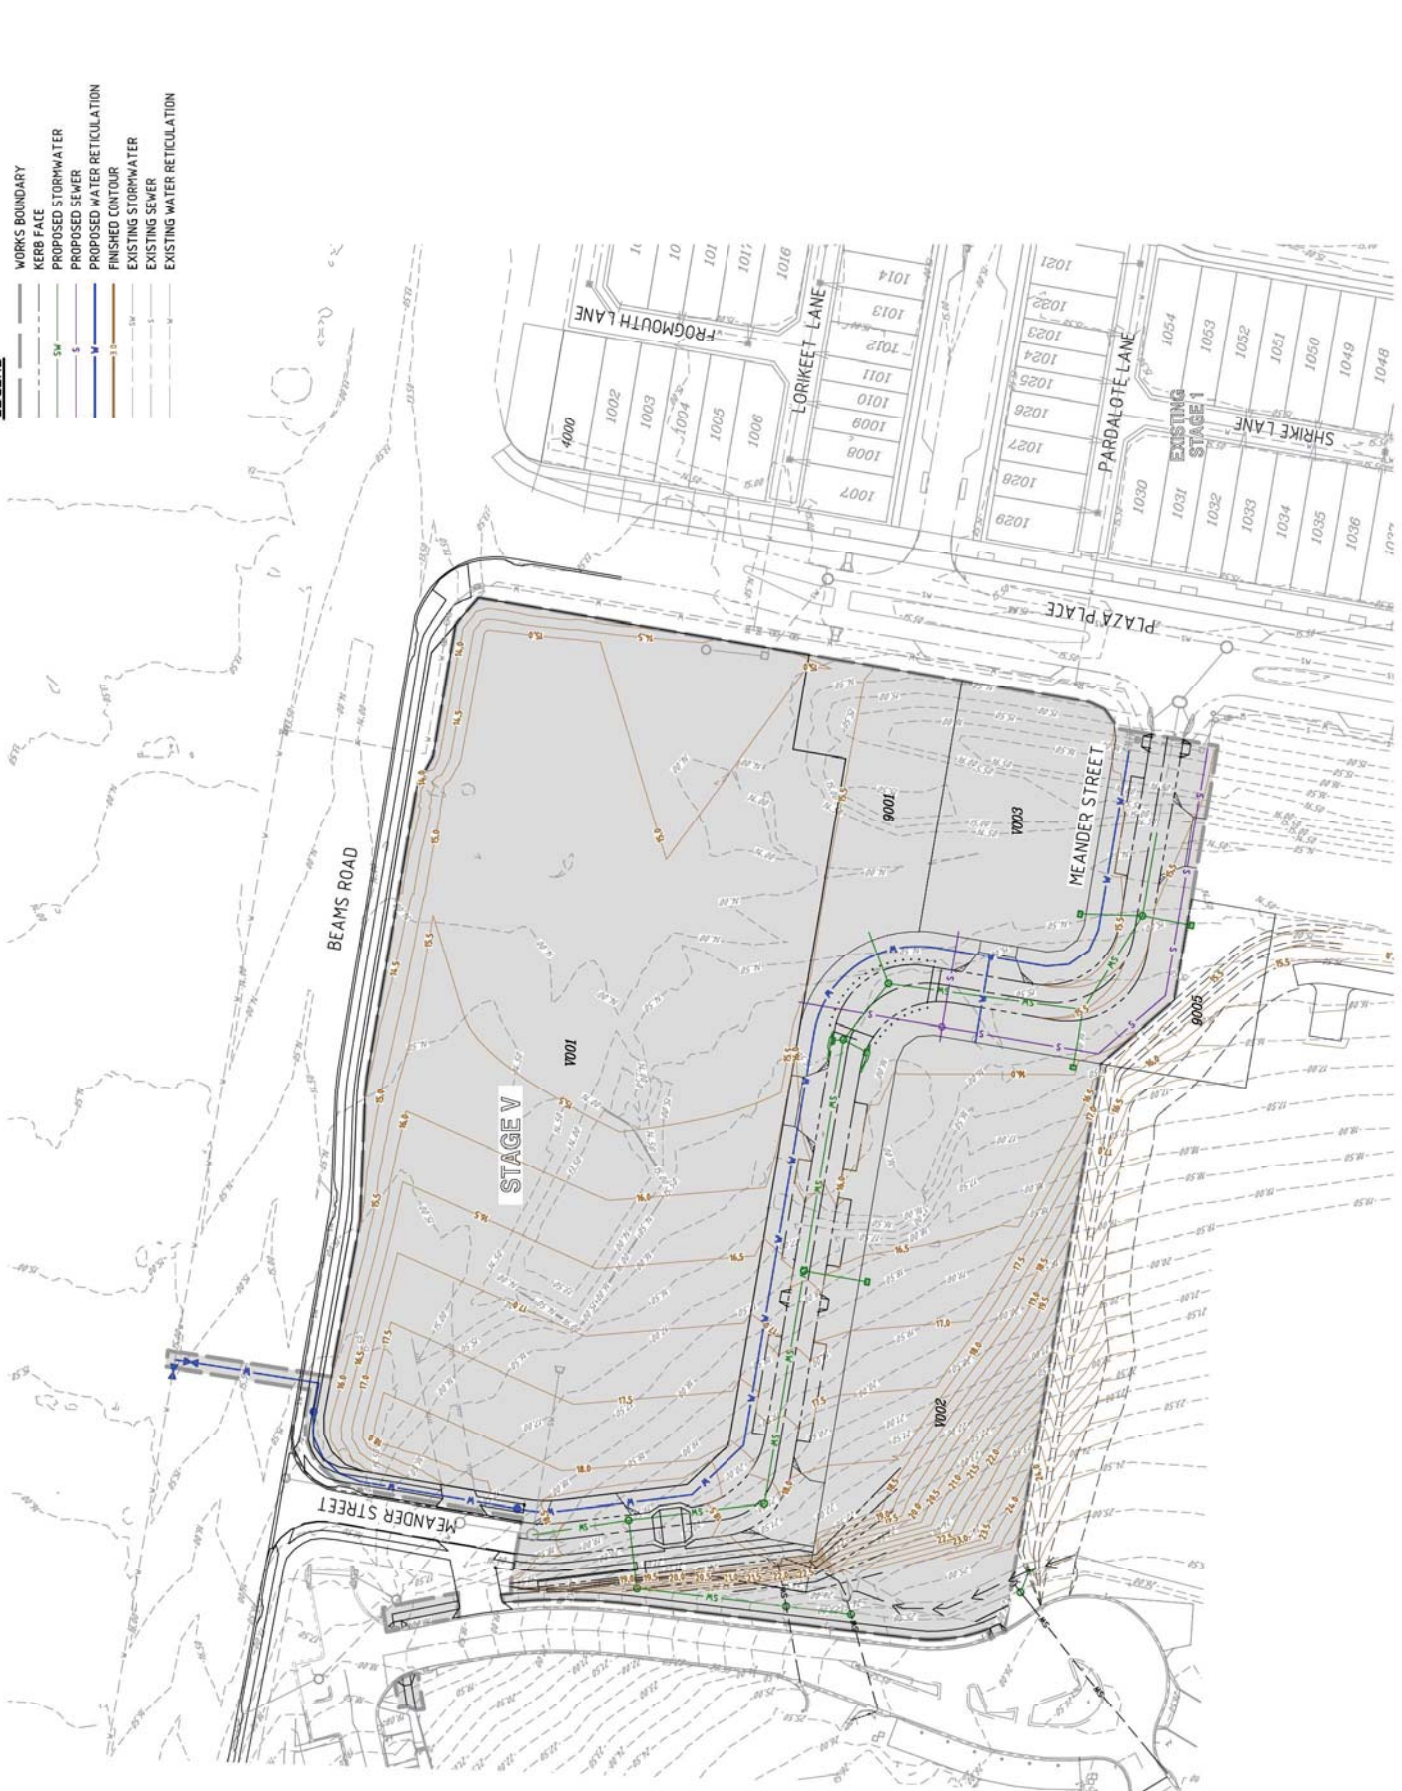
FUNCTIONAL LAYOUT - OVERALL SERVICES PLAN
SCALE 1:500 (A1 UNREDUCED)

- WORKS BOUNDARY
- KERB FACE
- PROPOSED STORMWATER
- PROPOSED SEWER
- PROPOSED WATER RETICULATION
- FINISHED CONTOUR
- EXISTING STORMWATER
- EXISTING SEWER
- EXISTING WATER RETICULATION

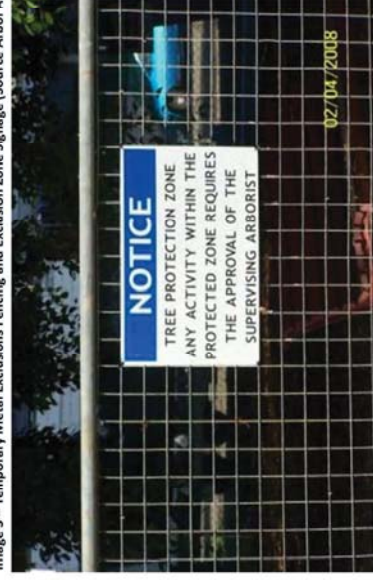
Image 3 – Temporary Metal Exclusions Fencing and Exclusion Zone Signage (Source Arbor Australis)

The Project Manager will be ultimately responsible to the establishment of or engage a contractor to establish the necessary Tree Protection Fencing in accordance with the recommendations by Project Arborist. Tree Protection Fencing must be erected under the direction of the Project Arborist and remain erected prior to and during all phases of the clearing and construction. Fencing may only be removed once construction works have been fully completed. Tree Protection Fencing requirements are outlined below:

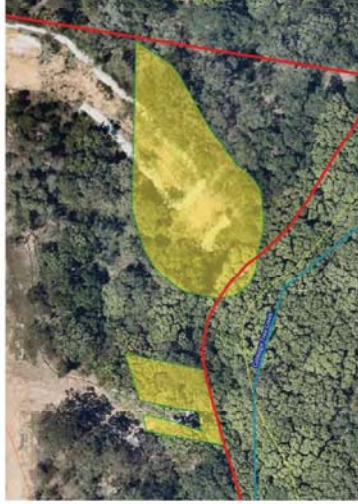
Inset 2 – MU1A Areas illustrating the extent of clearing works within the riparian areas of Cabbage Tree Creek (Preclear RE12.3.7)

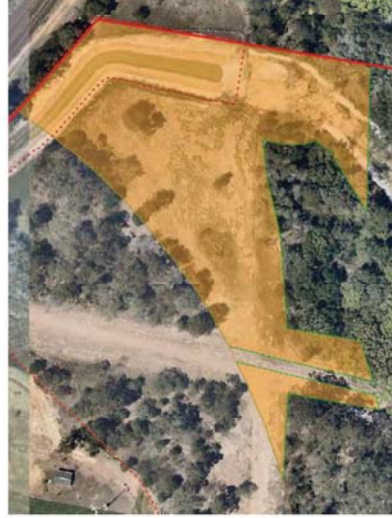
Inset 3 – MU1B Open grassy expanses on the upper alluvial terraces (Preclear RE12.3.11b)

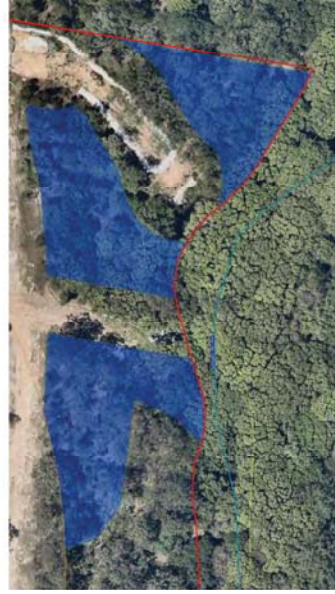
Inset 4 – MU2 and the degraded alluvial terrace

MU 2 is located within the far south eastern extent of the CV boundary and encompasses an existing patch of highly degraded vegetation. The existing vegetation is dominated by *Cinnamomum camphora** (camphor laurel), a highly invasive woody weed species with some highly scattered juvenile native canopy trees. This MU is considered to be non-remnant vegetation for the purposes of satisfying the compensation requirements under the FBMP and is a total of 0.59 hectares

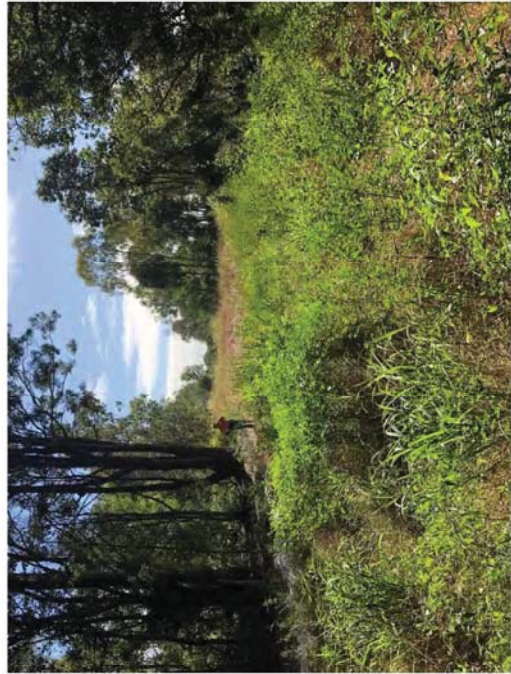
Inset 1 – View of MU1A - area subject to recent clearing for stormwater management for Stage 5.

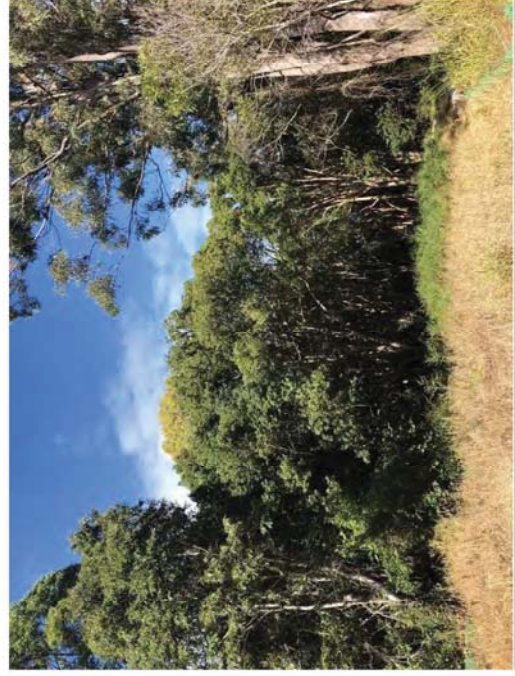
Inset 5 – View of MU2 and the significant areas dominated by camphor laurel

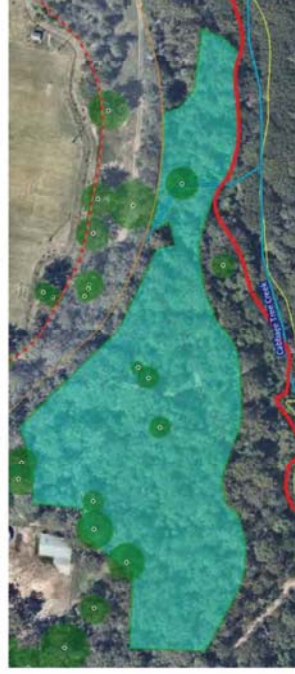
Inset 5 – View of MU4 and the extent of remnant vegetation to be subject to ANR

This community has a strong natural resilience and will benefit from weed management measures. The intent for this MU is to retain and enhance the open forest communities through natural regeneration methods. The main focus within this MU is to control, treat and remove the pest plant species, most notably the exotic understory. There are numerous exotic species present that will require attention the majority of which are listed in **Table 8**.

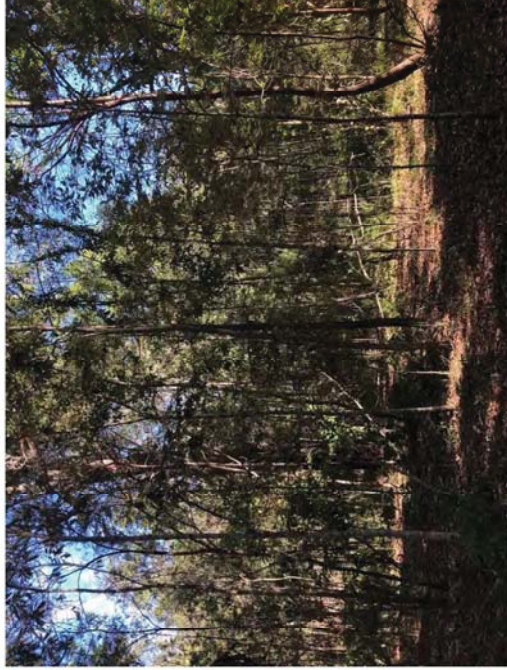
Inset 7 – View of regrowth forest (MU3) and the dense stands of Acacia

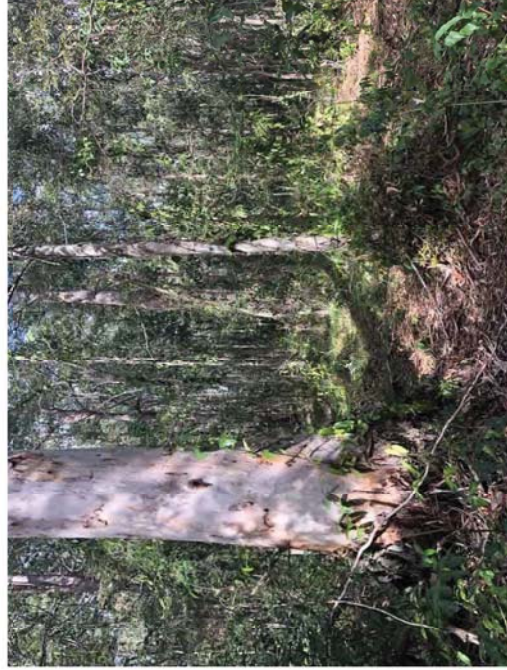
Inset 8 – View of remnant open forest community (MU 4)

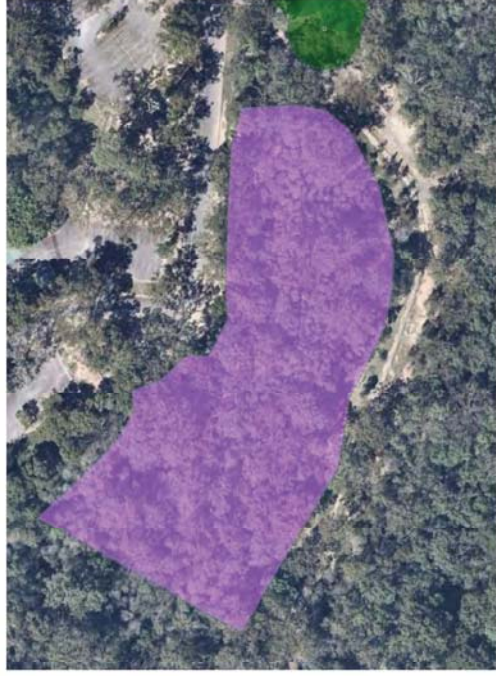
Inset 6 – View of MU3 and the expansion of regrowth forest

Where canopy gaps occur as a result of thinning activities, and/or native recruitment is limited after the initial 3 months of intensive Assisted Natural Regeneration (ANR) management works, in-fill planting will be undertaken. This will involve the planting of locally sourced native tube stock derived from **Table 5** which is derived from RE12.3.11. It is expected that a level of in-fill planting will be required, mainly for the ground cover strata. This forms compliance with Item a) iv) of Condition 32 for Stage 1.
